**OWLETT'S MANSION - MAIN HOUSE:  
ROOF GUTTERING DISCHARGE OUTLET**

**Defect Summary:**

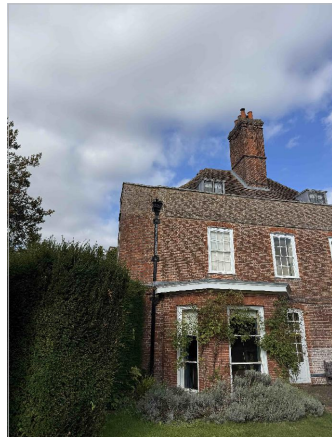
1. VIEW OF SOUTH EAST ELEVATION

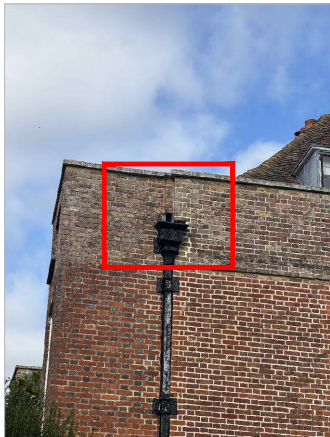
2. VIEW OF THE DRAINAGE OUTLET, HOPPER AND DOWNPIPE

The existing rainwater outlet serving the south east elevation of the main house is undersized in relation to the roof area it drains. The current opening measures approximately 110mm in width, creating a restricted discharge point for a comparatively large volume of rainwater

During periods of heavy rainfall, the outlet does not allow water to discharge at a sufficient rate. This results in water backing up behind the parapet gutter, increasing the risk of overflow and ponding at high level. The slow discharge is contributing to water penetration at the roof parapet, with moisture tracking into vulnerable masonry joints and roof details.

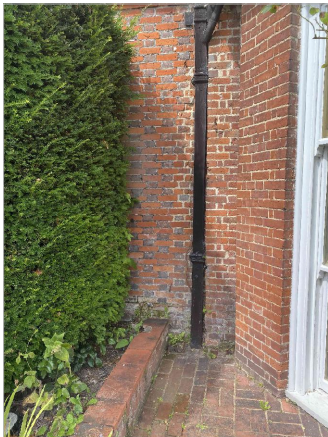
3. GULLY WHERE THE DOWNPIPE DISCHARGES

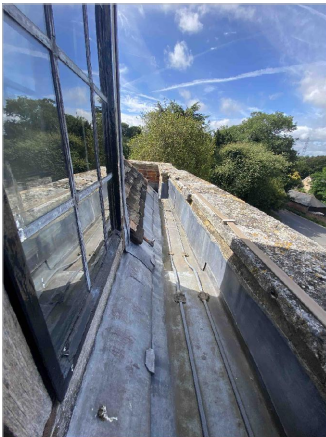
4. LEADED STEPPED GUTTERING BEHIND THE PARAPET WALL

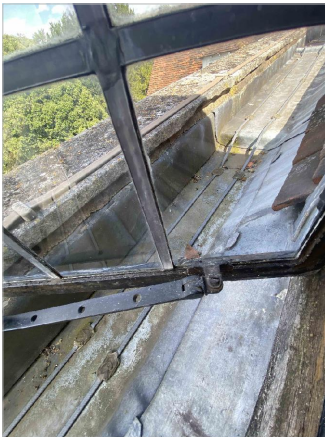
5. LEADED STEPPED GUTTERING BEHIND THE PARAPET WALL

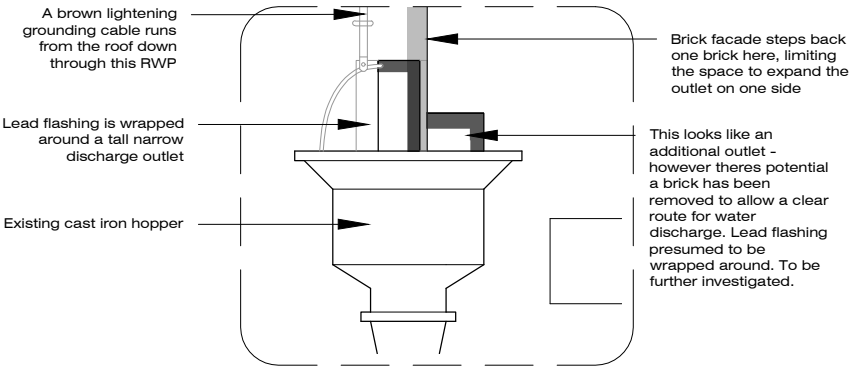
EXISTING DETAIL AA OF WATER OUTLET  
1:20

The restricted outlet width limits hydraulic capacity and places additional stress on the parapet and gutter system. Over time, this condition increases the likelihood of damp ingress, masonry staining, and accelerated decay of the parapet structure. The defect is therefore functional rather than aesthetic, arising from inadequate capacity for modern rainfall intensity and the roof catchment area it serves.
