**STRUCTURAL APPRAISAL OF GARDEN STRUCTURES**

**OWLETTS, COBHAM, KENT  
FOR  
THE NATIONAL TRUST**

| SFK Document No: | | 25198/R01 | | |

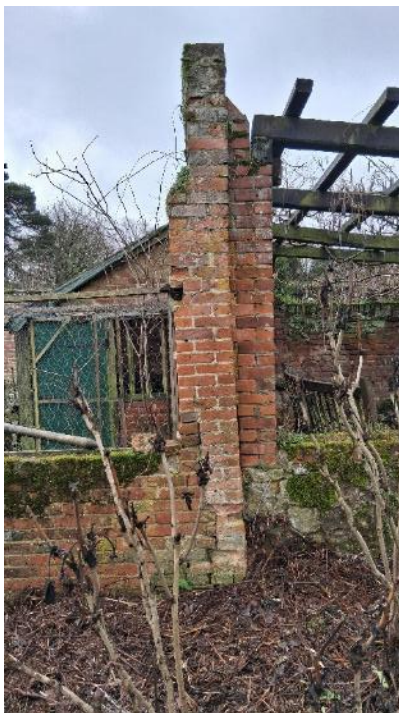
The garden wall in question is approximately 3.25m high. It is 335mm thick at its base and reduces in thickness with the top 700mm being 215mm thick. To the north side the wall forms the rear wall of a potting shed. To the South side the wall supports a timber pergola which has partially collapsed. An additional skin of brickwork has been partially added to this side of the wall presumably as part of works in the past, to install the pergola.

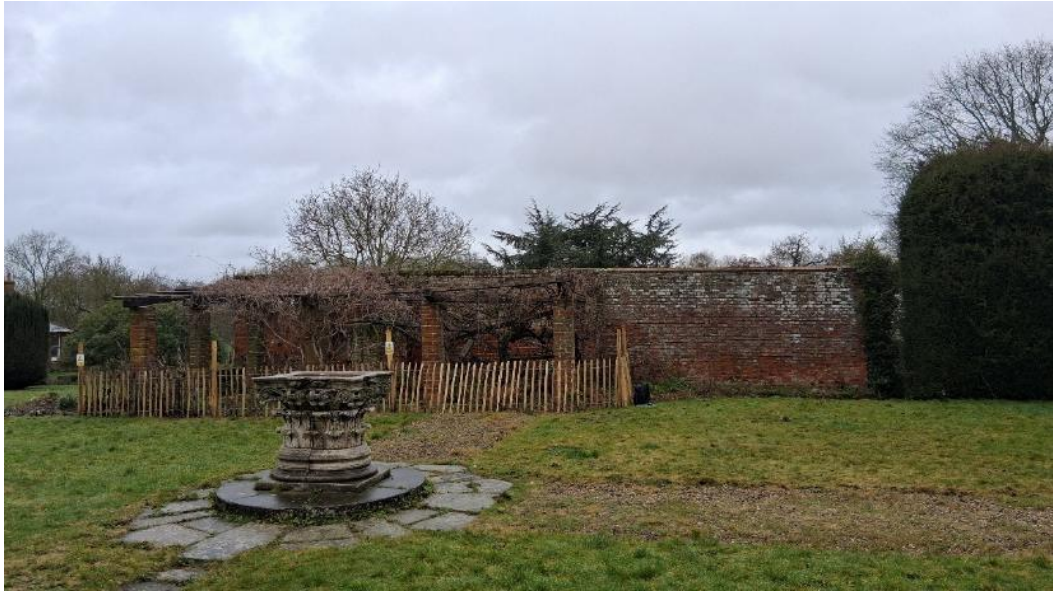
A timber pergola formed in 150 x 150mm beams overlaid with 100mm wide x 70mm deep timbers at 680mm centres, supports a large wisteria.

A large section of the Pergola has collapsed, and the remaining beams have deflected significantly with one further timber soon to fail.

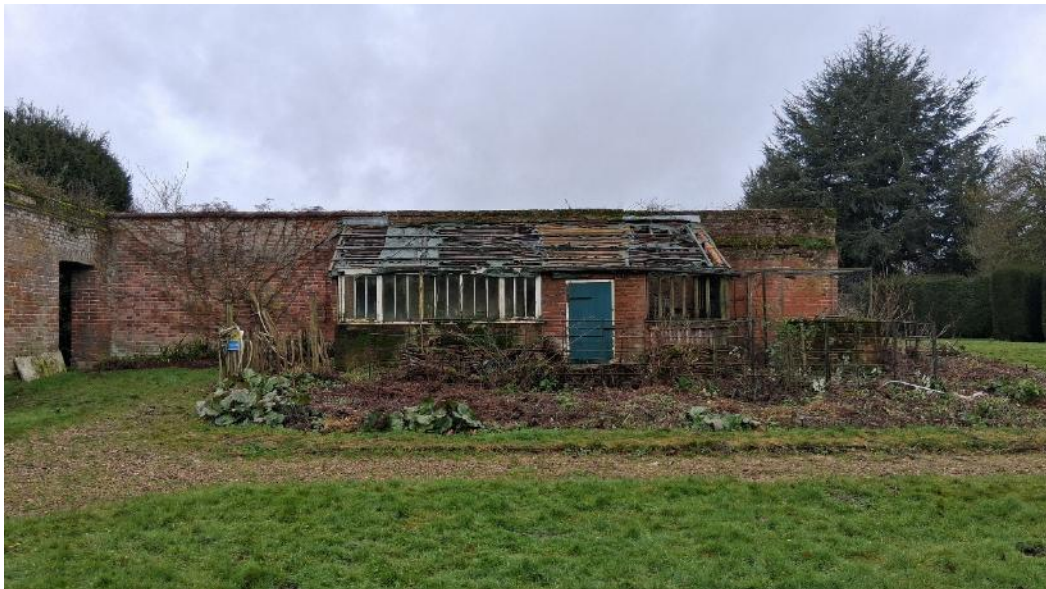
The potting shed runs along the North side of the wall for approximately 10m. It has a mono-pitch roof that extends, to within 350mm of the top of the wall. The pitched rafters span the full width of The Potting Shed (2m) and rest on the external wall of either brickwork or timber framed glazing.

The roof has no waterproof covering at present, and battens suggest that it was once finished in clay tiles. The timber rafters are 100 x 50mm timbers at 380mm centres.

At the garden wall end the bearing to the rafters has rotted causing the roof to drop and push out. This has caused the external wall to push outwards. At the eaves, many rafters do not reach the wall. Most of the softwood rafters are suffering from a combination of wet rot and have significant beetle infestation.

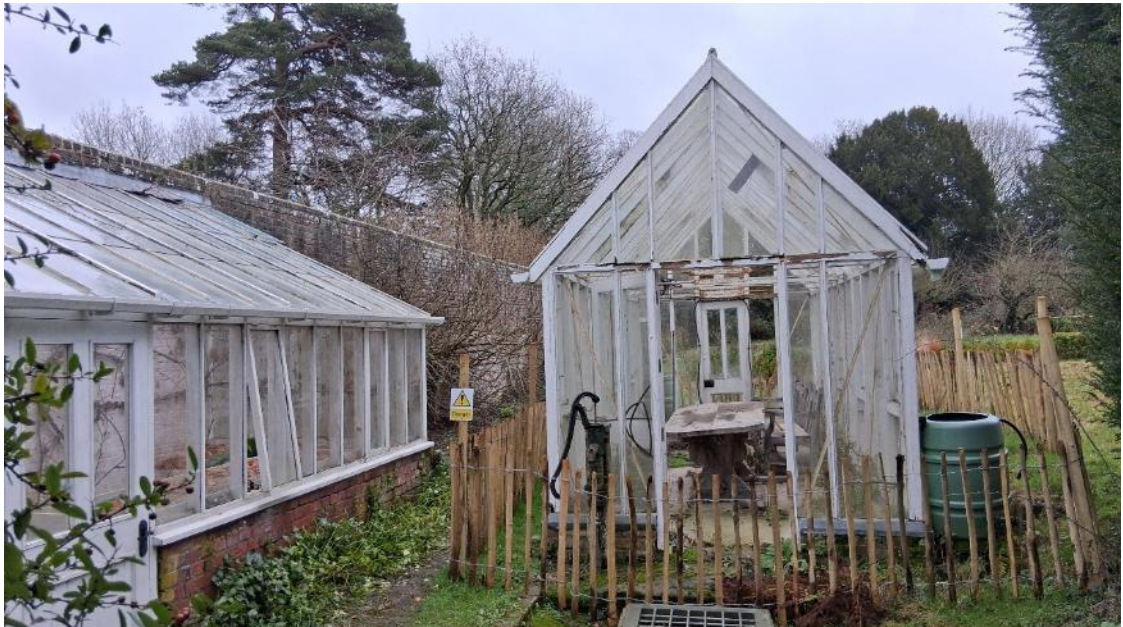
A modern Greenhouse is located within the walled garden, situated less than 2m from an historic glass house built into the garden wall.

The Greenhouse has significant wet rot at the base of the timber posts, and the exposed top surface of the rafters is also suffering from wet rot.

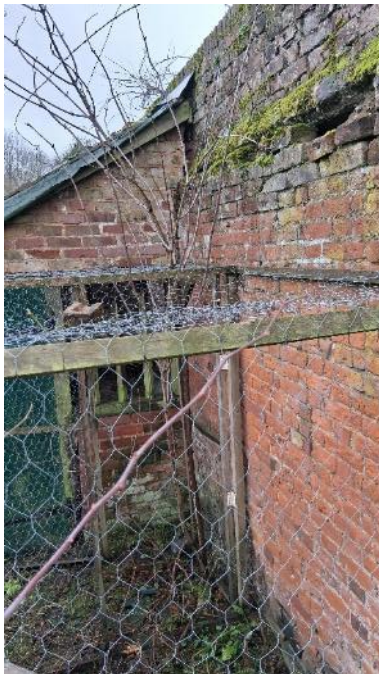
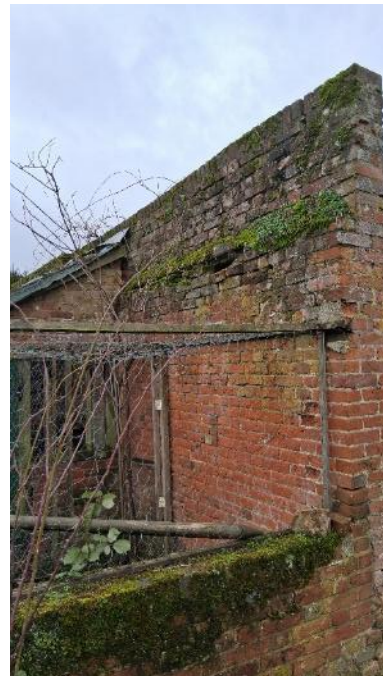
Within the potting shed the wall requires localised and some repointing in a lime mortar. There is an old flue formed within the wall midway within the potting shed. This requires some localised brick repairs to reinstate collapsing walls.

At the western end, beyond the potting shed the top 17 courses are in poor condition and require repairs comprising consolidation of the brickwork and repointing using lime mortar.

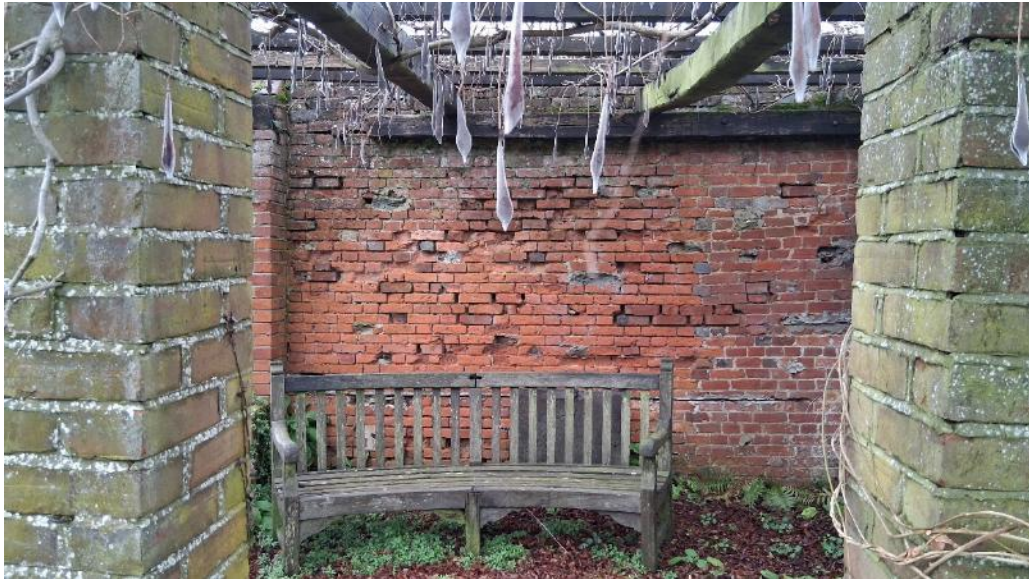
On the southern side of the wall (The pergola side) the western end is in poor condition. It was noted that the timber plate supported on the wall originally relied upon iron brackets built into the wall. These have corroded and have caused jacking of the top course of brickwork, leaving a significant horizontal crack. Corrosion jacking will continue unless the iron components are removed from the wall. It is recommended to remove the iron and re support a new timber plate with stainless steel fixings to the wall.

The brickwork facing added to the wall is in poor condition. It appears that the brick used was a soft brick and the face has eroded badly, most likely exacerbated by the

use of an inappropriate mortar. Whilst this is in poor condition and could be improved this is not a priority from a structural point of view, and could be left as it is for now.

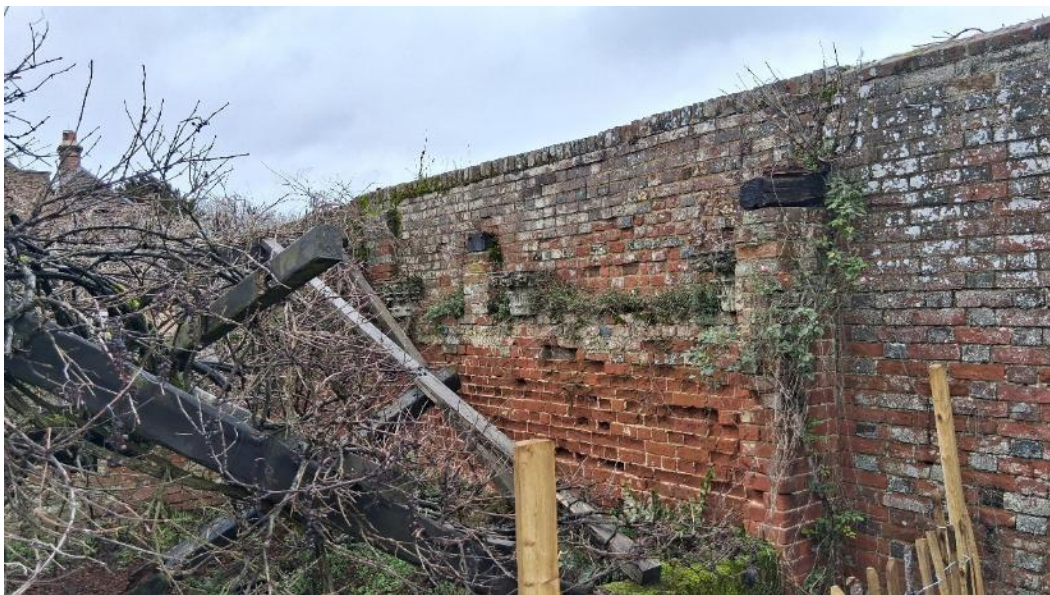
East of the pergola the wall is in reasonable condition, but the joints require raking out and repointing across the full height of the wall.

There is vegetation growing within the wall on the southern side that should be carefully removed, including all roots. This may require some localised rebuilding of the wall.

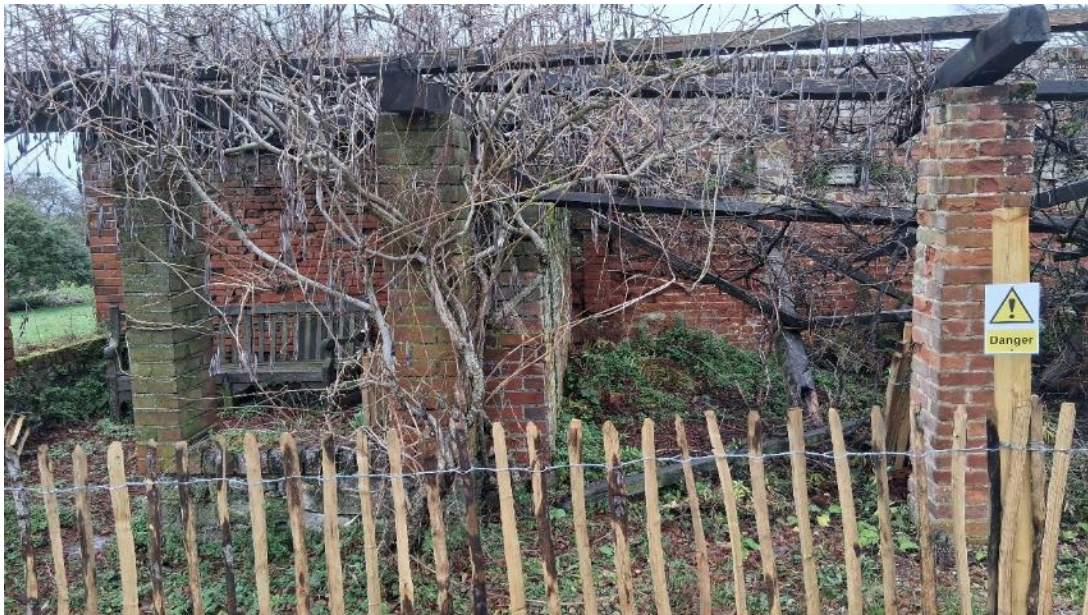
The pergola has partially collapsed, and the standing sections are close to collapse. The reason for collapse is likely to be the rot within the timber causing a significant weakness. The section size of the main timber beams is relatively small for the span. The capacity of the beam has been estimated to be 16kg per square metre. The Wisteria has become very large, and presumably it will do so again so we recommend increasing the size of main beam slightly to 200mm x 200mm. This will more than double the capacity and reduce excessive deflections. The rails between the beams could remain 100mm wide by 75mm deep but should also be lin oak to improve longevity.

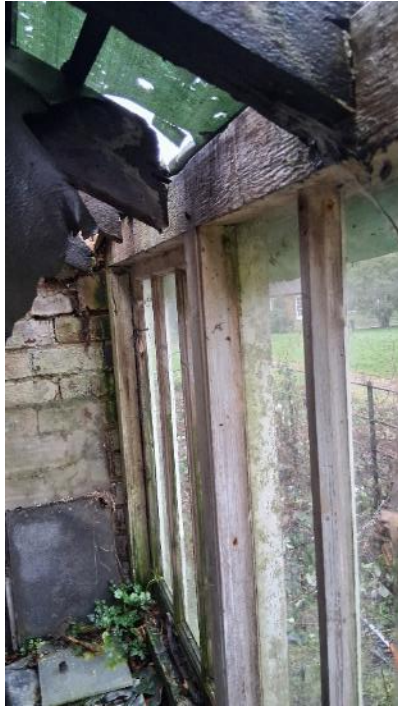
The potting shed roof requires replacement. The existing softwood rafters are beyond reuse, due to either decay, infestation. In some cases, the rafters do not reach from the brickwork wall the external wall due movements affecting the geometry. It is recommended that timber rafters are replaced on a like for like basis. If they are to be exposed consideration could be given to using Douglas Fir sections which will give a like for like appearance.

A new timber supporting plate should be fitted at the top of the brickwork wall to support the rafters ends. Given its vulnerability to damp ingress through the wall, consideration should be given to this element being in oak secured with stainless steel fixings. An alternative might be to use Douglas Fir with a damp proof material placed between the timber plate and the brickwork.

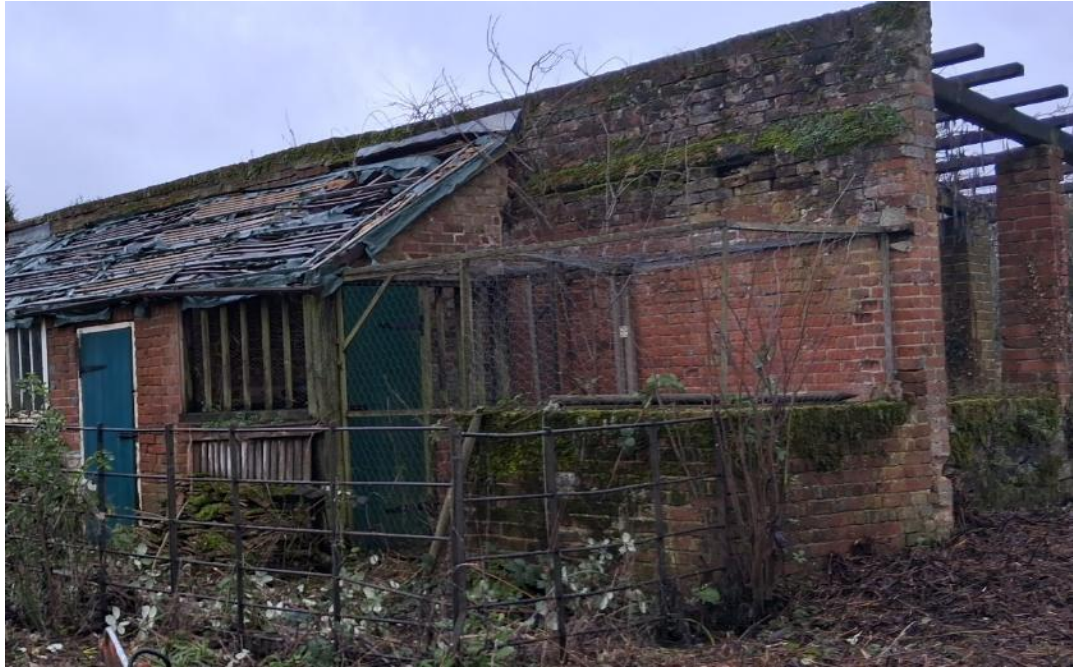
The northwest end wall has dropped relative to the main brickwork wall. This appears to have been caused by a rotten softwood post end which is supported on a square tapered staddle stone. The wall is 100mm thick brickwork largely supported of a timber frame and has wide joint with the main wall, caused by the movement. Given the wall is only half brick thick effective repairs are difficult. It is recommended to carefully take down the brickwork, form a new timber post in oak and rebuild the wall in the existing bricks in a lime mortar. This also gives the opportunity to repair the supporting timber frame should this prove to be necessary once all its surfaces are exposed.

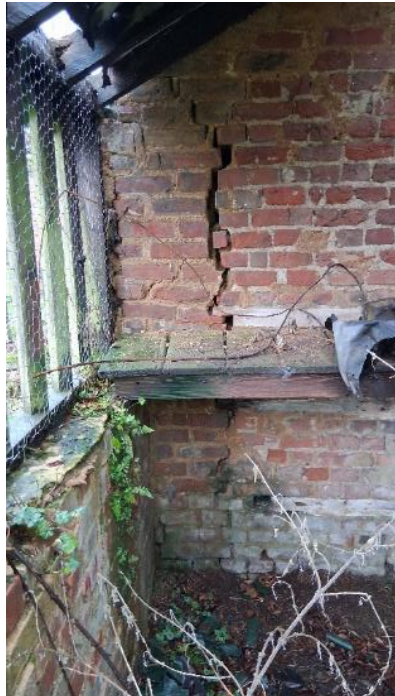
One cross wall has a significant vertical crack approximately 300mm from the external wall. The crack is approximately 20mm wide at the top to zero at the bottom of the wall. The most likely cause of this crack is the roof spreading as a result of loss of support at the top of the main wall. This crack requires repair by locally stitching in new brickwork to match existing and inserting stainless steel helifix bars in the bed joints, to every third joint.

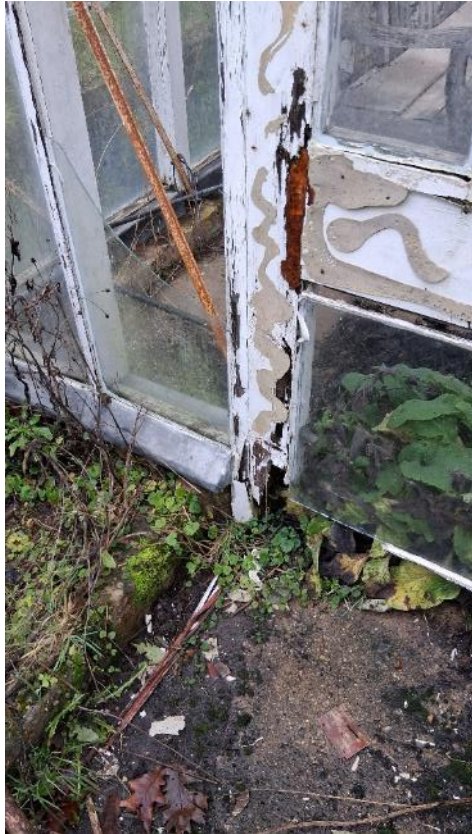
The greenhouse has significant wet rot at the base of the timber posts, and the upper surface of the rafters are also suffering wet rot. To make this area safe the glass needs to be completely removed. It is likely that timber repairs are such that the timber frame will need to be dismantled. Given that this is a modern structure we would recommend fully dismantling it.
