## Kent Minor Works Scope Document

Gravesend Old Town Hall

GTH-STL-XX-XX-RPT-S-0109

### 3. Schedule of Works

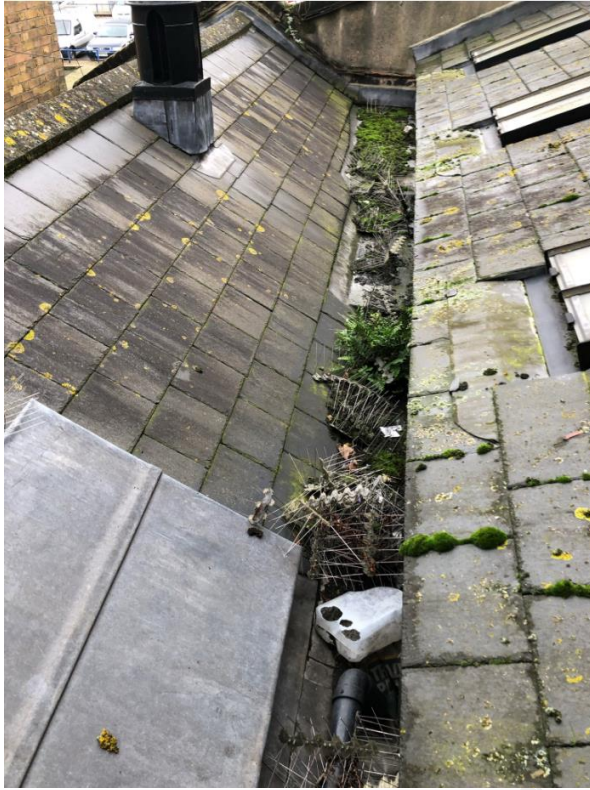
*Figure 1 – Roof and Valley*

| Item | Description | Estimated Quantity | Ref. |
|---|---|---|---|
| 1 | Roof: Cleaning of roof surface and valley gutters | Allow for 300m2 | Figure 1 |
| 2 | Roof: Replace artificial slates on roof where missing, displaced or they have become loose | 100m2 | Figure 1 |

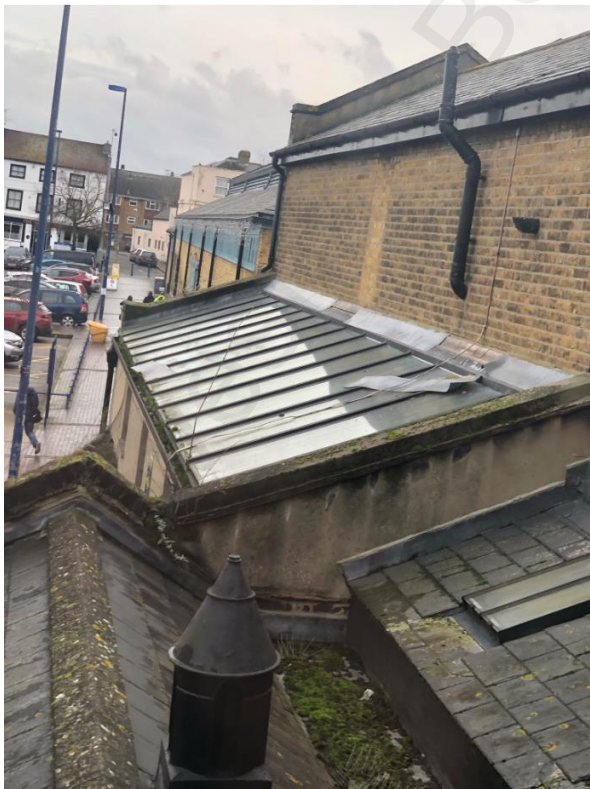
*Figure 2 – Down Pipes and gutters*

| Item | Description | Estimated Quantity | Ref. |
|---|---|---|---|
| 5 | Clearance of gutters and jetting down pipes | | Figure 2 |

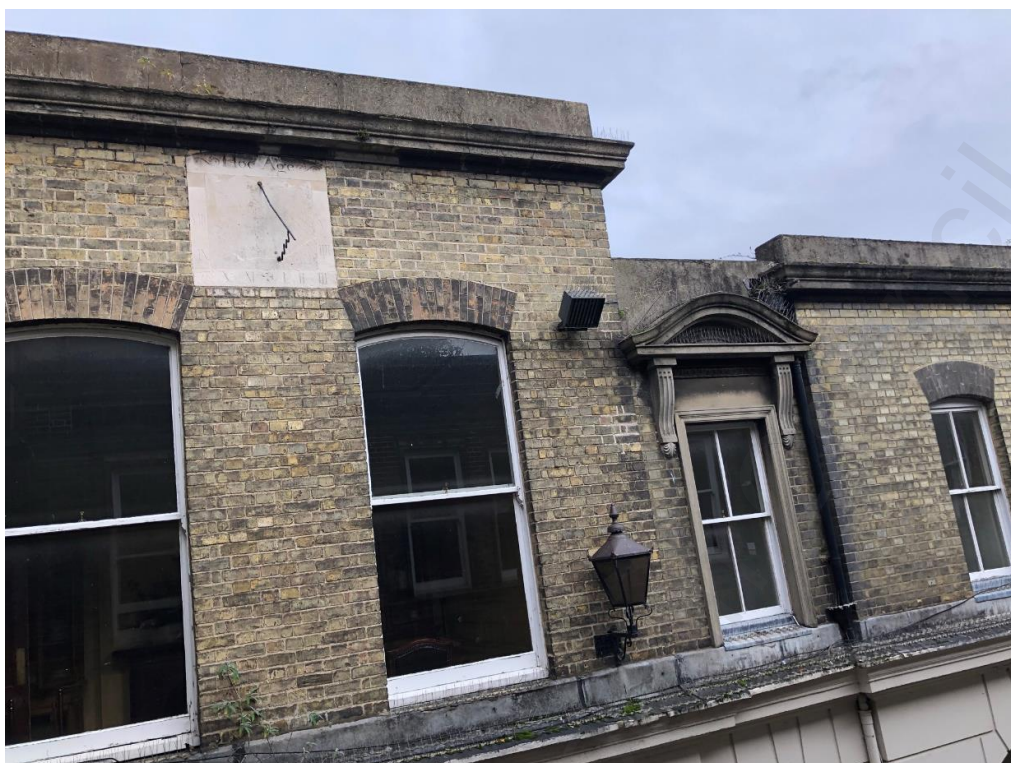
*Figure 3 – Stone and Render repair*

| Item | Description | Estimated Quantity | Ref. |
|---|---|---|---|
| 6 | Visual Survey to all elevations to determine condition of stonework/stucco | | Figure 3, 4,5,6 |

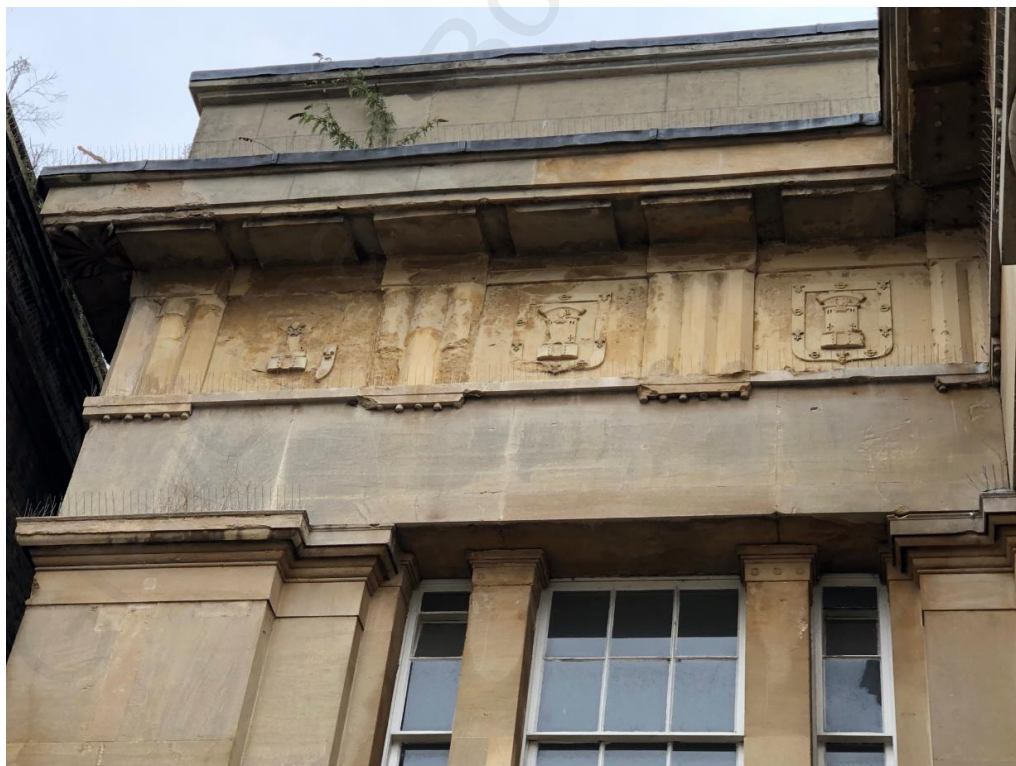
*Figure 4 – Stone repair – LHS of portico at main front entrance Gravesham coat of arms detail eroded*

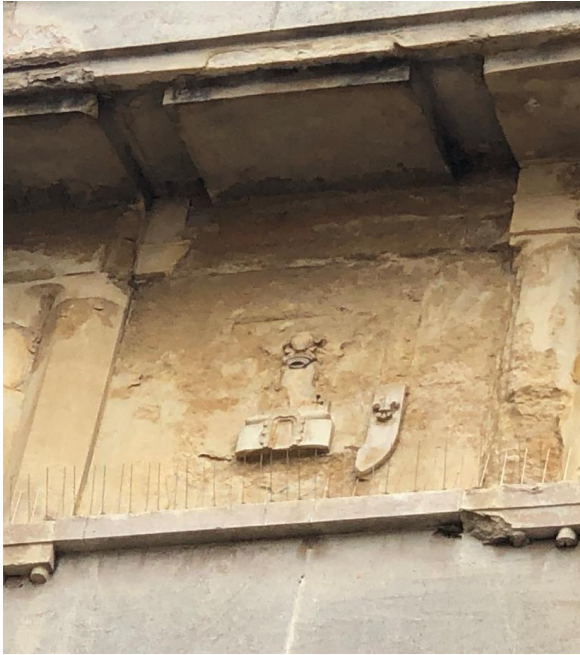
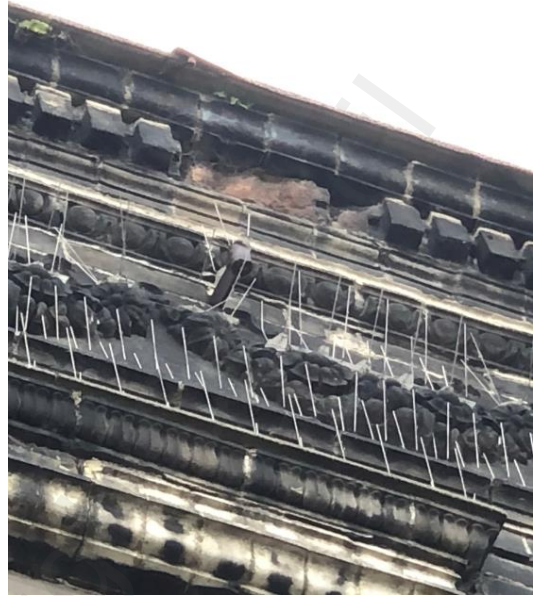
*Figure 5 – Stone repair to portico and thoroughfare*

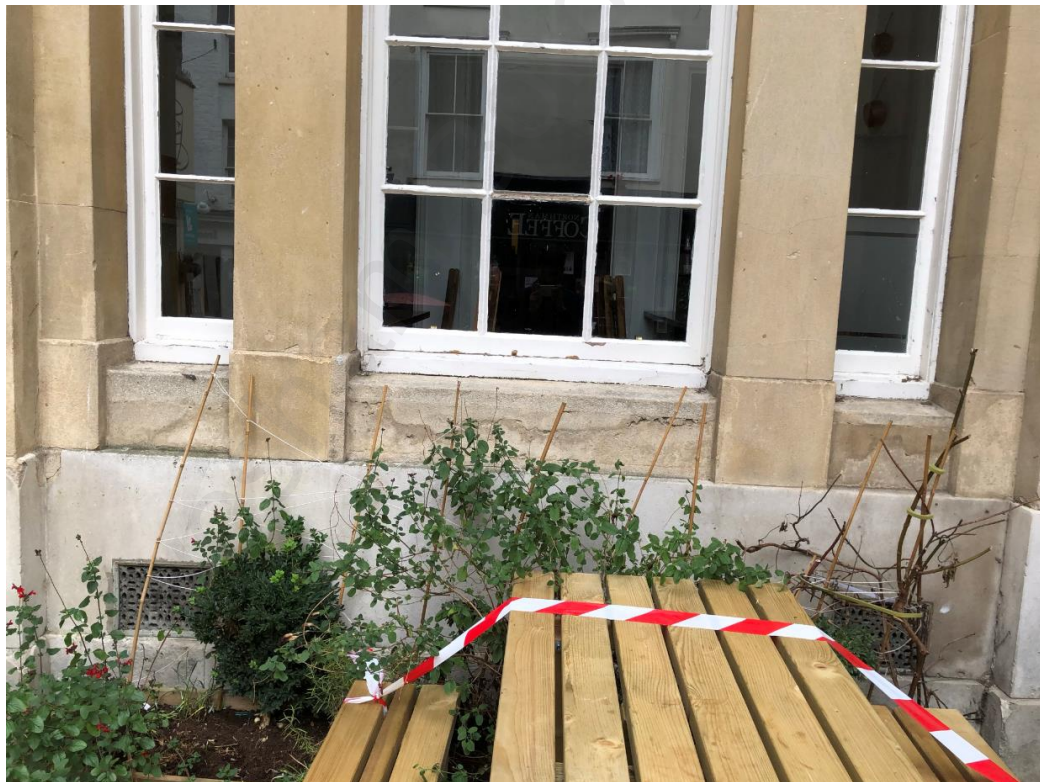
*Figure 6 – Stone repair*

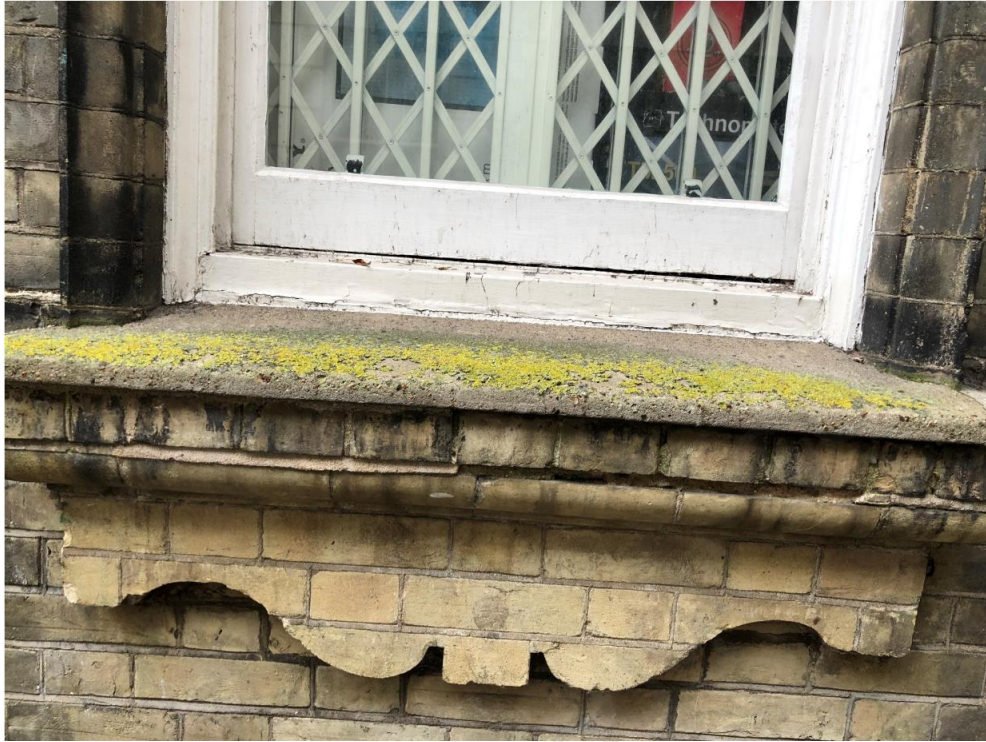
*Figure 7 – Window repair and repaint*

| Item | Description | Estimated Quantity | Ref. |
|---|---|---|---|
| 7 | Windows: timber repair including sills where decayed | | Figure 7 |
| 8 | Windows: decorate timber and timber sashes | Allow for 55 No. windows | Figure 7 |

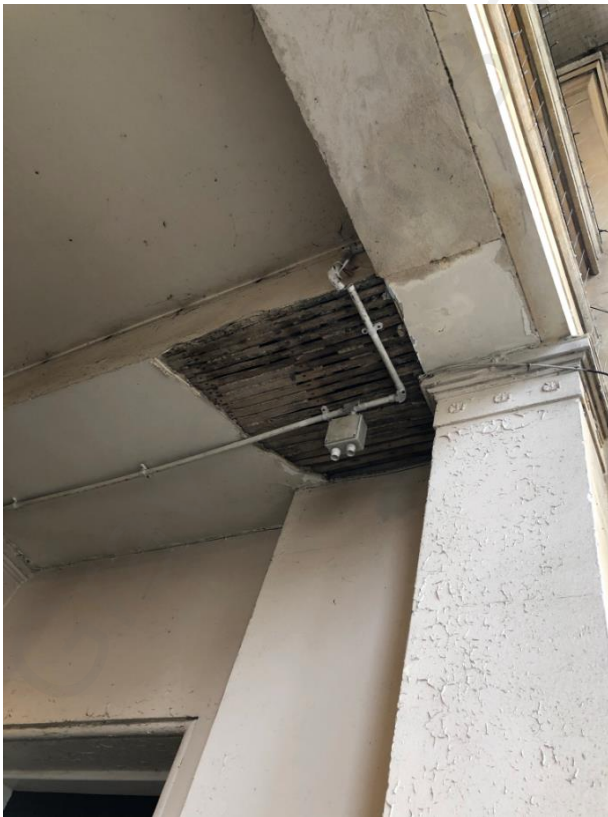
*Figure 8 – Undercroft repair*

| Item | Description | Estimated Quantity | Ref. |
|---|---|---|---|
| 9 | Undertake render repair to undercroft soffit | 5m2 | Figure 8 |

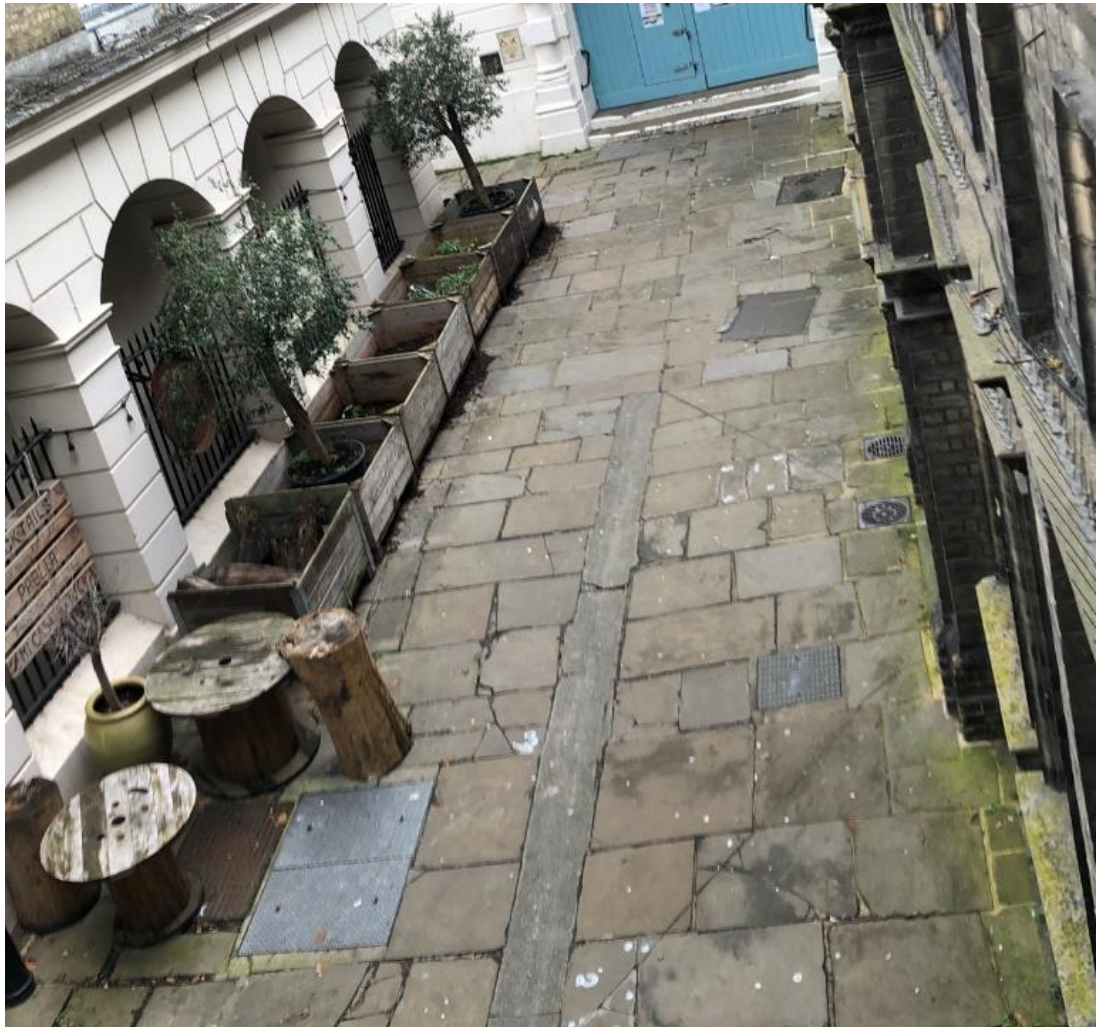
Figure 9 Replace/Re bed damaged/undulated pavers within thoroughfare

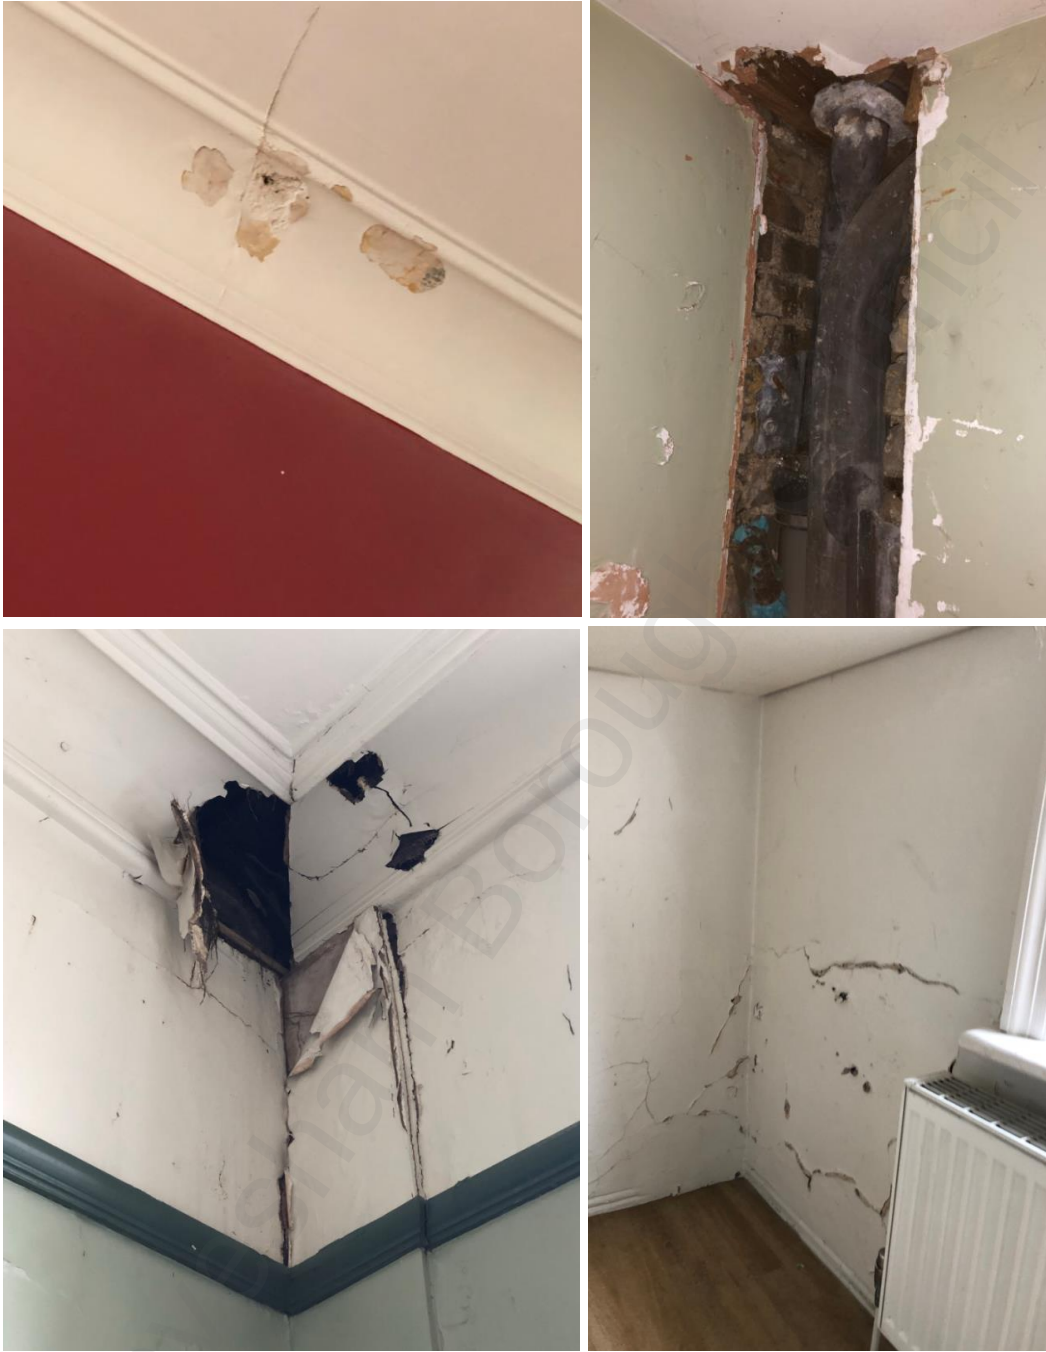
Figure 10 – Plaster and rainwater pipe repairs

| 16 | Plaster repair to exposed lathes within room 1.014<br><br>[coving repair/replacement required] | Allow for 5m2 | Figure 10 |
| 18 | Hack off damp plaster to entrance staircase (G.027 – G.029) and within the main hall (1.024), first floor corridors (1.011)<br><br>Allow for wall to dry<br><br>Renew plaster with lime-based plaster and decorate to finish | Allow for 30m2 | Figure 10 |

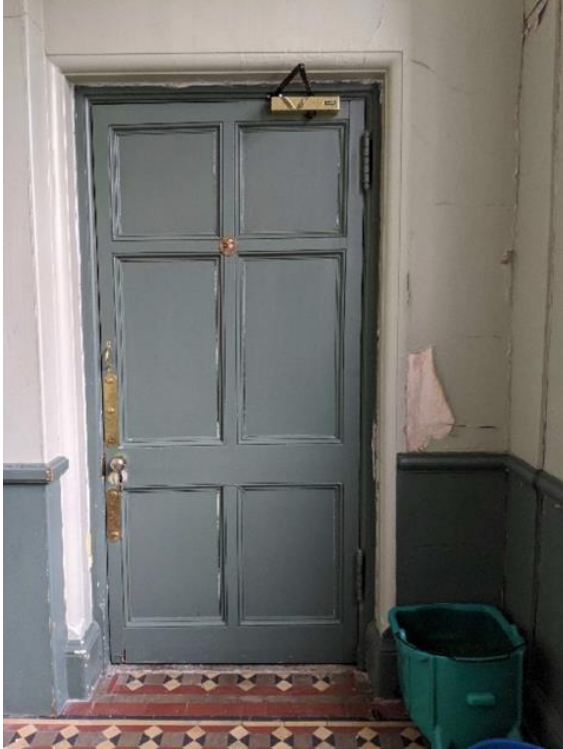
*Figure 11 Fire Door*

| Item | Description | Estimated Quantity | Ref. |
|---|---|---|---|
| 10 | Doors: Splice repair where decayed | | Figure 11 |

| 19 | Original panelled fire doors to be upgraded and not replaced by using intumescent veneers and paint | Allow for 20 no Doors | Figure 11 |

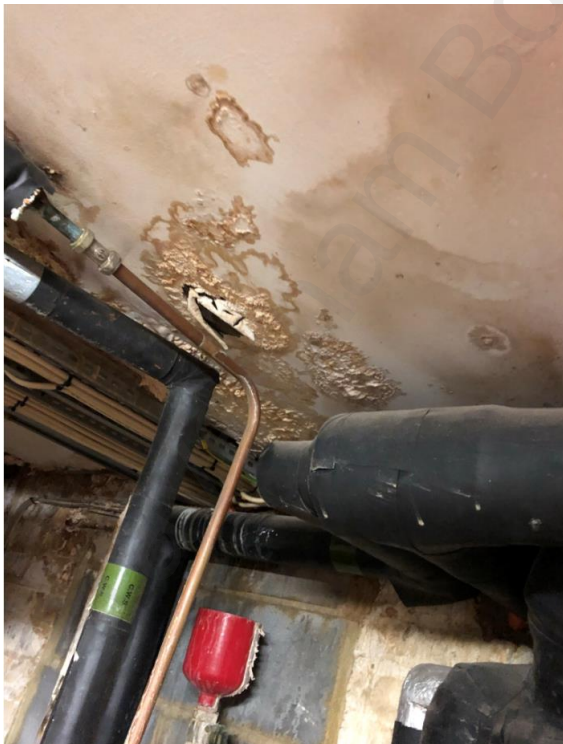
*Figure 12 - Trace and access required to identify source of leak causing damage*

| 17 | Trace and access required to identify and treat source of leak causing moisture in soffit of basement. Directly below G.026. | | Figure 12 |
