# ASBESTOS MANAGEMENT SURVEY

6 Overcliffe Gravesend Kent DA11 0EF

28 Sep 2024

J-2986

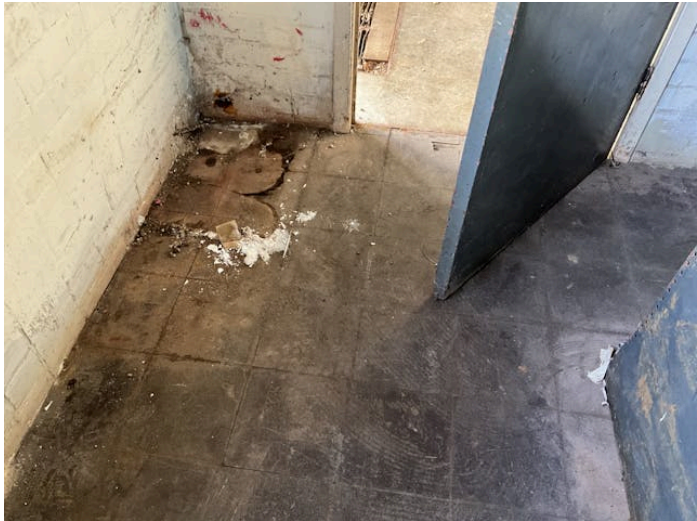
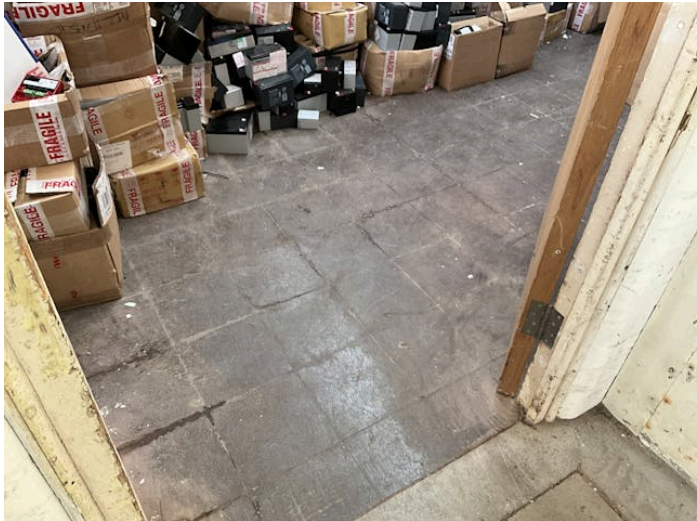
| Location | 001 - Stores | Item | Floor tiles and adhesive |

| Material | Reinforced Plastic | Extent | Throughout |
| Strategy / Sample Id | Sample / 007 | Fibre Type | Chrysotile |

| Product Type (or Debris from Product) | 1 | Extent of Damage / Deterioration | 1 |

| Recommendation | Manage and annually re-inspect | | |

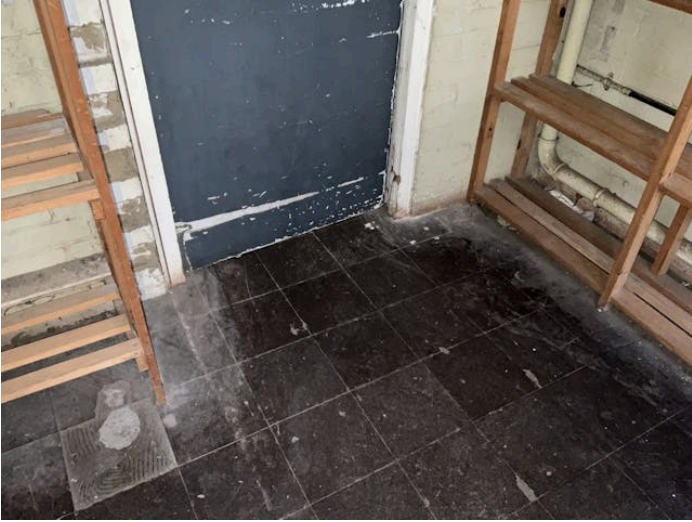
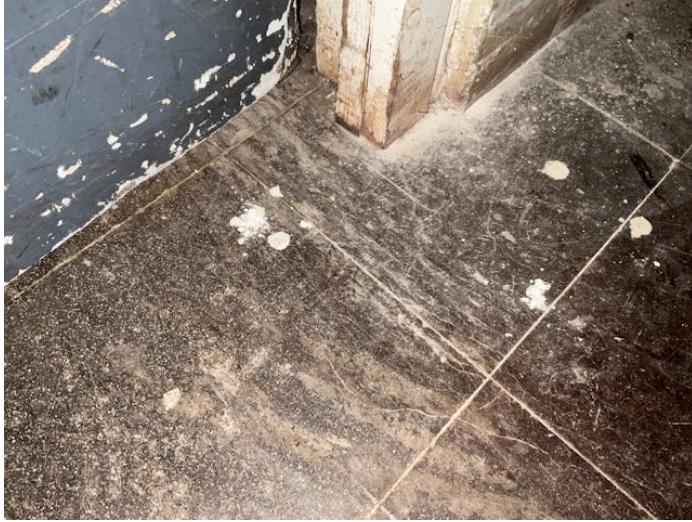
| Location | 001 - Stores | Item | Debris to floor |

| Material | Insulating Board | Extent | Small amounts |
| Strategy / Sample Id | Cross Reference / 008 | Fibre Type | Amosite and Chrysotile |

| Product Type (or Debris from Product) | 2 | Extent of Damage / Deterioration | 3 |

| Recommendation | Removal by licensed contractor | | |

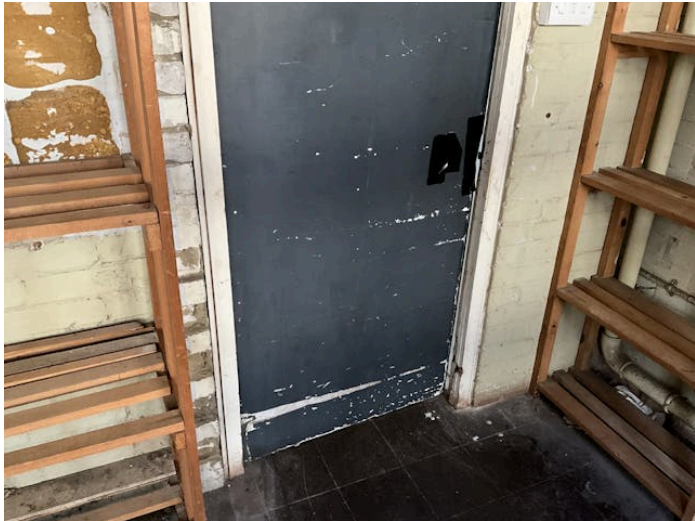
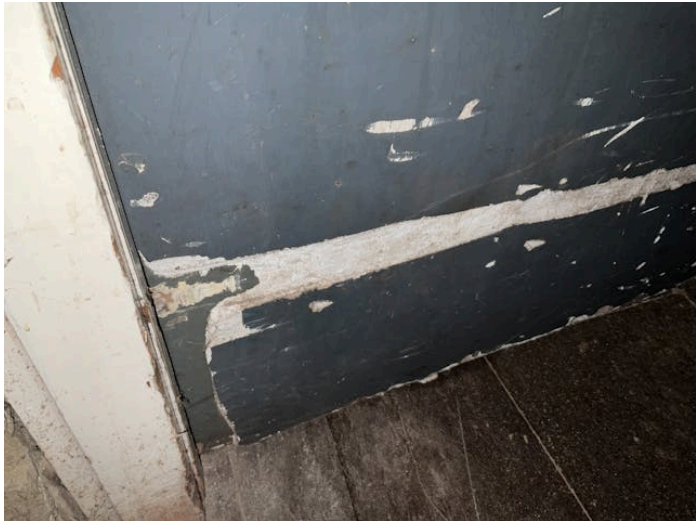
| Location | 001 - Stores | Item | Panels to doors |

| Material | Insulating Board | Extent | 5 No. |
| Strategy / Sample Id | Sample / 008 | Fibre Type | Amosite and Chrysotile |

| Product Type (or Debris from Product) | 2 | Extent of Damage / Deterioration | 3 |

| Recommendation | Removal by licensed contractor | | |

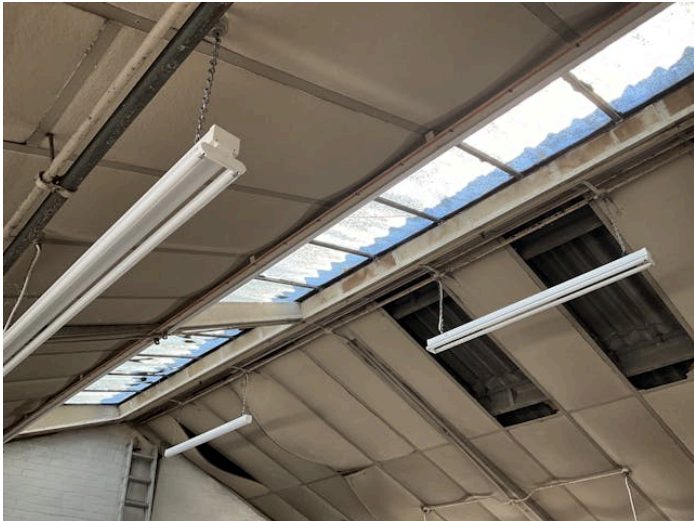
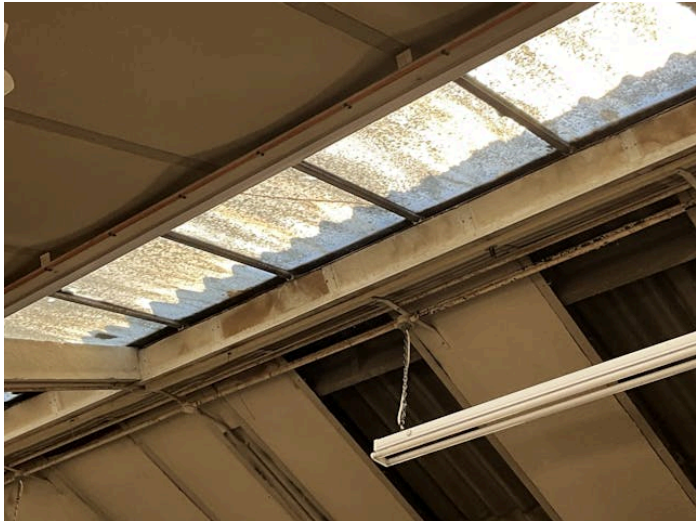
| Location | 001 - Stores | Item | Skylights |

| Access / Notes | No Access / Reasons Of Height | | |

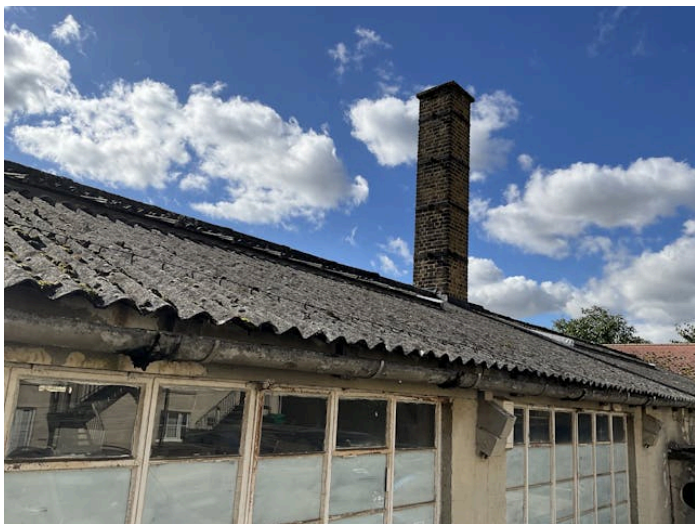
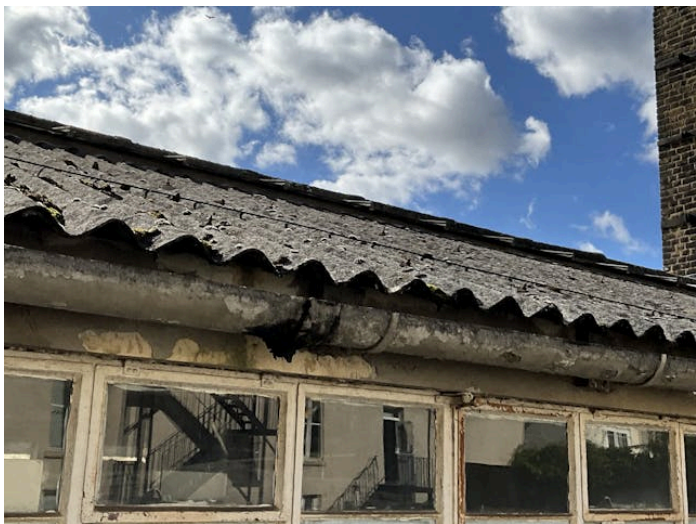
| Location | 001 - External | Item | Corrugated roof sheets and ridges |

| Material | Cement | Extent | 300 sq. m. |
| Strategy / Sample Id | Sample / 009 | Fibre Type | Chrysotile and Crocidolite |

| Product Type (or Debris from Product) | 1 | Extent of Damage / Deterioration | 1 |

| Recommendation | Manage and annually re-inspect | | |

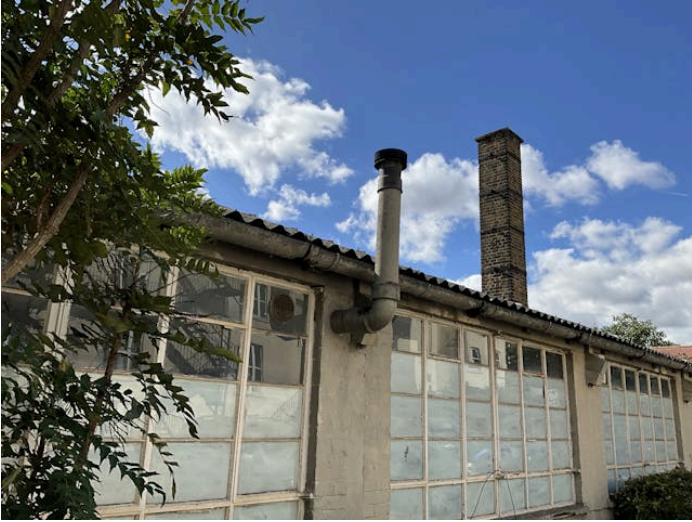
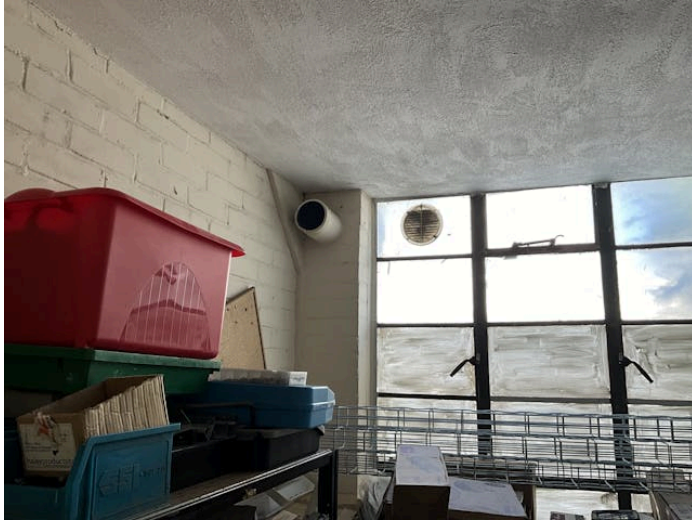
| Location | 001 - External | Item | Flue |

| Material | Cement | Extent | 2 Lm. |
| Strategy / Sample Id | Cross Reference / 009 | Fibre Type | Chrysotile and Crocidolite |

| Product Type (or Debris from Product) | 1 | Extent of Damage / Deterioration | 1 |

| Recommendation | Manage and annually re-inspect | | |

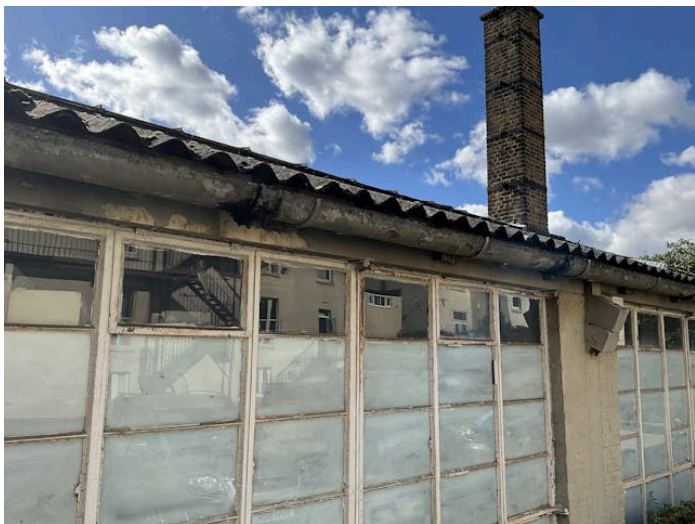
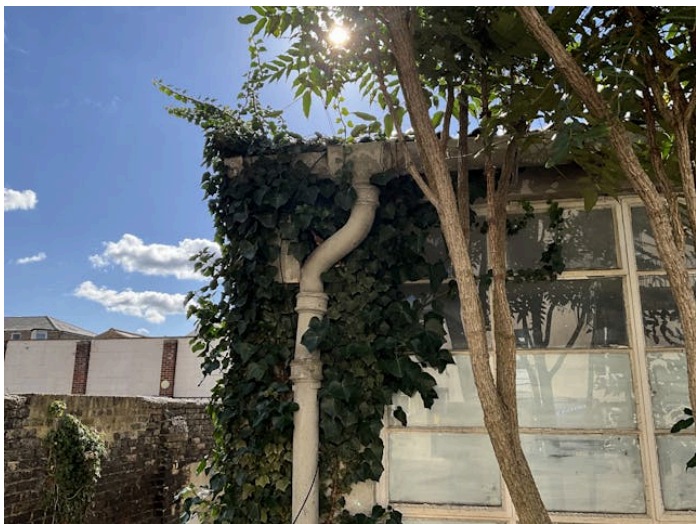
| Location | 001 - External | Item | Rain water goods and down pipes |

| Material | Cement | Extent | 80 Lm. |
| Strategy / Sample Id | Cross Reference / 009 | Fibre Type | Chrysotile and Crocidolite |

| Product Type (or Debris from Product) | 1 | Extent of Damage / Deterioration | 1 |

| Recommendation | Manage and annually re-inspect | | |

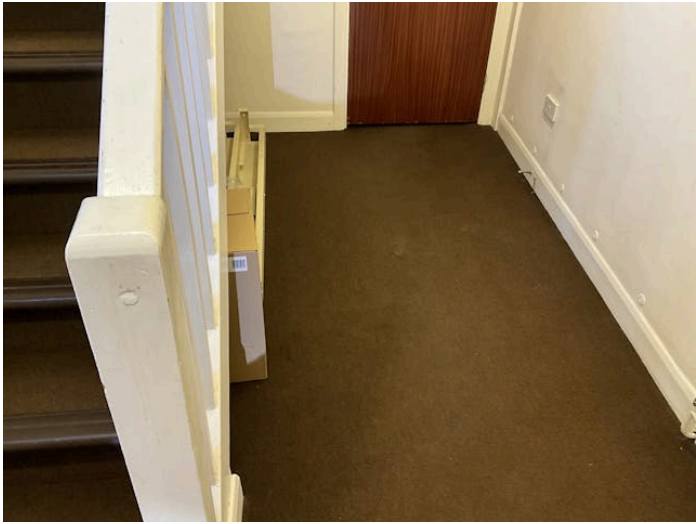
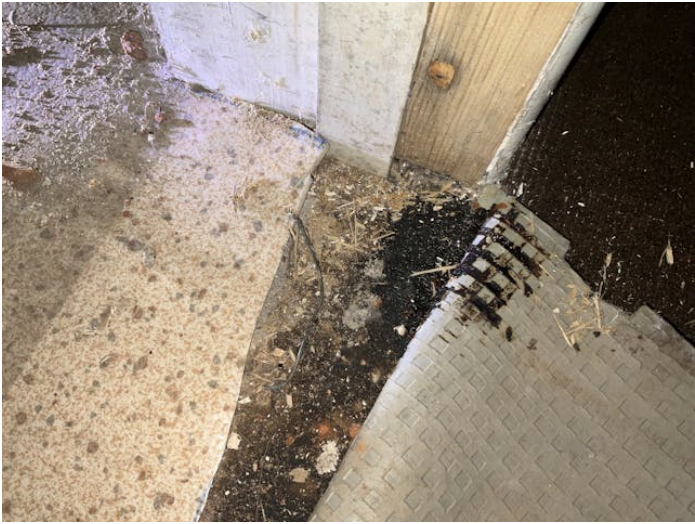
| Location | 001 - Stairs | Item | Adhesive to concrete floor |

| Material | Bituminous Product | Extent | 8 sq. m. |
| Strategy / Sample Id | Sample / 004 | Fibre Type | NADIS |

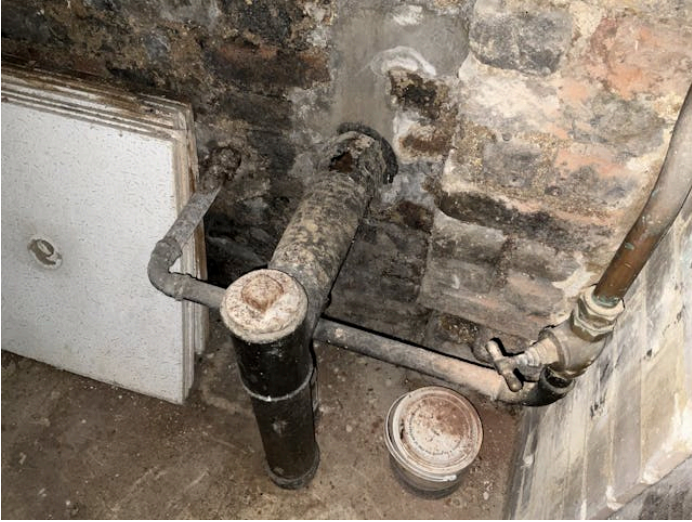
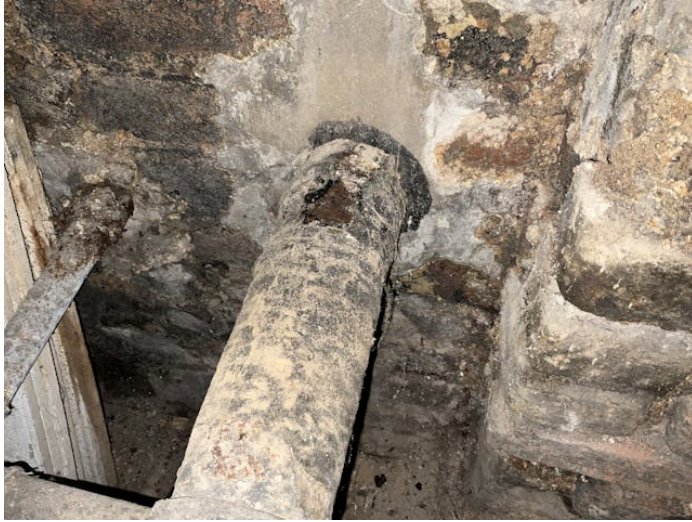
| Location | 002 - Gas Meter Room | Item | Wrap to metal pipework |

| Material | Bituminous Product | Extent | 1 Lm. |
| Strategy / Sample Id | Sample / 005 | Fibre Type | NADIS |

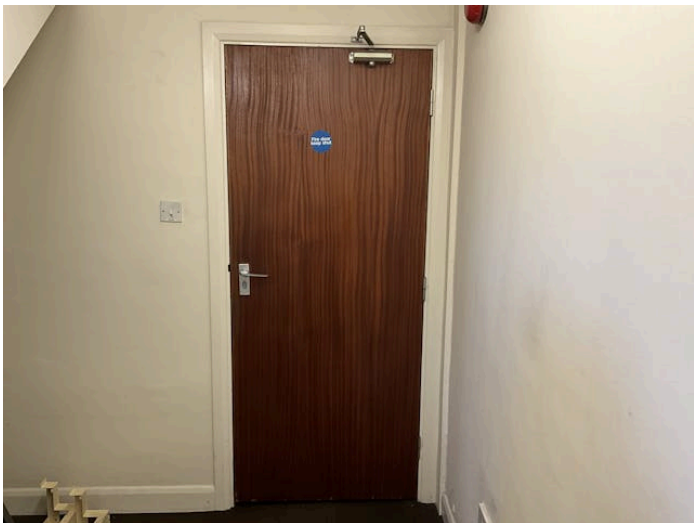
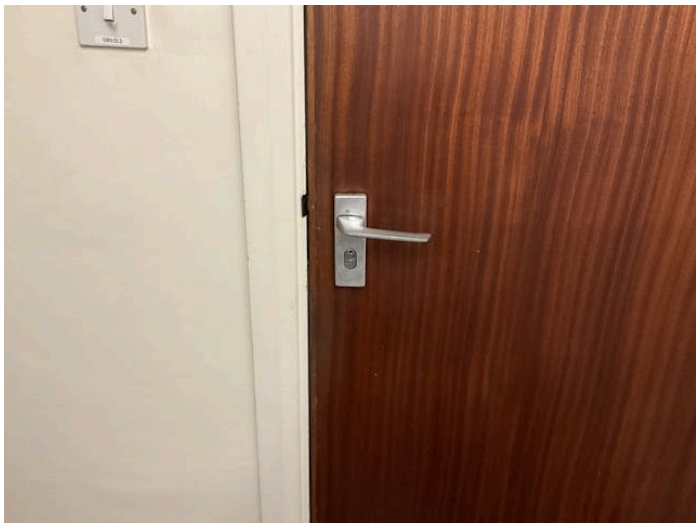
| Location | 003 - Office Areas | Item | |

| Access / Notes | No Access / Locked - Keys Off Site | | |

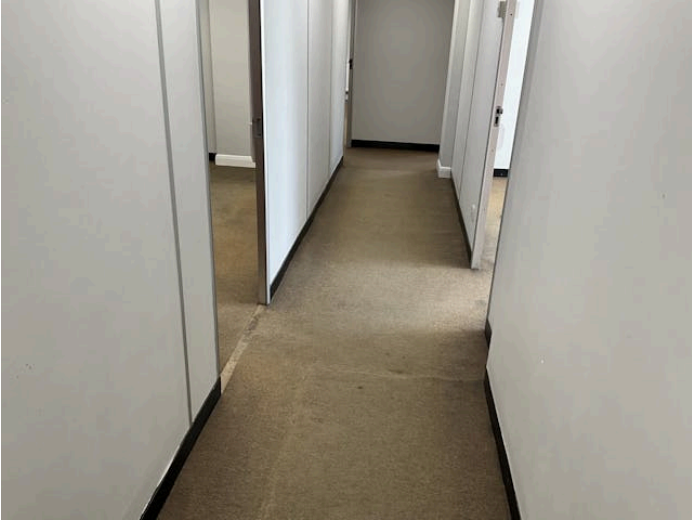
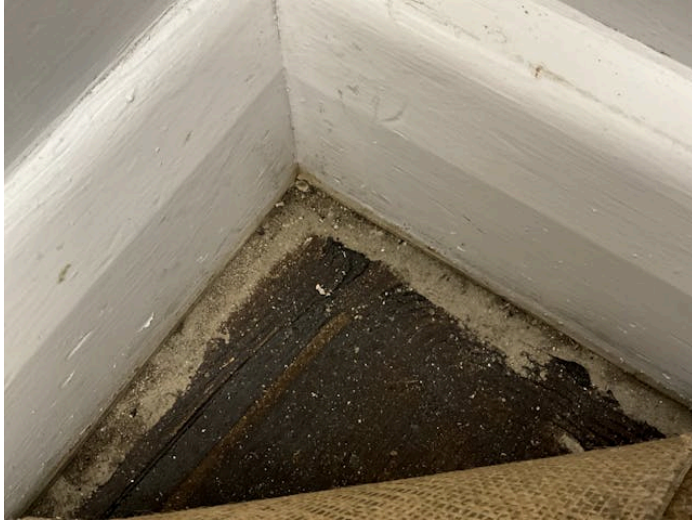
| Location | 007 - Offices | Item | Adhesive to concrete floor |

| Material | Bituminous Product | Extent | 48 sq. m. |
| Strategy / Sample Id | Cross Reference / 004 | Fibre Type | NADIS |

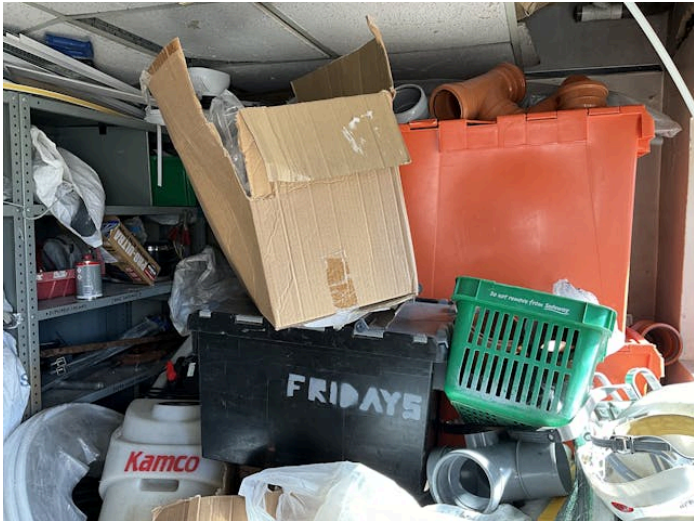
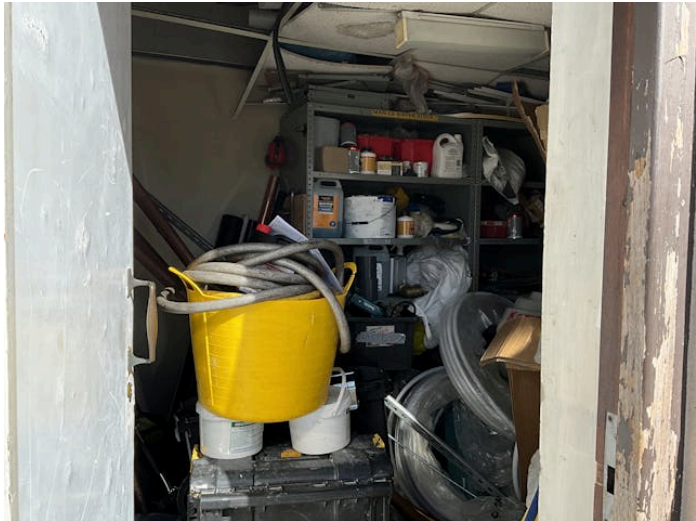
| Location | 008 - Boiler Room | Item | Whole location |

| Access / Notes | Limited Access / Stored items blocking full access | | |

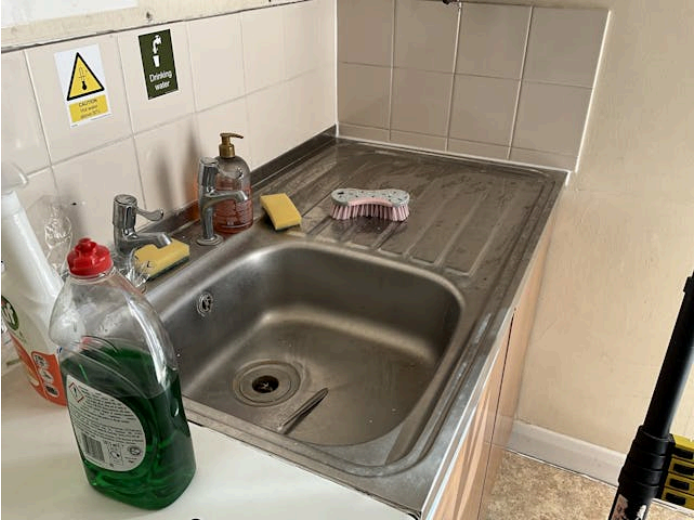
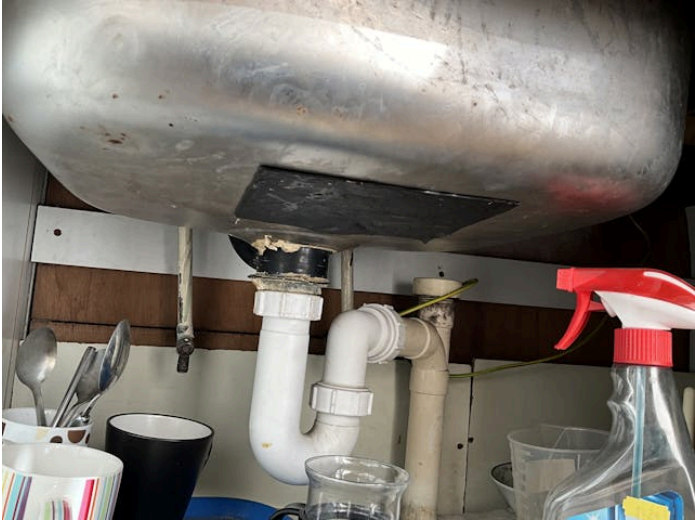
| Location | 004 - Kitchen | Item | Sink pad |

| Material | Bituminous Product | Extent | 2 No. |
| Strategy / Sample Id | Cross Reference / 002 | Fibre Type | NADIS |

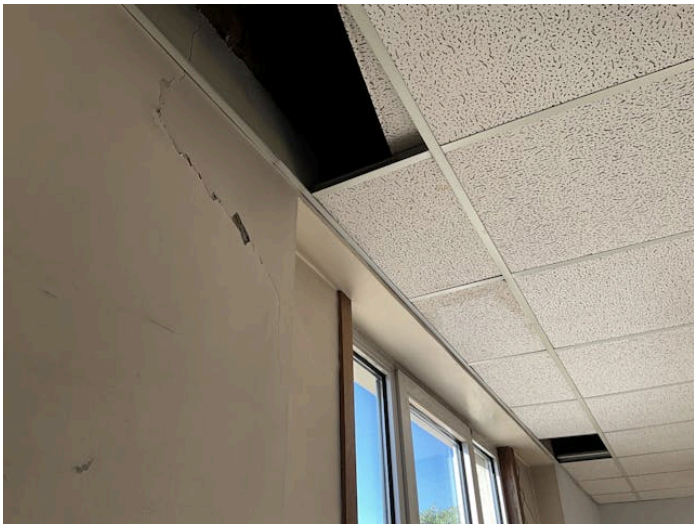
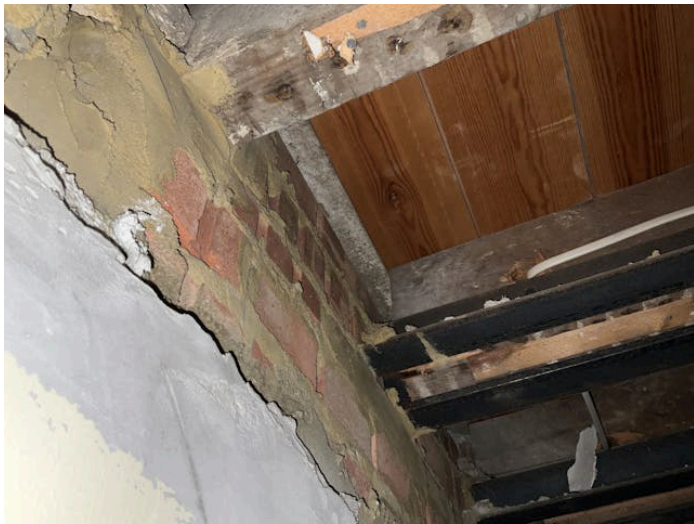
| Location | 008 - Open Plan Office | Item | Packers between ceiling and wall (within ceiling void above window) |

| Material | Cement | Extent | 4 Lm. |
| Strategy / Sample Id | Sample / 003 | Fibre Type | Chrysotile |

| Product Type (or Debris from Product) | 1 | Extent of Damage / Deterioration | 2 |

| Recommendation | Encapsulate | | |

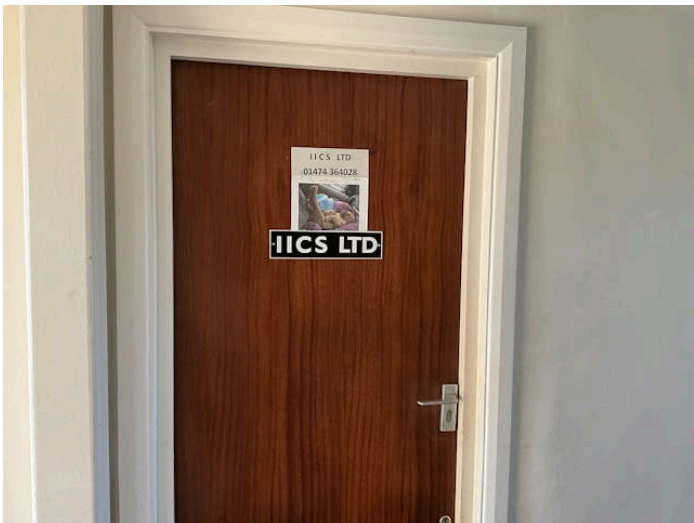
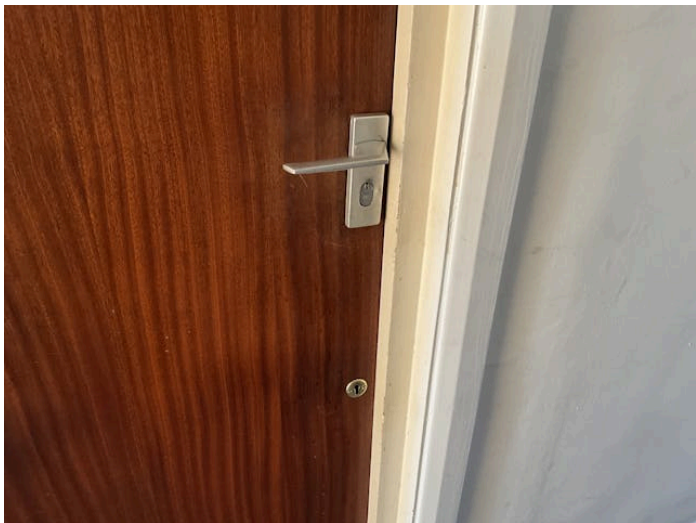
| Location | 014 - IICS Office | Item | |

| Access / Notes | No Access / Locked - Keys Off Site | | |

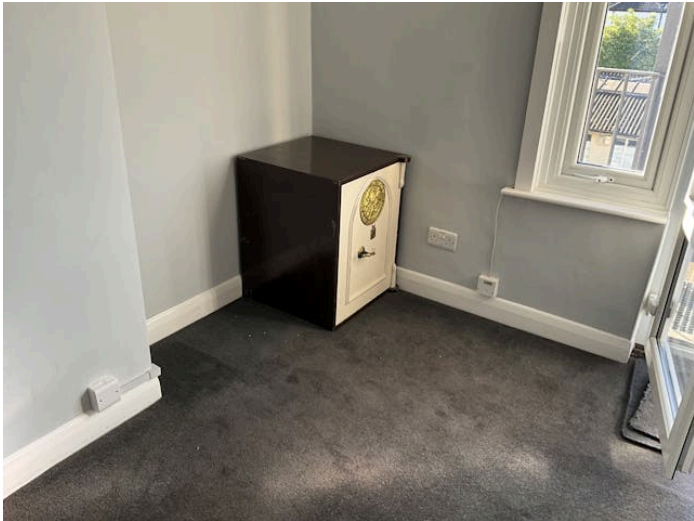
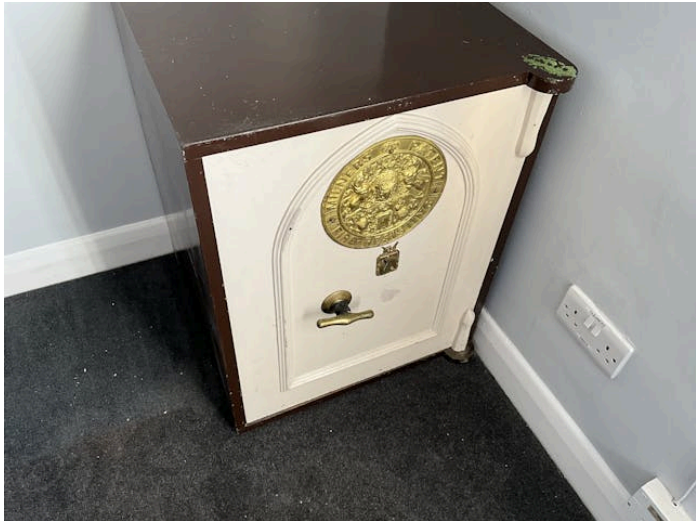
| Location | 008 - Office | Item | Safe |

| Access / Notes | No Access / Locked - Keys Off Site | | |

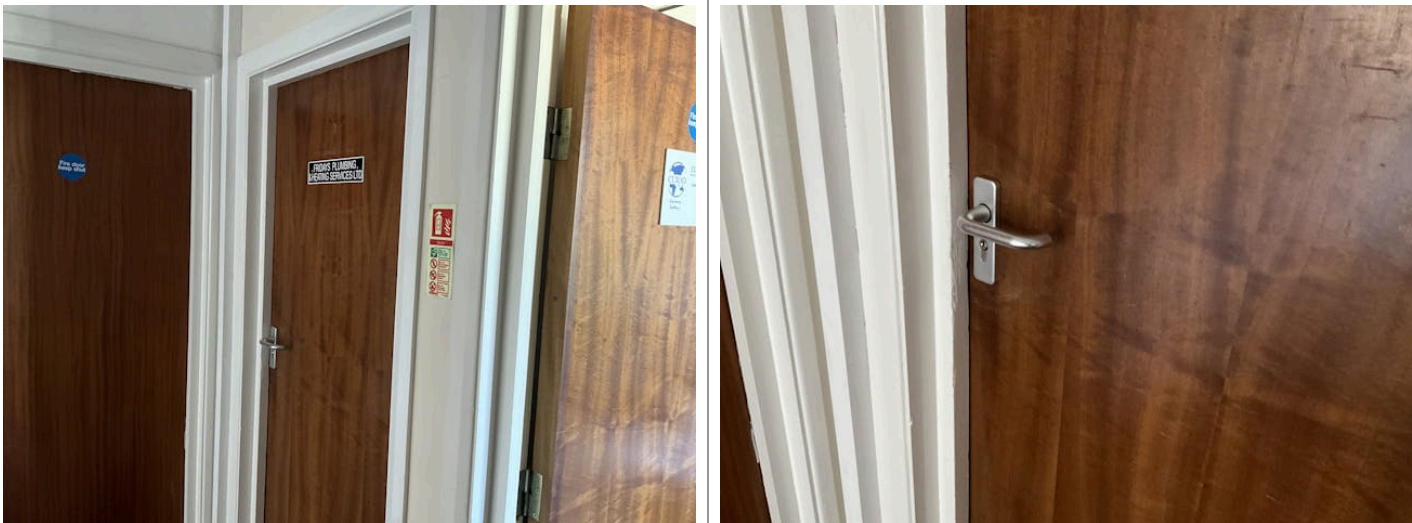
| Location | 011 - Office | Item | |

| Access / Notes | No Access / Locked - Keys Off Site | | |

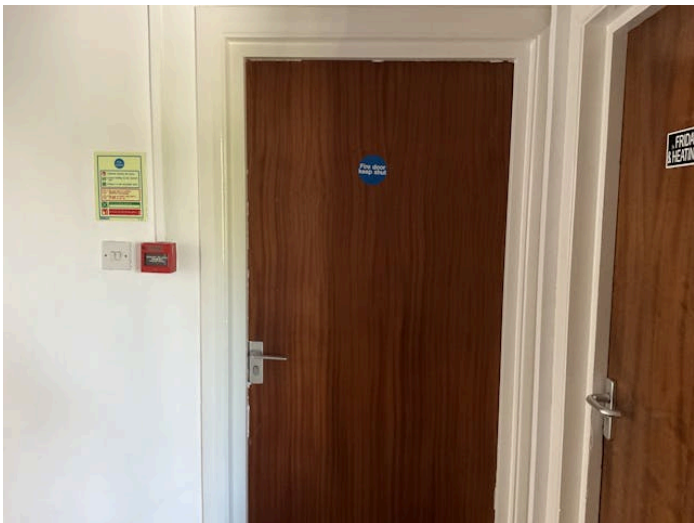
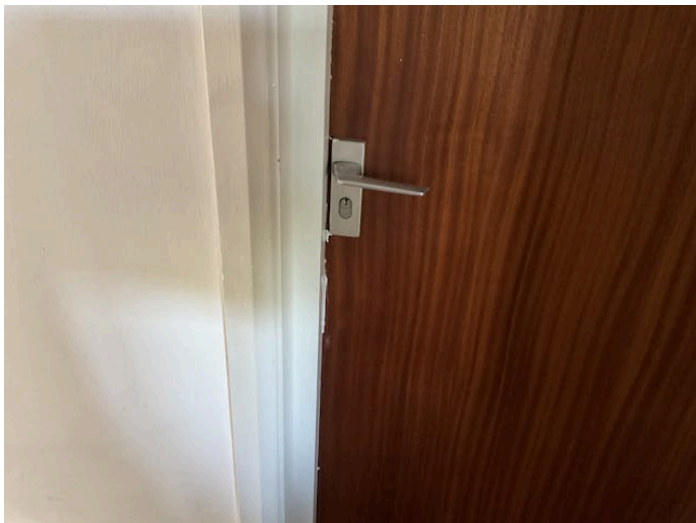
| Location | 012 - Office | Item | |

| Access / Notes | No Access / Locked - Keys Off Site | | |

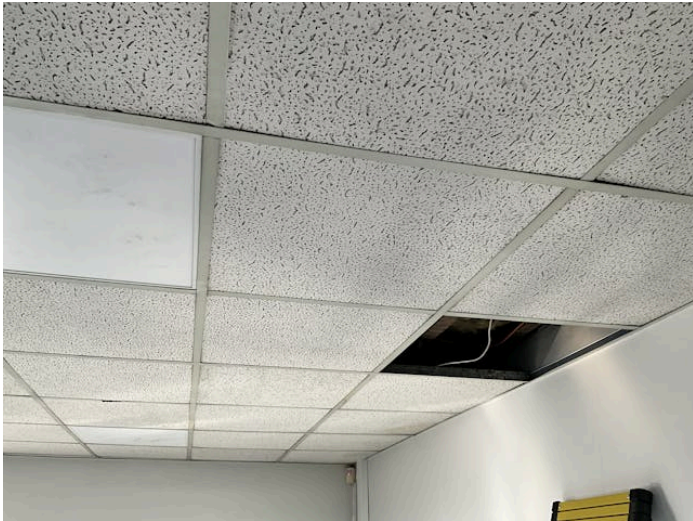
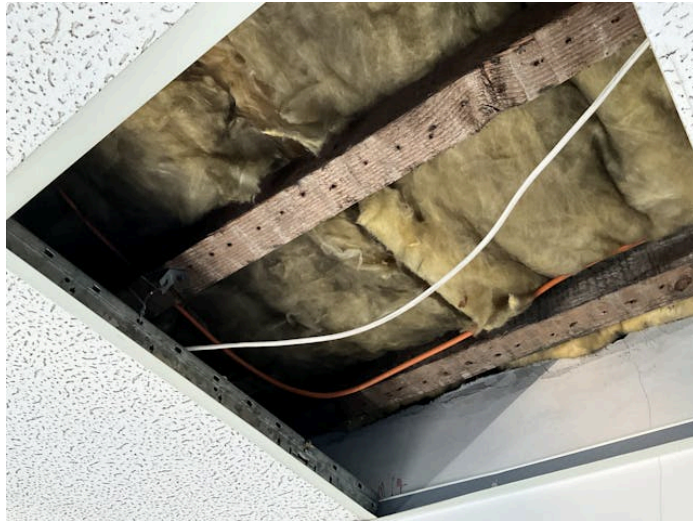
| Location | 004 - Open Plan Office | Item | Void above |

| Access / Notes | No Access / Physically Restricted Space - unable to access void | | |

| General Comments | Further investigation required if works are planned. | | |

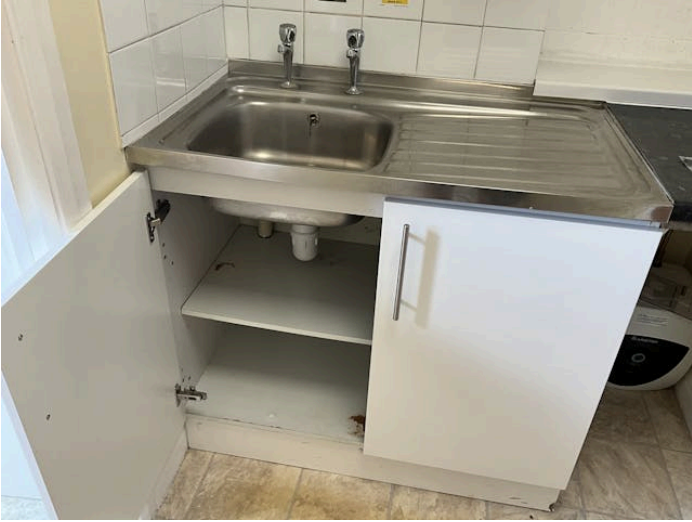
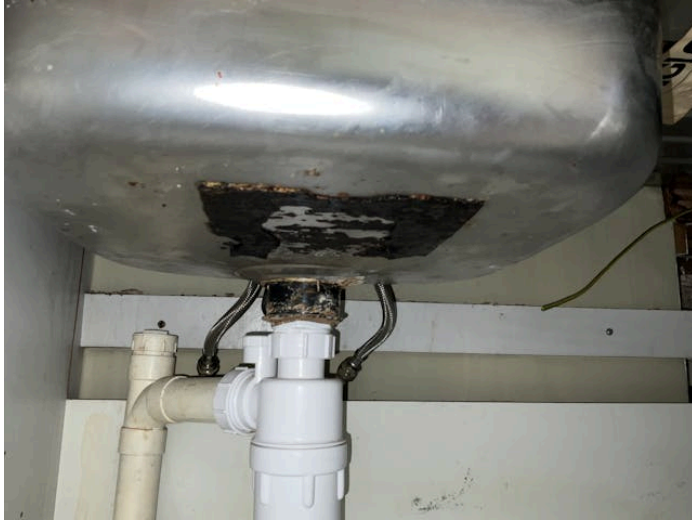
| Location | 008 - Tea & Shower Room | Item | Sink pad |

| Material | Bituminous Product | Extent | 2 No. |
| Strategy / Sample Id | Sample / 002 | Fibre Type | NADIS |

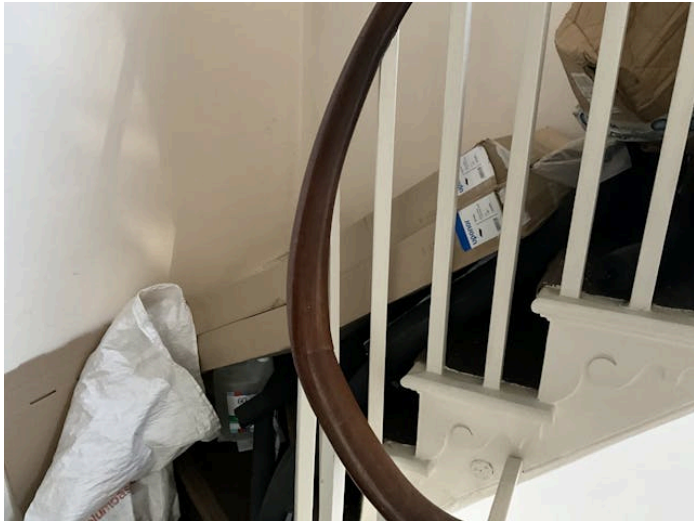
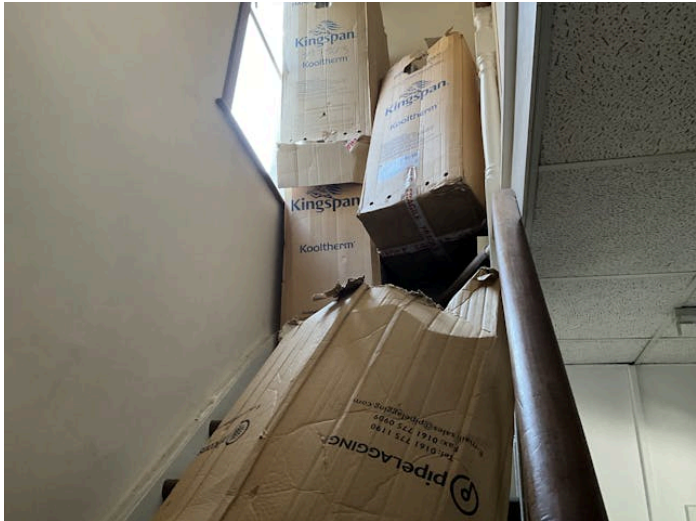
| Location | 011 - Stairs | Item | Whole location |

| Access / Notes | Limited Access / Stored items | | |

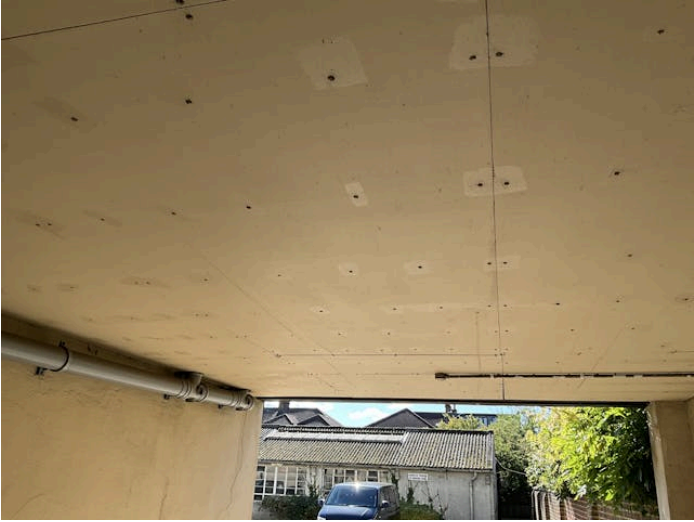
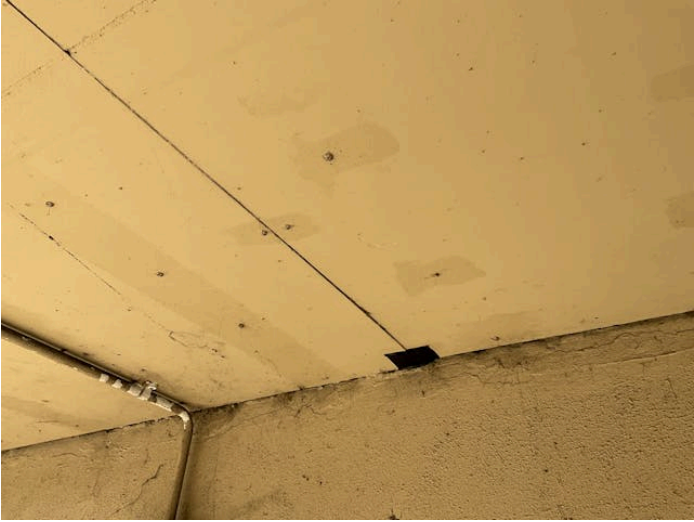
| Location | 001 - External | Item | Panels to undercroft |

| Material | Insulating Board | Extent | 24 sq. m. |
| Strategy / Sample Id | Sample / 006 | Fibre Type | NADIS |

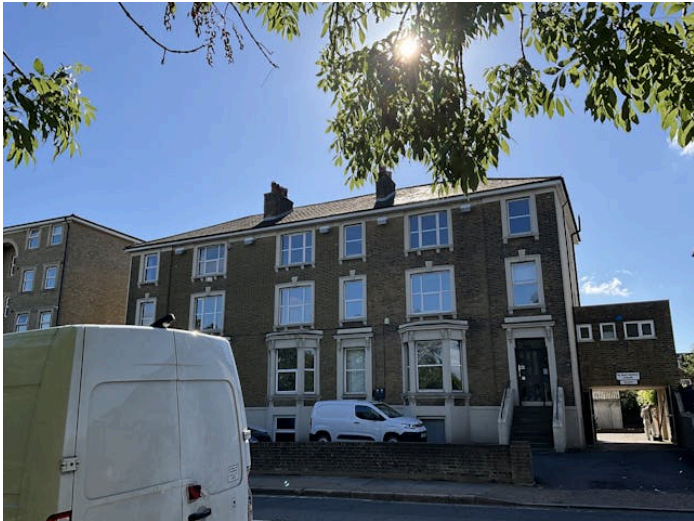
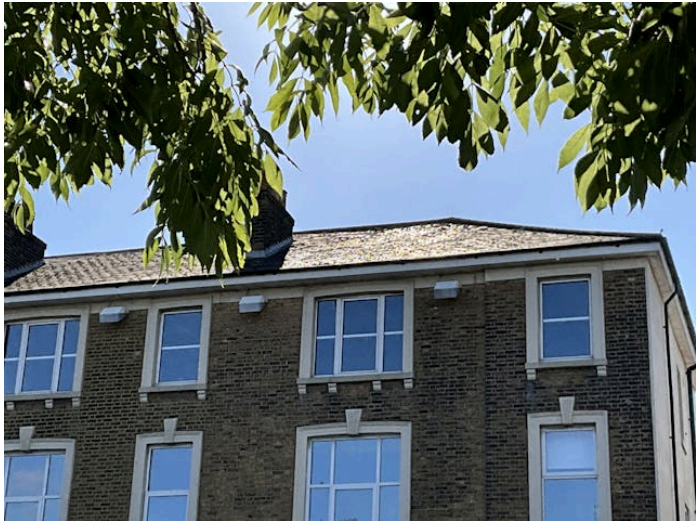
| Location | 001 - External | Item | Roof |

| Access / Notes | No Access / Reasons Of Height | | |

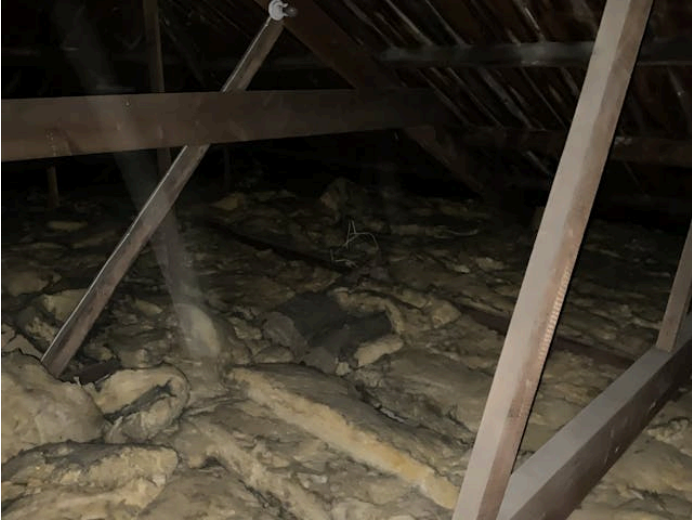
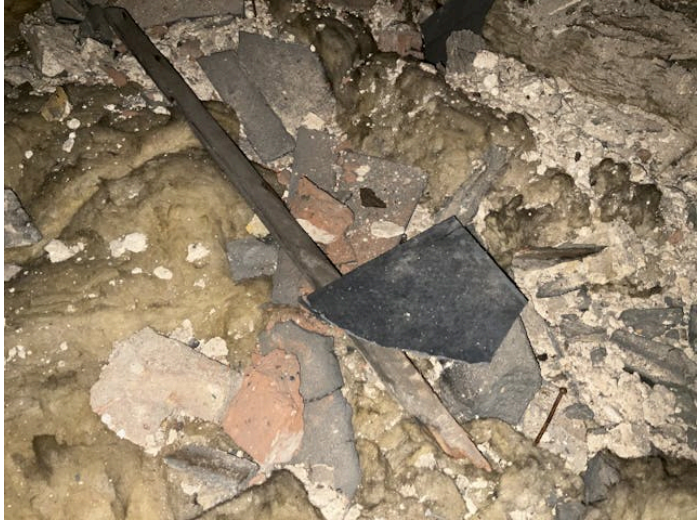
| Location | 002 - Loft Space 2 | Item | Debris to floor |

| Material | Cement | Extent | Throughout |
| Strategy / Sample Id | Sample / 001 | Fibre Type | Chrysotile |

| Product Type (or Debris from Product) | 1 | Extent of Damage / Deterioration | 3 |

| Recommendation | Remove | | |
