## HERITAGE DESIGN AND ACCESS STATEMENT -18Q-01 – JUNE 2023

**To accompany an application for listed building consent for; Nurstead Hall, Nurstead Lane,  
Longfield Hill, Kent, DA3 7AN**

Scope of proposals: Repairs to external render and joinery. Structural reinforcement internally to timber-frame and chimney. Replace flat roof dormer with tiled, pitched roof dormer to rear. Re-roof main house and add insulation to roof.

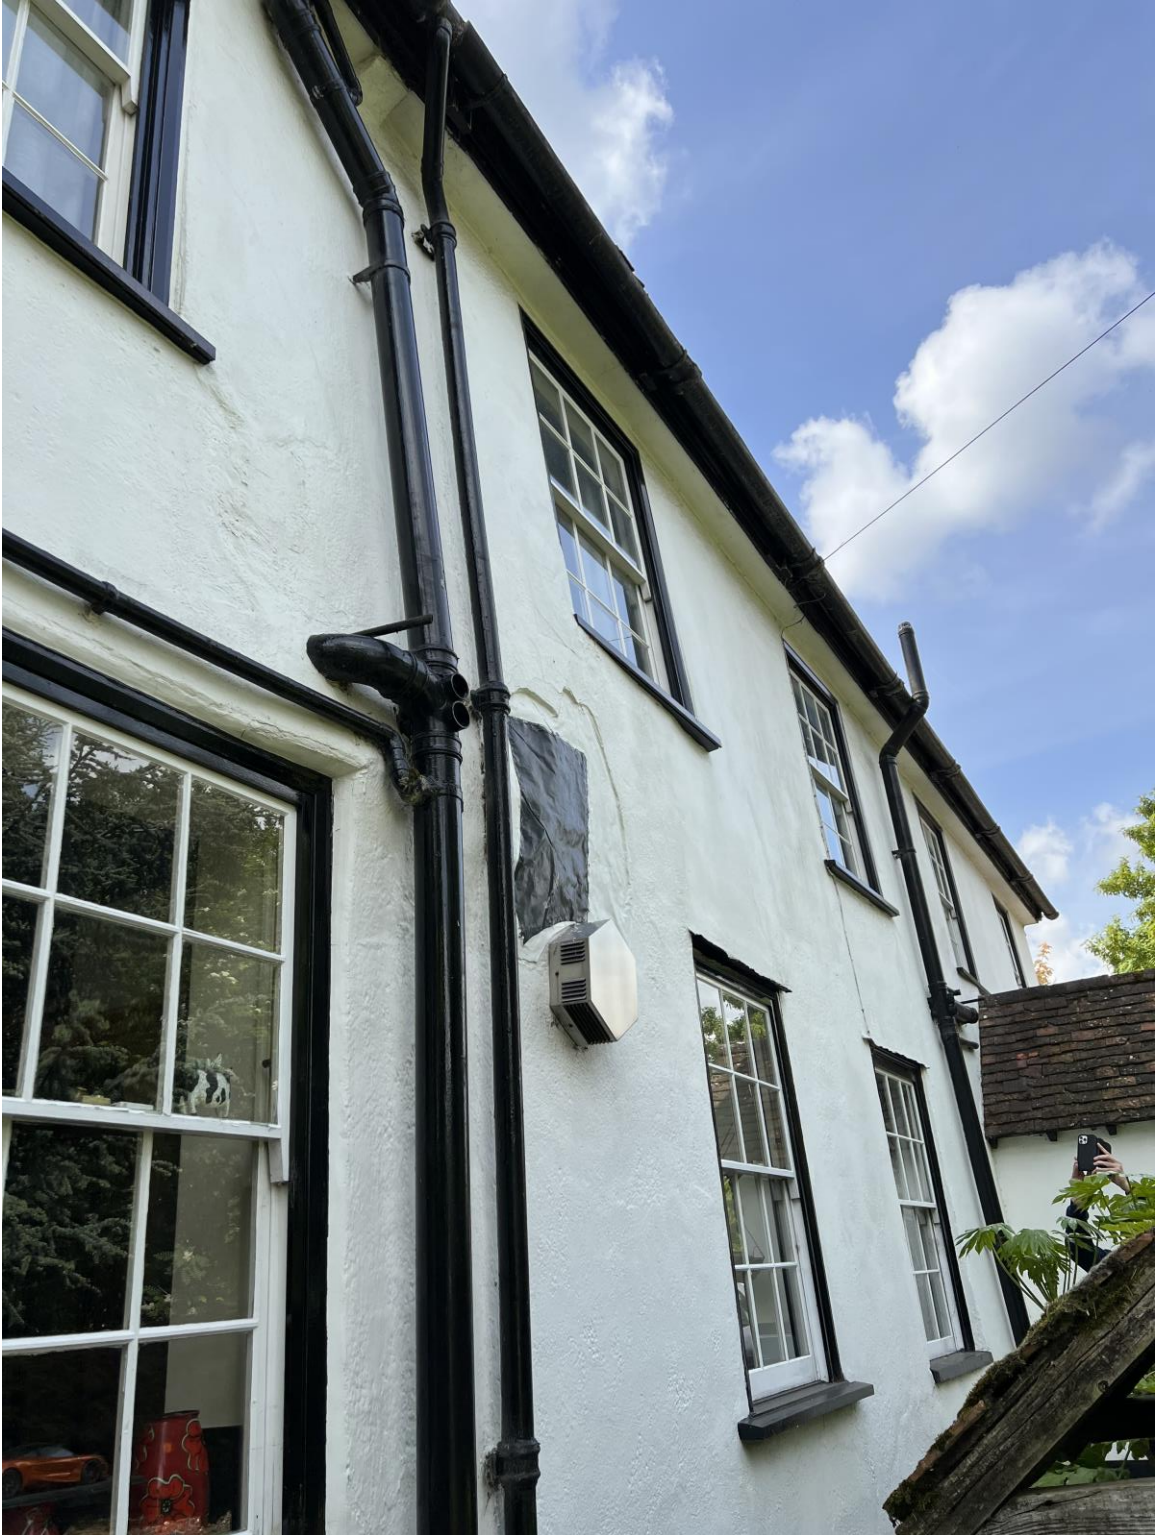
The north elevation has a large bulge in the external render where it has delaminated from the wall substrate and bowed outwards. Other areas of render have separated from the north wall, the extent of which is unknown at this time and cannot be fully established until scaffolding has been erected and opening up works has begun.

Bulge in external render on north elevation

The drawing numbered PP-18Q-06 (submitted with this application) shows the proposed areas of render to be replaced. A repair proposal can be discussed with the conservation officer once the delaminated render is removed, this may not end up a like-for-like repair and will depend on the practicalities of retaining sections of the render, as well as the materials used to affect repair / replacement.

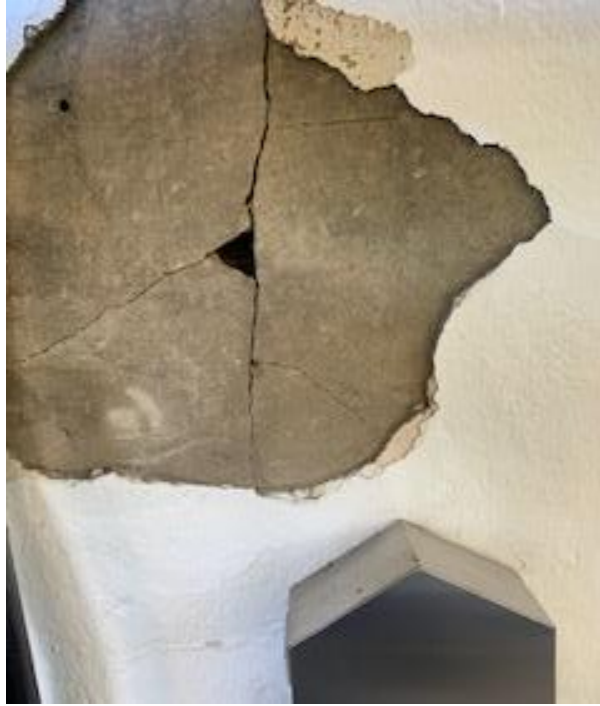
The external render has been built-up over time and through a failed section of wall, it can be seen that at least some of the rendered walls consist of three layers of render installed at different periods. The failed section of wall was partially opened to inspect the bulging render on the north (front) elevation where the first-floor timber-framed wall sits on an under-built masonry ground floor wall. Over the timber-frame the build-up consists of: sawn softwood laths; lime render; a full thickness of cementitious ashlar render; and a final layer, full thickness of cementitious flat render, painted white. It was not possible from the inspection hole to establish if both of the cementitious render layers cover the masonry sections of wall but it is most likely that the mid-layer (ashlar render) is below the existing flat render coat as ashlar rendering (the middle layer) was usually carried out to imitate a stone façade.

Top coat of render removed where cracking occurred at bulge in north elevation wall, exposing the second layer of ashlar render beneath.

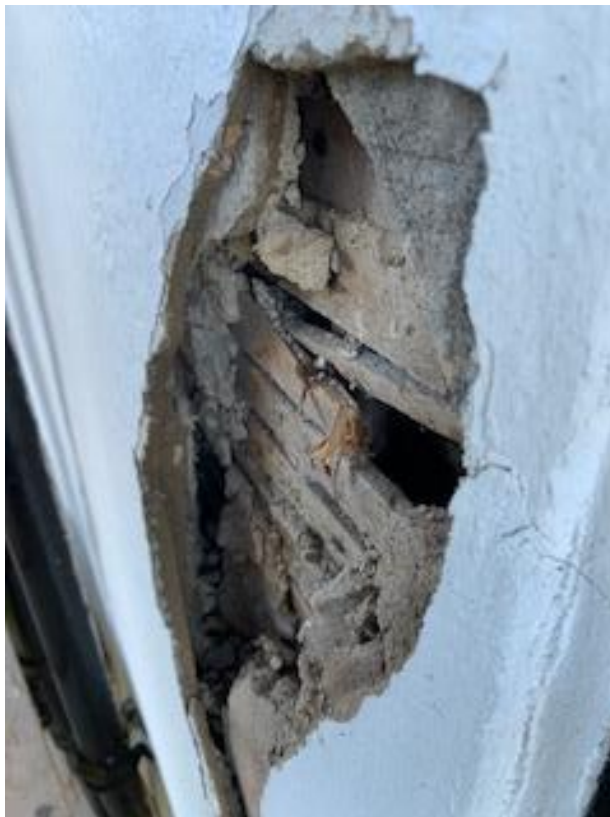
Inspection hole extended to the softwood laths showing the layers of render.

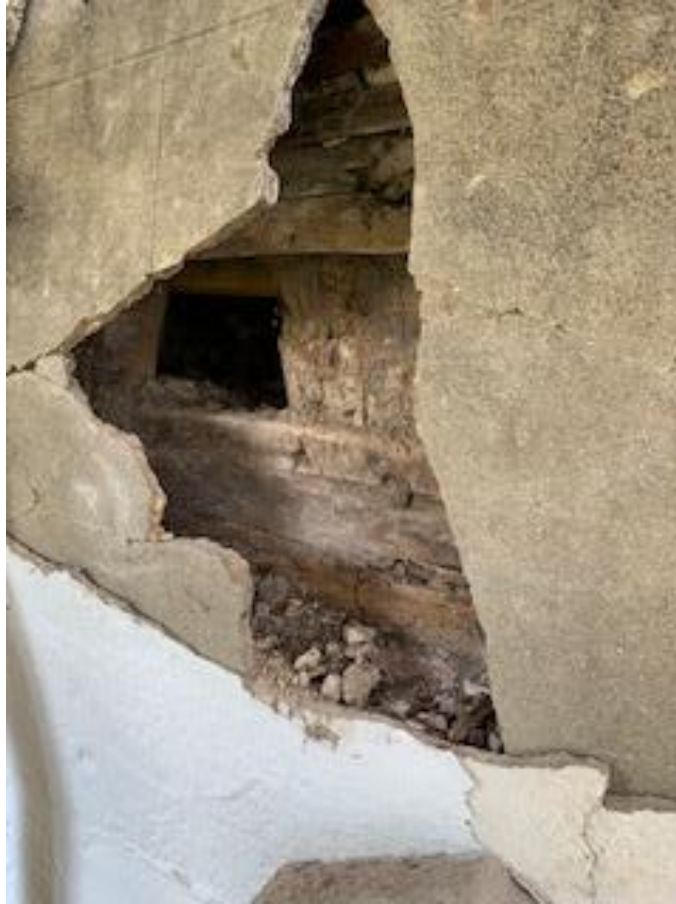
Inspection hole removing render build-up to expose framework behind.

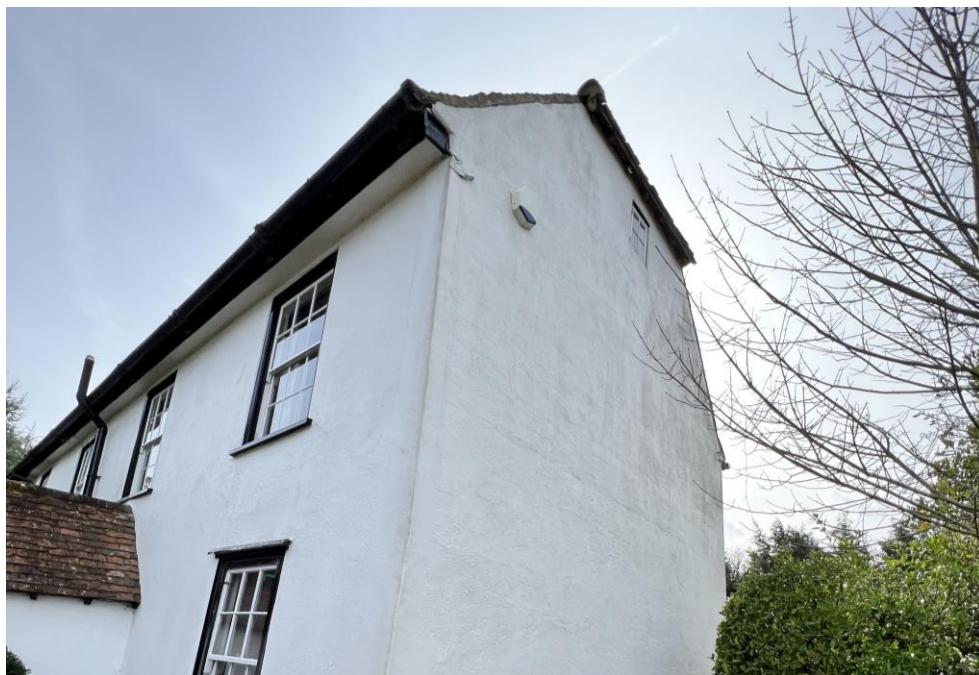
Roof verges do not extend fully beyond the face of the rendered wall.

The roof tiles, fittings and battens are proposed to be stripped to repair the roof cladding. Whilst the roof cladding and battens are off the roof, it is proposed we take advantage of that access and strip any impermeable roofing membrane and increase the level of insulation to the roof. It is proposed that TLX Gold is installed; a thin quilt insulation with a breather membrane as part of its build-up of layers. This insulation will add a minimal amount to the thickness of the rafter while maintaining the natural undulations of the historic roof. When the roof tiles are installed, the roof verges need to project from the rendered wall faces by approximately 50mm.

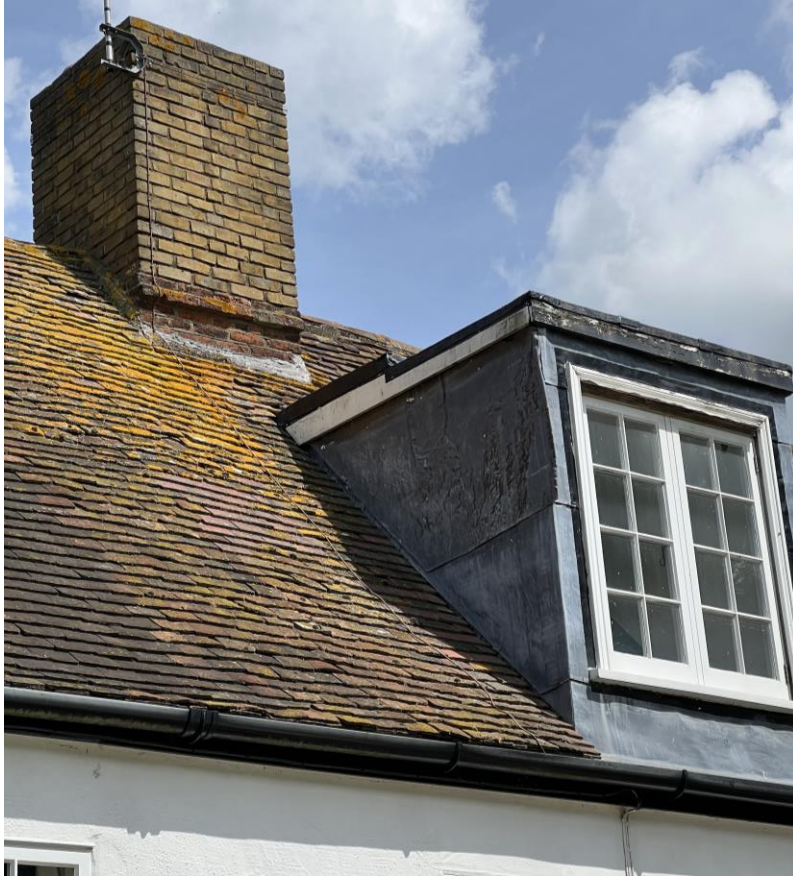
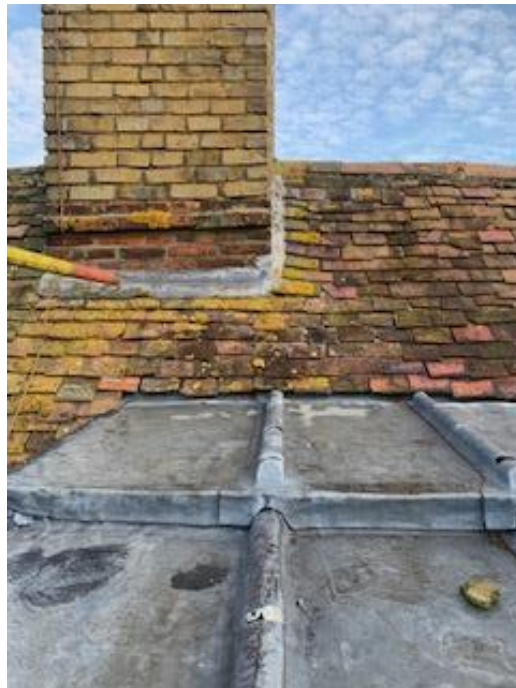
The chimney stack above the roofline of the large axial chimney has been rebuilt at some point in the late C20 in yellow stock bricks, an inappropriate match of brick with the remaining original chimney construction. This part of the stack has no historic or architectural value and would benefit from being rebuilt in an appropriate red brick.

Image of chimney stack above roofline and existing dormer window.

Image of chimney stack above roofline and existing dormer roof.

The dormer is proposed to be replaced with a new pitched-roof dormer in tiles matching the main roof. The sides and front are proposed to be clad in clay tile-hanging and a smaller painted, hardwood window with two opening casements (glazing patten – 2 over 3) separated by a mullion. The new casements to have slim double-glazing.

The central chimney is in need of structural repair and the stack above the roofline requires a rebuild in a more appropriate brick. The structural engineer has identified cracks above the west-facing bressummers of the ground and first floor that require 'Helifix' crack-stitching which will be pointed over in lime mortar to match the surrounding mortar. The fireplace of the first floor (west-facing) is a cast iron fireplace asymmetrically inserted into a larger fireplace opening and has been infilled with a mis-match of bricks and it is proposed that the lime mortar pointing to this infill section is repaired. See structural engineer's report pma 5291. The stack above the roofline has been rebuilt at some point in yellow stock bricks laid in cementitious mortar, whilst the remainder of the chimney is built in relatively thin red brick. It is proposed that the yellow bricks above the roofline are taken down and replaced with a more appropriate red brick and pointed in lime mortar.

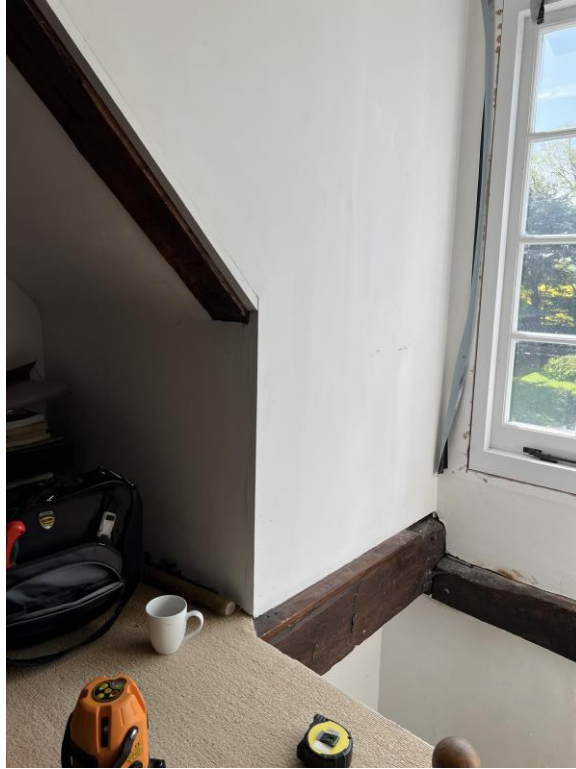
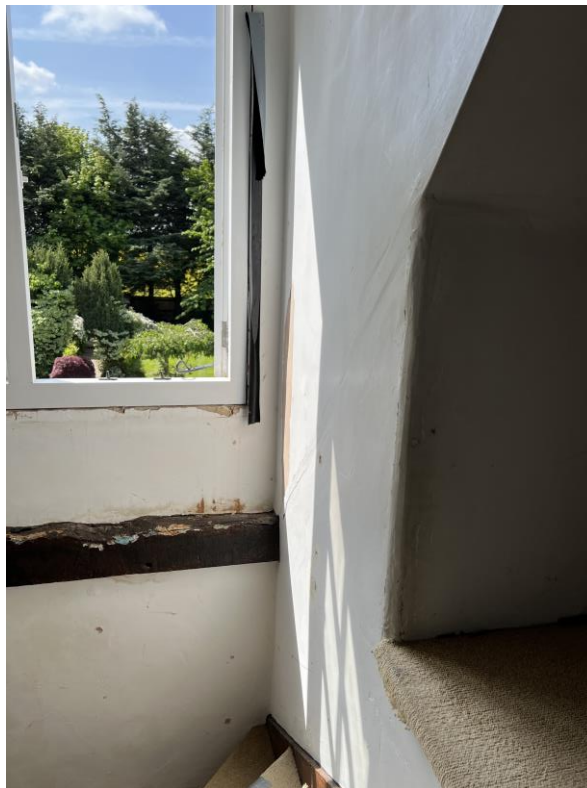
The existing dormer was constructed in the early 21<sup>st</sup> century under application reference numbers 20000367 & 20020165. Constructed as a flat lead roof with dormer cheeks and front clad in lead. The dormer has a painted softwood two opening casements (glazing patten - 2 over 4) separated by a mullion. The dormer window has begun to show signs of deterioration.

Image of existing dormer window, internally.

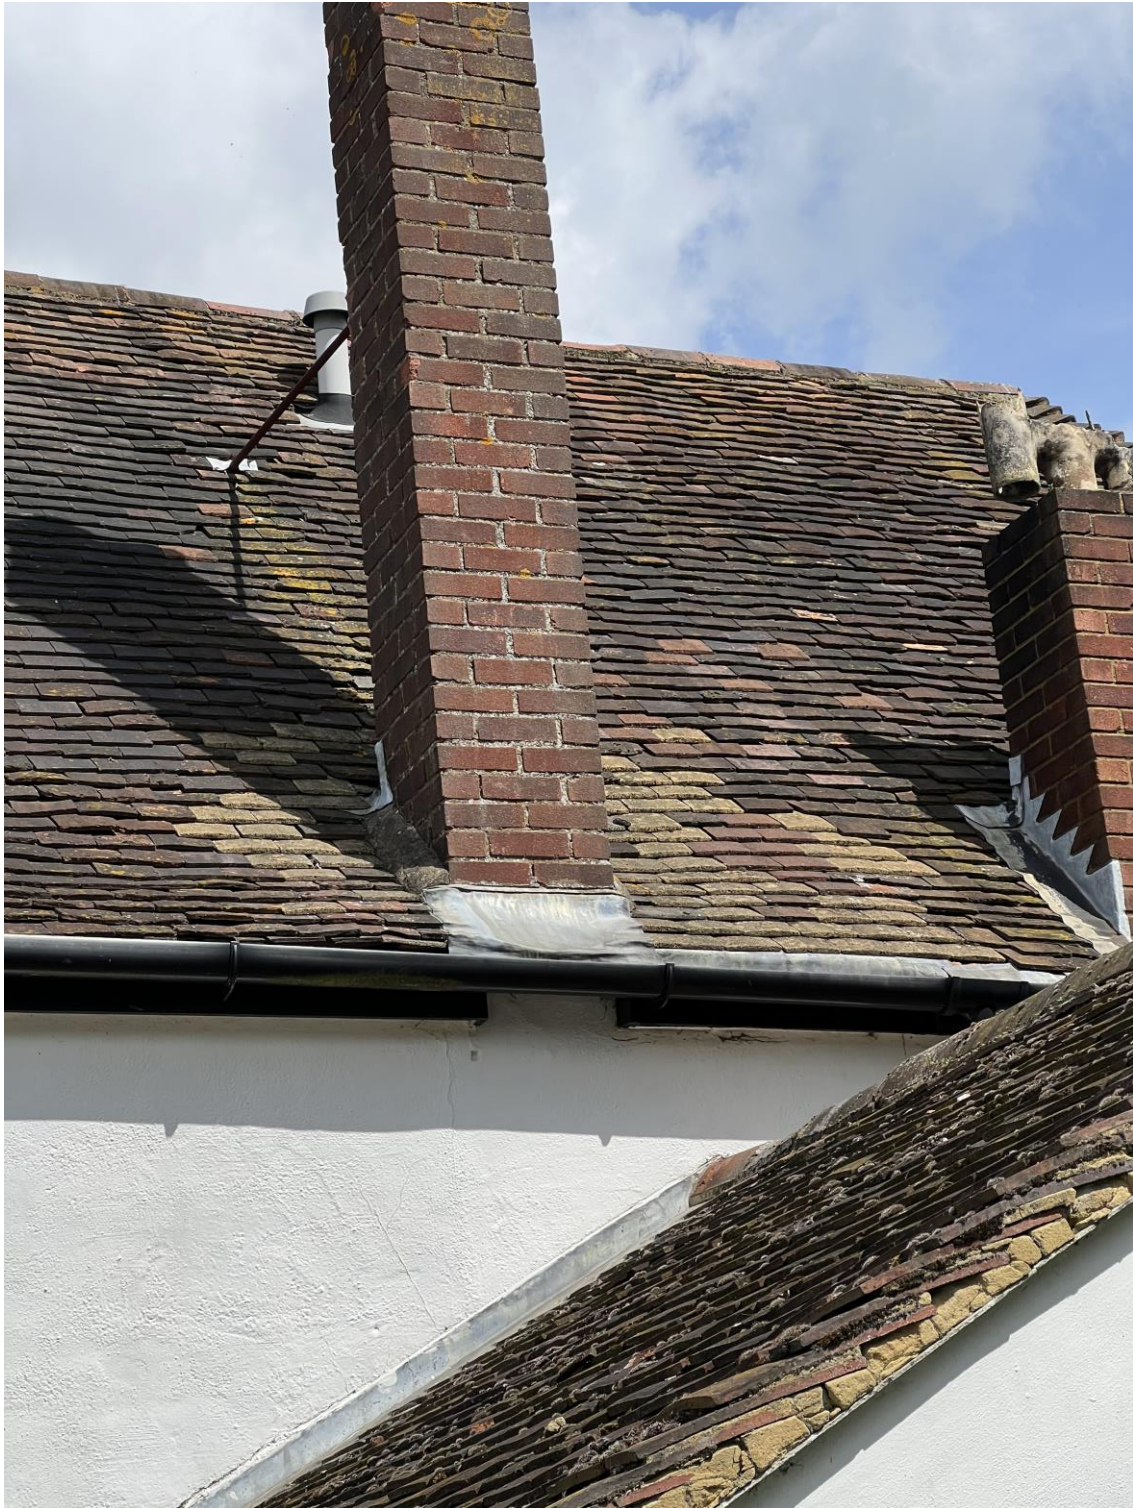
The existing roof cladding is in a poor state of repair, particularly the north-facing roof slope. It can be seen from the ground that there is a thick growth of moss clumps on this roof elevation and a high proportion of clay roof tiles are damaged and delaminated. There are some machine-made clay roof tiles in small areas where the roof has been repaired in the past. It can also be seen from the ground that the battens to the north roof elevation are damaged and there is pronounced waves of dipping where the battens span between the common rafters and the consequential rising of the roof at the rafters. This is likely to be caused by soft and decayed tile batten, which requires the batten to be stripped off the roof and new treated softwood tile battens installed. The rear (south) roof slope is in a better condition than the front. However, there appears to be a higher percentage of machine-made clay tiles and some concrete tile inclusions. The undulations in the roof at the rear is a more natural 'wave' where the principal timbers are the high spots and there is an even sag across the entire bay (and not between common rafters as can be seen on the front).

The small chimney on the south elevation, and towards the east end of the house, has a broken flue pot that requires replacing with a like-for-like flue pot.

Image showing some mis-matched roof tiles in the main range rear elevation roof-slope and broken flue pot.

Due to the high proportion of damaged and inappropriate roof tiles to the main roof slopes, the proposal is to grade, stack and store any salvageable hand-made clay roof tiles and utilise these for future repairs to the single storey extensions, out-buildings and porch. The roof slopes are proposed to be re-clad with new hand-made clay tiles; 'Brookhurst' hand-made clay tiles, 'Restoration' mix, manufactured by Sahtas.

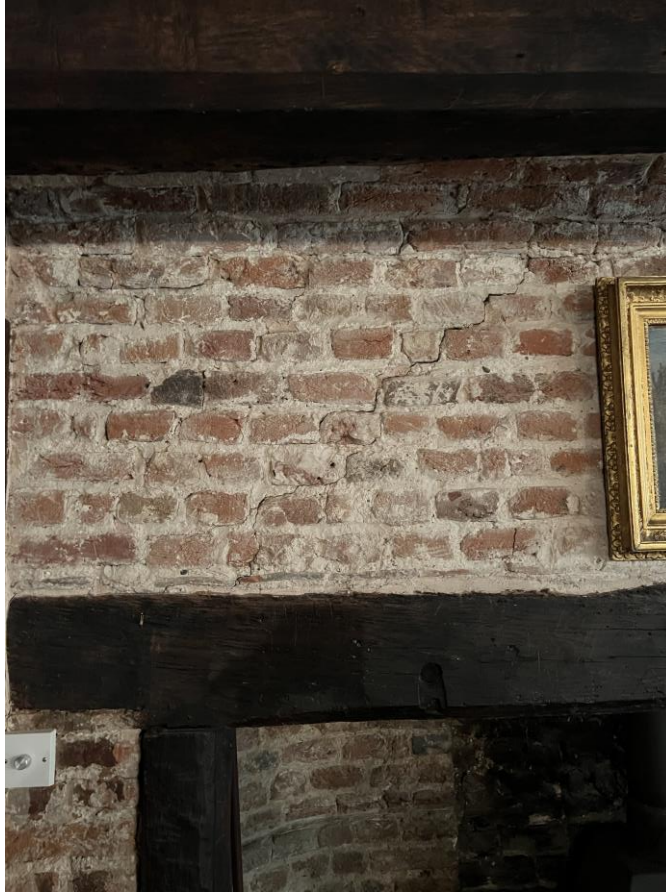
Image of the crack above the bressummer in the ground floor of the axial chimney facing west.

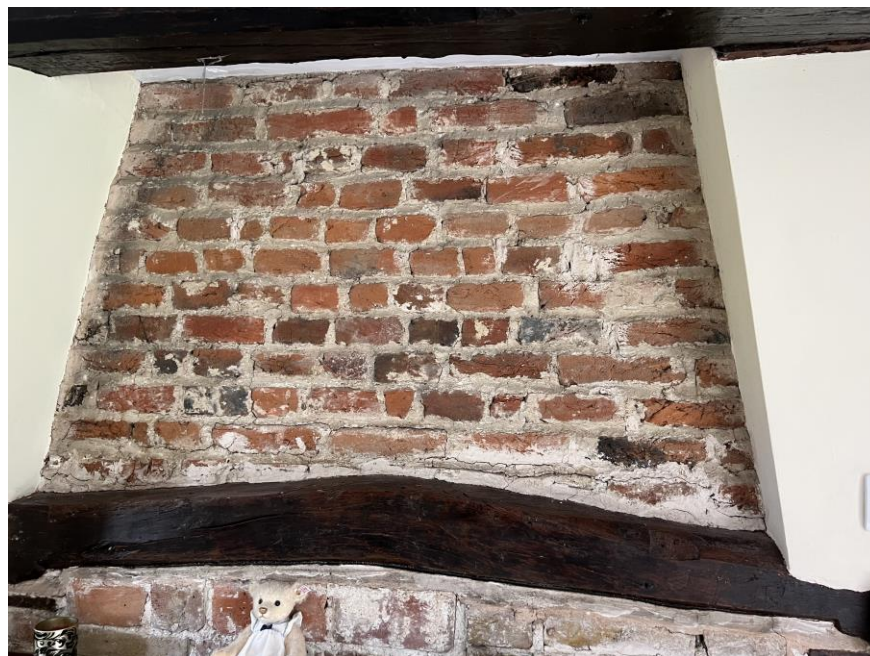
Image of the cracking above the bressummer in the first floor of the axial chimney facing west.

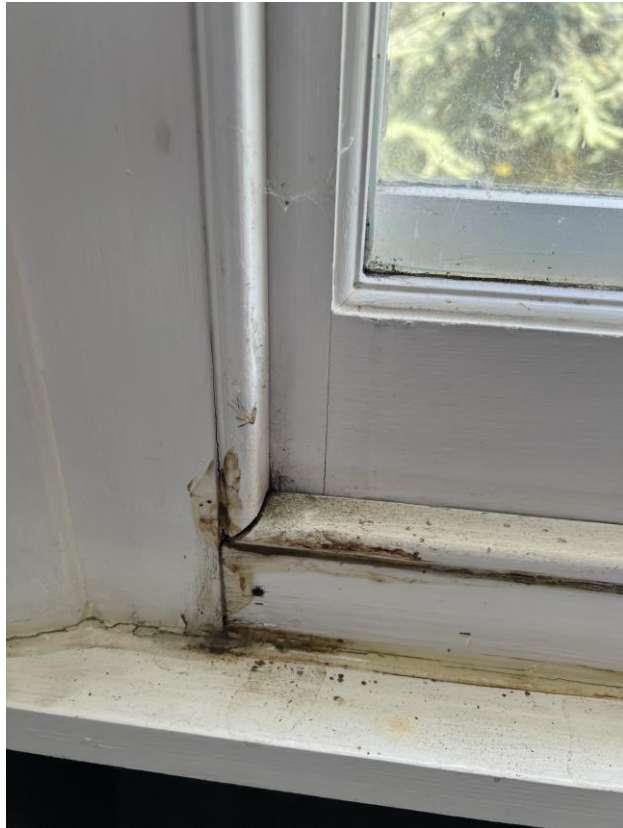
Internal image of the sliding sashes to the front elevation.

The joinery is proposed to be repaired using timber splices for larger areas of decay and smaller areas to be filled with 'Repair Care-DryFlex' resin filler. Where joinery items are beyond practical repair, it is proposed that they are replicated in a like-for-like manner but using hardwood as the construction material for durability. The joinery is proposed to be repainted in existing colour scheme where repairs / replacements are carried out.

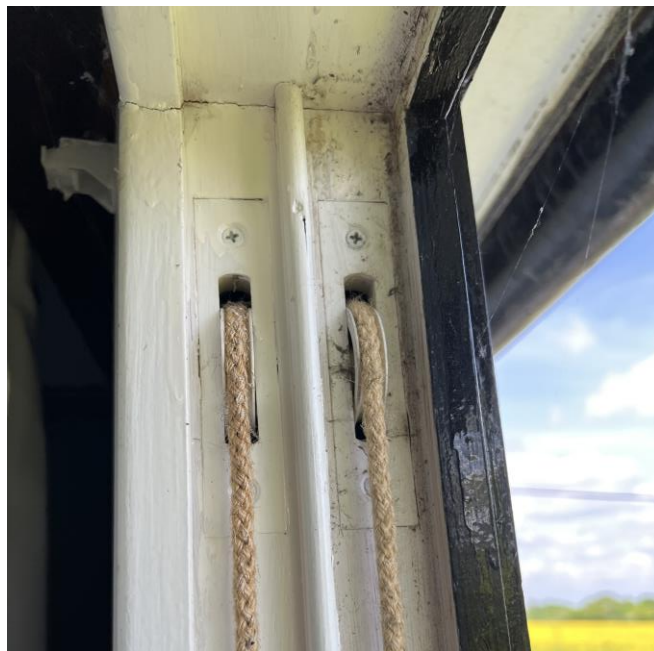
Internal image of the relatively modern axle pulley wheels and sash cords of the front elevation 'box-frames'.

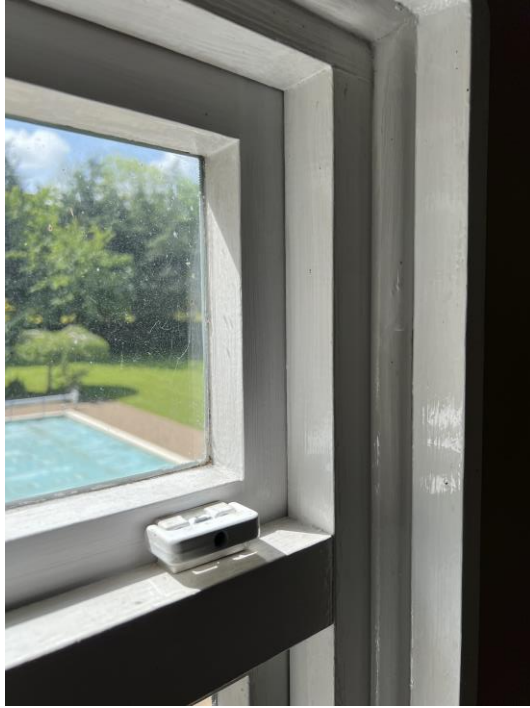
Internal image of the storm-proof windows to the rear elevation.
