# Clarence Place

## Masonry Façade Survey August 2023

REF 23108-PAYE-CPS-001

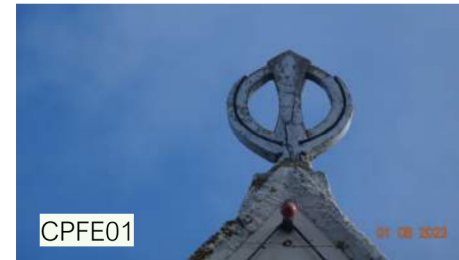
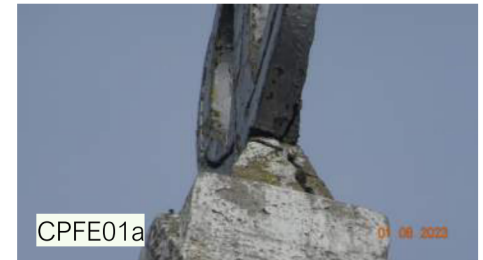
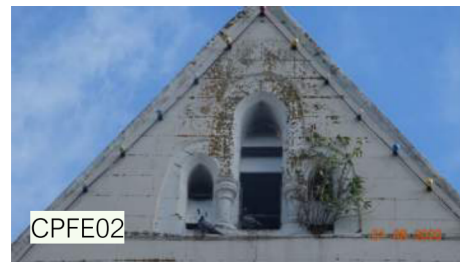
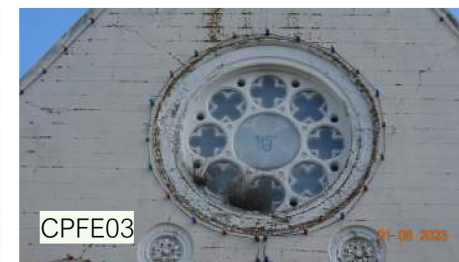
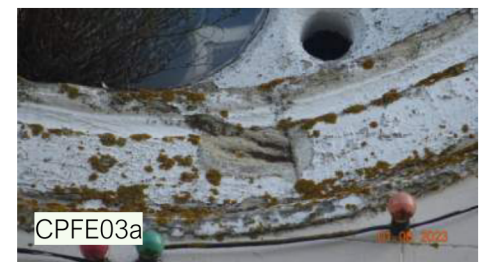
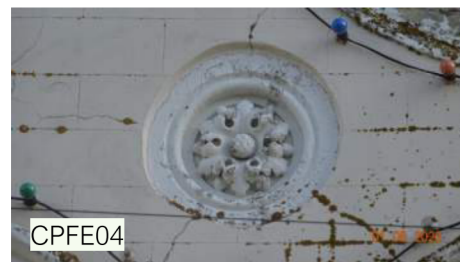
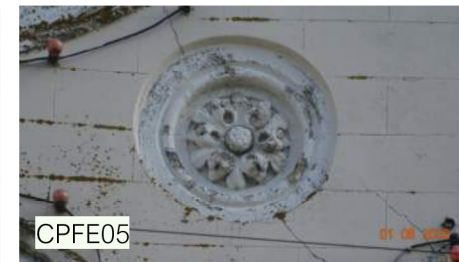
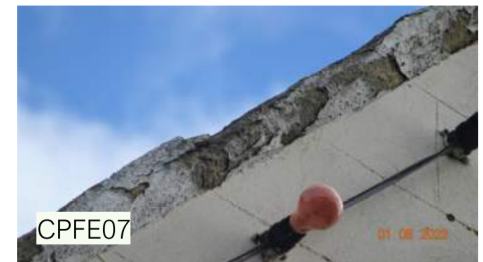
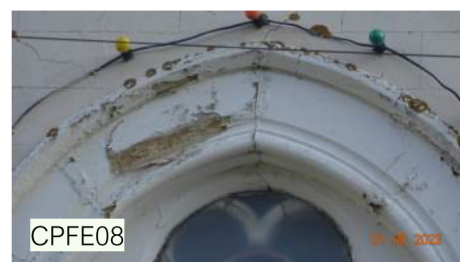
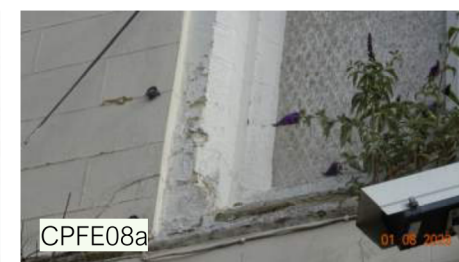
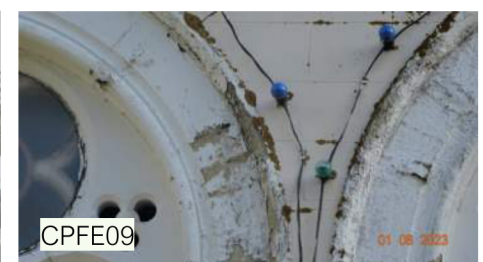
PHOTOS: CPFE02-05, 07-09 RISK: AMBER/RED

Finial damaged and fractured. Recommend further inspection to verify stability. Remove, repair/replace to de-risk potential detachment and damage.

De-vegetate to prevent further damage to masonry. Cut back loose, de-bonded mortar repairs from string course, window surrounds and roundels.

Drill in stainless steel reinforcement where necessary to provide added support. Reform original profiles using lime-based mortar.

Consideration given to alternative use of new natural stone indents for a long-term repair solution.

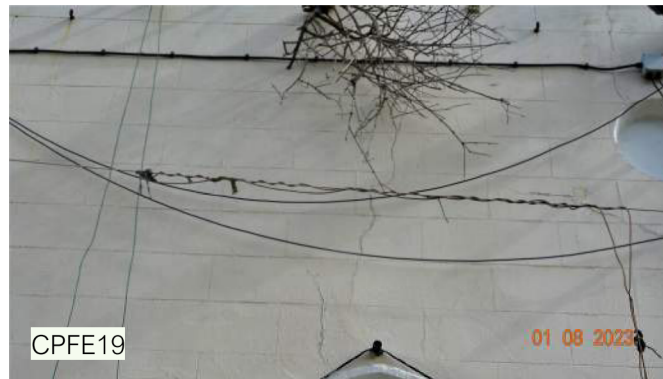
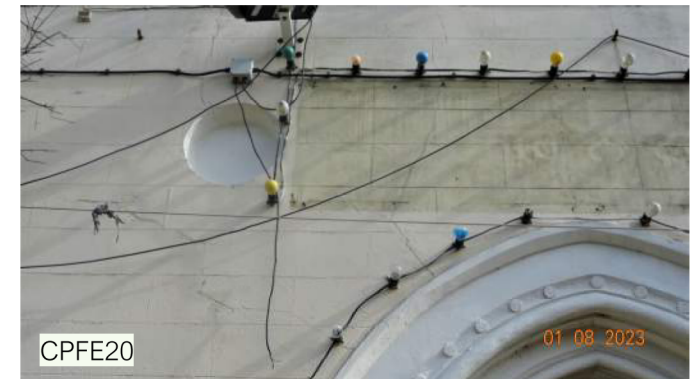
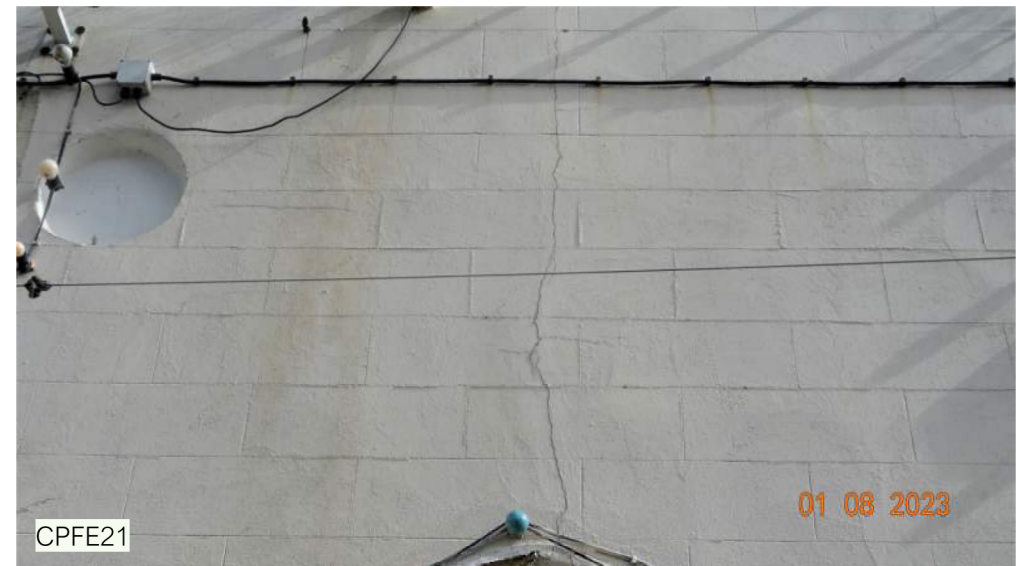
PHOTOS: CPFE19-20

Open continuous fractures through render. Carry out a tap test survey, remove loose, de-bonded back to a sound substrate and re-render as necessary.

It is assumed this still exists beneath the render. Use of cement-based render may inhibit the migration of moisture through the facade.

Recommend structural engineer consultation to inspect exposed structural fractures affecting substrates.

Consideration given to removing render, repair and re-point Rag stone and leaving exposed.

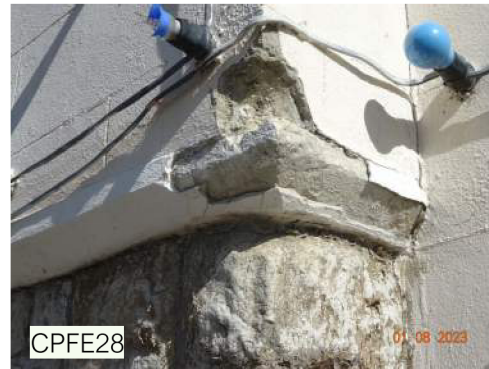
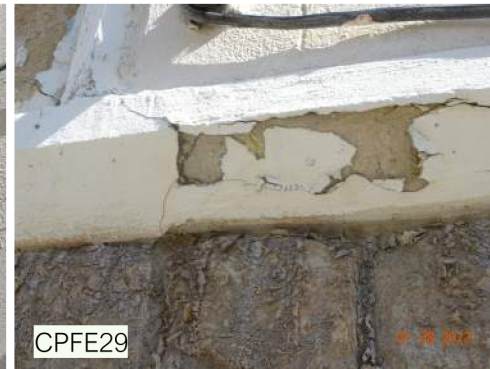
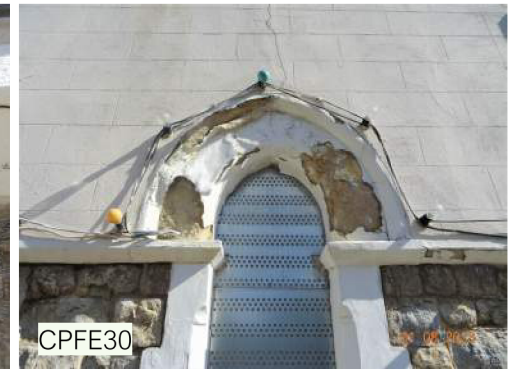
PHOTOS: CPFE28-30      RISK: AMBER/RED

Cut back loose, de-bonded mortar repairs from string course and window surround. Failed mortar repair has exposed the original Rag stone beneath the render.

Original Rag stone is in a deteriorating condition. Surface stone is loose and friable, sections have been excessively eroded and are undercutting masonry above.

Reform original profiles using lime-based mortar.

Consideration given to alternative use of new natural stone indents for a long-term repair solution.

Defrass loose, friable stonework, cut out and replace heavily eroded stonework, rake out and re-point loose, missing pointing using lime mortar.

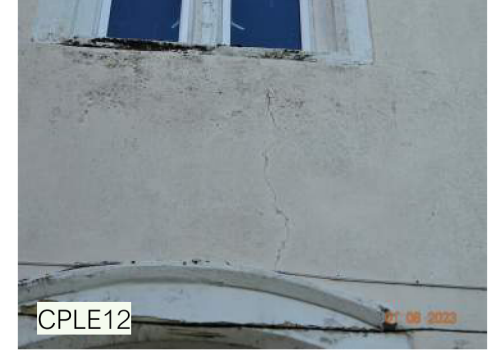
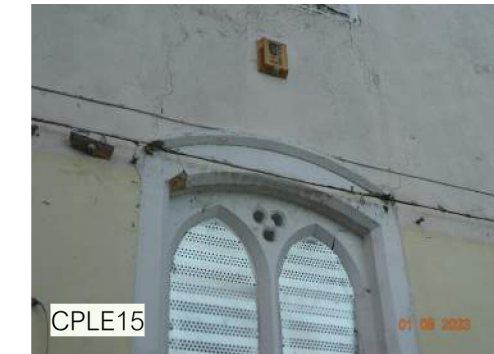
PHOTOS: CPLE13-15

Damaged stone hood moulding caused by previous intervention.

Cut and square up. Drill in stainless steel reinforcement. Re-form mouldings using lime mortar. Consideration given to use of natural stone indents.

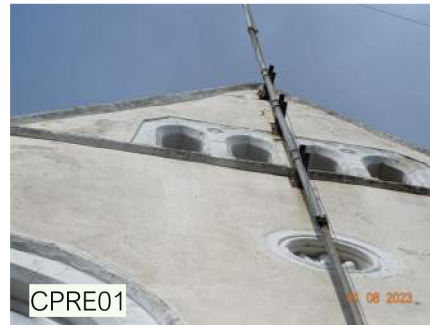
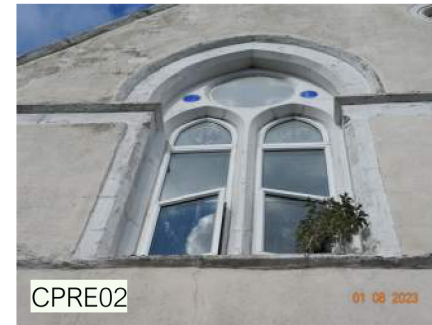
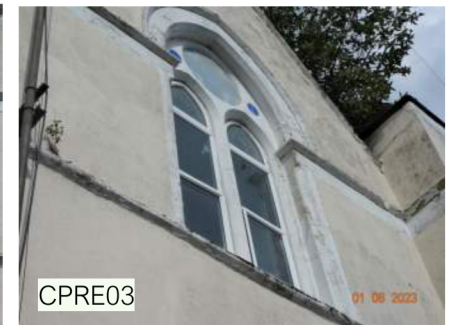
PHOTO: CPLRE01

Open continuous fractures through render. Carry out a tap test survey, remove loose, de-bonded back to a sound substrate and re-render as necessary.

Recommend structural engineer consultation to inspect exposed structural fractures affecting substrates.

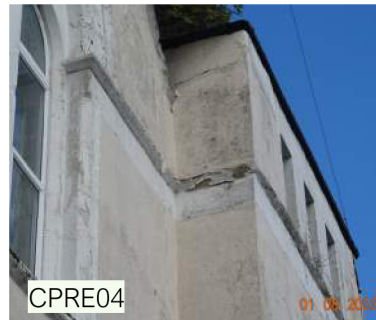
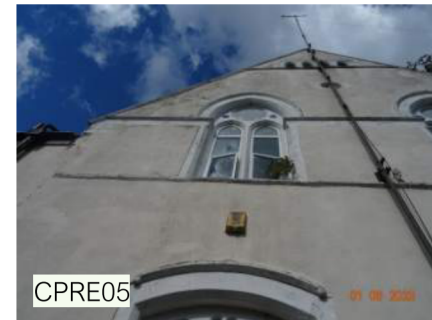
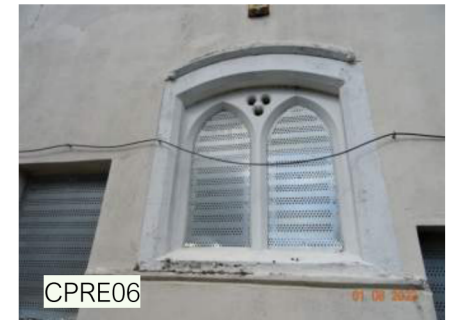
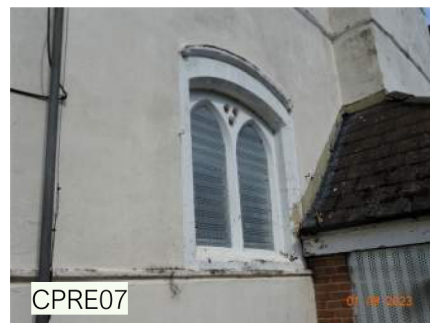
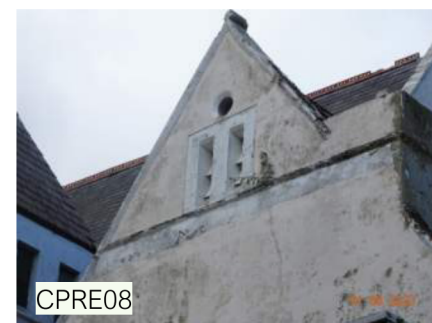
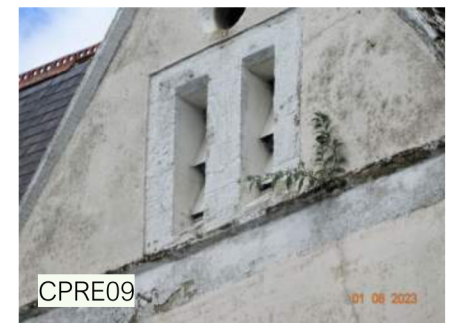
PHOTOS: CPRE02-09

De-vegetate to prevent further damage to masonry. Failed mortar repairs, loose, friable stonework. Cut back to a sound substrate, drill in stainless steel reinforcement as required. Re-form profiles using lime based mortar.

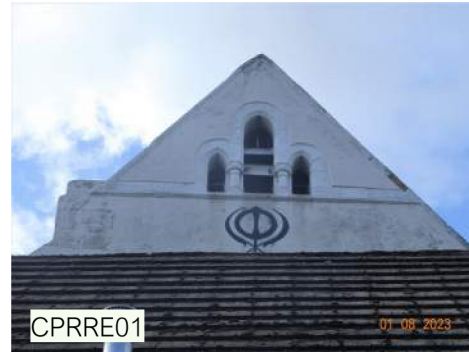
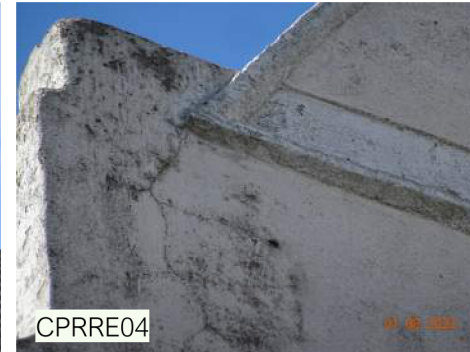
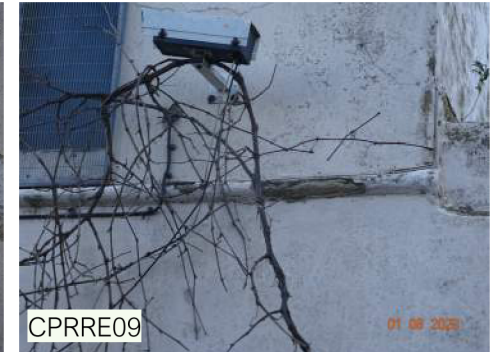
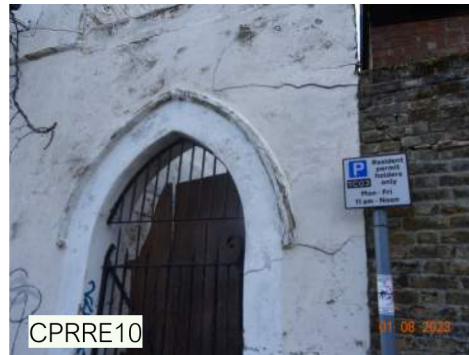
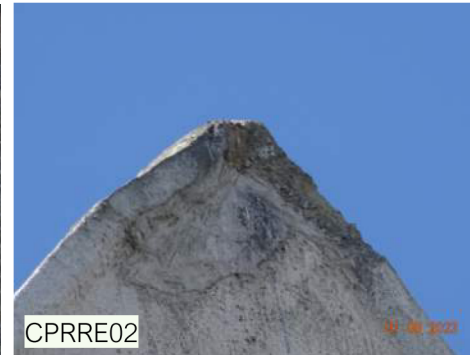
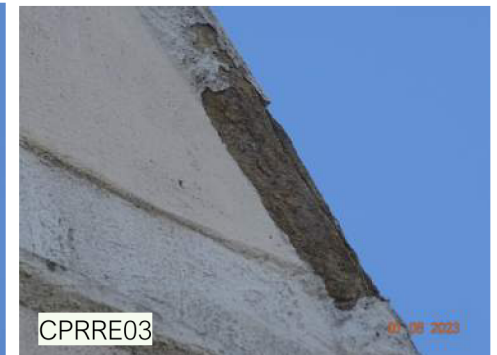
PHOTOS: CPRRE02-03 RISK: AMBER/RED

Failed mortar repaired, eroded copings. It is not recommended to mortar repair weathering surfaces unless protected by lead capping. Recommend replacing damaged coping with new. Recommend further survey of all copings, remove and replace as necessary.

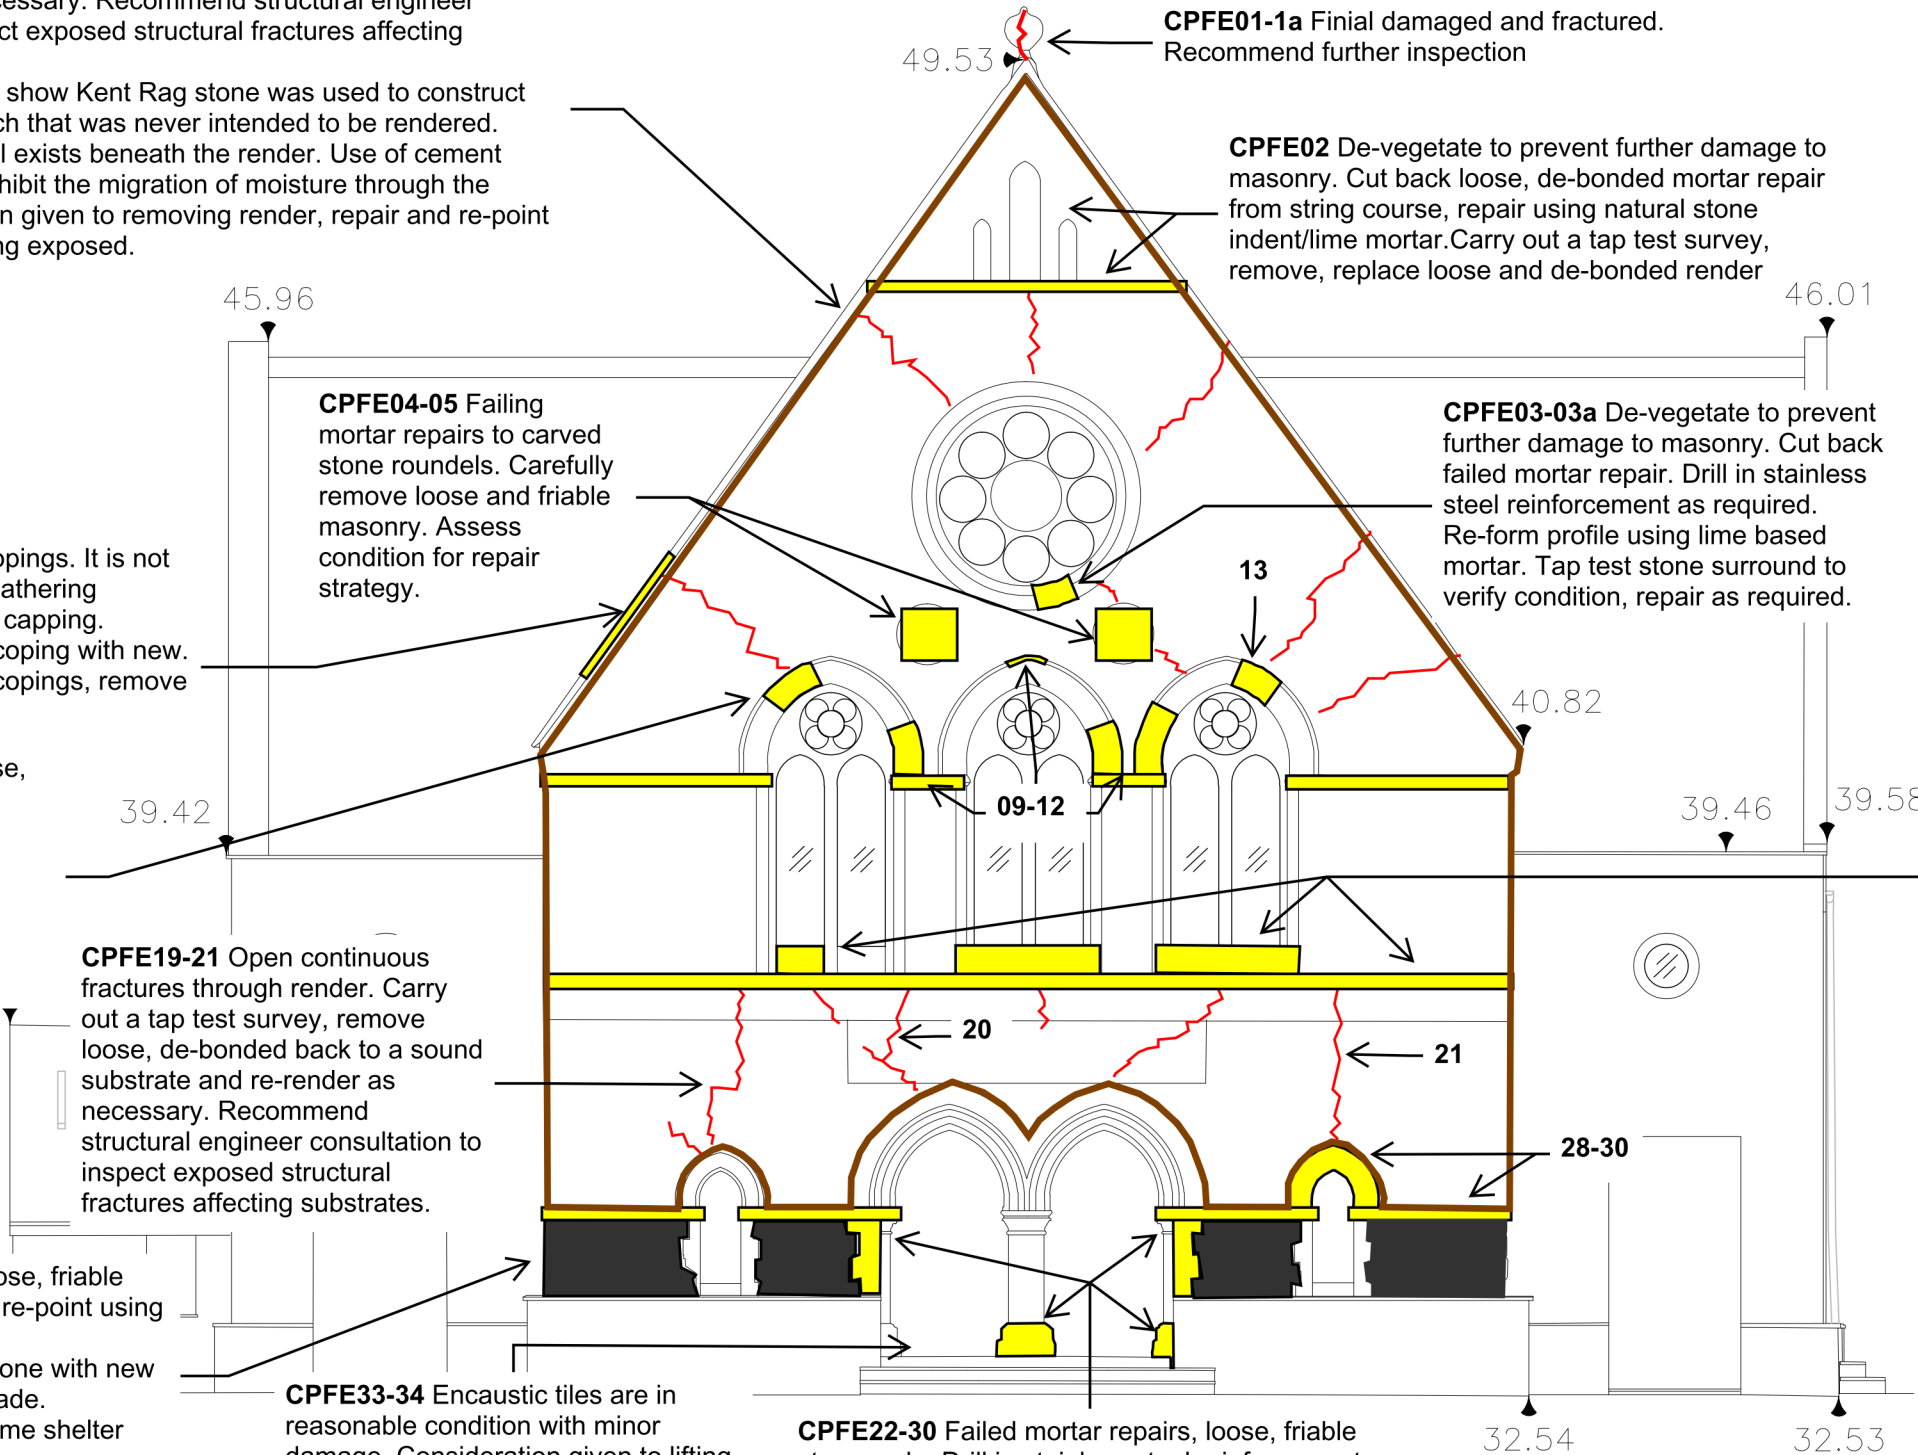
**CPFE06** Open continuous fractures through render. Carry out a tap test survey, remove loose, de-bonded back to a sound substrate and re-render as necessary. Recommend structural engineer consultation to inspect exposed structural fractures affecting substrates.  
Historic photographs show Kent Rag stone was used to construct the walls of the church that was never intended to be rendered. It is assumed this still exists beneath the render. Use of cement based render may inhibit the migration of moisture through the facade. Consideration given to removing render, repair and re-point Rag stone and leaving exposed.

**CPFE07** Failed mortar repaired copings. It is not recommended to mortar repair weathering surfaces unless protected by lead capping. Recommend replacing damaged coping with new. Recommend further survey of all copings, remove and replace as necessary.

**CPFE08-13** Failed mortar repairs, loose, friable stonework. Cut back to a sound substrate, drill in stainless steel reinforcement as required. Re-form profiles using lime based mortar. **Repaint using microporous paint to allow migration of moisture and prolong life of repair.**

**CPFE19-21** Open continuous fractures through render. Carry out a tap test survey, remove loose, de-bonded back to a sound substrate and re-render as necessary. Recommend structural engineer consultation to inspect exposed structural fractures affecting substrates.

**CPFE31-32** Kent Rag stone. Defrass loose, friable stonework. Rake out loose pointing and re-point using lime mortar. Recommend replacing deeply eroded stone with new rag stone to maintain integrity of the facade. Consideration given to application of a lime shelter coat to help conserve masonry

**CPFE33-34** Encaustic tiles are in reasonable condition with minor damage. Consideration given to lifting, subject to adhesion, salvage and re-use.

**CPFE22-30** Failed mortar repairs, loose, friable stonework. Drill in stainless steel reinforcement as required. Re-form profile using lime based mortar. Consideration given to the use of natural stone indents to provide long-term repair solution.

**CPFE01-1a** Finial damaged and fractured. Recommend further inspection

**CPFE02** De-vegetate to prevent further damage to masonry. Cut back loose, de-bonded mortar repair from string course, repair using natural stone indent/lime mortar. Carry out a tap test survey, remove, replace loose and de-bonded render

**CPFE03-03a** De-vegetate to prevent further damage to masonry. Cut back failed mortar repair. Drill in stainless steel reinforcement as required. Re-form profile using lime based mortar. Tap test stone surround to verify condition, repair as required.

**CPFE14-18** De-vegetate to prevent further damage to masonry. Cut back failed mortar repairs to string course and window jambs, mullions, sills. Drill in stainless steel reinforcement as required. Re-form profile using lime based mortar. Consideration given to the use of natural stone indents to provide a long-term repair solution.

Paint applied to stonework is failing. Stonework appears loose and friable. Consideration given to the use of microporous paint to allow migration of moisture and minimise the risk of continued depletion of stonework.

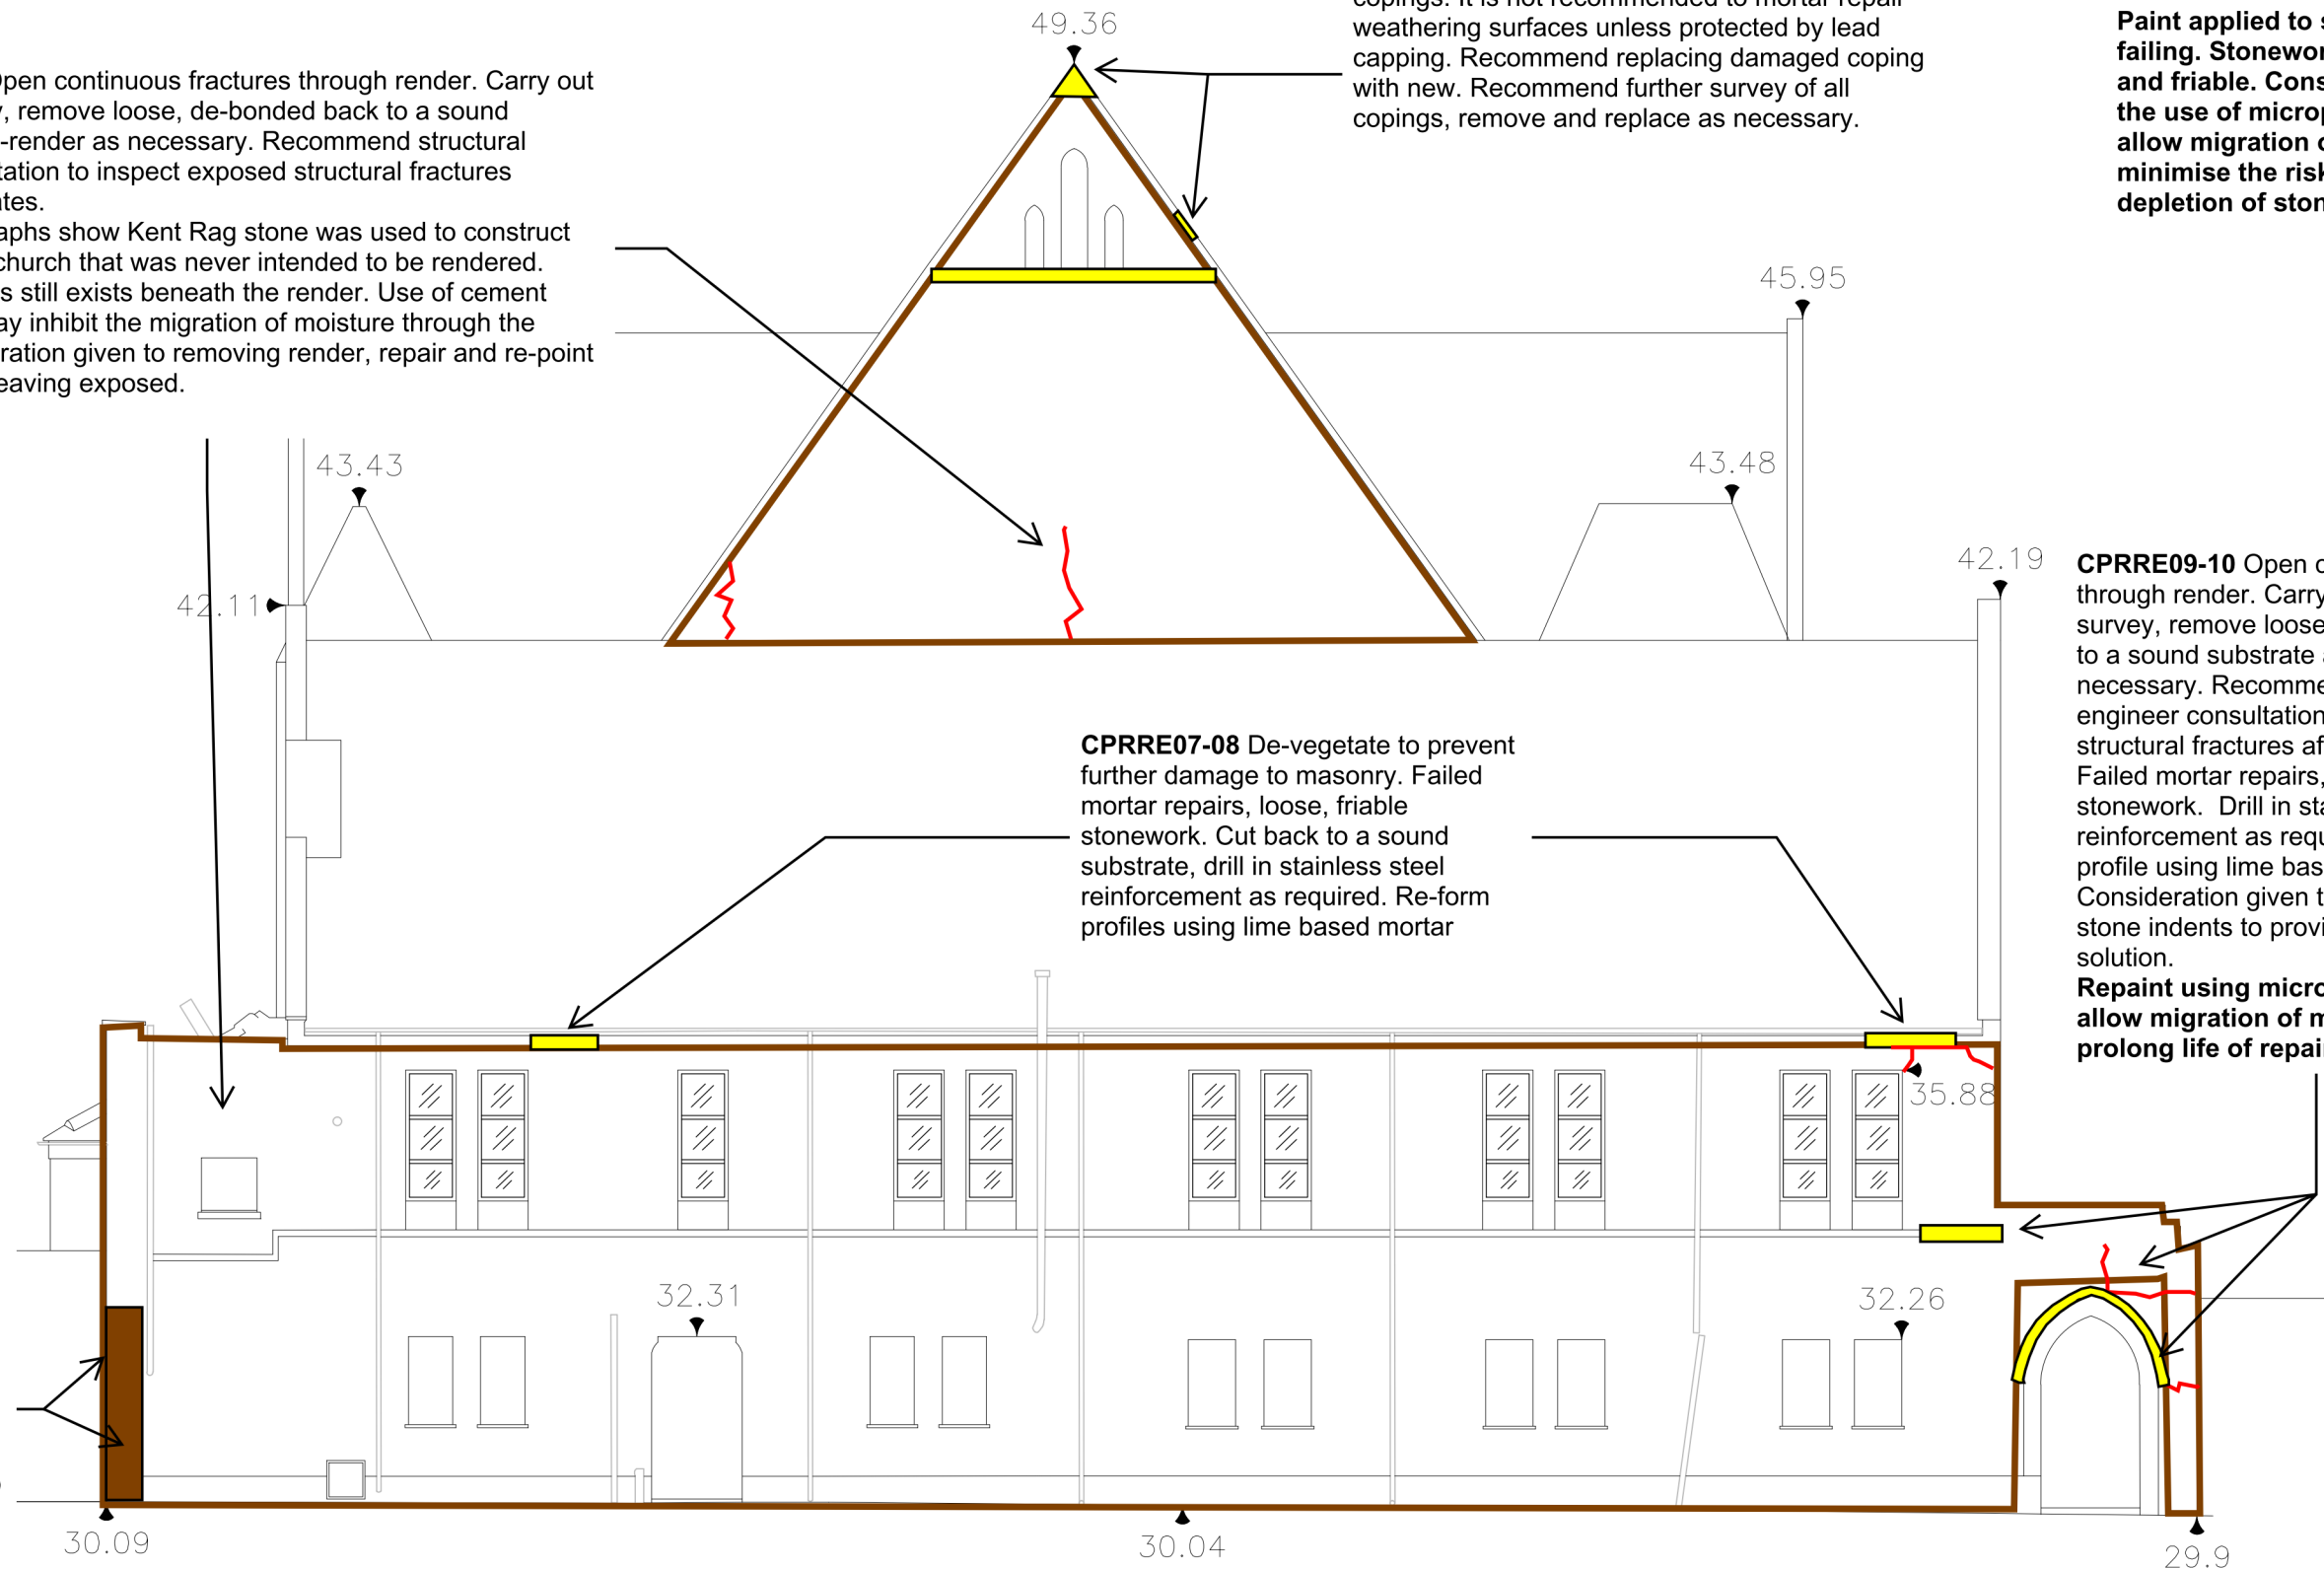
**CPRRE01, 04** Open continuous fractures through render. Carry out a tap test survey, remove loose, de-bonded back to a sound substrate and re-render as necessary. Recommend structural engineer consultation to inspect exposed structural fractures affecting substrates. Historic photographs show Kent Rag stone was used to construct the walls of the church that was never intended to be rendered. It is assumed this still exists beneath the render. Use of cement based render may inhibit the migration of moisture through the facade. Consideration given to removing render, repair and re-point Rag stone and leaving exposed.

**CPRRE02-03** Failed mortar repaired, eroded copings. It is not recommended to mortar repair weathering surfaces unless protected by lead capping. Recommend replacing damaged coping with new. Recommend further survey of all copings, remove and replace as necessary.

Paint applied to stonework is failing. Stonework appears loose and friable. Consideration given to the use of microporous paint to allow migration of moisture and minimise the risk of continued depletion of stonework.

**CPRRE07-08** De-vegetate to prevent further damage to masonry. Failed mortar repairs, loose, friable stonework. Cut back to a sound substrate, drill in stainless steel reinforcement as required. Re-form profiles using lime based mortar

**CPRRE09-10** Open continuous fractures through render. Carry out a tap test survey, remove loose, de-bonded back to a sound substrate and re-render as necessary. Recommend structural engineer consultation to inspect exposed structural fractures affecting substrates. Failed mortar repairs, loose, friable stonework. Drill in stainless steel reinforcement as required. Re-form profile using lime based mortar. Consideration given to the use of natural stone indents to provide long-term repair solution. Repaint using microporous paint to allow migration of moisture and prolong life of repair.

**CPRRE05-06** Displaced, de-bonded render, possible damage to brickwork. Caused by deep rooted vegetation. Cut back render to expose brickwork. Deconstruct as required to remove roots and repair brickwork. Re-render to original profile. Recommend structural engineer consultation to inspect exposed structural damage for comment and repair specification.
