# **R. CARR GEOTECHNICAL SERVICES**

**PROPOSED REDEVELOPMENT AT  
SALEM YARD, SALEM PLACE,  
NORTHFLEET, KENT DA11 9QA.**

**PHASE I GEO ENVIRONMENTAL DESK STUDY  
AND PRELIMINARY RISK ASSESSMENT**

**December 2016**

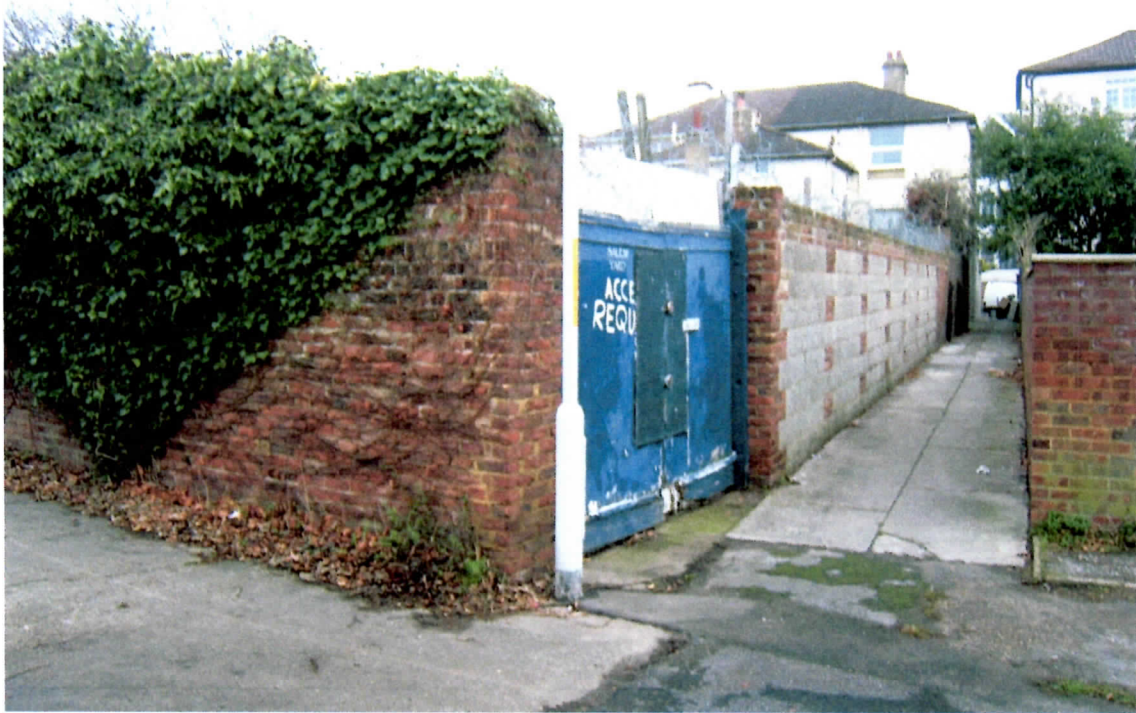
**Plate 1**

- 7.1 An inspection of the site was undertaken on 15<sup>th</sup> December 2016 in the company of Mr Robinson.
- 7.2 Access into the site was gained via a pair of padlocked wooden gates located on the southwest corner of the site (Plate 1).

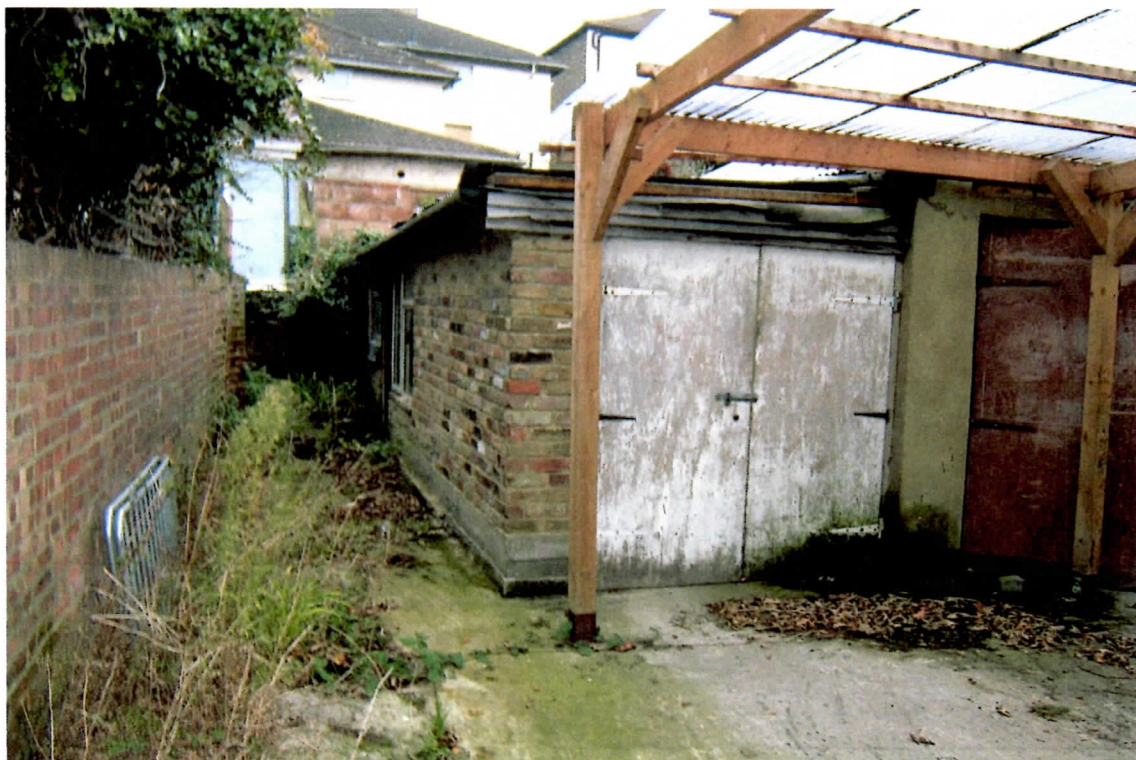
**Plate 2**

- 7.4 The site surface consisted entirely of concrete. A single storey brick building divided into two sections under a corrugated steel roof occupied the east section of the site (Plate 2). A small kitchen area was located at the rear of the structure. The building was currently being utilised for the storage of hand tools, timber sheets, plastic pipes and a portable scaffolding tower (Plate 3 & Plate 4).

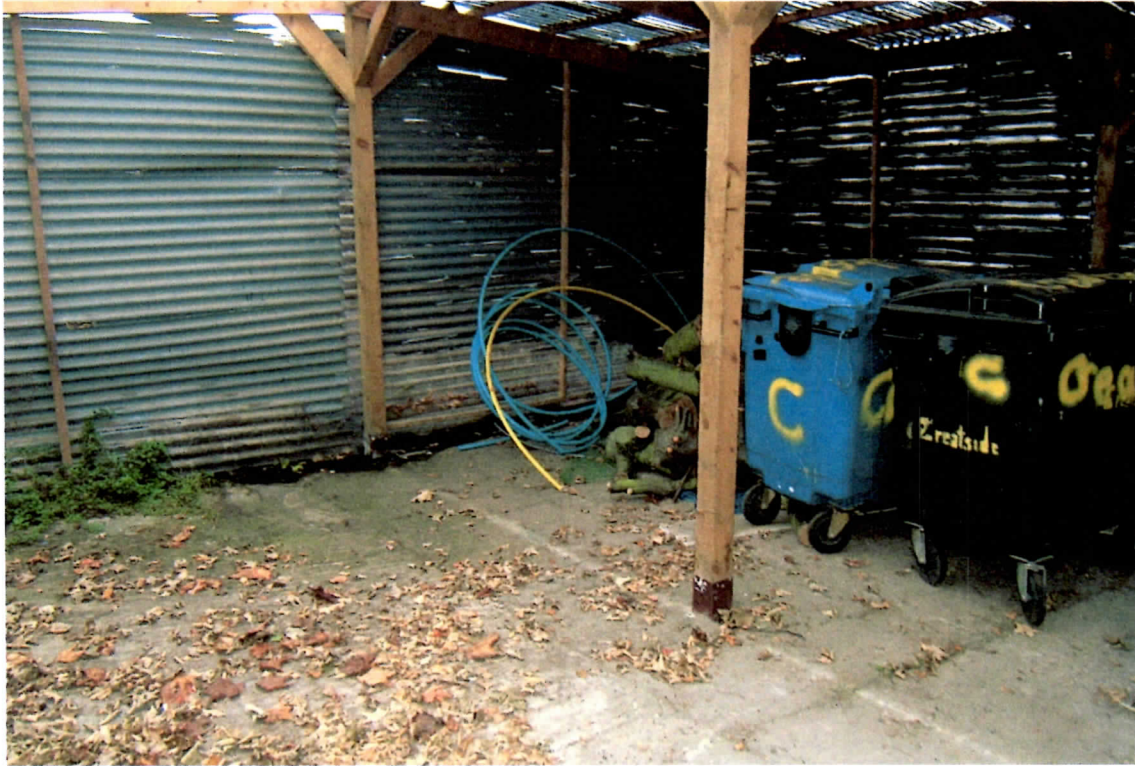
**Plate 5**

- 7.5 The central area of the site supported a lean-to constructed from timber and corrugated plastic sheeting. Two waste bins, plastic water pipes and a pile of logs were stored within the structure (Plate 5).

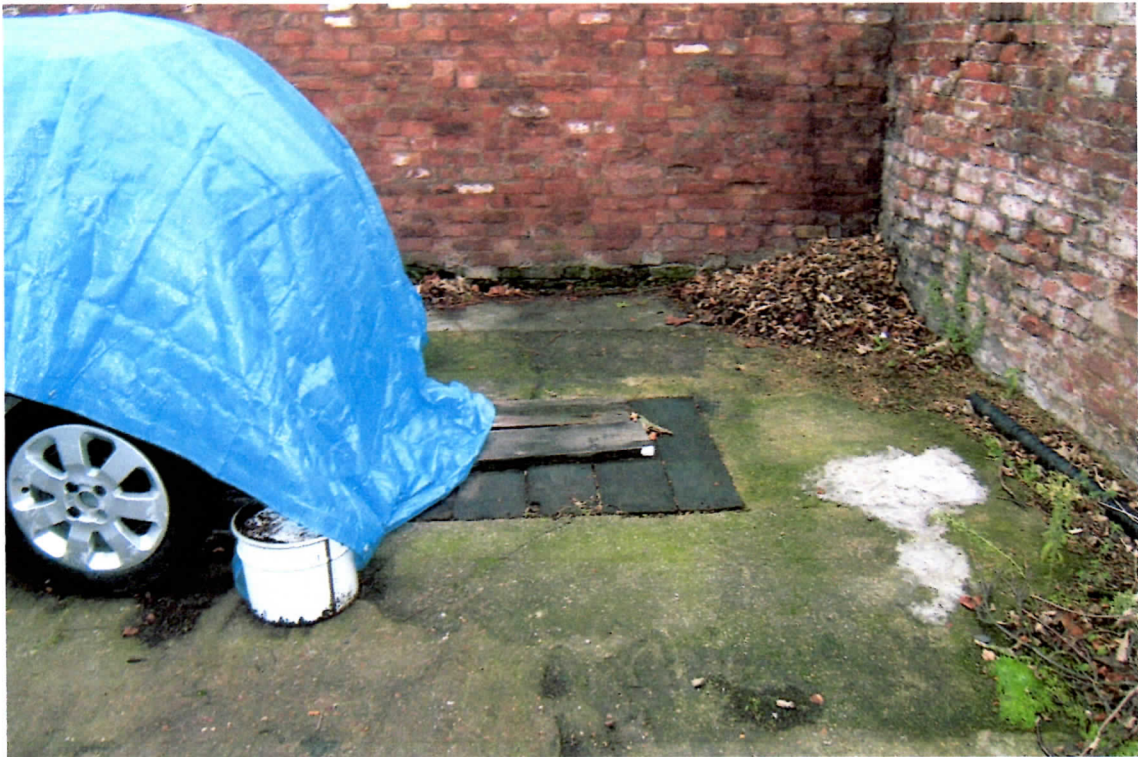
**Plate 6**

- 7.6 A motor vehicle belonging to one of the site's current owners was parked on the west section of the site, to the rear of which was located a covered inspection pit (Plate 6). Mr Robinson confirmed that the sides and base of the pit were constructed from concrete and that it had been partially infilled with rubbish.

- 8.1 Based upon the available information, the site would appear to have comprised a domestic garden from the mid-nineteenth century until the latter part of the twentieth century, when it was apparently occupied by an amateur boat-builder. The presence of a vehicle inspection pit on the west section of the site implies that vehicle servicing may have been undertaken at some point in the more recent history of the site, though if this was indeed the case the size of the existing buildings is indicative that it was only likely to have been on a small scale, or simply for private use. Twenty-five water abstractions have been identified within 500m of the site, though these relate to industrial and agricultural abstractions rather than potable water supplies.

the site surface. Areas of the site which should be particularly targeted include the proposed garden and in the vicinity of the inspection pit. Samples of soil obtained from the excavations should be tested for a suite of common metals, speciated PAH, TPH fractions, VOC, SVOC and asbestos.

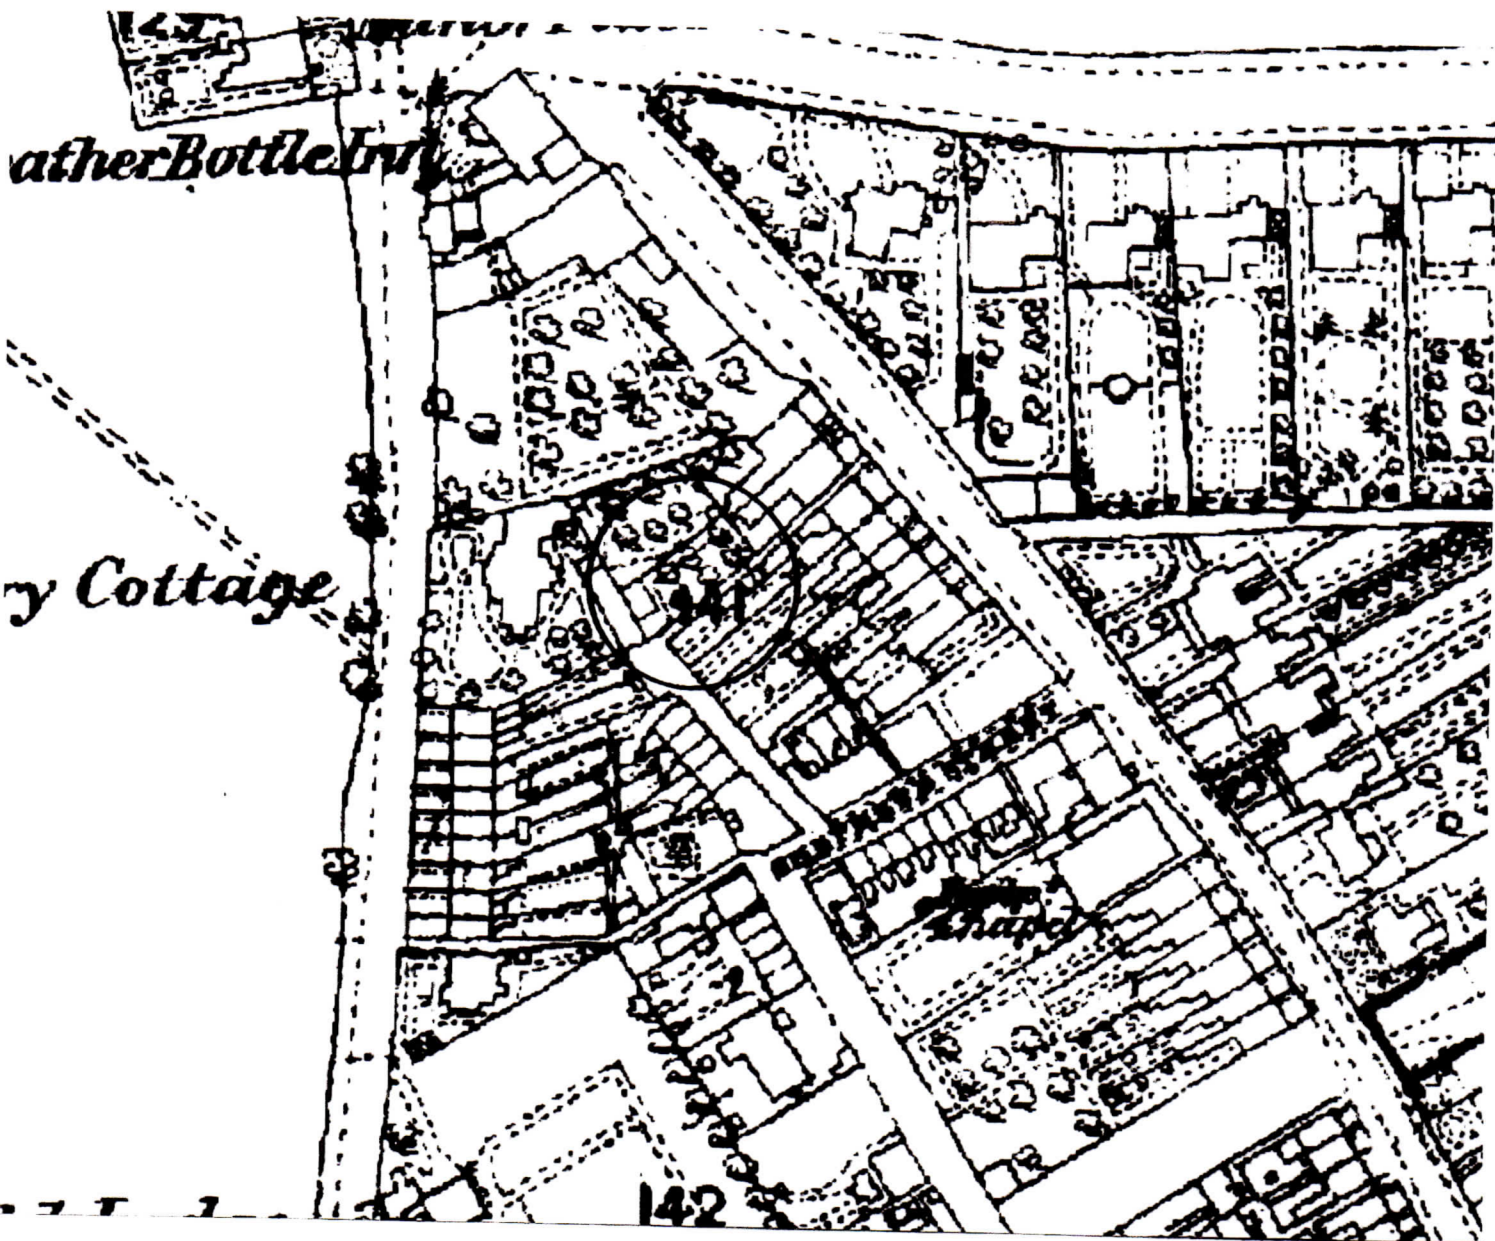
Salem Yard, Salem Place, Northfleet.  
OS map scale 1:1250 1871-1890.

- 5.2 OS map scale 1:1250 1871-1890:  
On site: The site comprises the rear garden of a semi-detached dwelling. A rectangular outbuilding is located in its northwest corner.  
Off site: The site is located within a residential area and is enclosed by the gardens of neighbouring properties. A chalk quarry containing a rifle range is located within 250m to the north and a railway is in evidence within 500m to the south.

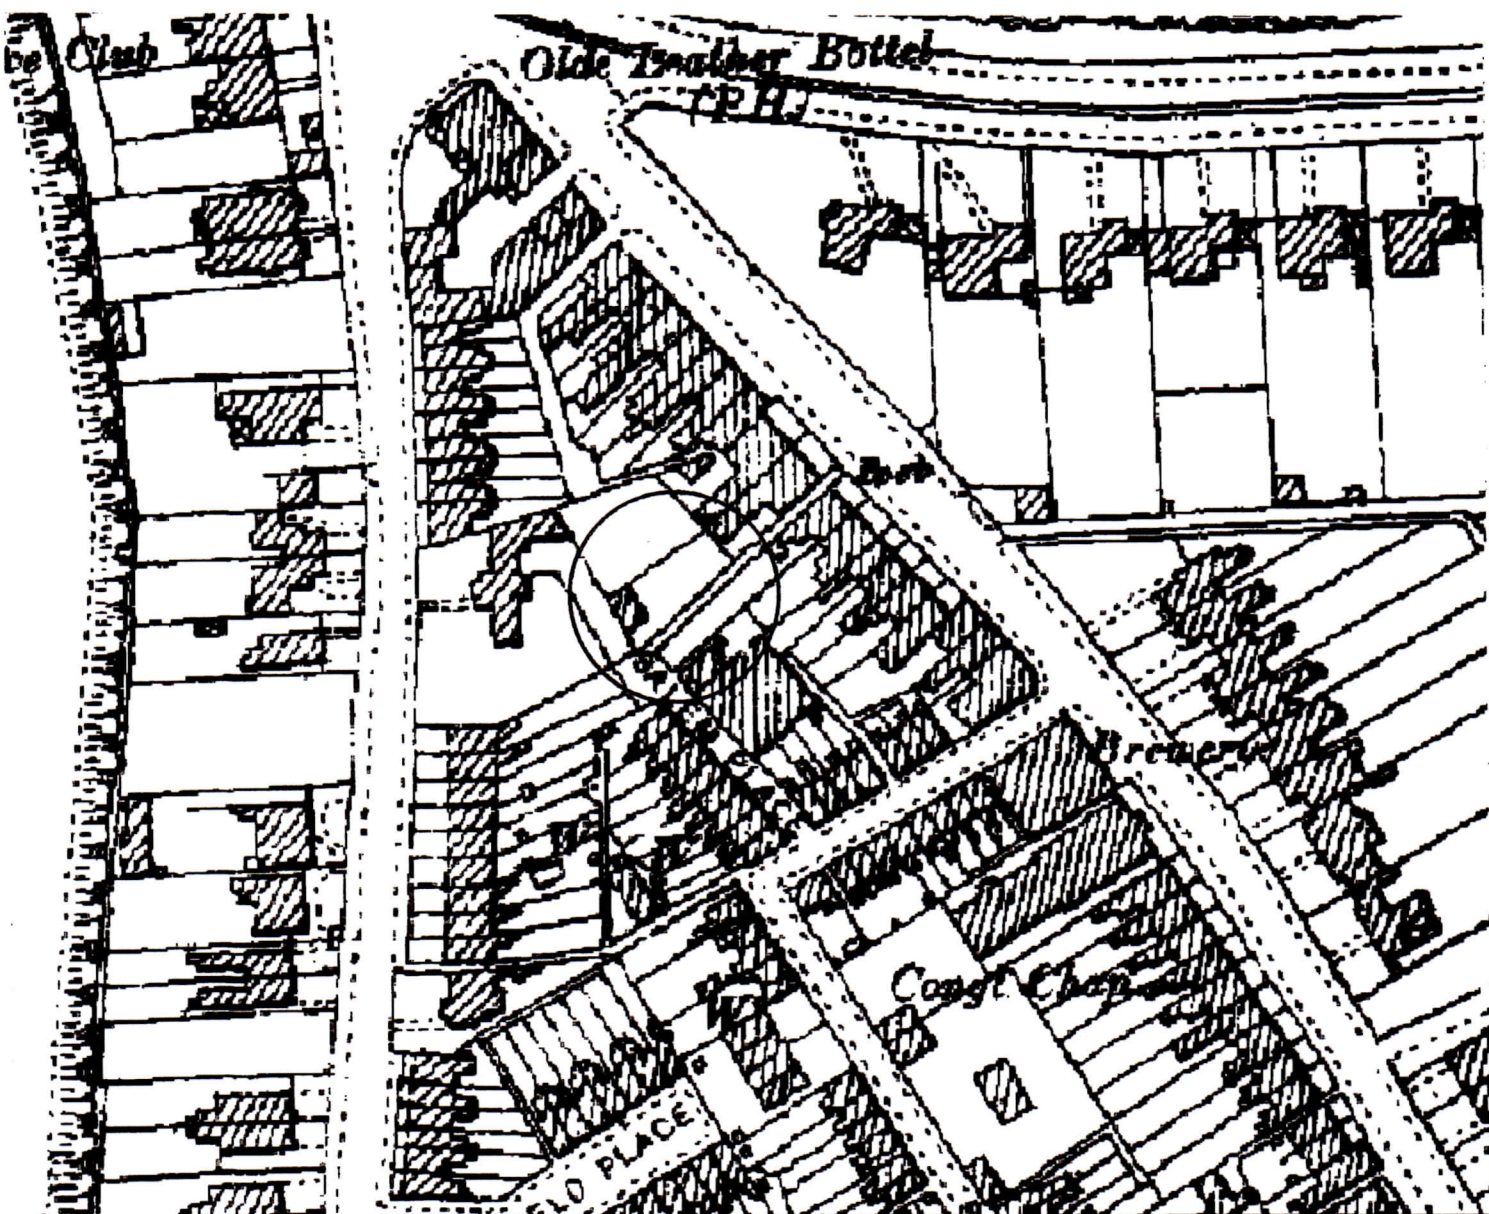
Salem Yard, Salem Place, Northfleet.  
OS map scale 1:1250 1897-1900.

- 5.3 OS map scale 1:1250 1897-1900:  
On site: No significant change.  
Off site: Additional residential development has taken place within 50m to the north of the site. A brewery is denoted within 250m to the southeast. Brickworks are denoted within the chalk quarry to the north. An additional chalk pit is in evidence to the west.

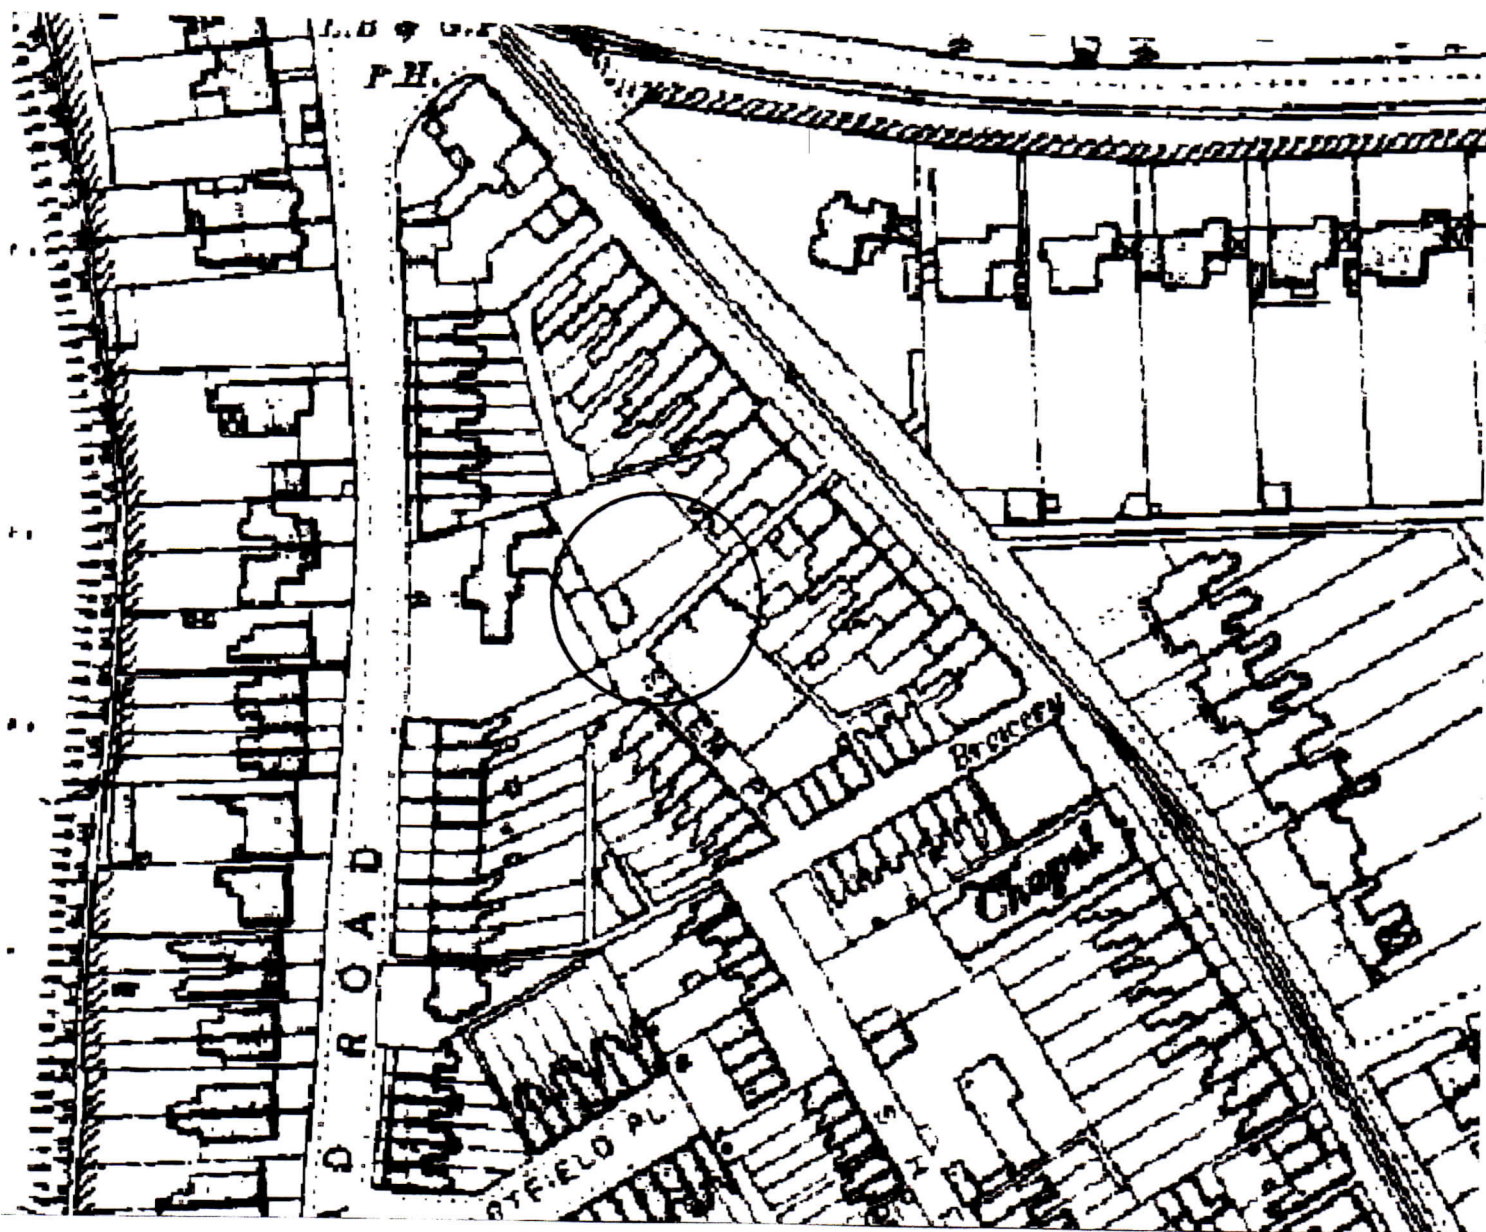
Salem Yard, Salem Place, Northfleet.  
OS map scale 1:1250 1907-1923.

On site: No significant change.

Off site: The brewery remains to the southeast. The quarry to the west has fallen into disuse.

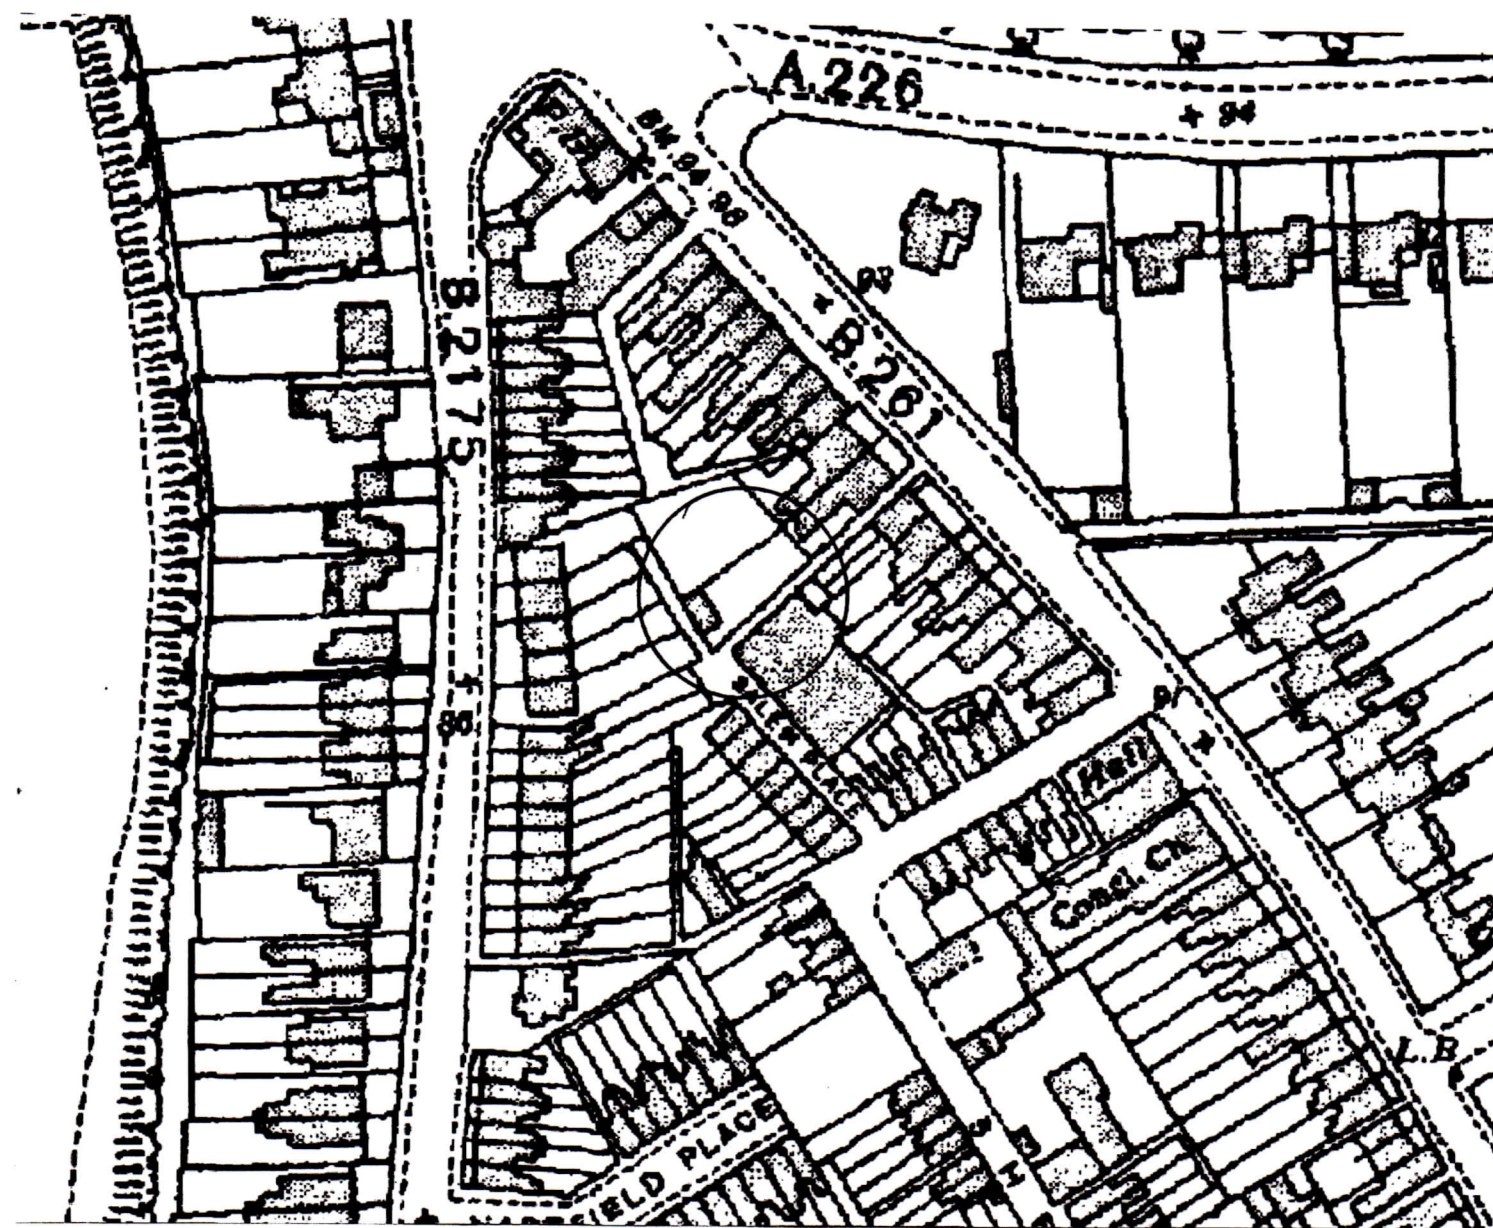
Salem Yard, Salem Place, Northfleet.  
OS map scale 1:1250 1925-1952.

On site: No significant change.

Off site: The brewery has been converted to use as a hall. The former quarry to the west now supports allotment gardens. An additional chalk pit is in evidence within 500m to the southeast.

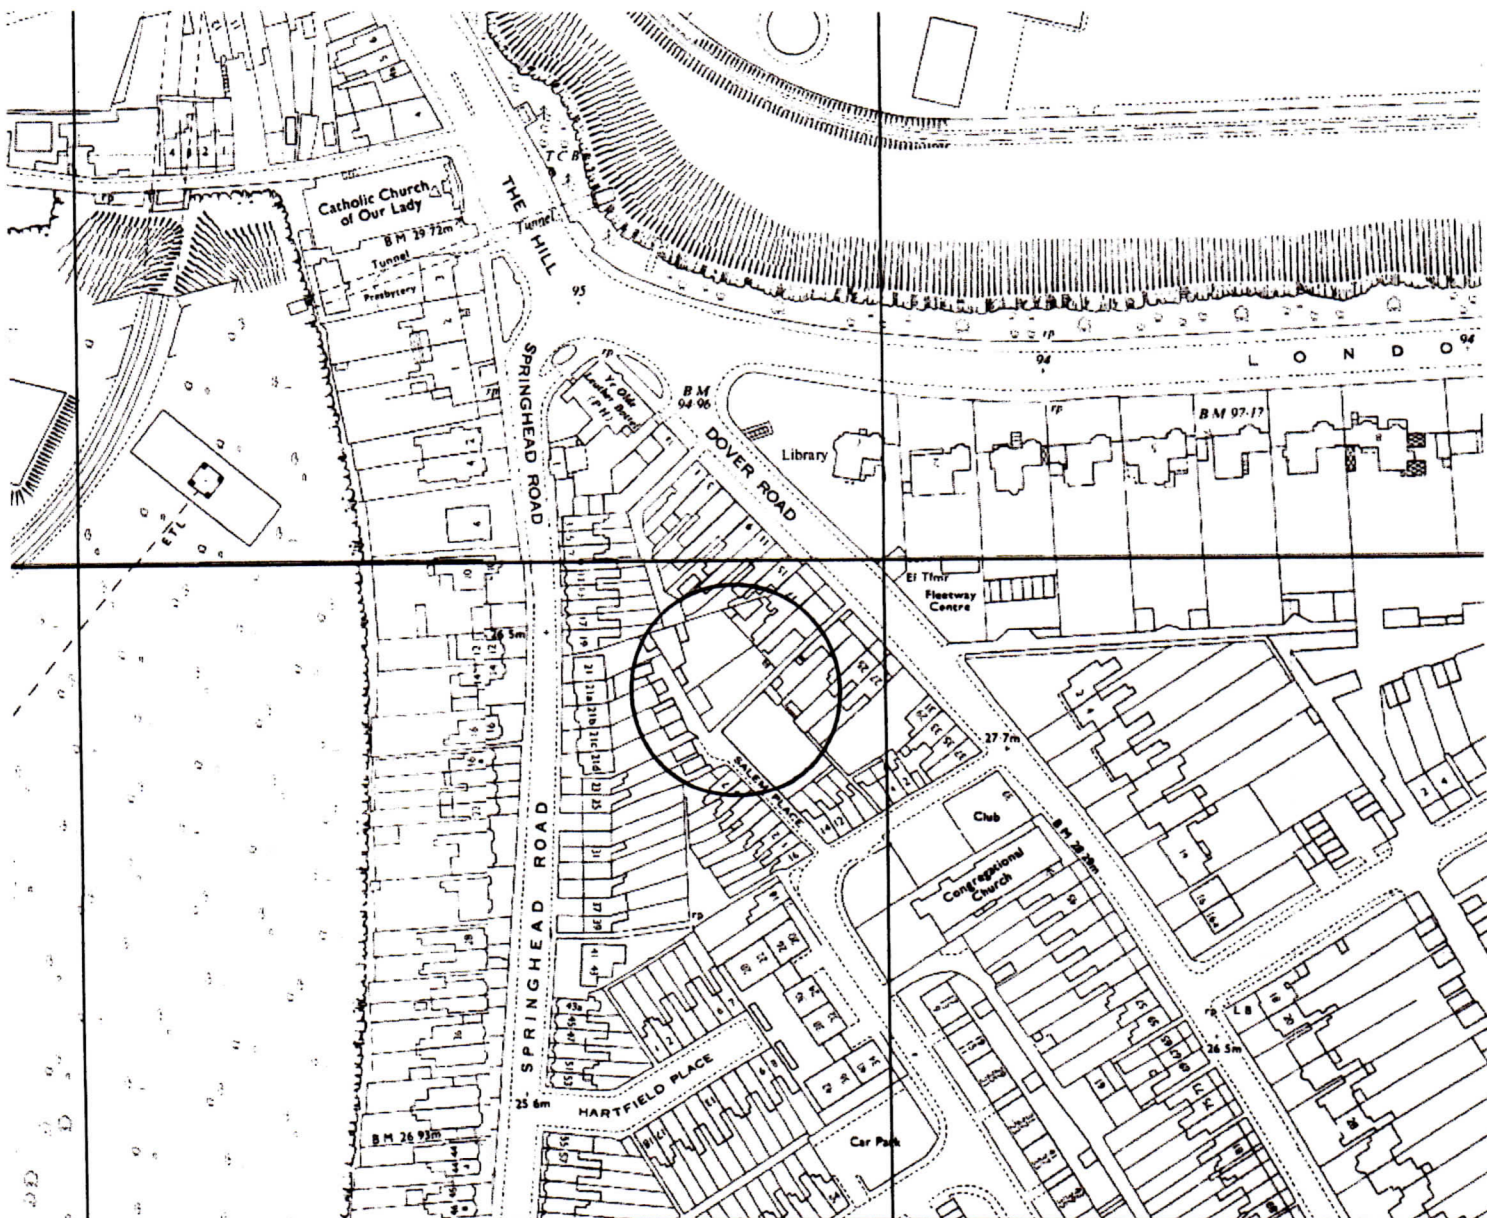
**OS map scale 1:1250 1960-1972.**

On site: No significant change.

Off site: Industrial buildings and railways have been constructed within the former quarry to the north and at the north end of the quarry to the west.

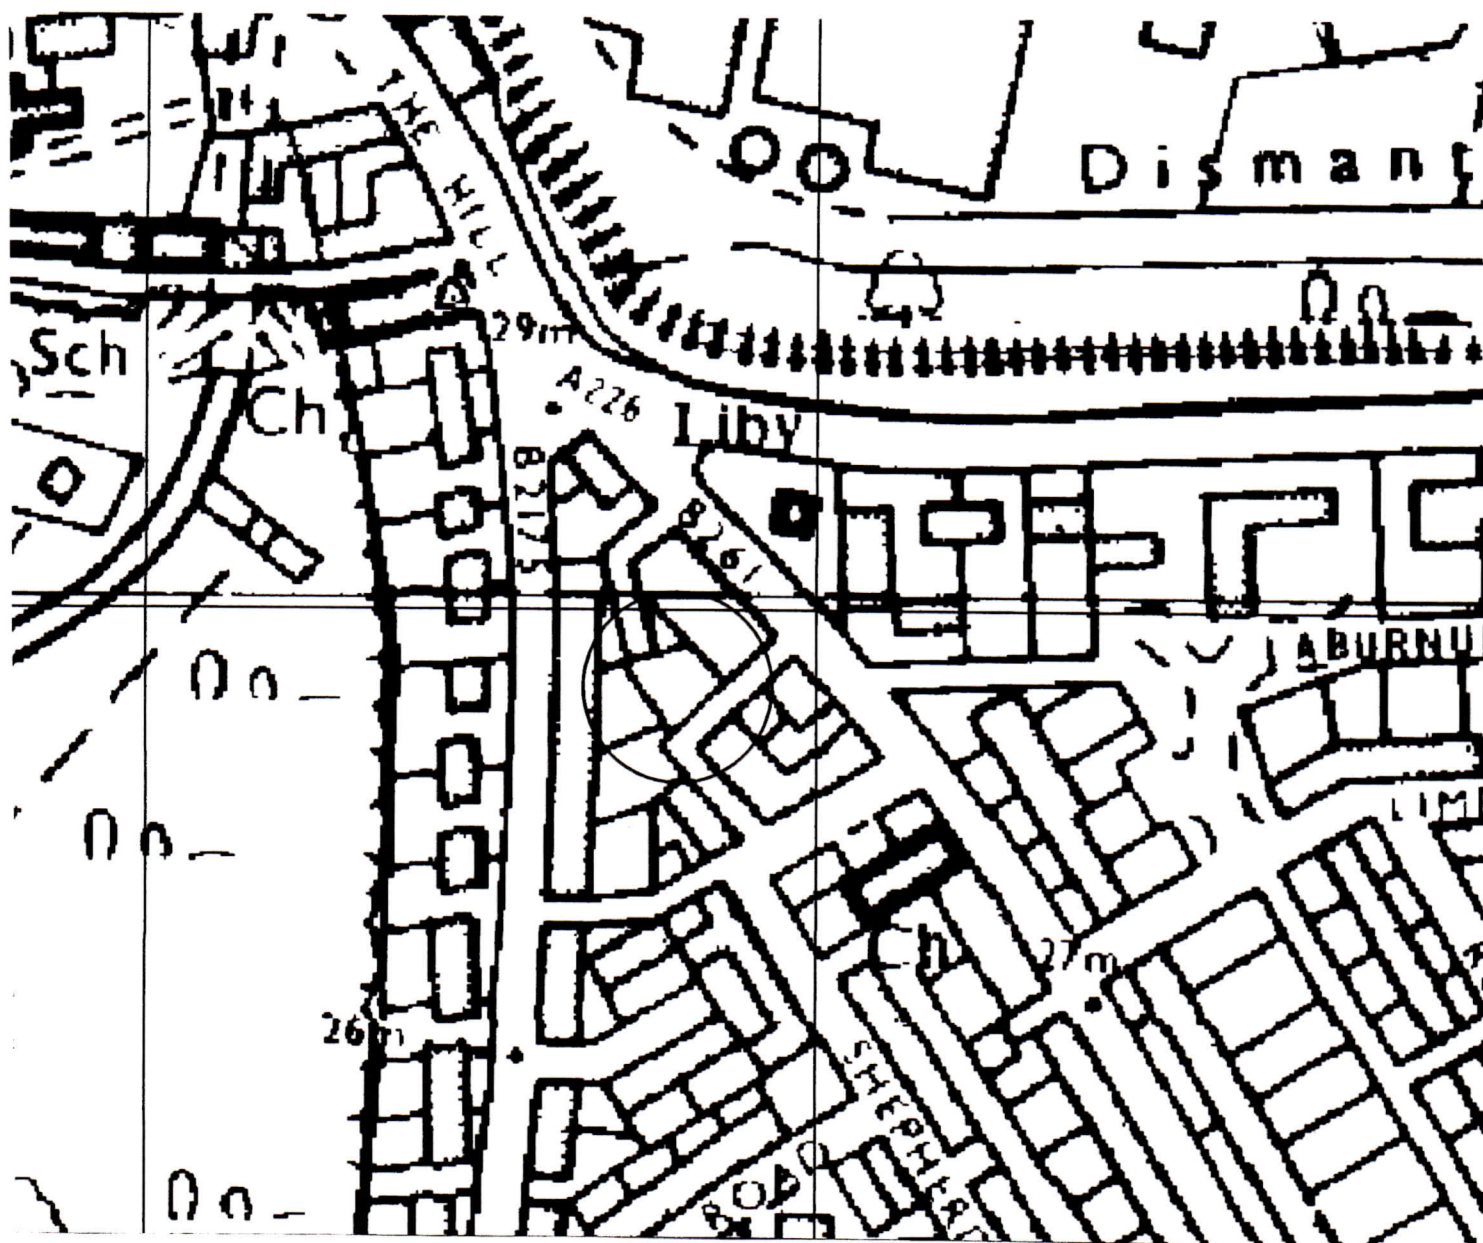
Salem Yard, Salem Place, Northfleet.  
OS map scale 1:10000 1980.

On site: The building previously located within the site's northwest corner is no longer in evidence.

Off site: The railway within the former quarry to the north has been dismantled. Industrial buildings remain within the quarries to the north and the northwest.
