**Asbestos Management Survey Report  
Of  
Hartshill Bungalow  
Thong lane  
Shorne  
Gravesend  
Kent  
DA12 3HE**

**No Asbestos Detected**

Client: Carter Jonas HE  
Order Placed By: Khadeza Yasmin  
MCP Project Number: M-143968  
UPRN: 4716058

Survey Date: 18/03/2024  
Report Date: 26/03/2024

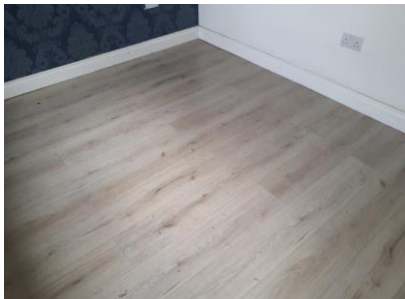
| Area Ref | Location | Area/Item Not Accessed | Reason for Non-access | Photo |
|---|---|---|---|---|
| 004 | Hartshill Bungalow /<br>Ground Floor<br>Bedroom 2 | under Flooring | No access gained<br>No access beneath Laminate Flooring due to the<br>amount of damage it may cause | |

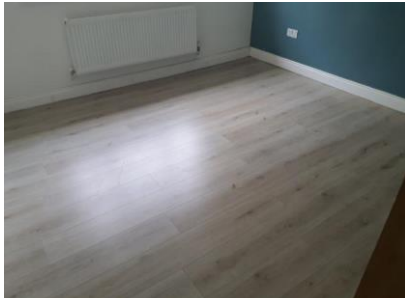
| Area Ref | Location | Area/Item Not Accessed | Reason for Non-access | Photo |
|---|---|---|---|---|
| 005 | Hartshill Bungalow /<br>Ground Floor<br>Bedroom 3 | under Flooring | No access gained<br>No access beneath Laminate Flooring due to the<br>amount of damage it may cause | |

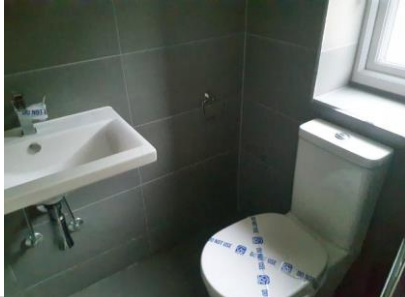
| Area Ref | Location | Area/Item Not Accessed | Reason for Non-access | Photo |
|---|---|---|---|---|
| 006 | Hartshill Bungalow /<br>Ground Floor Ensuite<br>1 | behind Ceramic Wall and Floor Tiles | No access gained<br>No access behind Ceramic Wall and Floor Tiles<br>due to the damage it would cause | |

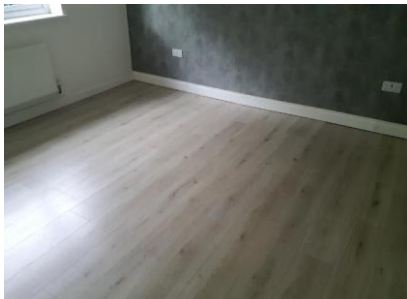
| Area Ref | Location | Area/Item Not Accessed | Reason for Non-access | Photo |
|---|---|---|---|---|
| 007 | Hartshill Bungalow /<br>Ground Floor<br>Bedroom 4 | under Flooring | No access gained<br>No access beneath Laminate Flooring due to the<br>amount of damage it may cause | |

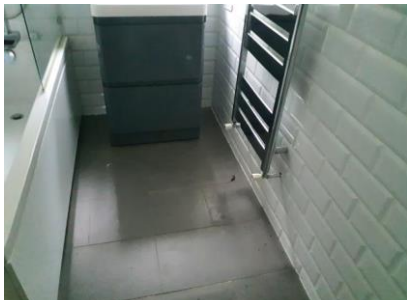
| Area Ref | Location | Area/Item Not Accessed | Reason for Non-access | Photo |
|---|---|---|---|---|
| 008 | Hartshill Bungalow /<br>Ground Floor<br>Bathroom | behind Ceramic Wall, Floor Tiles &<br>bath panel | No access gained<br>No access behind Ceramic Wall, Floor Tiles or<br>behind Bath Panel due to the damage it would<br>cause | |

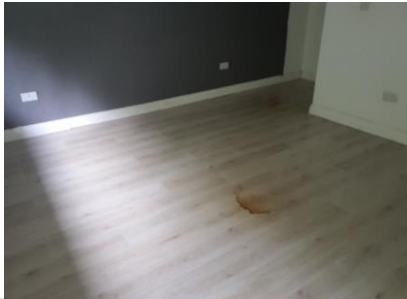
| Area Ref | Location | Area/Item Not Accessed | Reason for Non-access | Photo |
|---|---|---|---|---|
| 009 | Hartshill Bungalow /<br>Ground Floor<br>Bedroom 5 | under Flooring | No access gained<br>No access beneath Laminate Flooring due to the<br>amount of damage it may cause | |

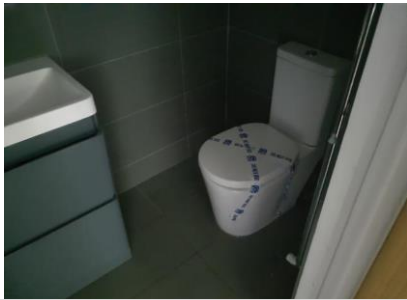
| Area Ref | Location | Area/Item Not Accessed | Reason for Non-access | Photo |
|---|---|---|---|---|
| 010 | Hartshill Bungalow /<br>Ground Floor Ensuite<br>2 | behind Ceramic Wall and Floor Tiles | No access gained<br>No access behind Ceramic Wall and Floor Tiles<br>due to the damage it would cause | |

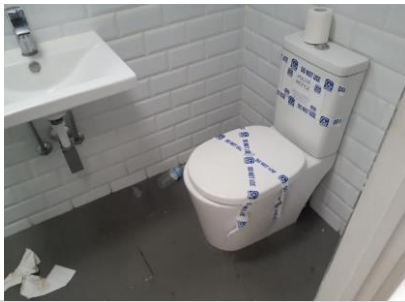
| Area Ref | Location | Area/Item Not Accessed | Reason for Non-access | Photo |
|---|---|---|---|---|
| 011 | Hartshill Bungalow /<br>Ground Floor WC | behind Ceramic Wall and Floor Tiles | No access gained<br>No access behind Ceramic Wall and Floor Tiles<br>due to the damage it would cause | |

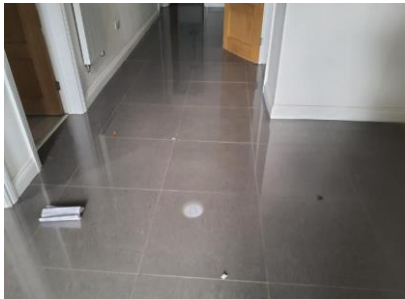
| Area Ref | Location | Area/Item Not Accessed | Reason for Non-access | Photo |
|---|---|---|---|---|
| 012 | Hartshill Bungalow /<br>Ground Floor Hall | under Flooring | No access gained<br>No access beneath Ceramic Floor Tiles due to the<br>damage it would cause | |

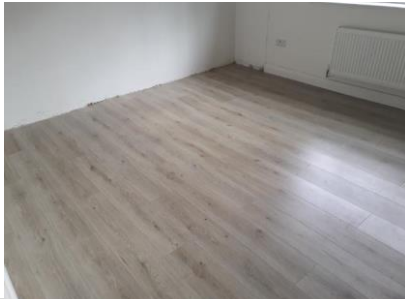
| Area Ref | Location | Area/Item Not Accessed | Reason for Non-access | Photo |
|---|---|---|---|---|
| 013 | Hartshill Bungalow /<br>Ground Floor<br>Bedroom 6 | under Flooring | No access gained<br>No access beneath Laminate Flooring due to the<br>amount of damage it may cause | |

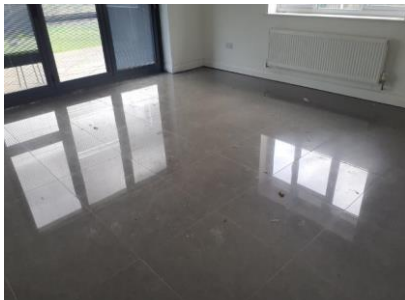
| Area Ref | Location | Area/Item Not Accessed | Reason for Non-access | Photo |
|---|---|---|---|---|
| 014 | Hartshill Bungalow /<br>Ground Floor Lounge | under Flooring | No access gained<br>No access beneath Ceramic Floor Tiles due to the<br>damage it would cause | |

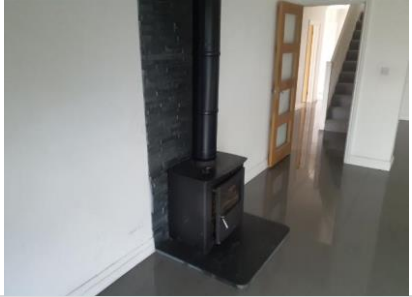
| Area Ref | Location | Area/Item Not Accessed | Reason for Non-access | Photo |
|---|---|---|---|---|
| 015 | Hartshill Bungalow /<br>Ground Floor Kitchen | under Flooring & behind fireplace<br>surrounds | No access gained<br>No access beneath Ceramic Floor Tiles or within<br>fireplace surrounds due to the damage it would<br>cause | |

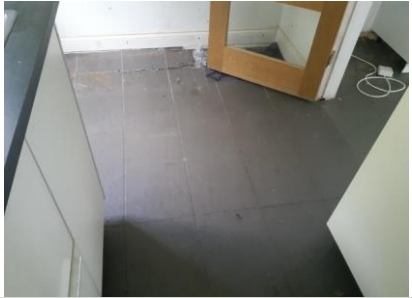
| Area Ref | Location | Area/Item Not Accessed | Reason for Non-access | Photo |
|---|---|---|---|---|
| 016 | Hartshill Bungalow /<br>Ground Floor Utility | under Flooring | No access gained<br>No access beneath Ceramic Floor Tiles due to the<br>damage it would cause | |

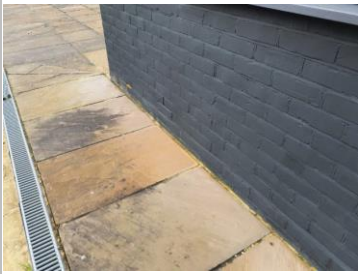
| Sample Information | | | | | | | | | | | | | | |
|---|---|---|---|---|---|---|---|---|---|---|---|---|---|---|
| 018 | 99 | | S001 | Bituminous product<br>Damp proof course<br>Present to original section of the property. | ID | Hartshill Bungalow / External | N/A | 40lin m | - | - | - | NAD | - | - |
