*Gad's Hill Place Cupola Repairs.*  
*Notes taken from*  
*meeting @ Fareham Joinery*  
*22/5/2024.*  
*1 of 14 pages.*

Project GAD'S HILL SCHOOL, HIGHAM  
GAD'S HILL PLACE REPAIRS

Title CUPOLA REPAIRS  
EXISTING SECTION AND SIDE ELEVATION

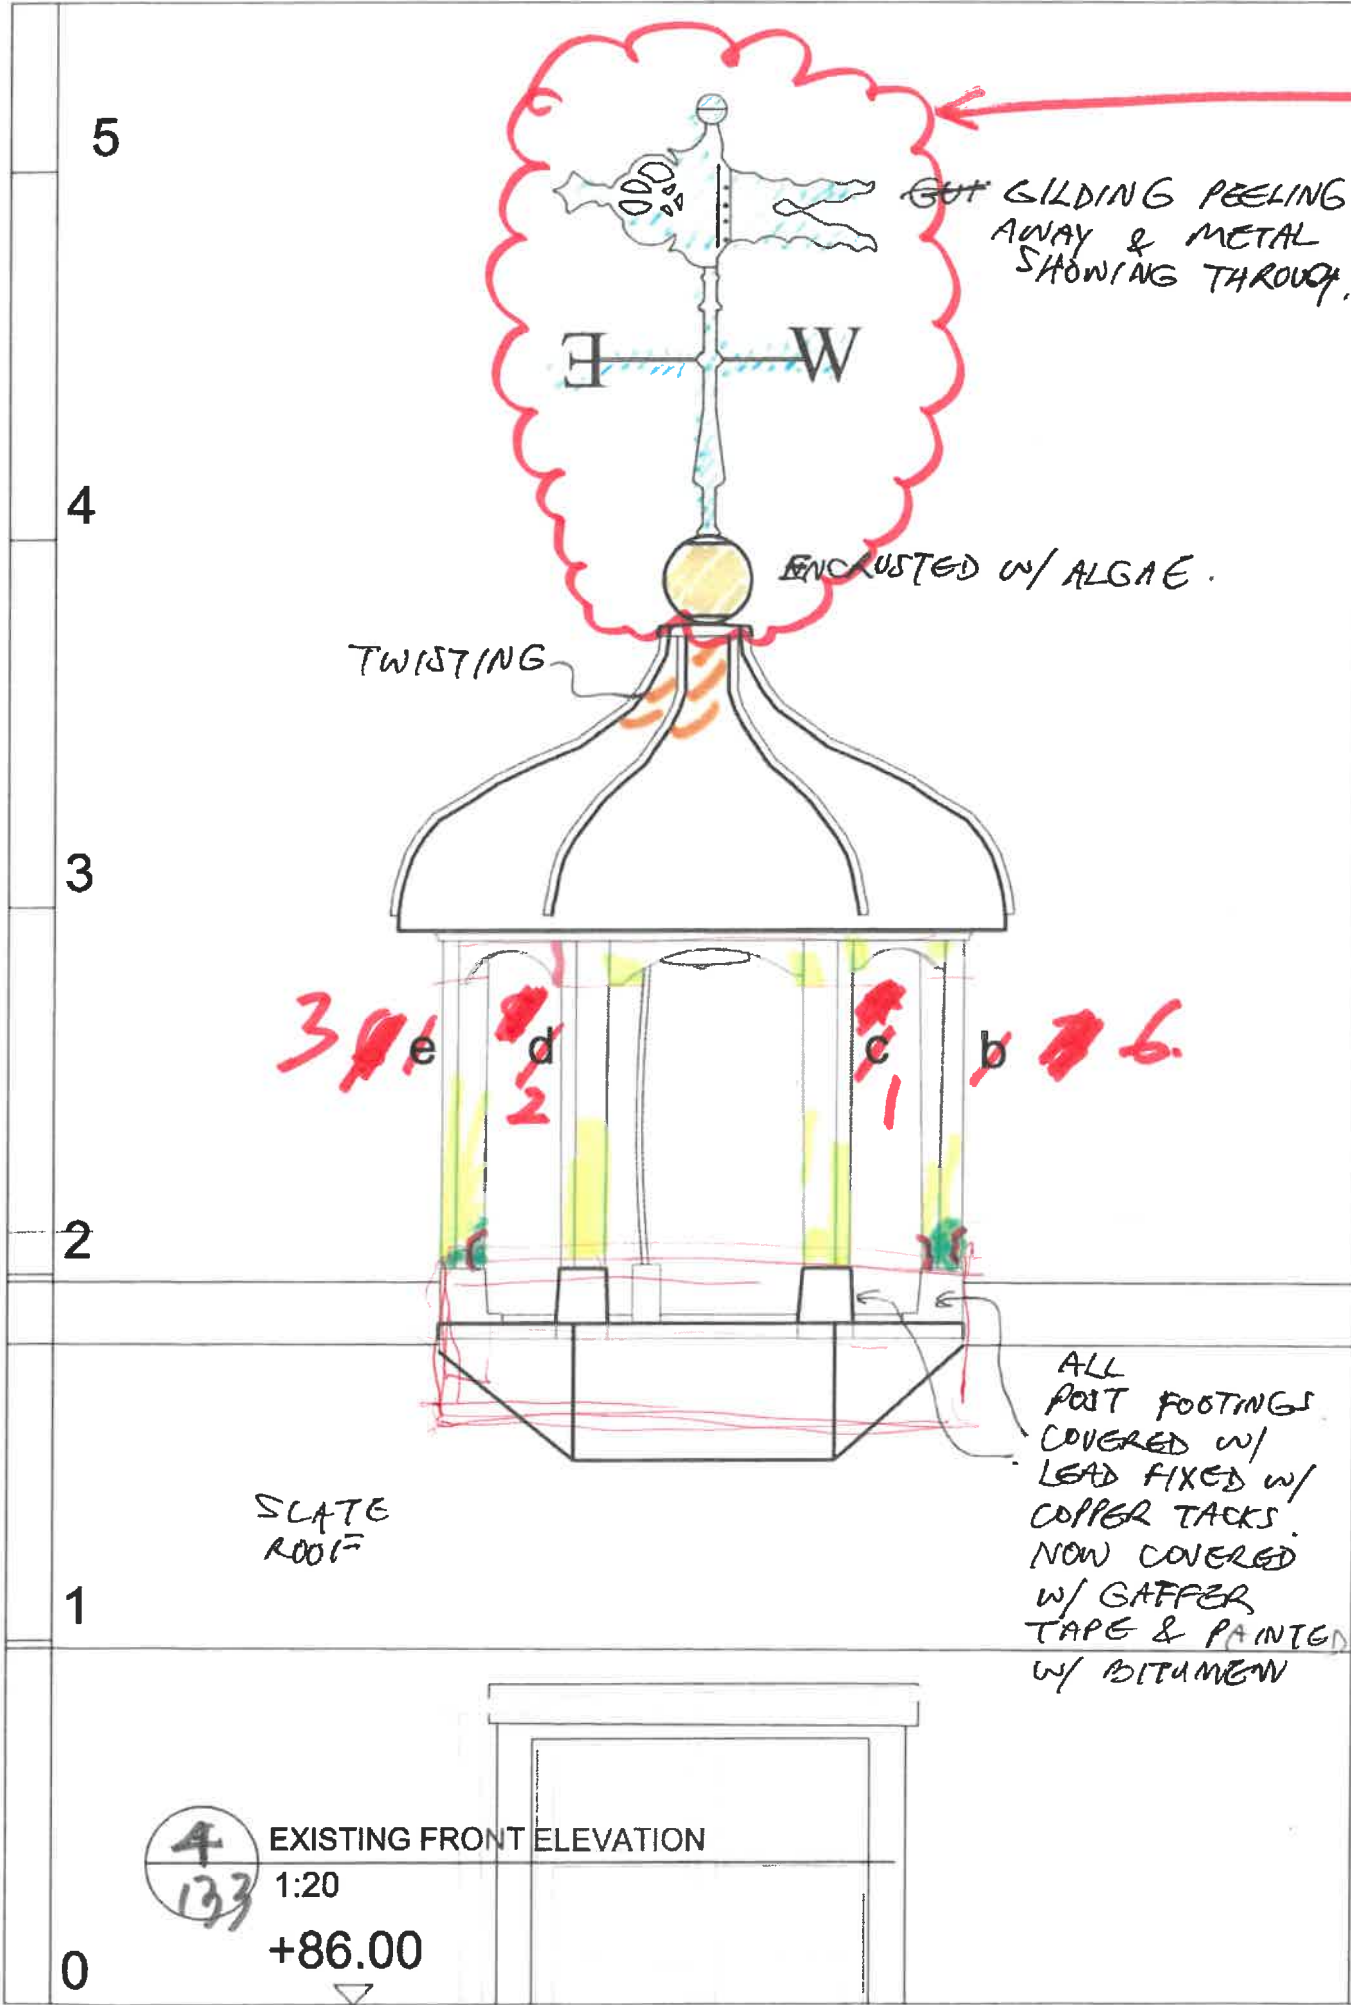
60% of weather vane is lead.  
 Gold leaf won't hold.  
 Prepare wire brush & repaint w/ gold.  
 coloured paint instead

SPLIT.

CRACKED & PEELING PAINT. EXPOSED TIMBER.

ROTTED

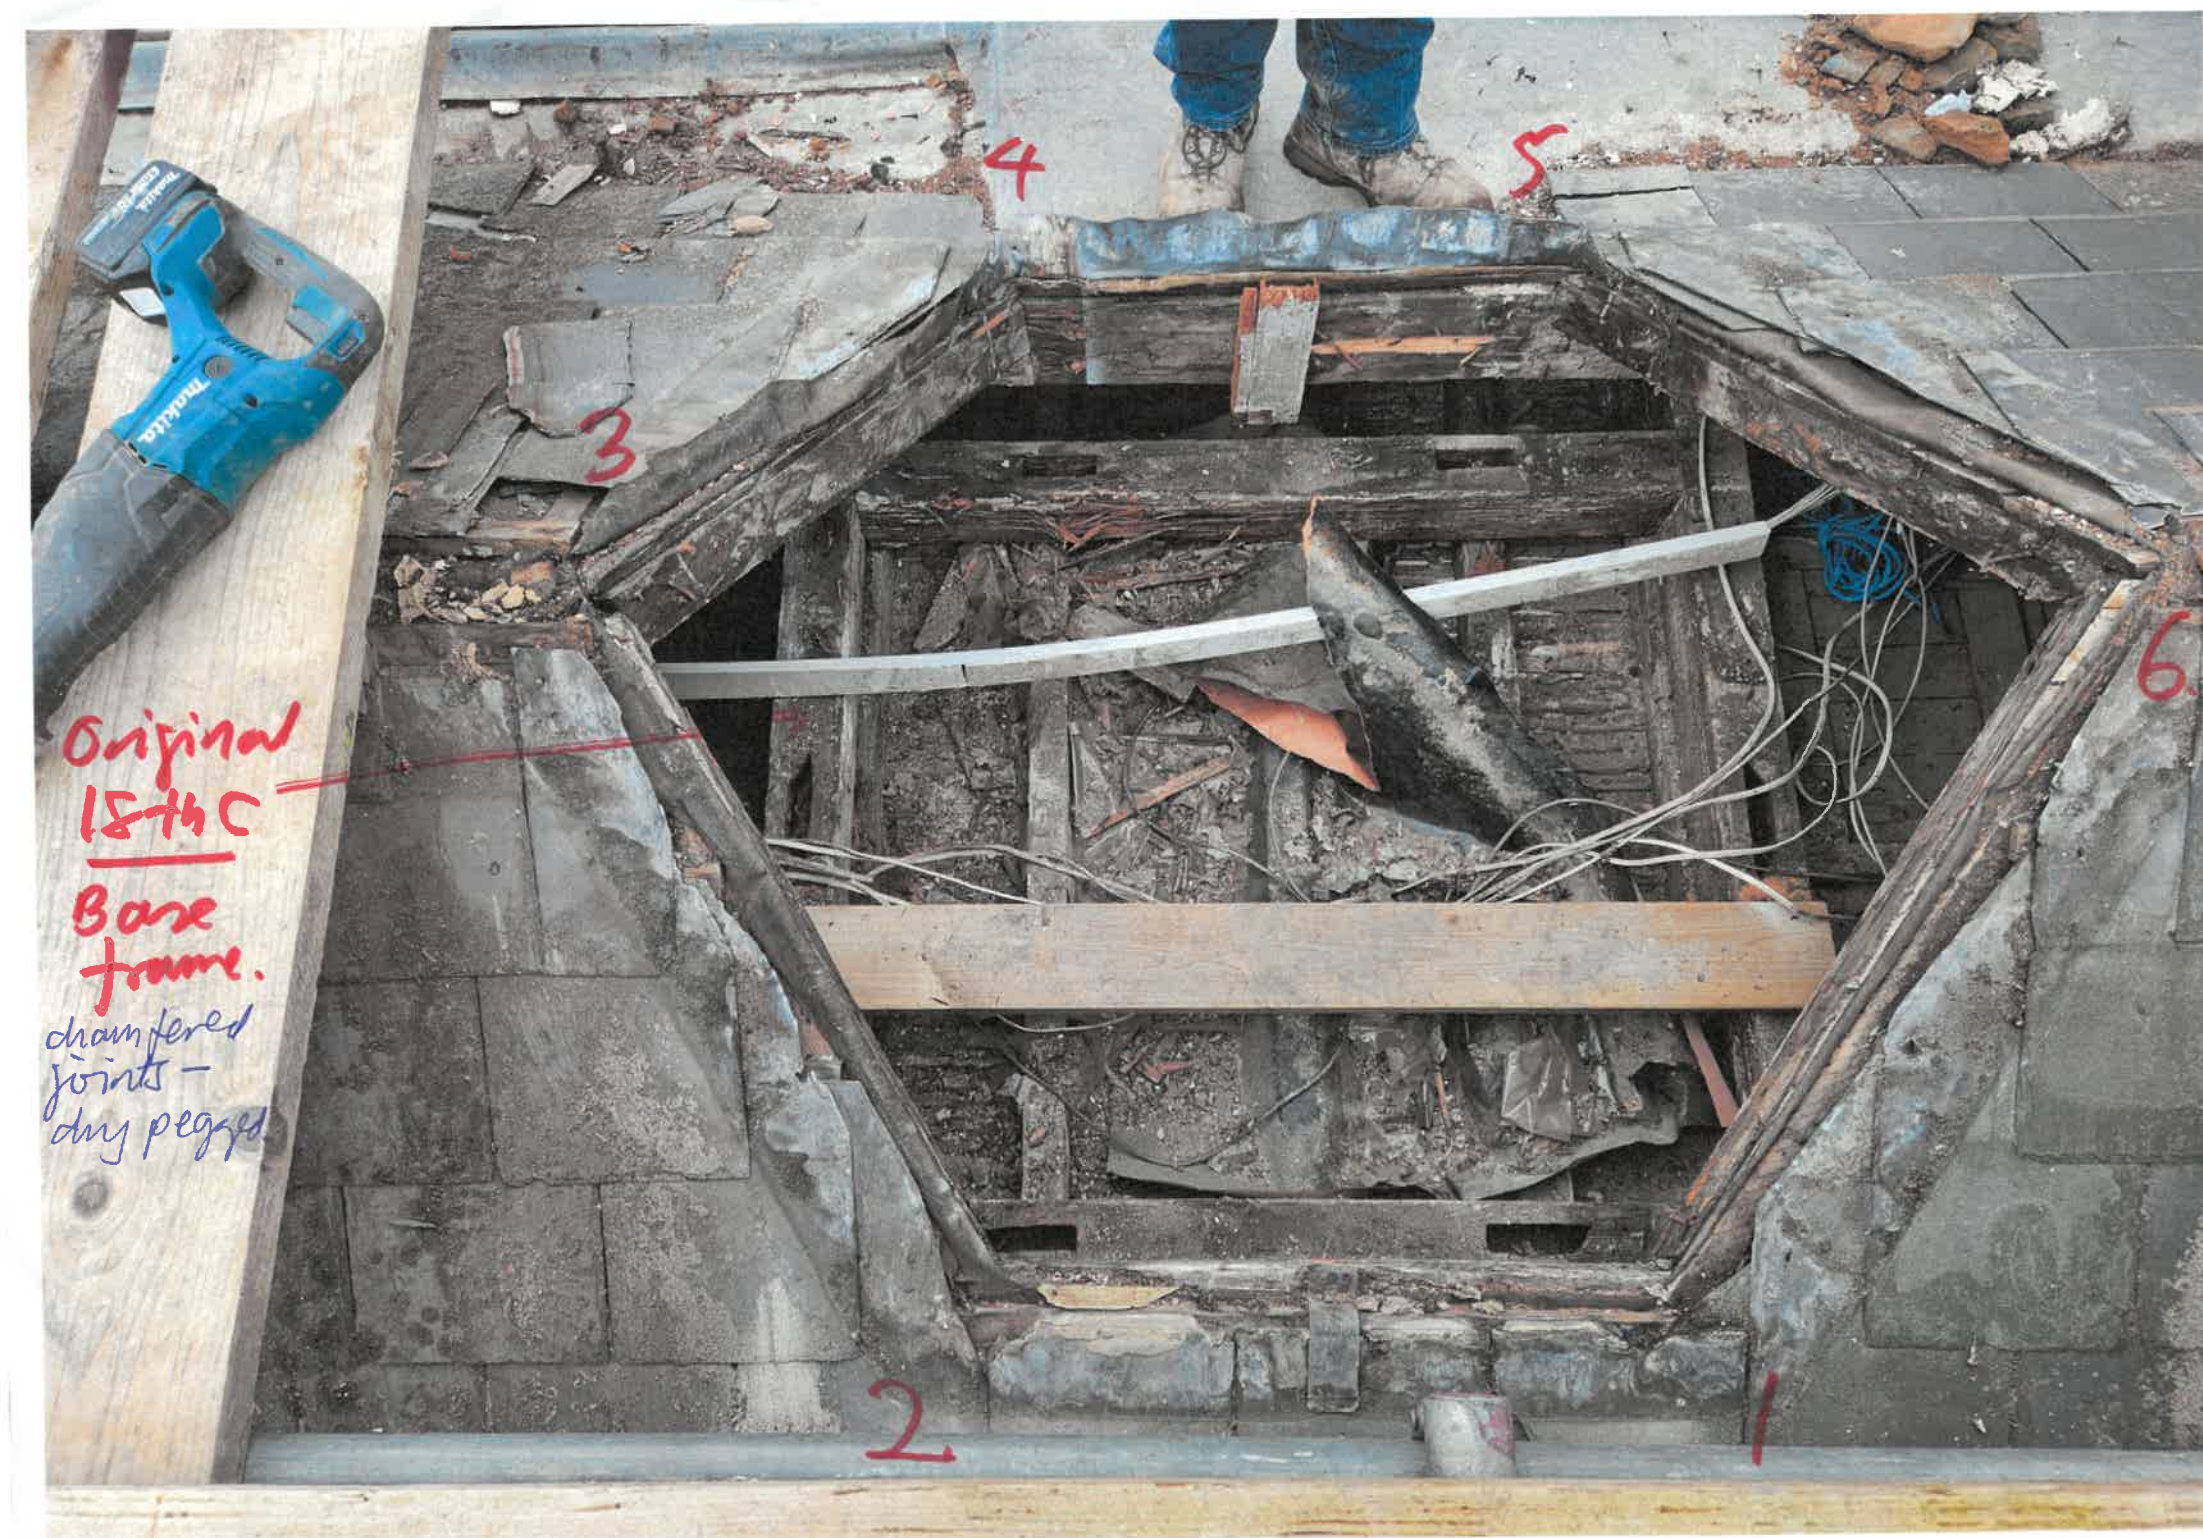
Original  
18th C  
Base  
frame.

chamfered  
joints -  
dry pegged

Removed  
19th C BASE  
Sat on top of  
THIS

Historic water  
damage

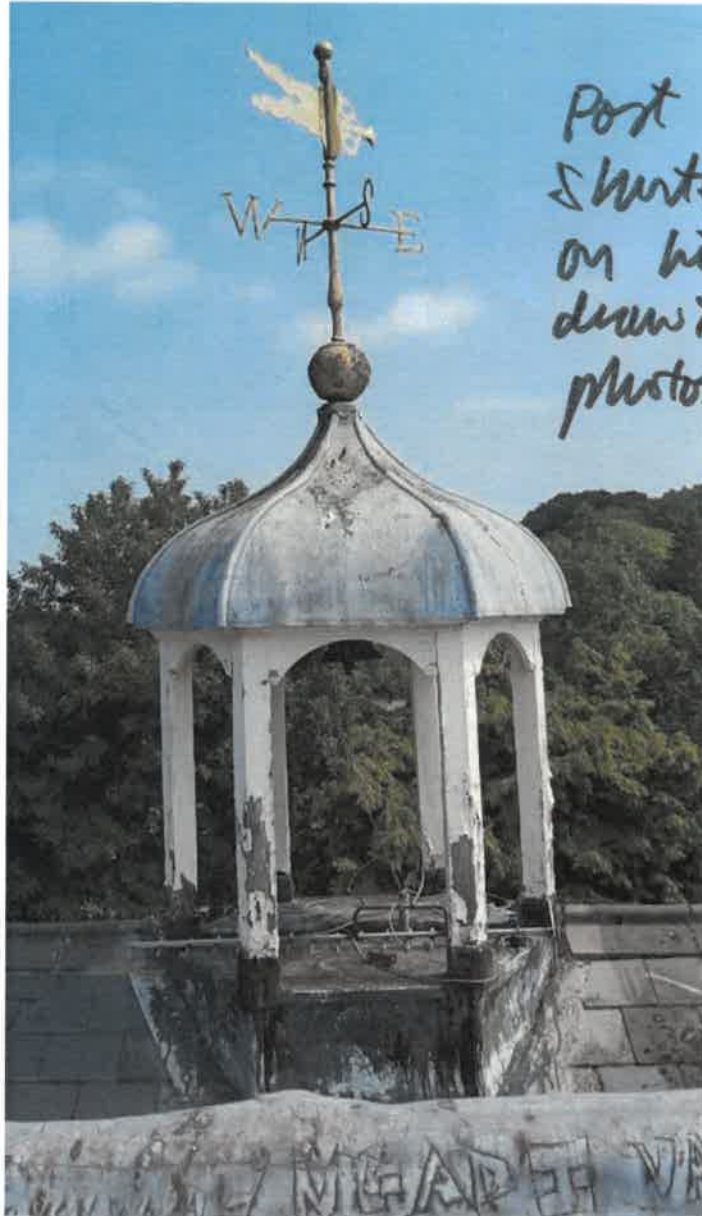
3) Cupola HCPX01 looking north.

Post appears shorter than on historic drawings or photos.

Some of the posts are rotten, paintwork has cracked allowing water ingress. Cupola has twisted.

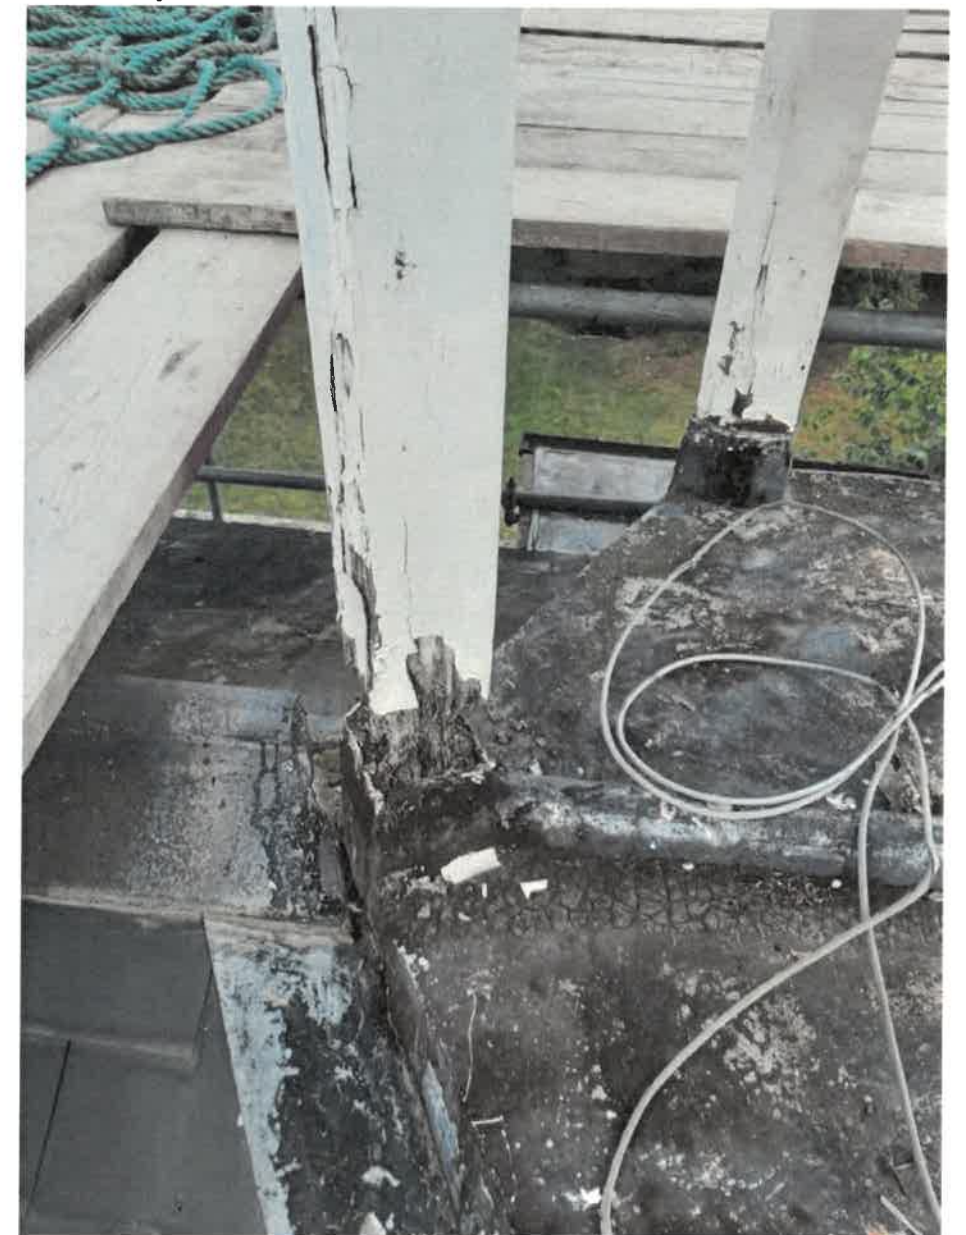
3) Base of cupola post by roof HRFX04.

Post is rotten and needs to be replaced.

Propose to replicate historic base flashing detail to protect exposed base of the posts.

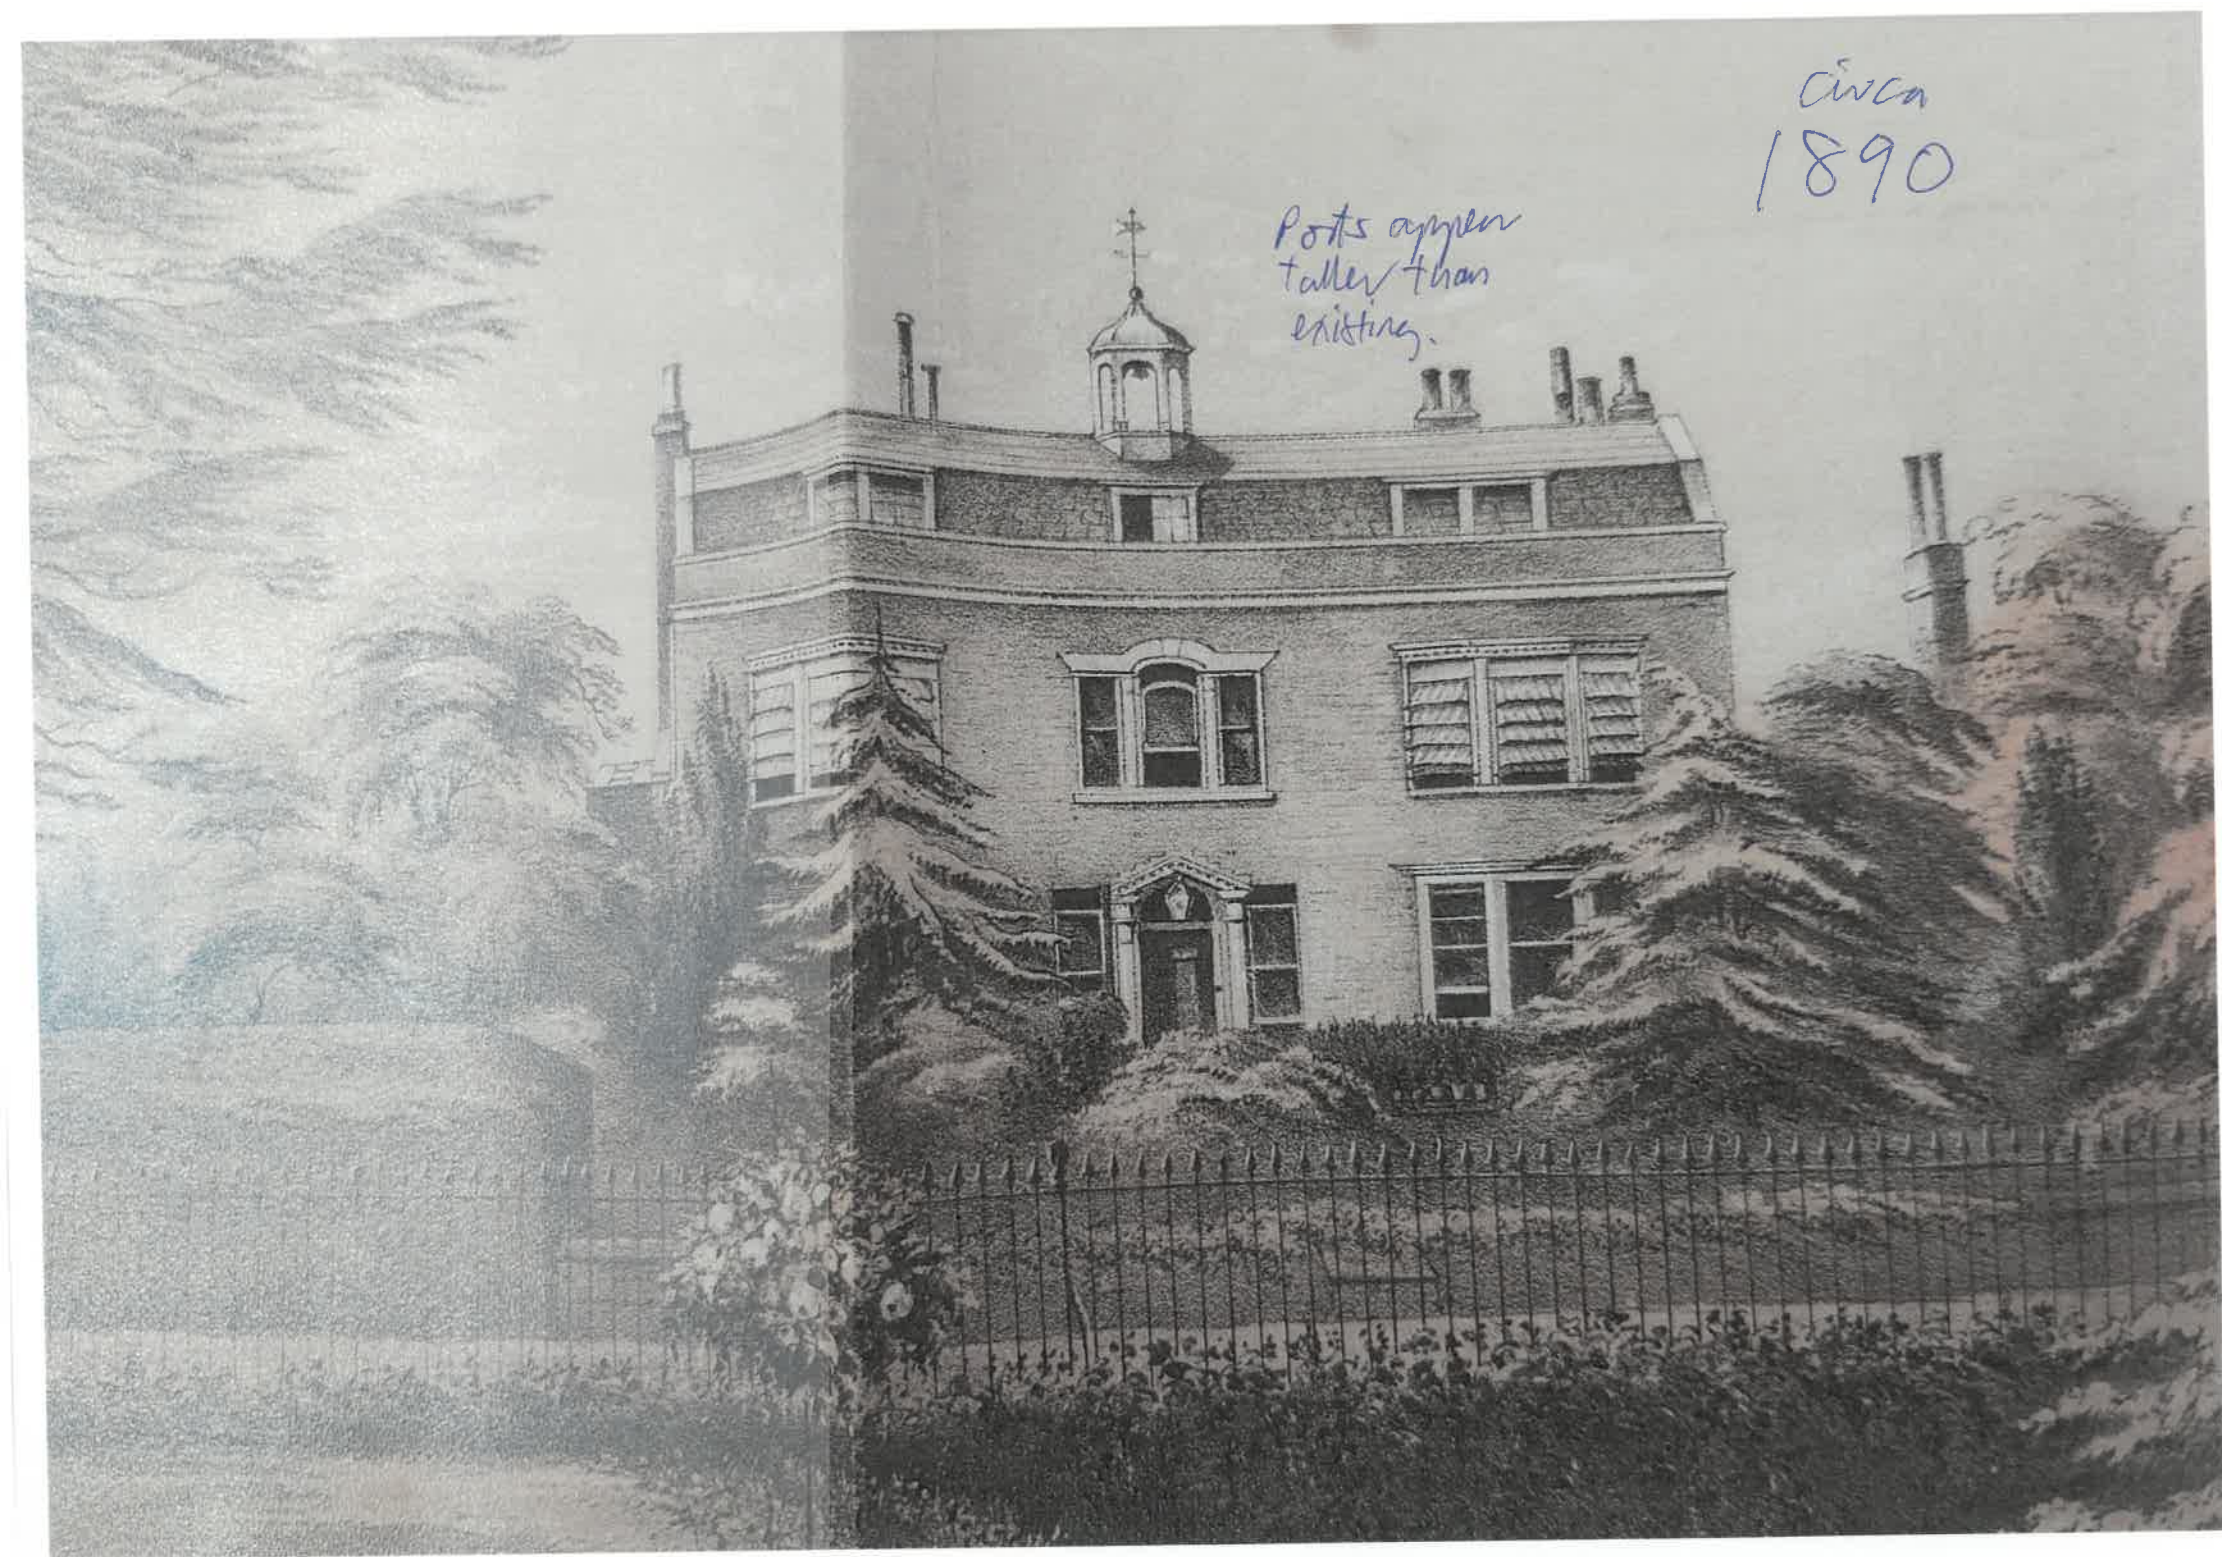
circa  
1890

Roofs appear  
taller than  
existing.
