# STRUCTURAL INSPECTION REPORT

## Imperial Wharf Flood Defence Inspection

File Reference:  
317181-FCG-SW-XX-RP-C-3101-S2-P03

**ON:** IMPERIAL WHARF FLOOD DEFENCE INSPECTION  
**FOR:** FM CONWAY  
**FRANKHAM PROJECT NO.:** 317181

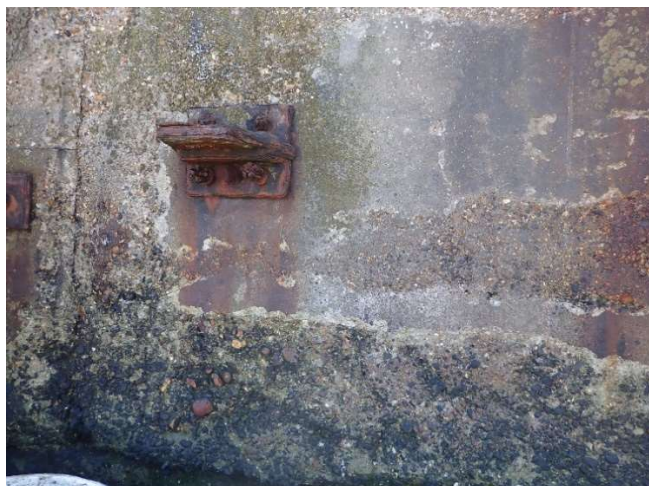
Wall 1 was found to be in overall fair condition with minor honeycombing ([Photo 23](#)) at 3 m from the downriver end of Wall 1. Along the concrete wall 4 No. voids size 0.6 m x 0.8 m, 0.3 m x 0.35 m, 0.2 x 0.3 m and 0.54 m x 0.19 m each were observed. The origin of the voids is not clear but they are not deemed critical for the stability of the deck, which is supported by concrete beams, columns, and struts, and for the flood capacity of the wharf, which is understood being relied on Walls 2, 3, 4, 5, 6 & 7. It is suspected that the voids were created to allow a hydrostatic balance on both sides of the wall.

**Photo 23- View of honeycombing on wall 1**

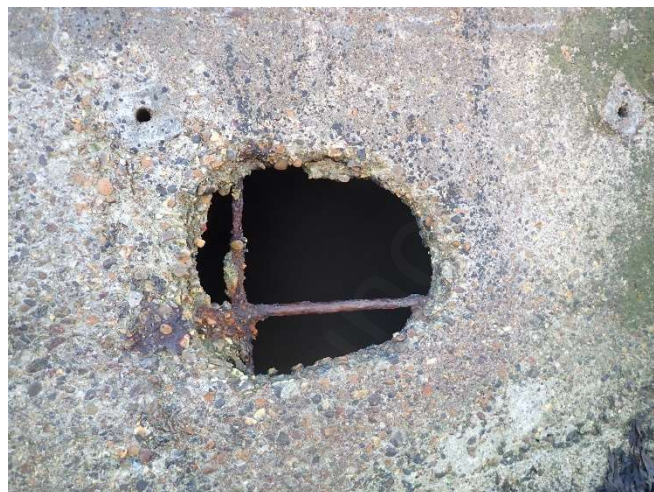
**Photo 24 – View of 0.3 x 0.35 x 0.14 m void with rebar visible on wall 1**

| Defect | Grade | Recommendation |
|---|---|---|
| <b>Wall 1 voids</b> | 3 | It should be found out if the voids to Wall 1 are handmade to for hydrostatic purposes on the concrete wall. |

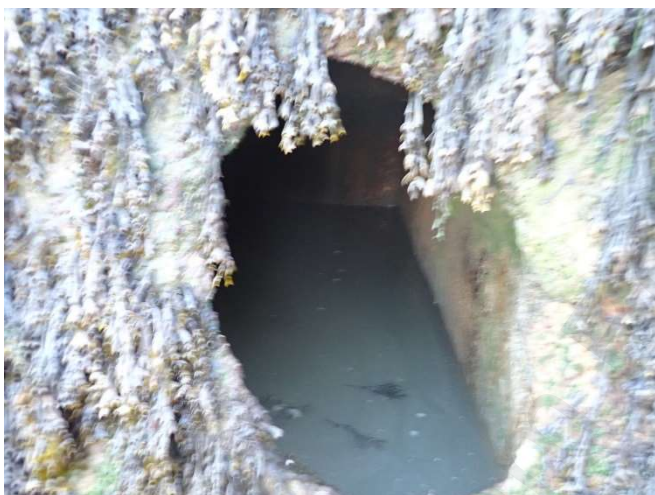
**Photo 25 – View of 0.6 x 0.8 x 0.15 m void on wall 1**

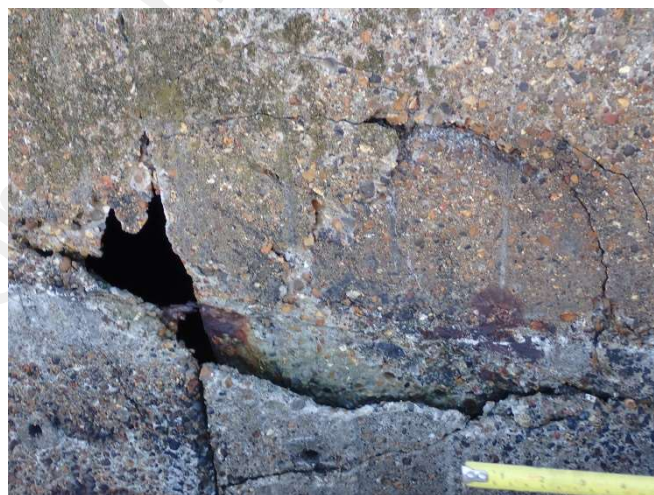
**Photo 26 – View of 0.2 x 0.3 x 0.15 m void on wall 1**

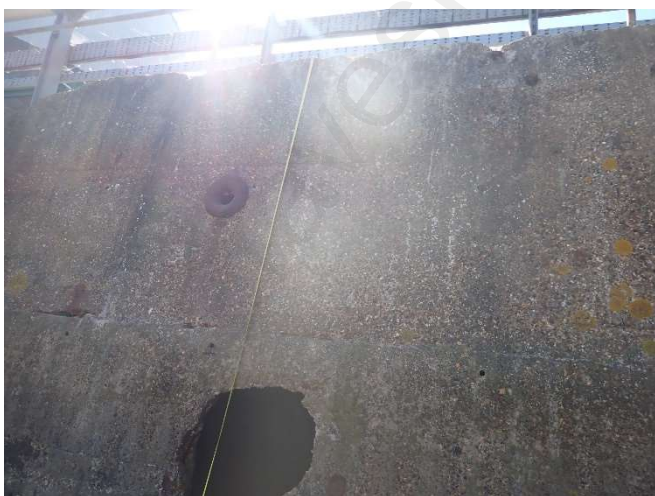
**Photo 27 – View of 0.5 m x 0.4 m x 0.19 m void on wall 1**

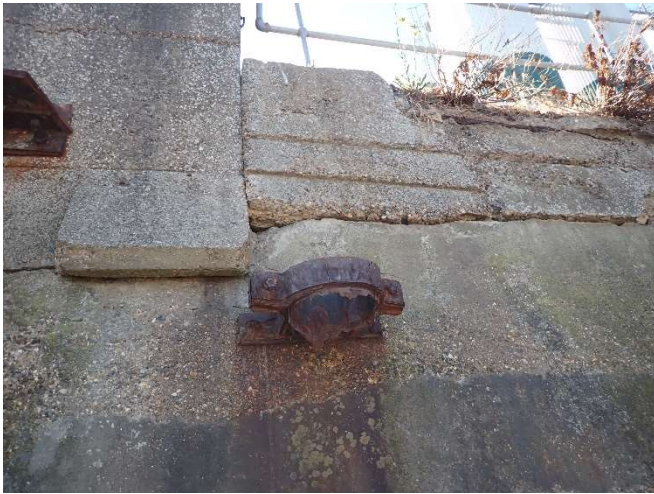
Remnants of a steel pipe and wall anchors were observed along the face of Wall 1 ([Photo 29](#)). Generally, these elements were found to be in overall poor condition.

**Photo 29 – View of remains of steel pipe on wall 1**

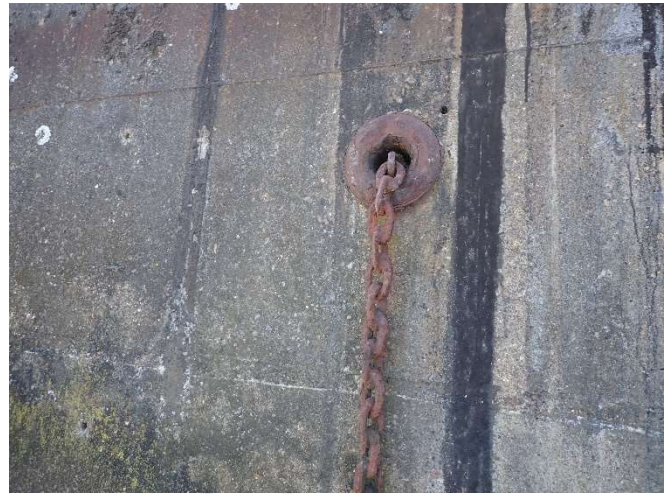
Wall ties and chains were observed throughout the wall and were found to be in overall poor condition with extensive signs of corrosion and delamination ([Photo 30](#)).

**Photo 30 – Typical view of wall chain on wall 1**

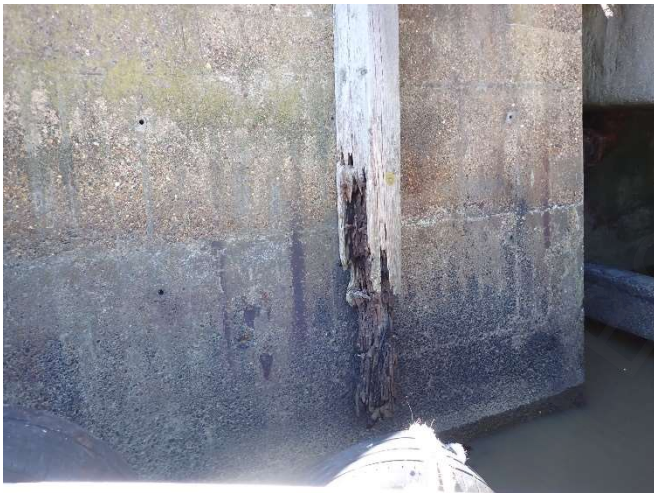
The timber fenders were found to be in overall poor condition with severe decay and section loss ([Photo 31](#)). The section loss ranges from 20% to 50%. The anchors holding the fenders to the wall were generally in overall fair condition with signs of minor corrosion.

**Photo 31 – View of wall 1 timber fender**

| Defect | Grade | Recommendation |
|---|---|---|
| <b>Wall 1 timber fender</b> | 4 | Replace with like for like (hardwood) timber fenders. |

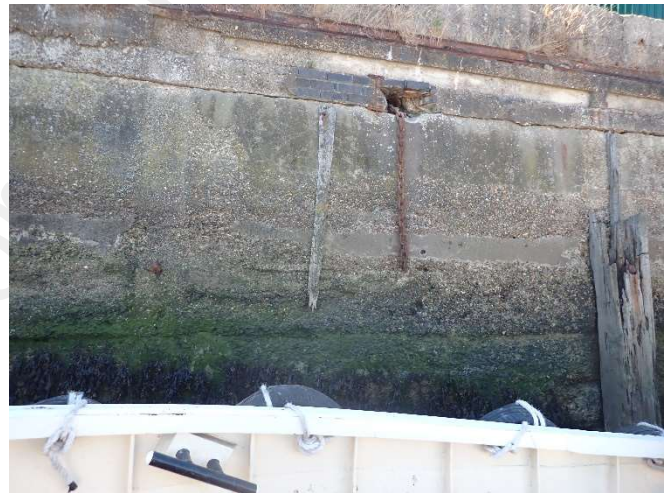
Brickwork was noted around a chain in the wall, this is assumed to be a previous repair ([Photo 32](#)). The brickwork appeared to be in overall fair condition, with minor signs of spalling around the chain. The concrete kerb at the top of the wall was found to be in overall good condition with isolated areas of spalling with size 50 mm x 50 mm x 10 mm.

**Photo 32 – View of wall 1 brickwork**

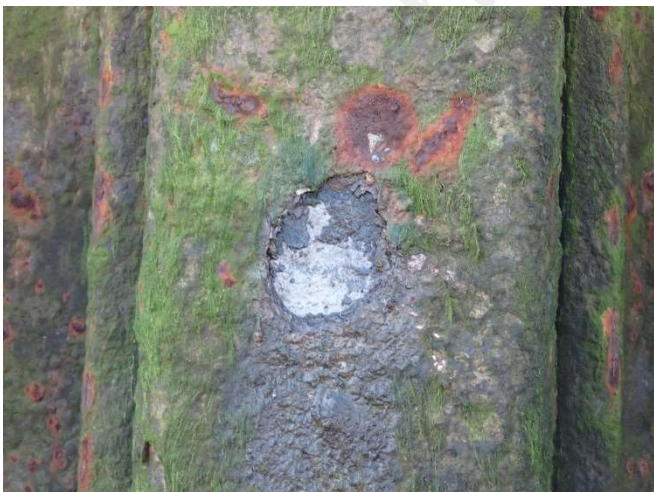
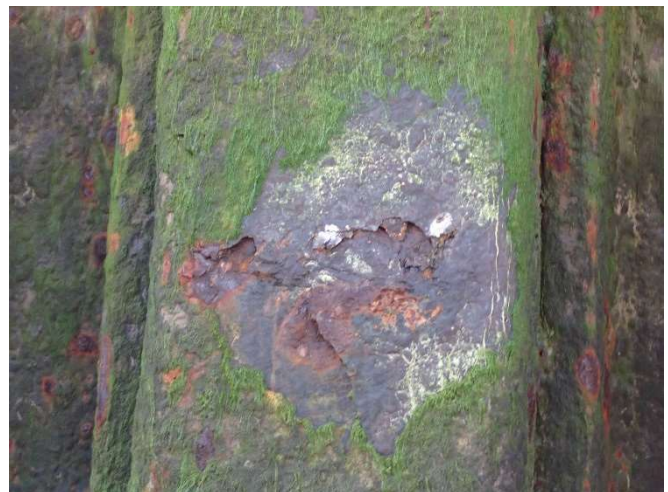
Wall 2 was generally found to be in overall fair condition. Severe corrosion, delamination and 100% of protective coating loss was noted in the splash zone. The protective coating appeared to be failing to <25% of the tidal zone and signs of ALWC were observed to the higher areas of the tidal zone ([Photo 33](#)). No tactile access could be gained to the low water zones due to the limited workboat draught. It is suspected the wall may be affected by ALWC to the areas above the riverbed. Signs of marine growth in the tidal zone along with corrosion and delamination were observed, with the maximum delamination observed being 20 mm ([Photo 34](#)). Fractures were noted on the face of the sheet piles ([Photo 35](#)).

**Photo 33 – Typical view of accelerated low water corrosion to wall 2**

**Photo 34 – View of 20 mm delamination to wall 2**

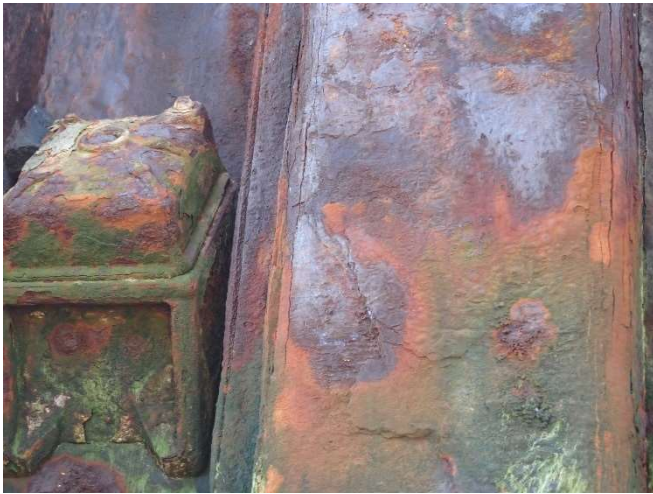
**Photo 35 – View of sheet splitting to wall 2**

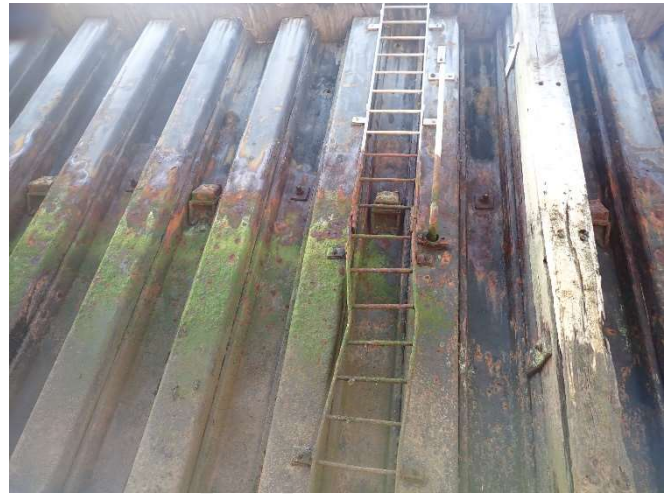
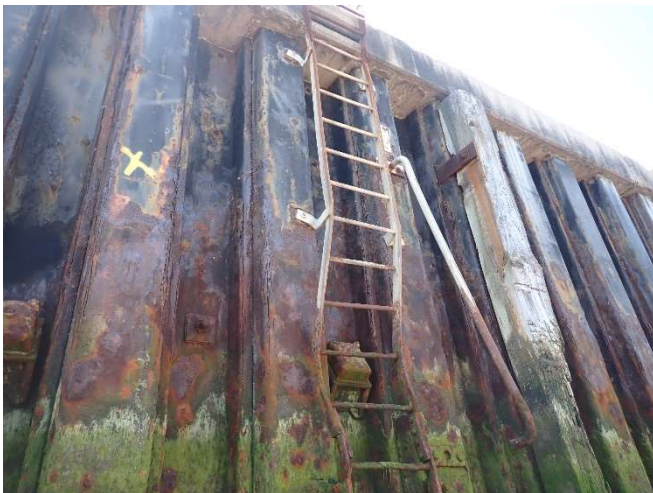
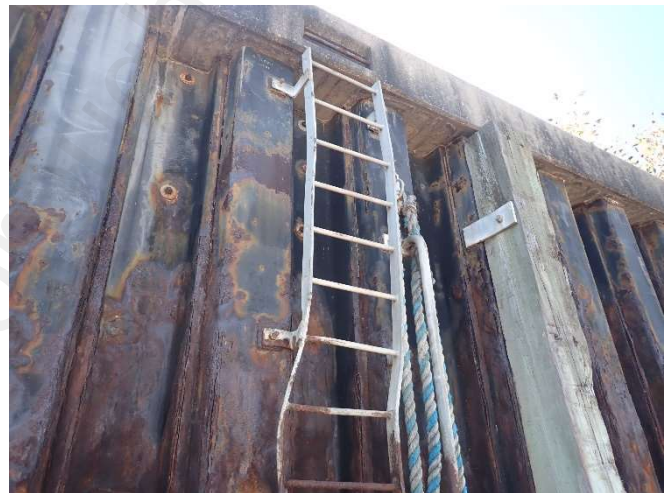
The ladders were found to be deformed, in overall very poor condition and affected by heavy corrosion, and are considered unsafe and not deemed safe for access ([Photo 36 – Photo 38](#)).

**Photo 36 – General view of ladder 1 on wall 2**

**Photo 37 – General view of ladder 2 on wall 2**

**Photo 38 – General view of ladder 3 on wall 2**

| <b>Wall 2 ladders</b> | 5 | Ladders are to be removed and replaced with a like for like ladder. |

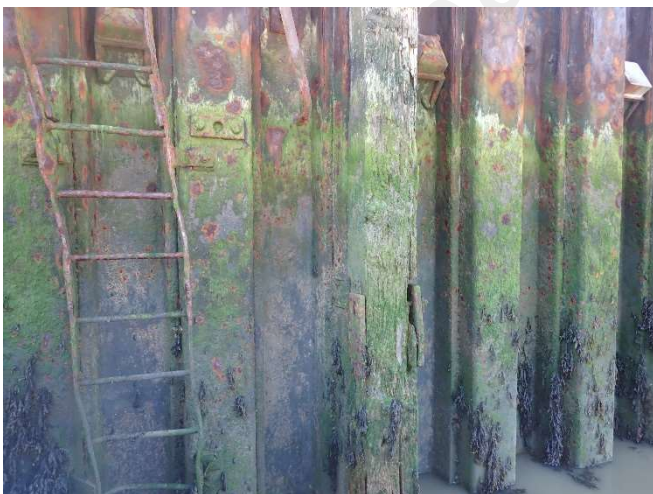
The handrails were found to be in overall poor condition with major corrosion and protective coating loss ([Photo 39](#)).

**Photo 39 – View of ladder 2 handrail fixing on wall 2**

| <b>Wall 2 handrail</b> | 5 | Handrails should be replaced. |

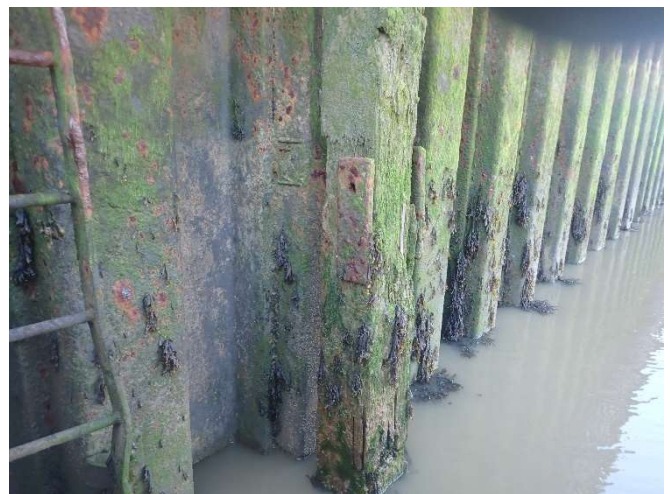
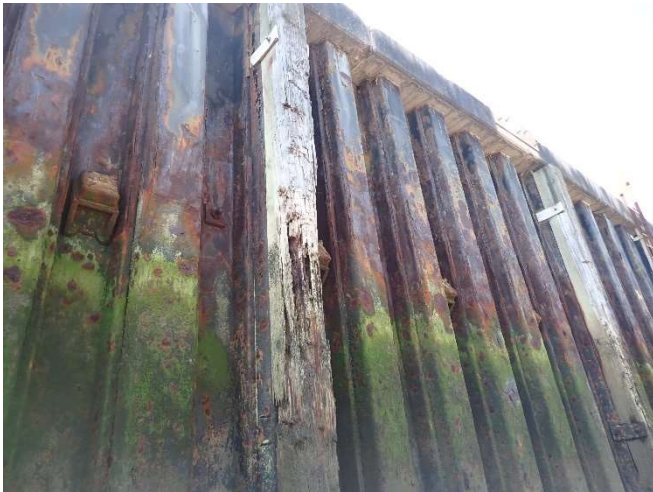
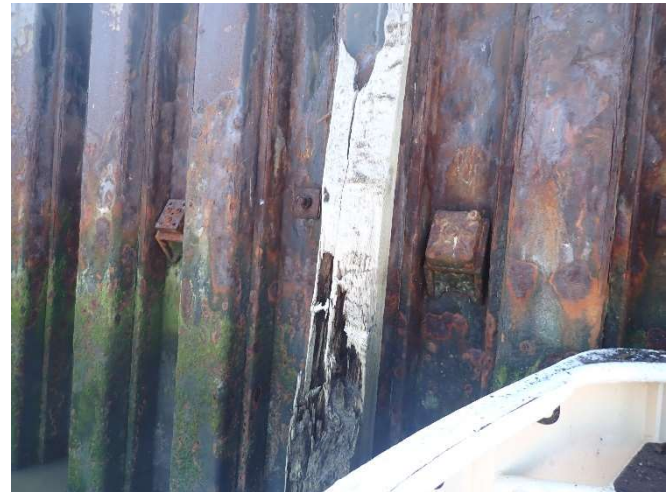
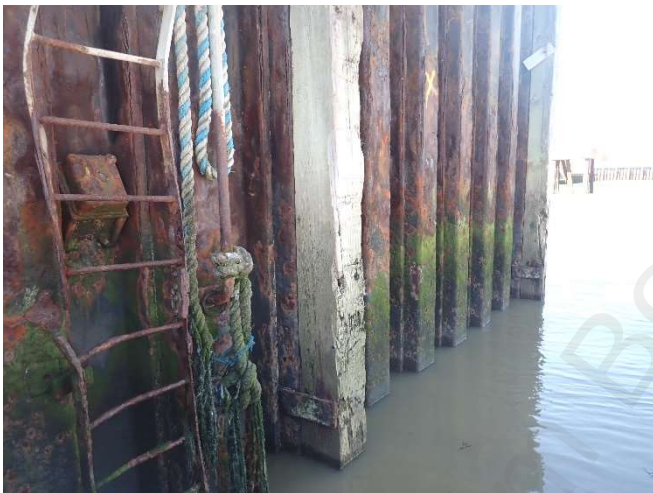
The timber fenders were found to be in overall poor condition with signs of major decay observed to the tidal zone. The section loss ranges from 20% to 60% ([Photo 40 – Photo 43](#)). The anchors holding the fenders to the wall were generally found to be in a fair condition with signs of minor corrosion and delamination throughout. Generally, the further upriver the worse the condition of the fenders.

**Photo 40 – Typical view of wall 2 fender**

| <b>Wall 2 timber fender</b> | 4 | Fenders with section loss above 50% are to be removed and replaced. |

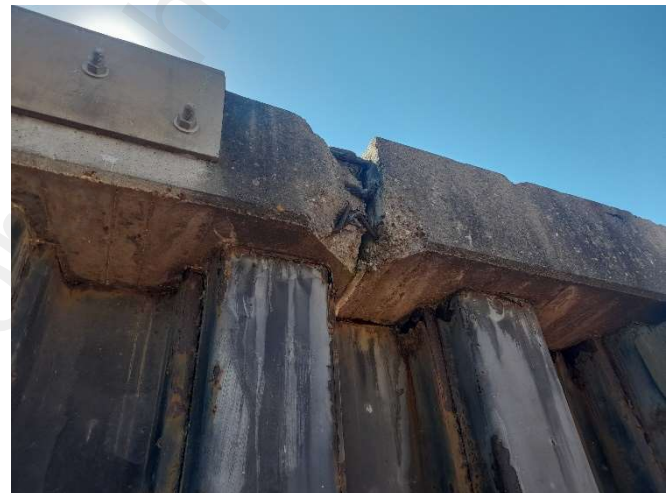
The concrete capping beams were found to be in overall fair condition with areas of spalling and exposed reinforcement, ranging from 0.3 m x 0.3 m x 0.1 m to 0.3 m x full height x 0.1 m noted ([Photo 44](#)). 75% of the capping beam's length could not be accessed and tactile inspected due to the presence of stored plastic tanks on the deck. Generally, the sealants were found to be in overall fair condition with isolated areas of sealant failing or missing due to vegetation growth or weather decay ([Photo 45](#)).

**Photo 44 – View of exposed rebar to wall 2 capping beam**

| <b>Wall 2 concrete capping beam</b> | 3 | Break out defective concrete and apply a suitable concrete repair material to the affected area ensuring full surround of reinforcement by repair material is achieved. |

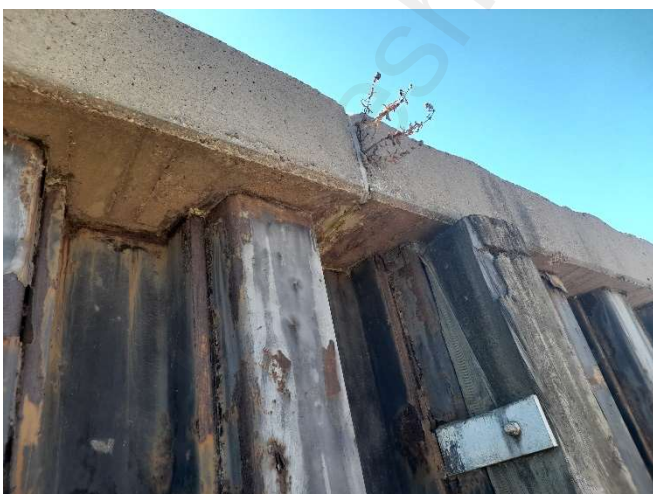
**Photo 45 – View of vegetation growth to sealant**

| <b>Wall 2 sealant</b> | 3 | Failing or weather decayed sealants should be raked out and replaced with a like for like sealant. |

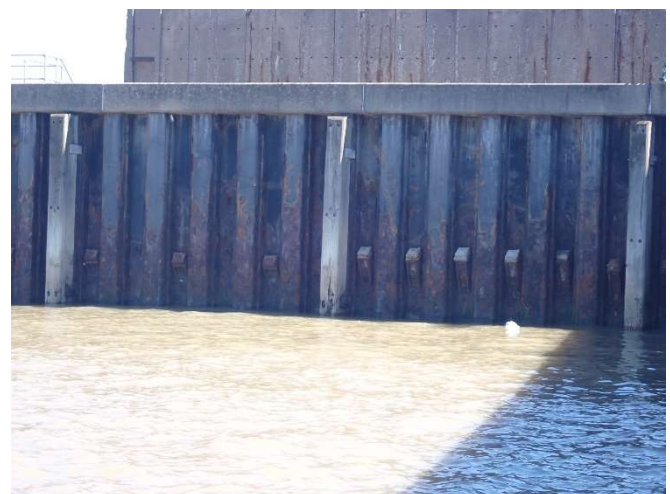
Wall 3 was generally found to be in overall fair condition, with 25% of protective coating loss in the splash zone ([Photo 46](#)). Severe corrosion, delamination and approximately 100% of protective coating loss was noted in the splash zone. The protective coating appeared to be failing to <25% of the tidal zone and signs of ALWC were observed to the higher areas of the tidal zone (see [Photo 33](#) for a typical view). No tactile access could be gained to the low water zones due to the limited workboat draught. It is suspected the wall may be affected by ALWC to the areas above the riverbed. Signs of marine growth in the tidal zone along with corrosion and delamination were observed, with the maximum delamination observed being 20 mm ([Photo 34](#) for a typical view). Fractures were noted on the face of the sheet piles ([Photo 35](#) for a typical view).

**Photo 46 – View of 25% protective coating loss above splash zone to wall 3**

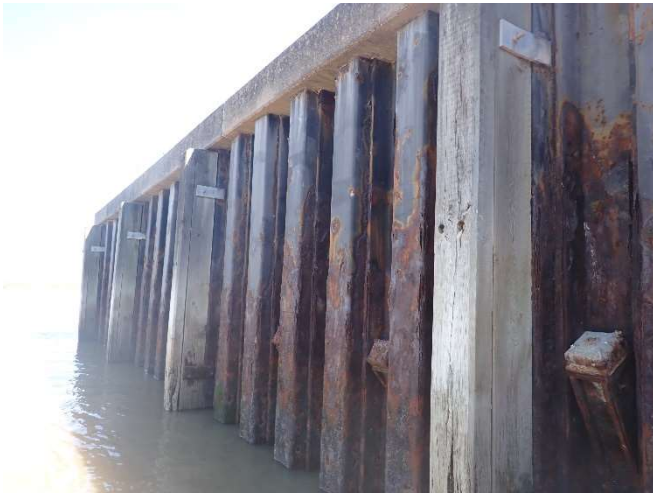
The timber fenders were found to be in overall fair condition with little to no deterioration and minor signs of splits and shakes observed to high water zones ([Photo 47](#)). No tactile access could be gained to

low water zones where it is suspected that the fenders may be affected by decay. The anchors holding the fenders to the wall were generally found to be in overall fair condition.

**Photo 47 - General view of wall 3 fenders**

| <b>Wall 3 fender</b> | 3 | Monitor fenders over a 24-month period to ensure decay at the base of the fender does not significantly worsen. Splice repairs may be required. |

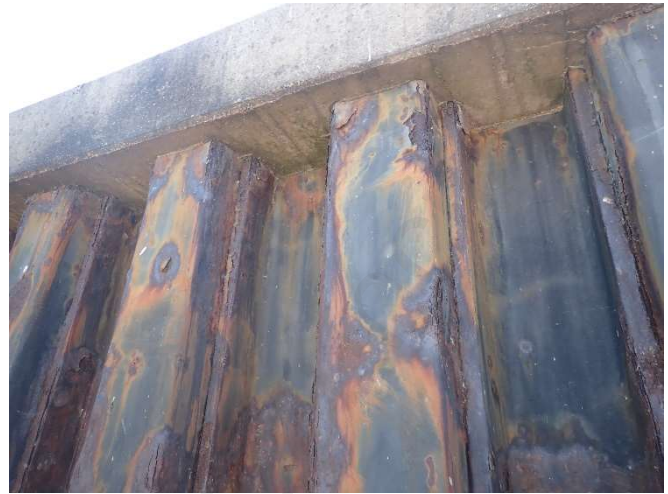
**Photo 48 - View of 40% protective coating loss at splash zone on wall 4**

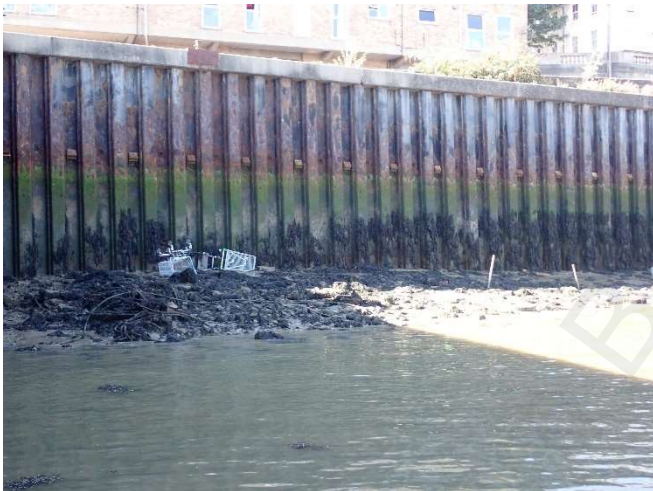
Wall 4 was found to be in a fair condition with 40% of protective coating loss in the splash zone and 75% in the tidal zone ([Photo 49](#)).

**Photo 49 - View of 75% protective coating loss below splash zone**

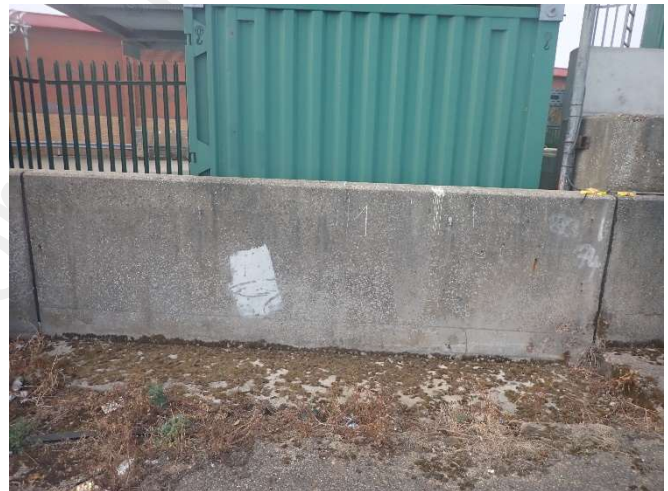
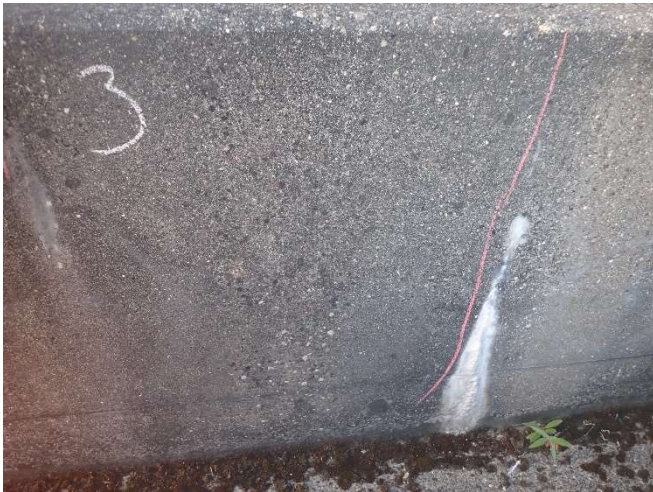
Wall 5 was found to be in overall fair condition. Multiple hairline cracks were observed throughout the wall ([Photo 50 - Photo 51](#)).

**Photo 50 - View of cracking to wall 5**

**Photo 51 - View of cracking to wall 5**

| <b>Wall 5 concrete blocks</b> | 3 | Break out defective concrete and apply a suitable concrete repair material to the affected area ensuring full surround of reinforcement by repair material is achieved.<br>All cracks are to be chased out and concrete repaired. |

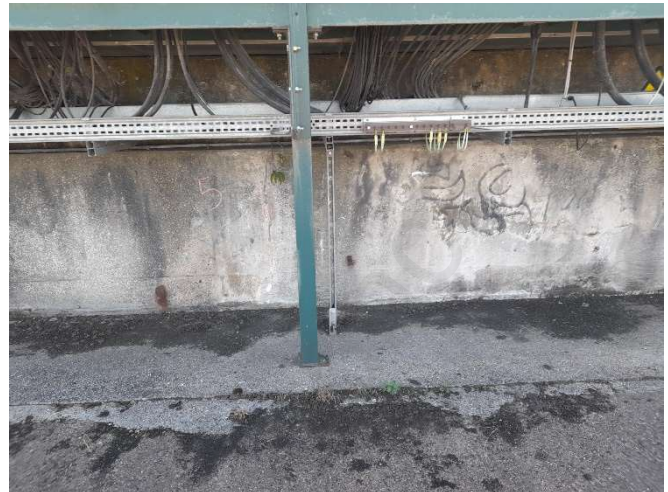
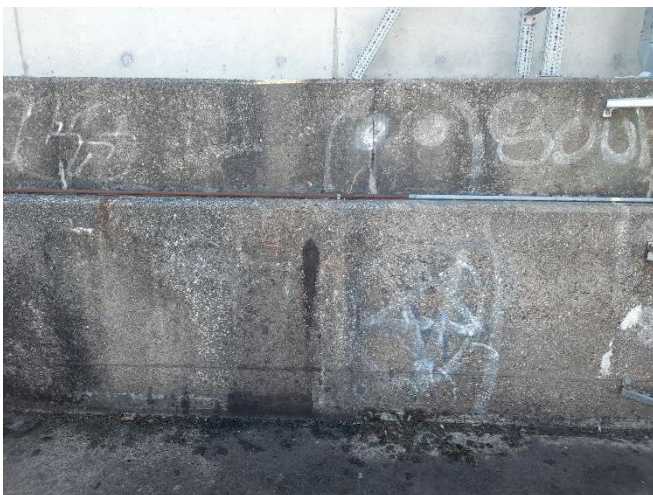
A suspected oil leak and calcite deposits were observed to the wall ([Photo 52 - Photo 53](#)) but following a further inspection by FM Conway operatives on both sides of the wall together with the use of a wire brush it was determined that there is no active oil leak from operations and that the stain observed is likely an act of graffiti or other paint thrown to the wall ([Photo 61](#)).

**Photo 52 - View of calcite deposit on wall 5**

**Photo 53 - View of stains and graffiti to wall 5.**

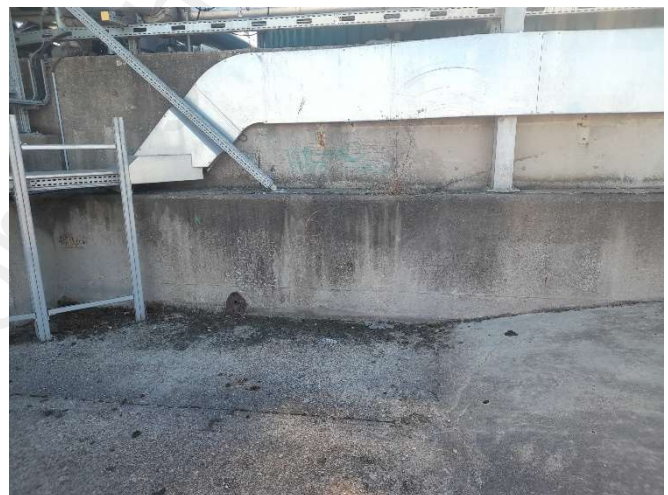
The sealants were generally found in overall fair condition with isolated areas of failing due to vegetation growth ([Photo 54](#)).

**Photo 54 - View of vegetation growth to sealant on wall 5**

| <b>Wall 5 sealant</b> | 3 | Failing or weather decayed sealants should be raked out and replaced with a like for like sealant. |

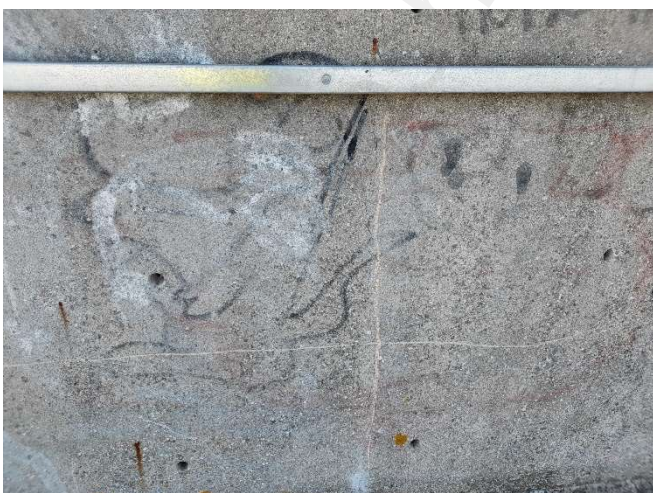
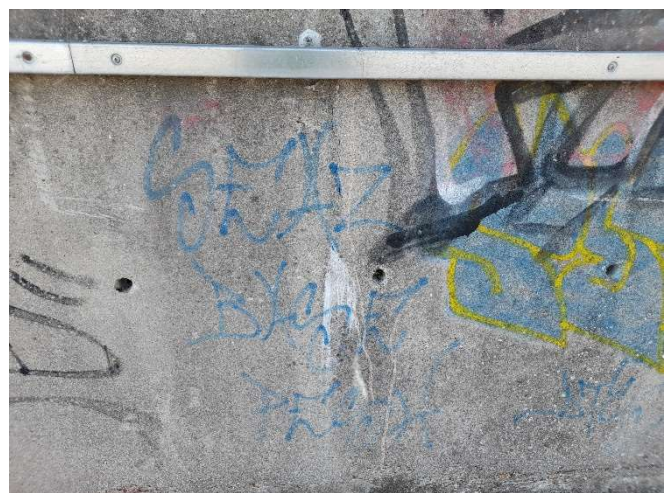
Wall 6 was found to be in overall fair condition with multiple minor cracks throughout the wall ranging from hairline to 3 mm in width ([Photo 55-Photo 56](#)).

**Photo 55 - View of crack on wall 6**

**Photo 56 - View of crack on wall 6**

| <b>Wall 6 concrete blocks</b> | 3 | All cracks are to be chased out and concrete repaired. |

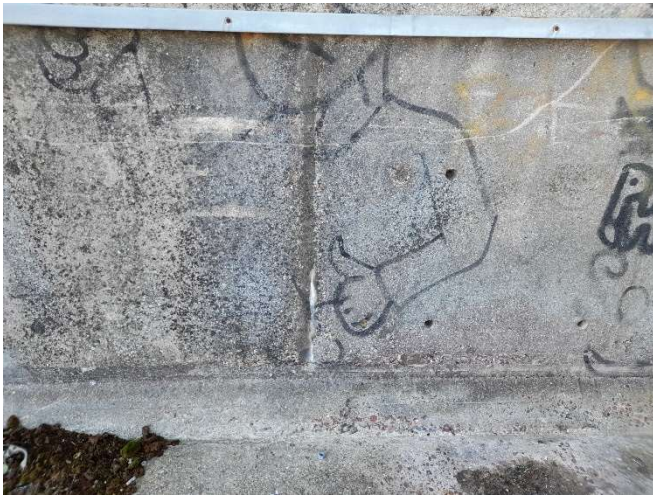
Isolated areas of calcite deposits ([Photo 57](#)), spalling and vegetation growth were noted throughout.

**Photo 57 – View of calcite deposits on wall 6**

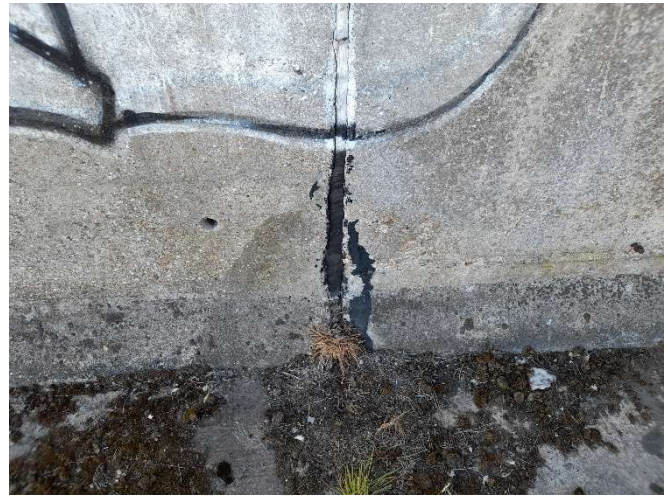
Generally, the sealants were found in overall fair condition with isolated areas of decayed and failing sealant due to vegetation growth ([Photo 58](#)).

**Photo 58 – View of vegetation growth on sealant on wall 6**

| <b>Wall 6 sealants</b> | 3 | Failing or weather decayed sealants should be raked out and replaced with a like for like sealant. |

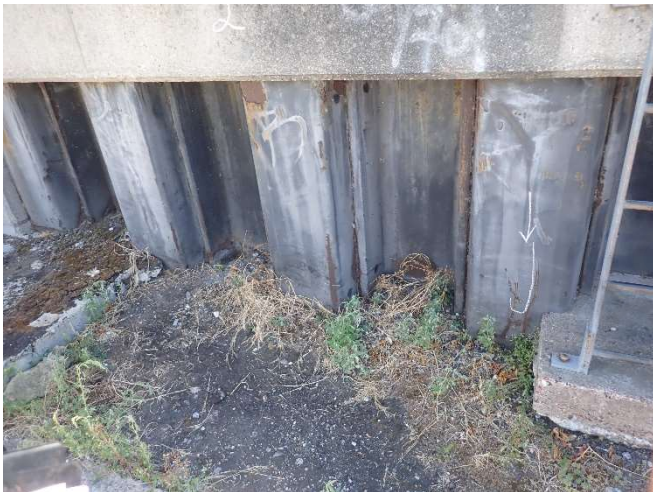
Generally, Wall 7 was found in overall fair condition with 25% of protective coating failing to the sheet piles and minimal cracking to the concrete ([Photo 59](#)). The sealants were found in overall fair condition with the material in very poor condition with 90% of the sealant missing to the entire thickness at the upriver end of the wall being a leaking point for approximately the total height of the capping beam ([Photo 60](#)).

**Photo 59 – View of 25% protective coating loss to sheet piling on wall 7**

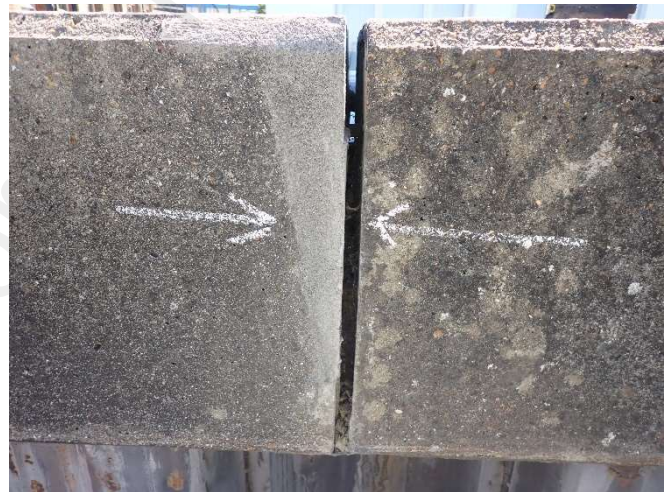
**Photo 60 – View of missing sealant between capping beams on wall 7**

| <b>Wall 7 sealant</b> | 3 | Failing or weather decayed sealants should be raked out and replaced with a like for like sealant. |

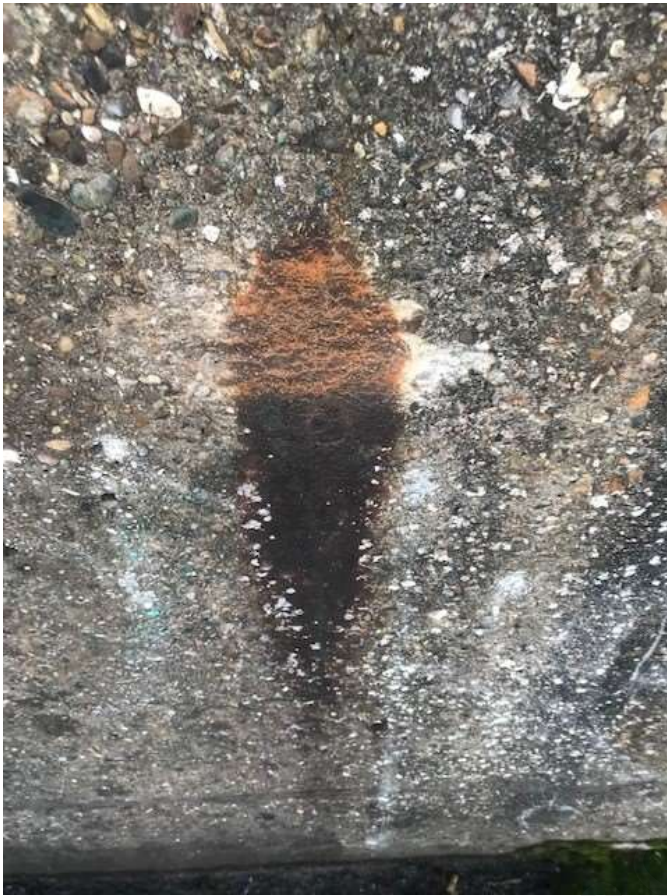
**Photo 61 – Stain to wall 5 following wire brushing (by FM Conway).**
