# Contaminated Land Review for Proposed Car Wash & Valeting Site at Vale Road, Northfleet, Gravesend, Kent, DA11 9RE.

Prepared for:

Design Solutions Architecture & Planning,  
Unit 19 Eastway Business Village,  
Olivers Place,  
Fulwood,  
Preston,  
PR2 9WT.

August 2026

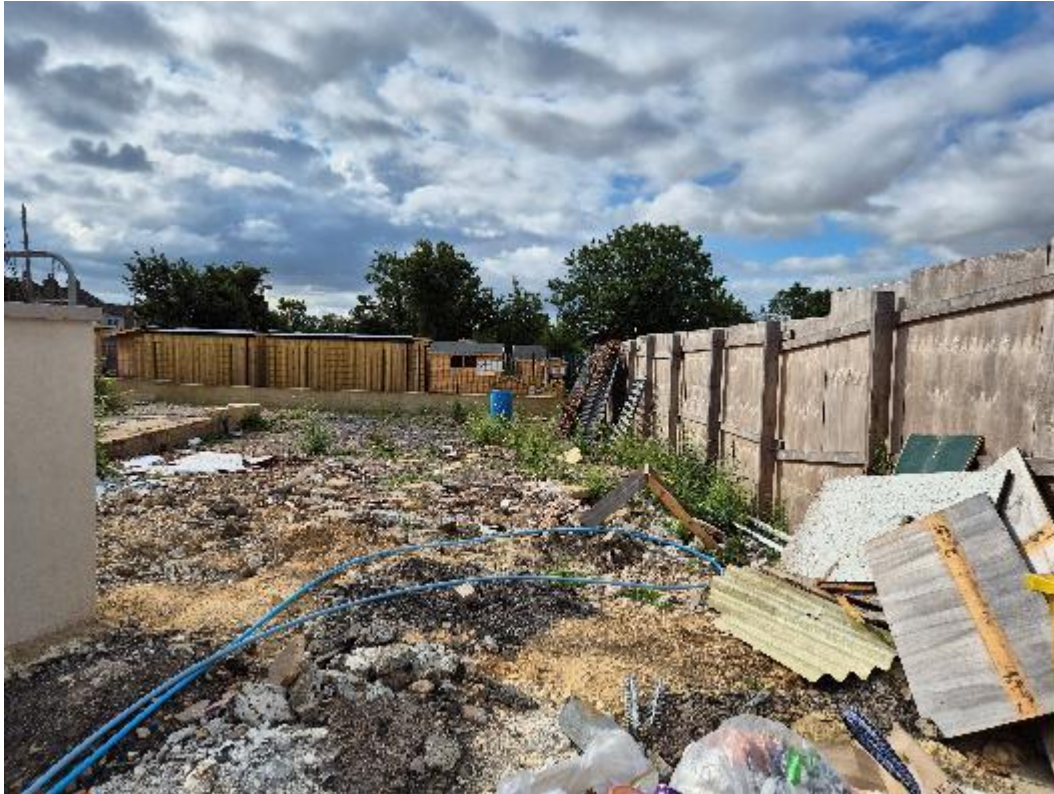
Western boundary of the site looking south

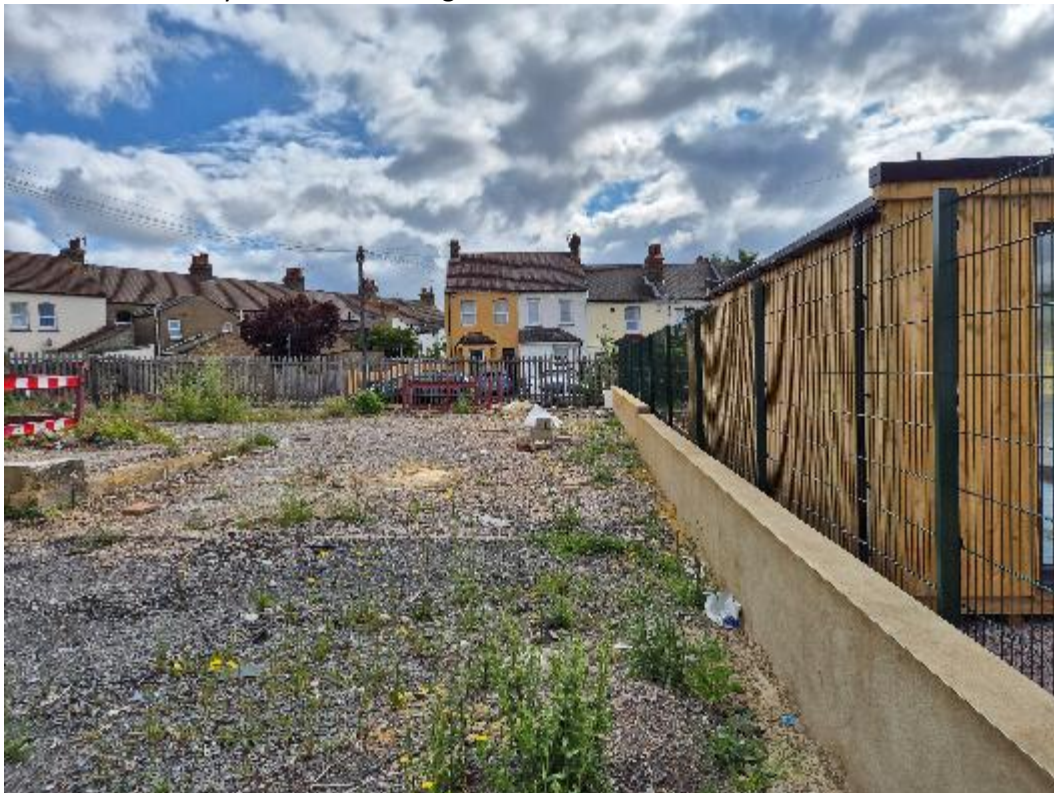
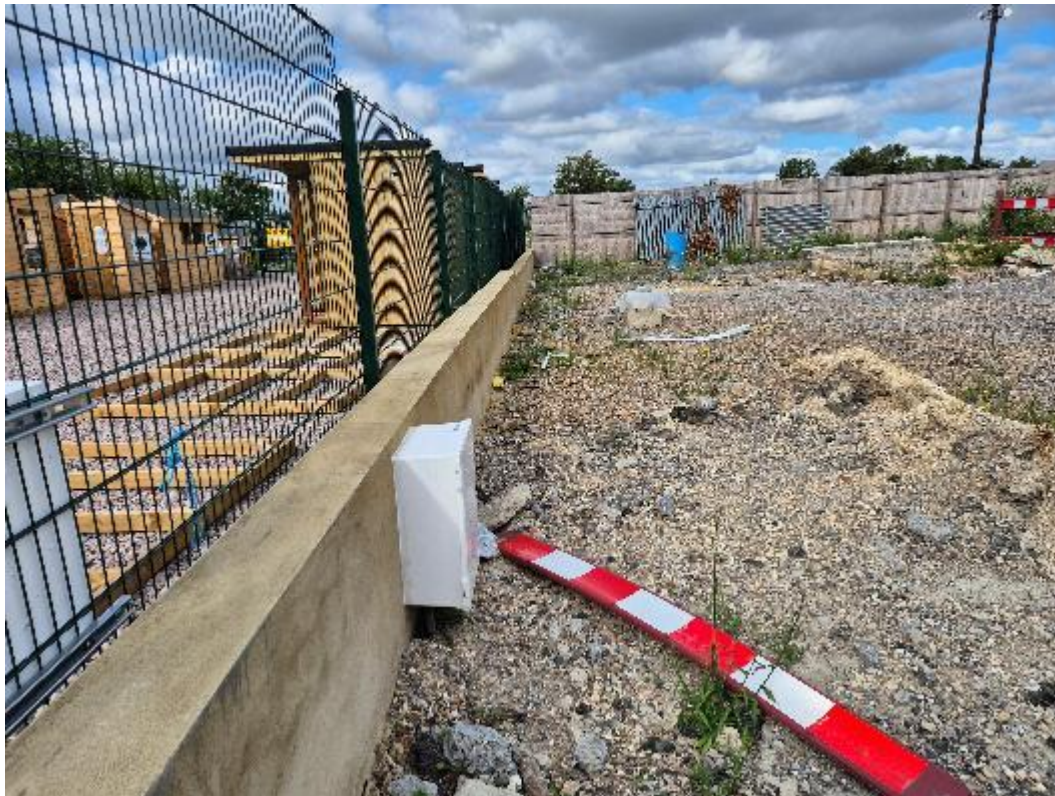
Southern boundary of the site looking east

and then west

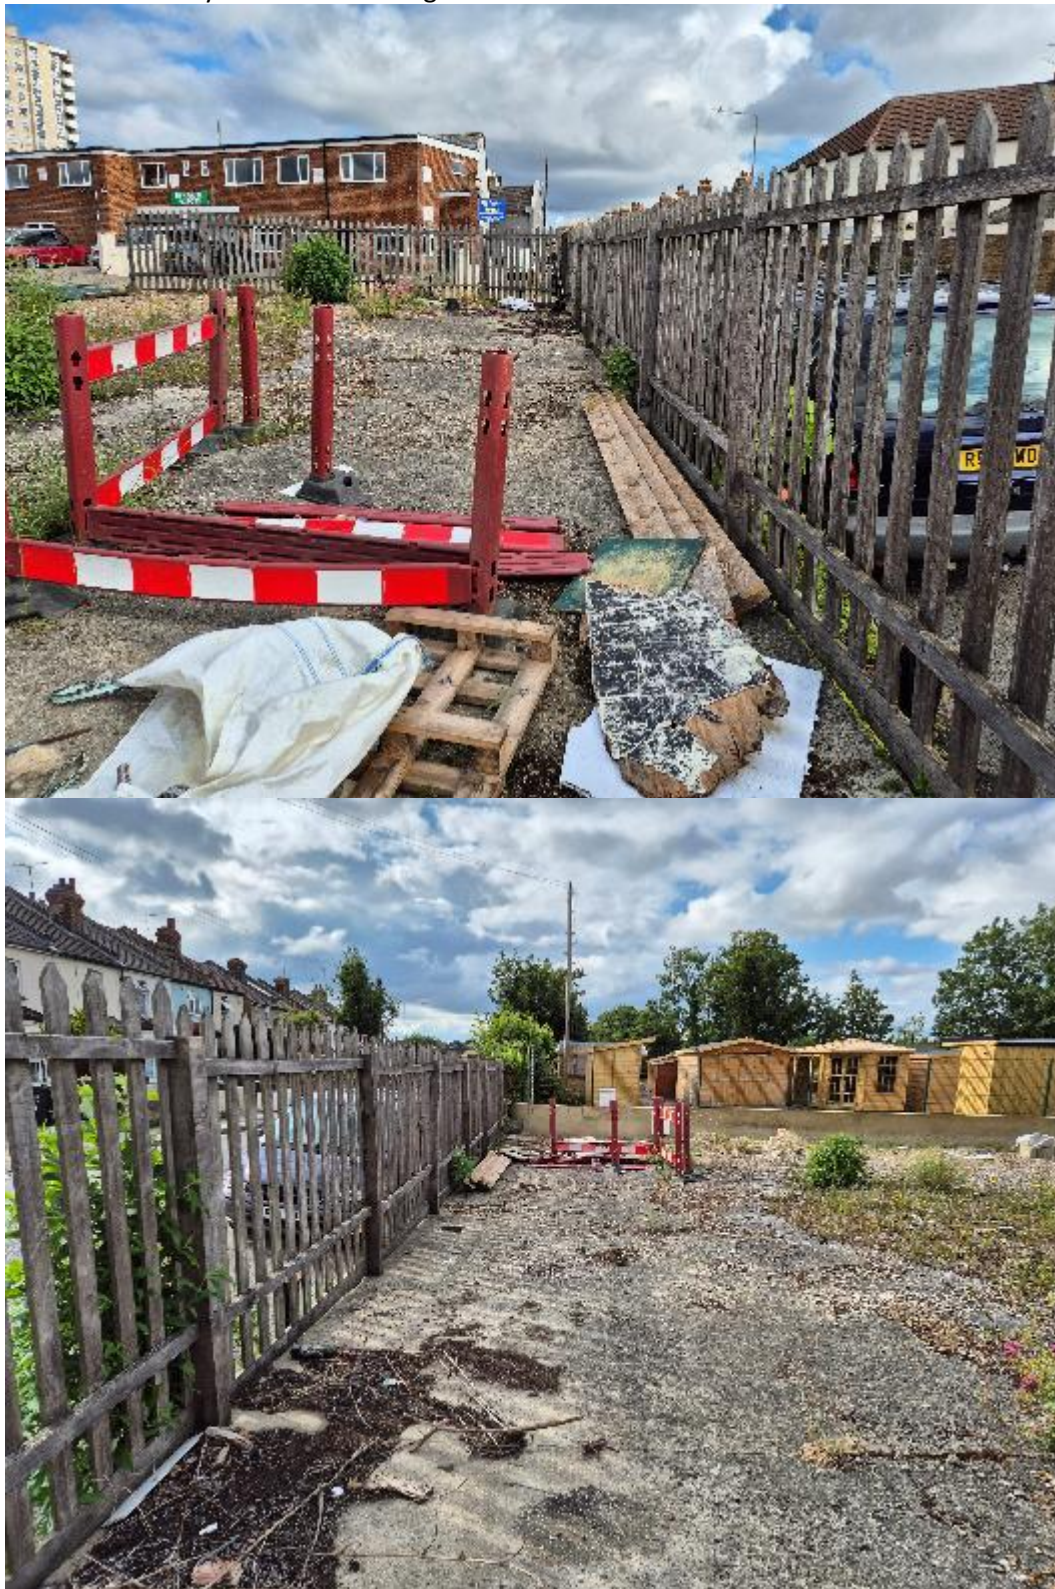
Eastern boundary of the site looking north then south

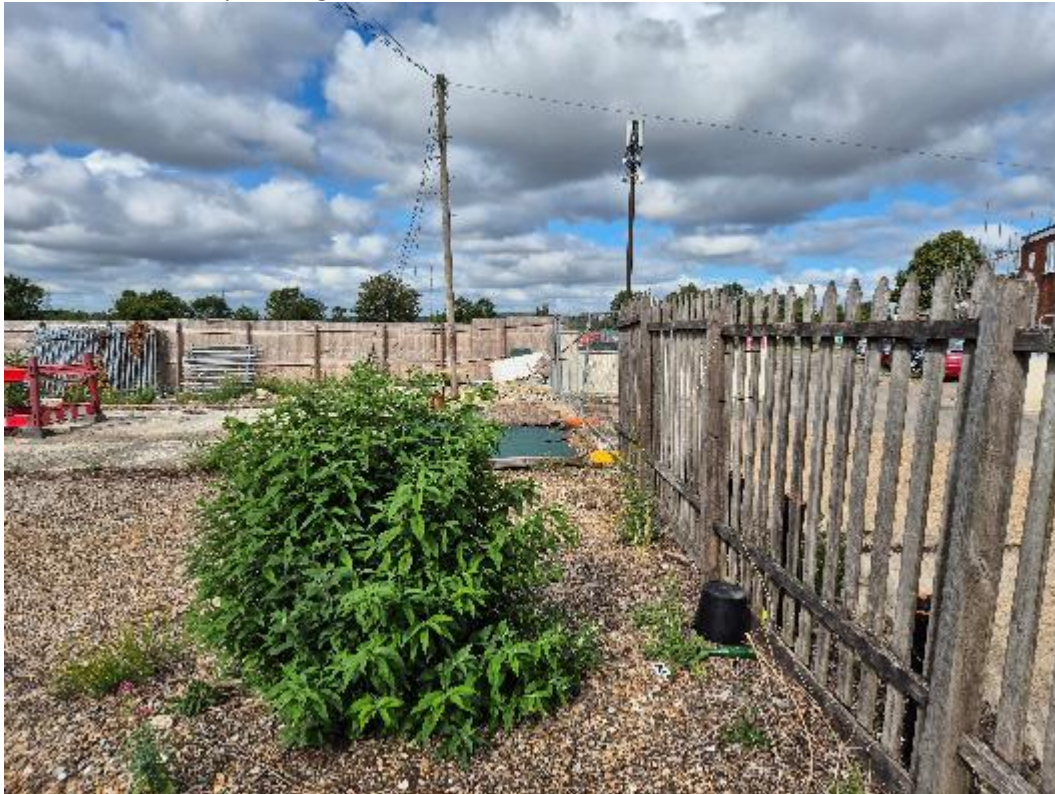
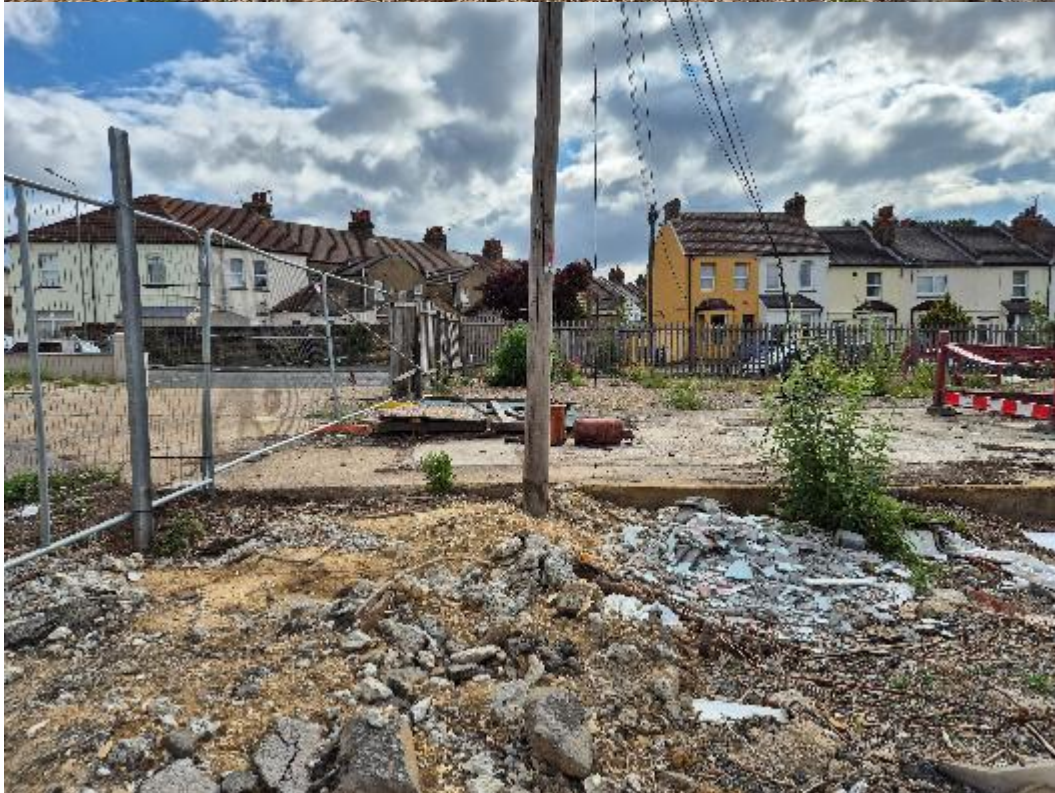
Northern boundary looking west and east

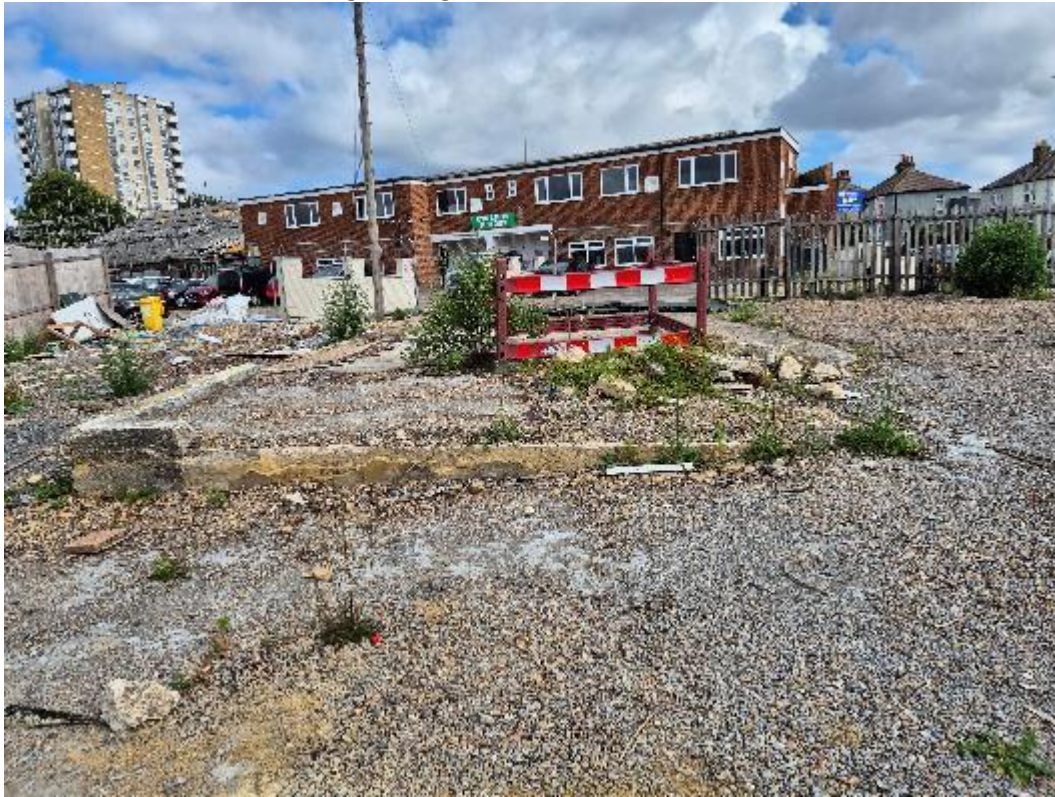
The central concrete standing looking south to north

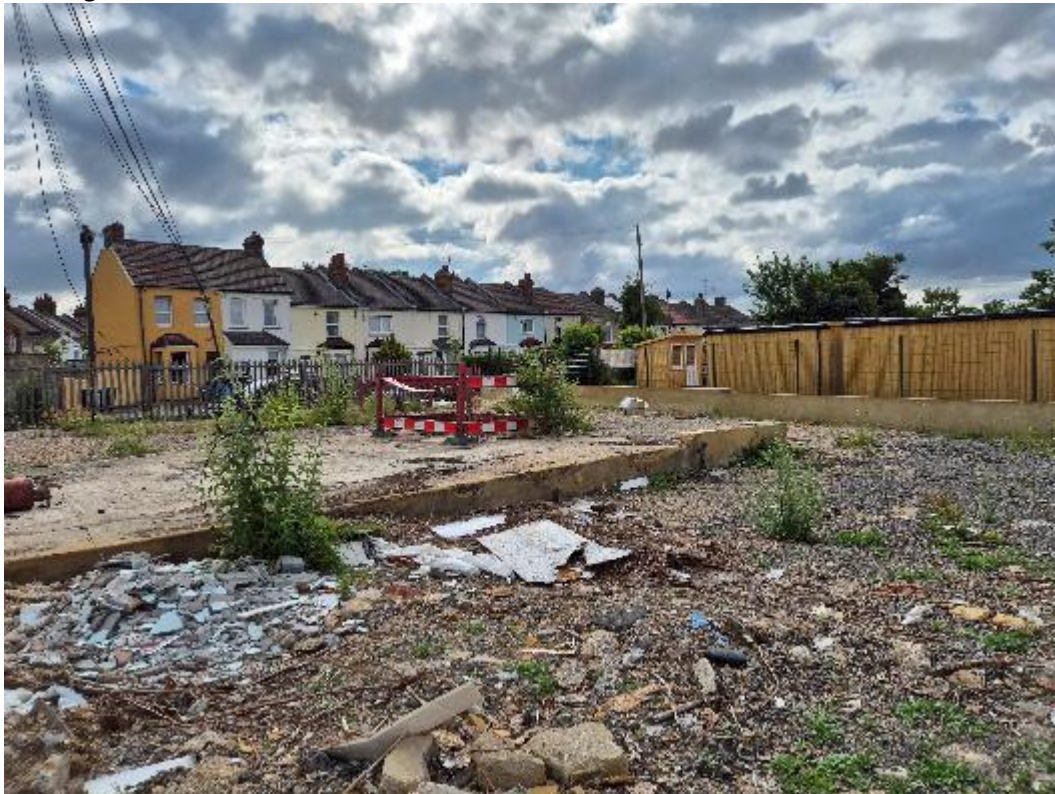
Looking across the site from the northwest to southeast corners

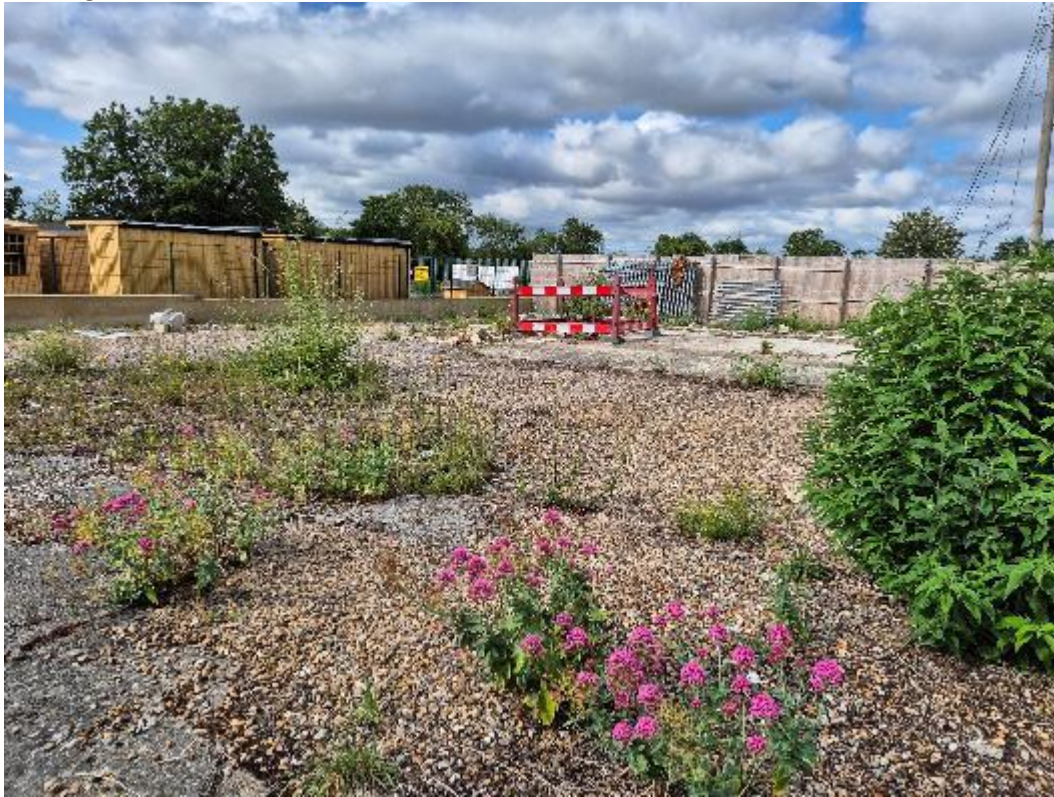
Looking from the northeast to southwest corner
