## **BS5837:2021 Tree Survey & Impact Assessment**

Prepared by Fellgrove on behalf of: **Baxhall Construction**

**Gravesend Grammar School  
Church Walk  
DA12 2PR**

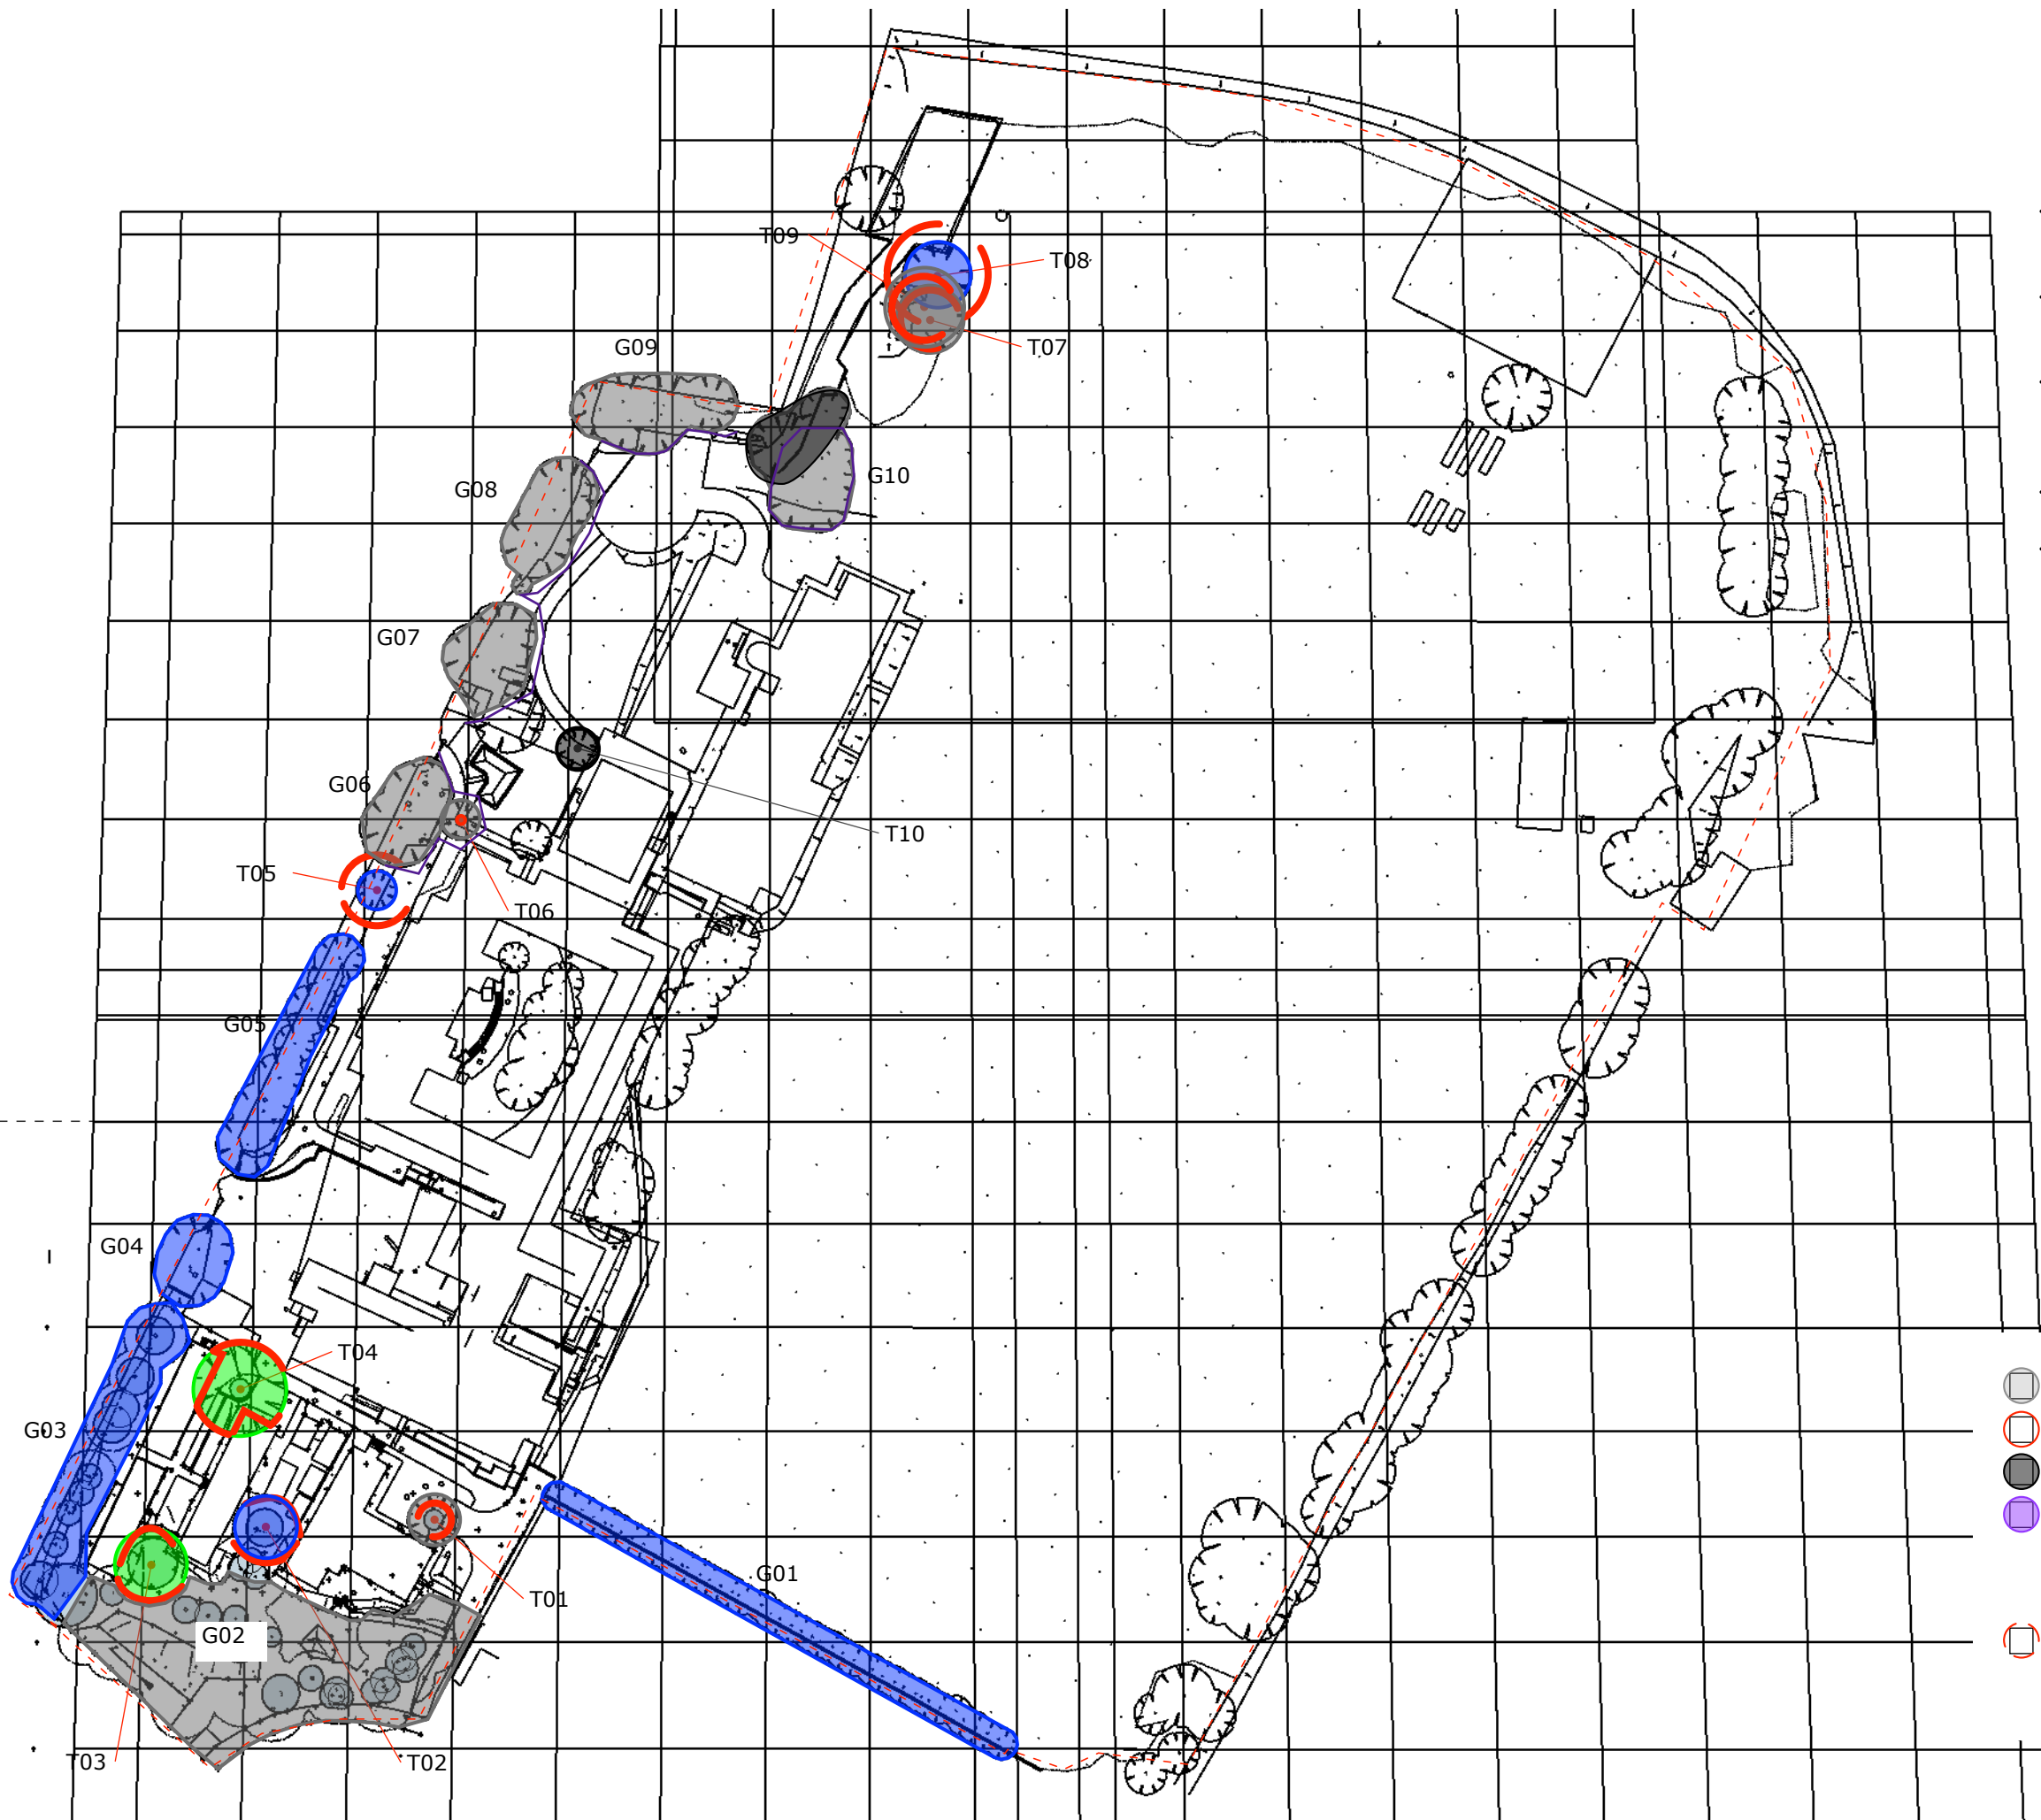
The overall impact of the proposed development on the site trees is negligible. The three trees recommended for removal are of low category and should not impact on the design layout. In planning context they do not warrant retention and an appropriate landscape scheme will be more than adequate to mitigate any impacts.

Trees recommended removal to facilitate the proposal
-

**Leaf litter** - Impacts may be encountered around paving and building gutters, to mitigate any impact non slip paving and gutter guards are recommended.
