**DRAINAGE REPORT**

**Date Of Attendance:** 05/08/2021  
**Customer Ref:**  
**Absolute Ref:** JB13665

**Roses Tea Barns  
17 Church Lane, Gravesend DA12 2NL**

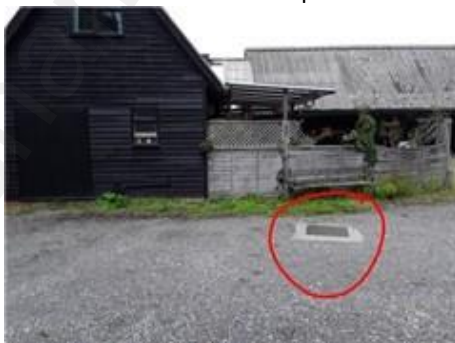
Location of cesspit

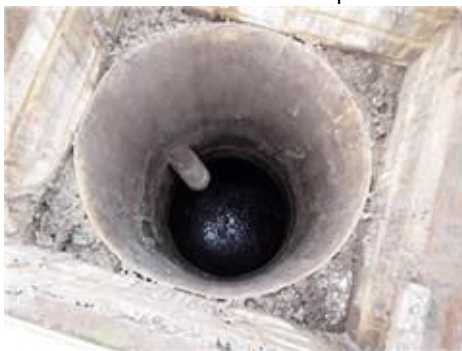
| <p>Attended site, carried out CCTV camera survey of the drains surveying both barns, and a visual inspection of of the cess pit. We roughly measured the cesspit to be 3mx3mx4m and hold approximately 6000 to 8000 gallons. The drain material throughout the site is PVC and there are x3 inspection chambers 2 are 450mm circular and 1 250mm circular. All the drainage is in a good serviceable condition, the cesspit has no bulges or splits and is believed to be made of fibre glass and is also visually in good condition.</p> <p>We believe the drainage to be adequate for both domestic and commercial purposes.</p> |

View of inside the cesspit.
