# Tree Hazard Survey Report

St John the Baptist Church  
Wrotham Road, Meopham  
Gravesend  
DA13 0AA

NPC Tree Surgery was commissioned to carry out a Tree Hazard Survey at St John the Baptist Church, Wrotham Road, Meopham, Gravesend DA13 0AA. The tree survey was undertaken by NPC Tree Surgery to identify the tree locations and assess the tree health and safety with the outlining of any proposed remedial works. The site visit was carried out on the 05<sup>th</sup> October 2022.

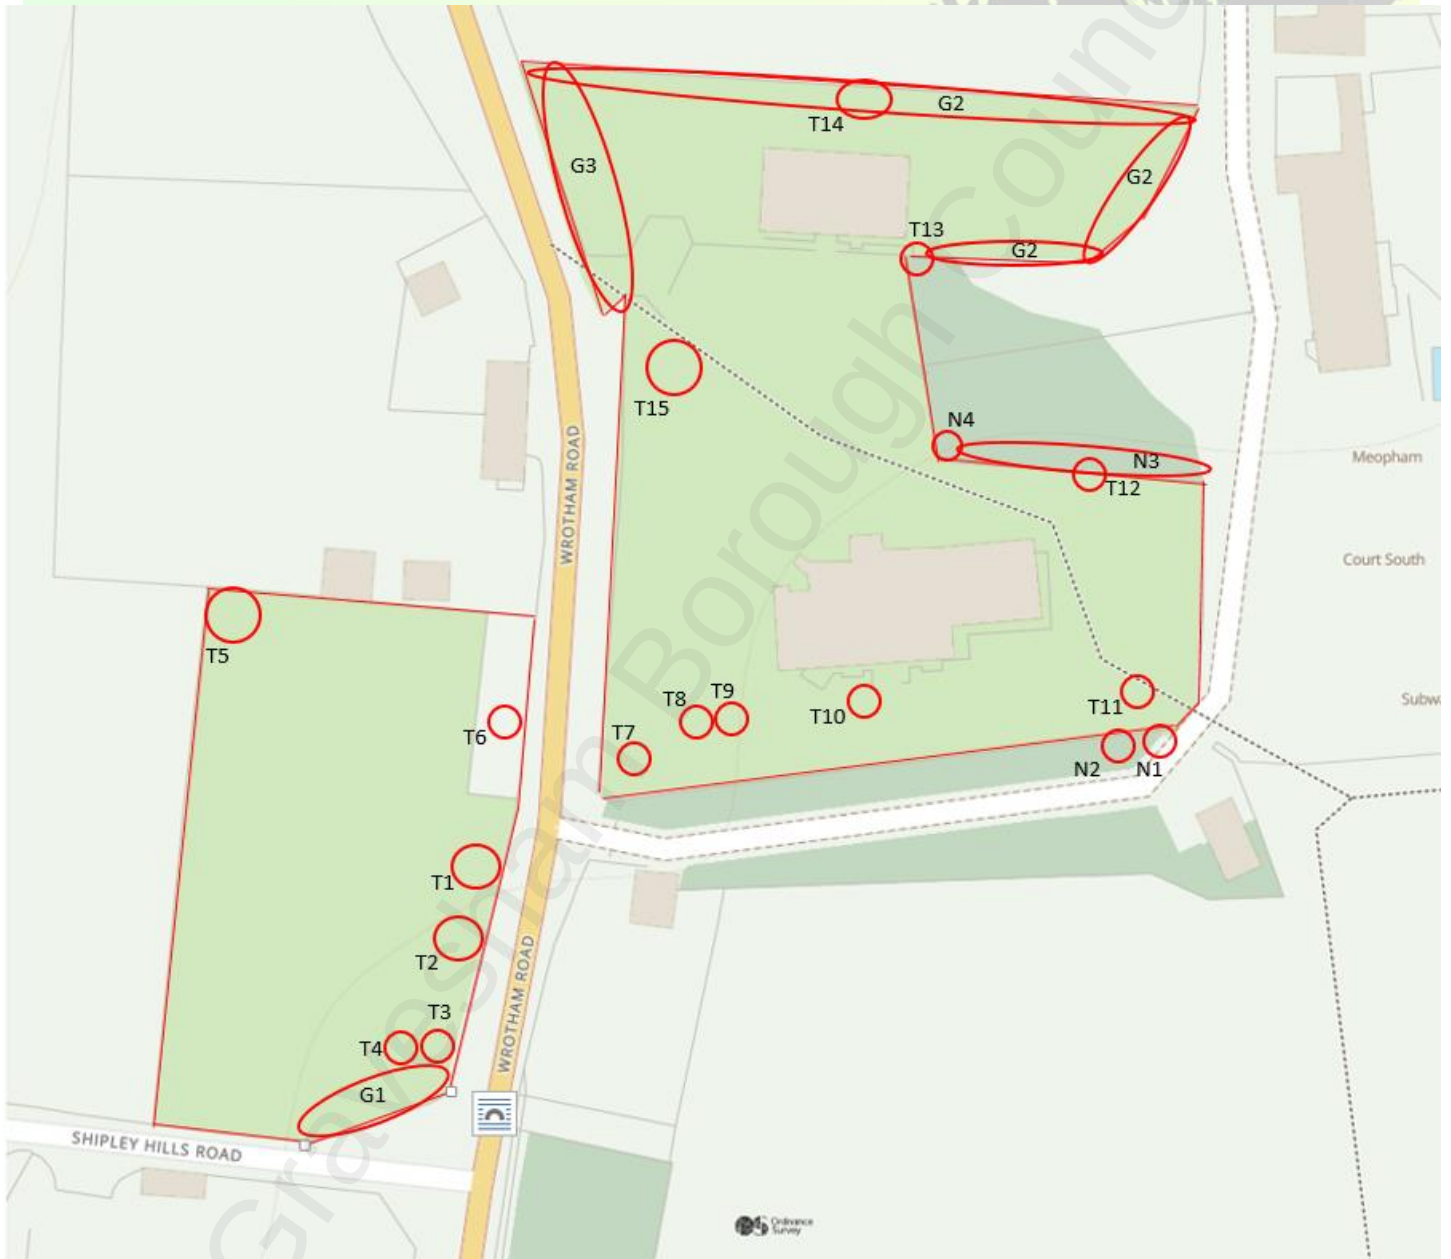
Fig 4: Map showing tree location

| Tree Number | Tree Species | Height in meters | Spread In Meters | Surveyor Comments | Recommendations | Work Priority |
|---|---|---|---|---|---|---|
| T1 | Pine | 12 | 3 | Ivy covering trunk. | Sever ivy at base. | Med |
| T2 | Pine | 12 | 8 | Minor Deadwood throughout Crown. | Remove Deadwood. | Med |
| T3 | Pine | 12 | 6 | Ivy covering trunk. | Sever ivy at base. | Med |
| T4 | Horse Chestnut | 10 | 3 | Ivy covering trunk. | Sever ivy at base to allow future assessment of trees condition. | Low |
| T5 | Common Ash | 10 | 6 | Advance stages of Ash dieback, 1m cavity in trunk. | Dismantle tree to ground level. | High |
| T6 | Standing Dead Tree | 6 | 1 | Standing dead tree | Dismantle tree to ground level. | High |
| T7 | Sycamore | 14 | 8 | Overhanging Deadwood branch presenting hazard to grave-sites<br>Dead wood present throughout Crown. | Remove Deadwood Branch<br>Remove Deadwood in crown. | Med |
| T8 | Cherry | 6 | 8 | Major Deadwood present throughout crown. | Remove Deadwood in crown.<br>Continue to monitor for additional limb failings. | Med |
| T9 | Cherry | 3 | 3 | Standing dead tree | Dismantle tree to ground level. | High |
| T10 | Cherry | 8 | 5 | Branches heading toward church building. | Tip prune to give 2m clearance from building. | High |
| T11 | Sycamore | 12 | 4 | Ivy covering trunk. | Sever ivy at base to allow future assessment of trees condition. | Low |
| T12 | Holly | 6 | 2 | Standing Dead Tree. | <b>Land Owner Action required</b><br>Dismantle tree to ground level | Med |

| Tree Number | Tree Species | Height in meters | Spread In Meters | Surveyor Comments | Recommendations | Work Priority |
|---|---|---|---|---|---|---|
| T13 | Elder | 3 | 3 | Standing Dead Tree | Dismantle Tree to ground level | High |
| T14 | Walnut | 12 | 12 | Ivy covering trunk. | Sever ivy at base to allow future assessment of trees condition. | Low |
| T15 | Sycamore | 8 | 6 | Overhanging branches presenting hazard to pedestrians on pathway. | Crown Lift to 3m and remove branches overhanging path. | Med |
| G1 | Holm Oak | N/A | N/A | Overhanging branches presenting hazard to pedestrians and roadway. Ivy present throughout tree. | Sever Ivy at base. Crown lift to Highway Spec. | Med |
| G2 | Various | N/A | N/A | Overhanging branches presenting hazard to pedestrians and vehicles. | Crown lift to give 3m clearance on car park | Low |
| G3 | Various | N/A | N/A | Overhanging branches presenting hazard to pedestrians. | Cutback to Highway Spec. | Med |
| N1 | Beech | 20 | 10 | Overhanging branches presenting hazard to pedestrians. | <b>Land Owner Action required</b><br>Crown lift to 2.5m and cut back to boundary. | Med |
| N2 | Holm Oak | 10 | 6 | 1m cavity in trunk @ 2m bifurcation point. | <b>Land Owner Action required</b><br>Remove large overhanging branch @ main union. | High |
| N3 | Mainly Redwood Group | N/A | N/A | Potential Weaknesses in holding wood, major deadwood throughout. Tree's move heavily under wind stress – Target Area high Risk.<br>1 x leaning dead tree overhanging grave. | <b>Land Owner Action required</b><br>Micro drill survey to establish internal resistance of basal holding wood.<br>Dismantle dead tree to ground level. | High |
| N4 | Redwood | 16 | 4 | Tree in seemingly in poor health. Large cavity in Trunk, Root plate compromised by animals.<br>Tree moves heavily under wind stress – Target Area high Risk. | <b>Land Owner Action required</b><br>Micro drill survey to establish internal resistance of basal holding wood. | High |
