| DESCRIPTION | |
|---|---|
| FIRST FLOOR PLAN AS PROPOSED | |
| LOCATION<br>NURSTED HALL | DRG No.<br>PP-18Q-04 |
| CLIENT<br>MR & MRS HOLM | SIG<br>RP |

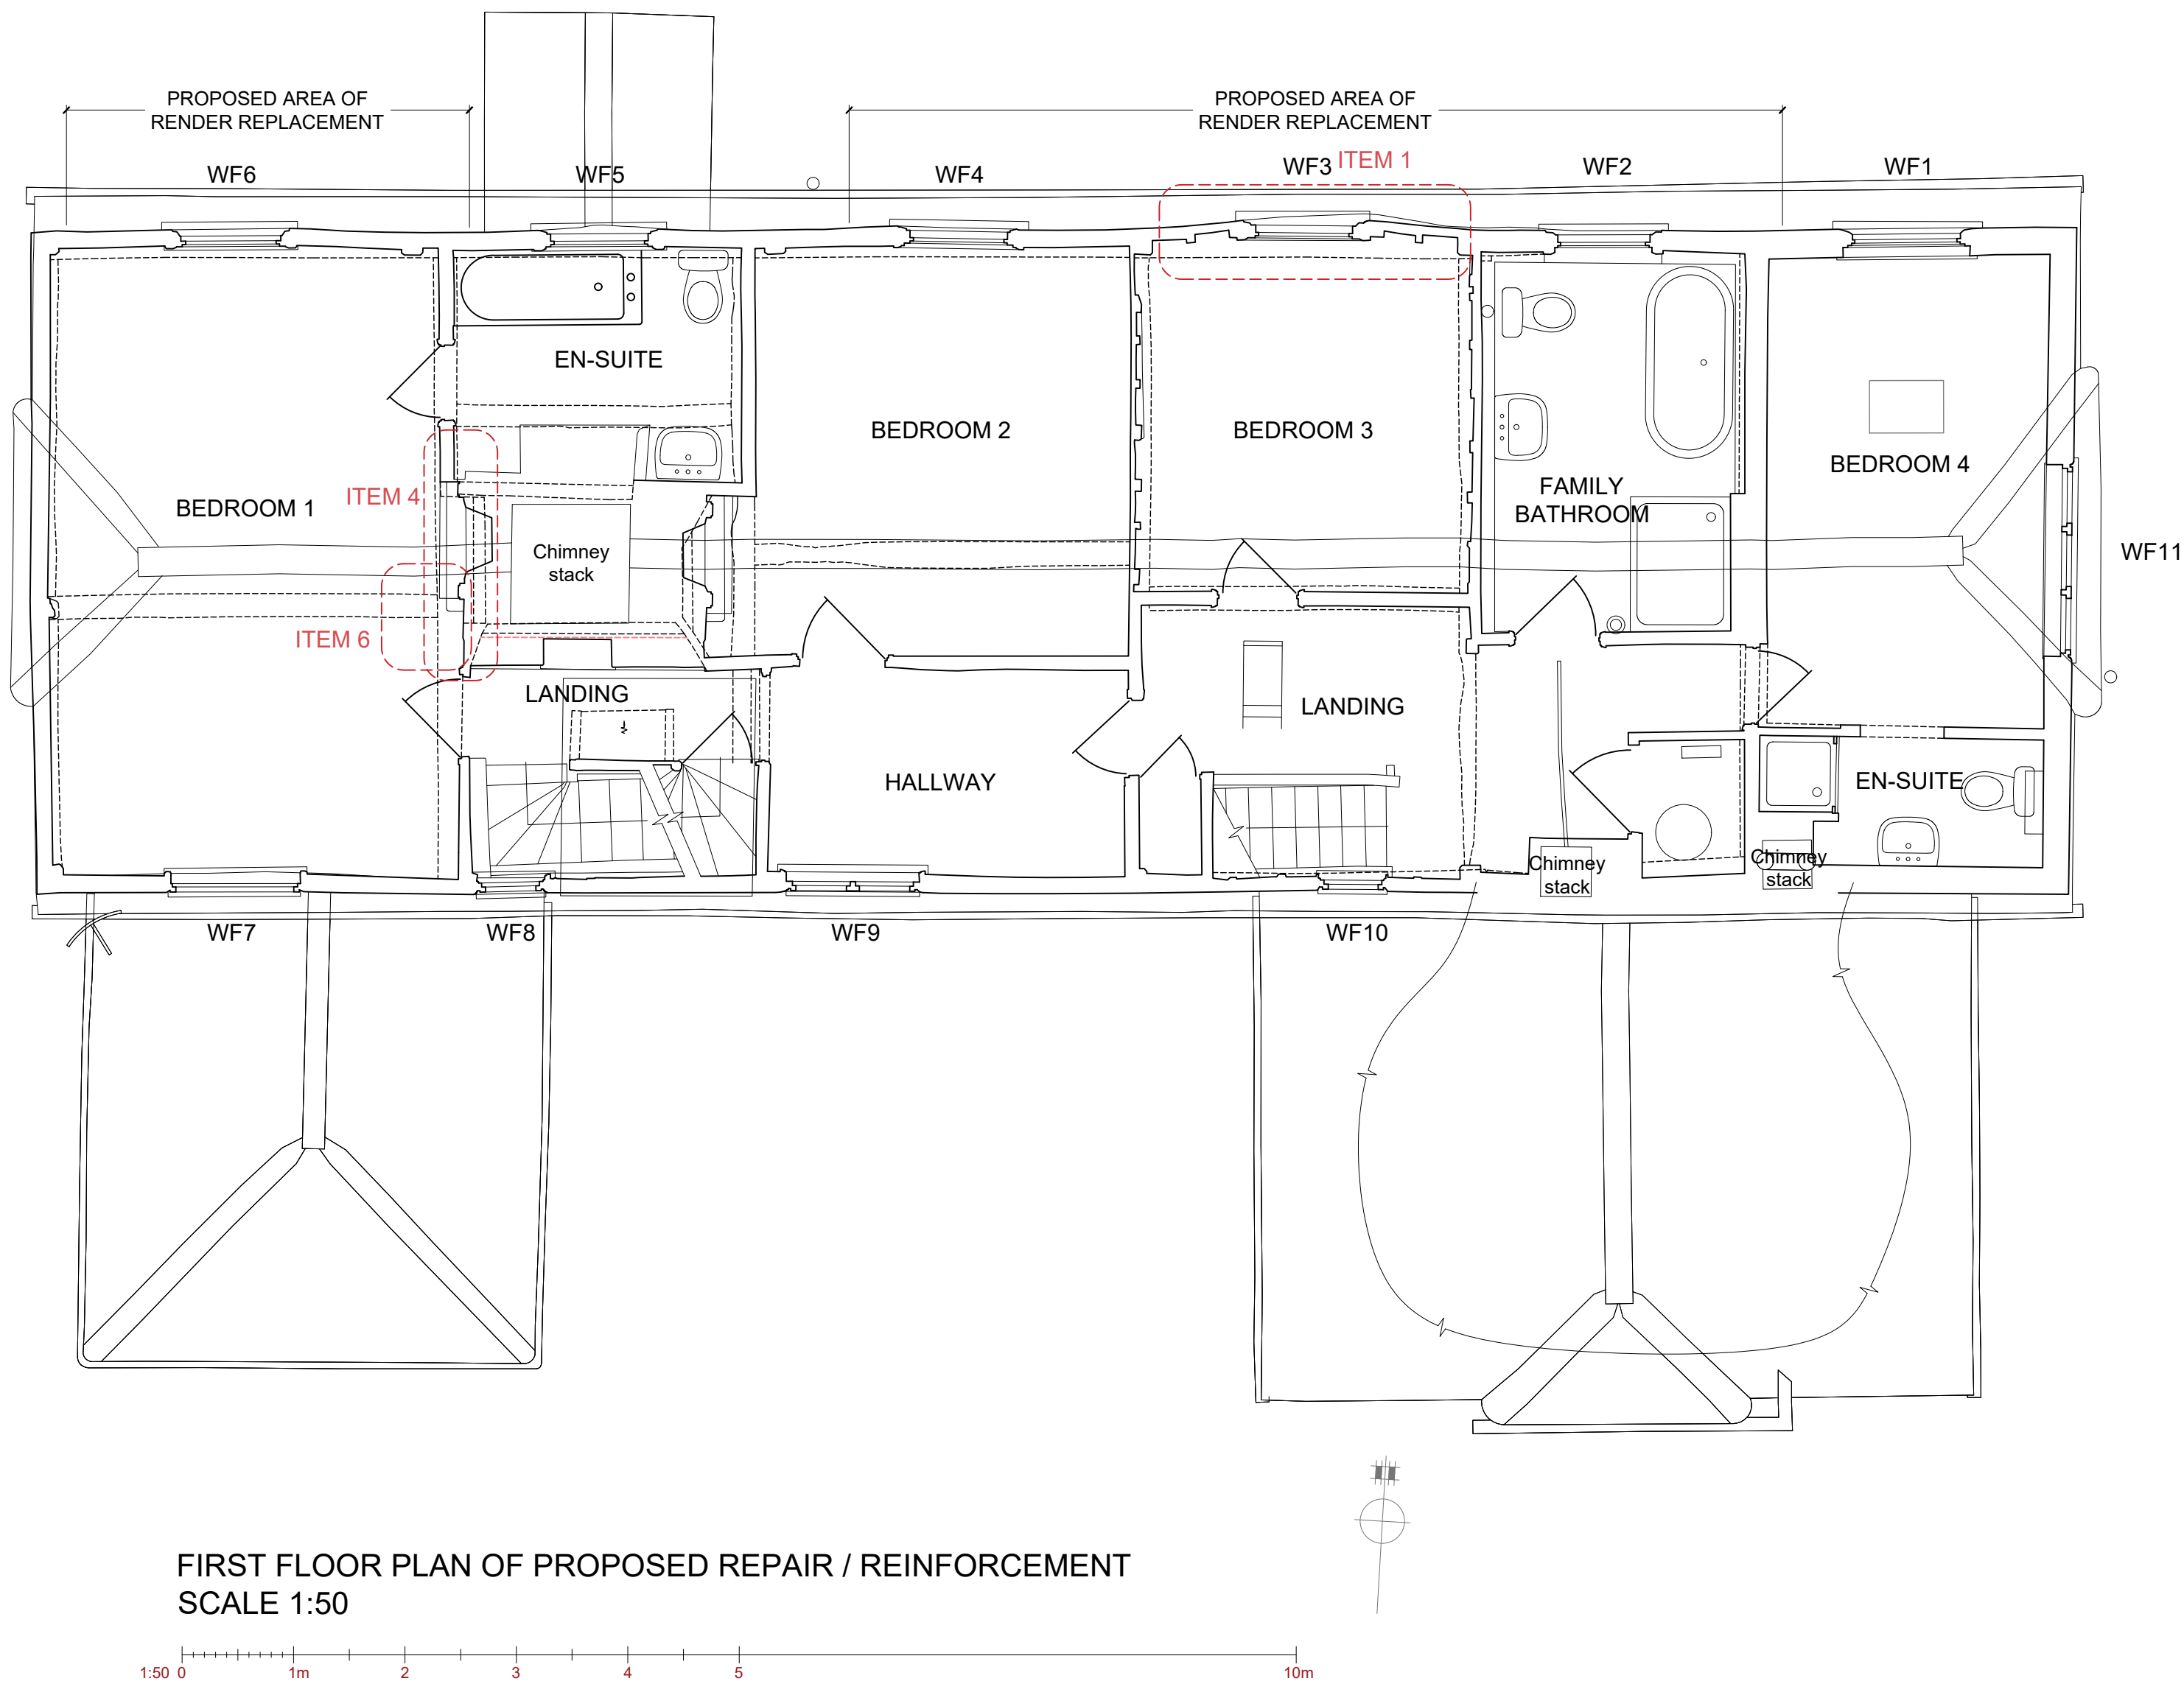
FIRST FLOOR PLAN OF PROPOSED REPAIR / REINFORCEMENT  
SCALE 1:50

This wall was found to be bowing out significantly adjacent to the kitchen windows at just above first floor level. An inspection of the oak frame internally local to this bulge found all timbers to be in reasonable condition, with all joints looking fairly tight and reasonably level. A small inspection hole had been formed externally which revealed that the render has become completely detached from the oak framework behind, leaving a gap of up to 100mm. The lathes were also found to be loose. The small area of studwork that could be seen externally Generally looked in reasonable condition, although the first floor sole-plate appeared to contain a small fracture. It is therefore clear that the bond between the render and oak frame behind has been completely lost which will require the render finishes to be removed and re-applied. The slight fracture to the sole-plate should be reinforced with a 600mm long x 100mm deep x 8mm thick steel strap coached screwed to the outer face of the plate. Elsewhere around the property, the render was seen to be loose and has become detached from the oak framework behind, so these areas should be investigated further but we feel that it is likely that large areas of render will require replacement. As discussed on site, an incoming overhead power cable is located in close proximity to the works, so a method statement will be required to ensure this is adequately isolated/protected. Specialist advice should be sought.

This again contains some cracking above the timber bressummer, although the cracking in this instance is only hairline in nature. We would still recommend that this is strengthened by installing 3No rows of stainless steel hell-bars at 225mm vertical centres for the entire panel length and re-pointed with lime mortar to match the composition of the existing. The mortar is loose in places to the other faces of this stack so local re-pointing will be required. A section of brickwork below the bressummer has been previously infilled and this has become very loose and will require re-bedding.

This connection is between a primary and secondary floor beam that has opened up. A tenon could be seen entering into the supporting beam and, although there is no evidence to suggest that the tenon is failing, it is also not possible to comment on its condition and adequacy as the vast majority of it can't be seen. As with the kitchen beam, we would recommend that the joint is nominally strengthened by installing 120x120x8mm thick x 150mm deep angle cleats to both sides of the supported beam and fixed each leg with 2No.M12 coach screws. As this joint has opened up more than the kitchen beam, we would also recommend that a strap is added to the top of both beams which will require the local removal of some floor boards above.

Carefully remove the staff beads and parting beads, set aside for re-use.  
Detach the sash cords from the top and bottom sashes and temporarily remove the windows.  
Remove the existing decayed window cill and install a new hardwood window cill.  
Remove the decayed lower sections, both sides of the box frame and splice in new timber sections.  
Remove and replace the bottom rail of the bottom sash.  
Re-putty the window where required, leave any fresh putty a minimum of 7 days before over-painting.  
Install new parting beads to match existing section where required.  
Renew the sash cord if necessary and attach the sash cords to the repaired sashes.  
Re-fit the staff beads and prepare the surfaces of the existing windows, removing loose paint only and lightly sand to provide a key.  
Re-paint the window internally and externally with Superdec paint or similar breathable paint.  
Adjust existing ironmongery.

Carefully remove the staff beads and parting beads, set aside for re-use.  
Detach the sash cords from the top and bottom sashes and temporarily remove the windows.  
Remove decayed pocket sections of rot to the window cill, repair sections on window cill with 'Repair Care - Dry Flex'.  
Remove the decayed lower sections, both sides of the box frame and splice in new timber sections.  
Re-putty the window where required, leave any fresh putty a minimum of 7 days before over-painting.  
Install new parting beads to match existing section where required.  
Renew the sash cord if necessary and attach the sash cords to the repaired sashes.  
Re-fit the staff beads and prepare the surfaces of the existing windows, removing loose paint only and lightly sand to provide a key.  
Re-paint the window internally and externally with Superdec paint or similar breathable paint.  
Adjust existing ironmongery.

Carefully remove the staff beads and parting beads, set aside for re-use.  
Detach the sash cords from the top and bottom sashes and temporarily remove the windows.  
Remove the existing decayed window cill and install a new hardwood window cill.  
Remove the decayed lower sections, both sides of the box frame and splice in new timber sections.  
Remove and replace the bottom sash in a like-for-like manner but constructing window from hardwood.  
Re-putty the window where required, leave any fresh putty a minimum of 7 days before over-painting.  
Install new parting beads to match existing section where required.  
Renew the sash cord if necessary and attach the sash cords to the repaired sashes.  
Re-fit the staff beads and prepare the surfaces of the existing windows, removing loose paint only and lightly sand to provide a key.  
Re-paint the window internally and externally with Superdec paint or similar breathable paint.

Complete some minor filling and putty repair.  
Prepare the surfaces of the existing window removing loose paint only and lightly sand to provide a key.  
Re-paint the window internally and externally with Superdec paint or similar breathable paint.

Replace window in a like-for-like manner but constructed in hardwood.  
Re-use existing ironmongery.  
Paint the new window internally and externally with Superdec paint or similar breathable paint.

Replace window in a like-for-like manner but constructed in hardwood.  
Re-use the existing ironmongery.  
Paint the new window internally and externally with Superdec paint or similar breathable paint.
