## ARBORICULTURAL REPORT

25 The Avenue, Gravesend, Kent, DA11 0NA

ARB\_EXAMINER - TREE REPORT - V1

AUTHOR - PHIL GOWER - Dip Arb L4 (ABC) TecArbora

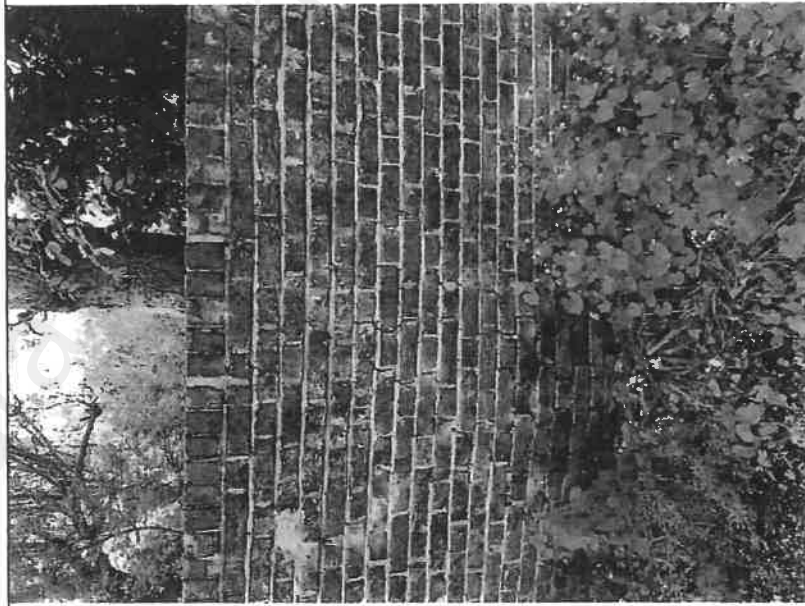
- 5.1.5. The damage to the wall in question is very obvious with multiple cracking and a clear 'bulge' which leans inwards on the client's garden.

- 5.2.1. This tree is visibly the closest tree to the damaged wall and is in line with the centre of the damage (see photo 1 & 4).
- 5.2.2. The tree has been previously pollarded at approximately 8-10 meters. Pollards require continual management on a 3-5-year cycle of which this tree in my opinion appears to be due.

Photo 1 (Wall Damage)

- 6.1.4. It is important to mention that 80-90% of root mass of most tree species are located within the top 50cm of soil.
- 6.1.5. It would be my recommendation that to prevent further damage and possible collapse as well as facilitate the required repairs to the wall and to ensure future damage is avoided that the Ash tree be removed, and the stump ground out to a suitable depth (approximately 300-500mm below ground level).

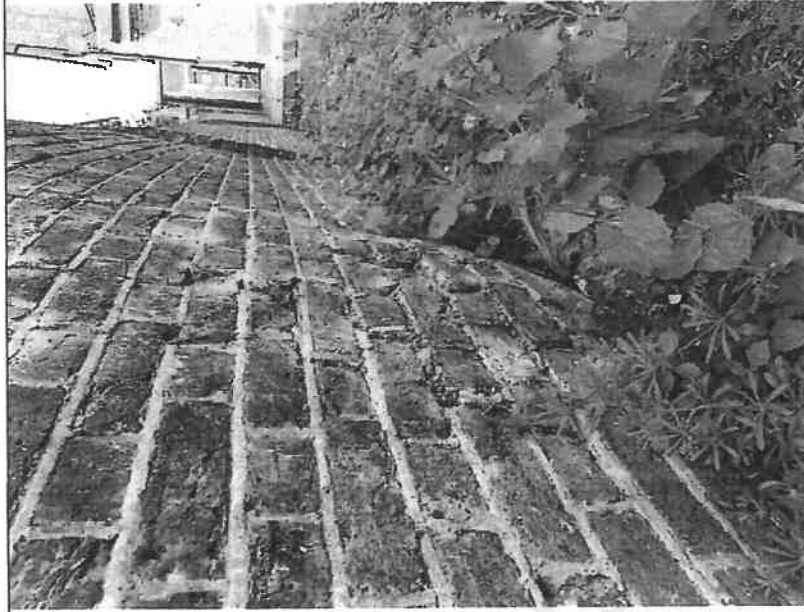
Photo 2 (Wall Damage)

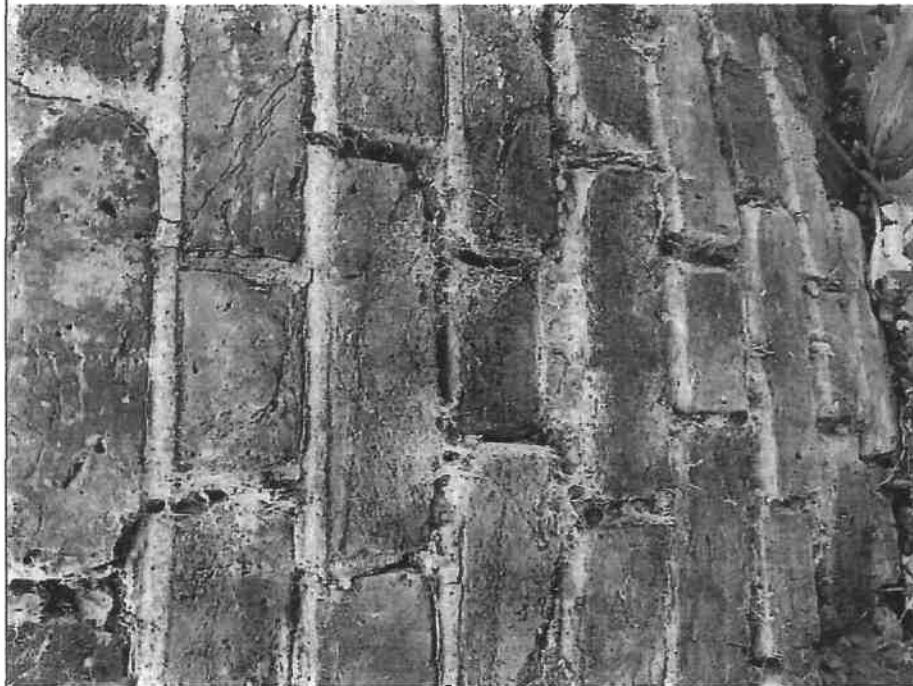
Photo 3 (Wall Damage)

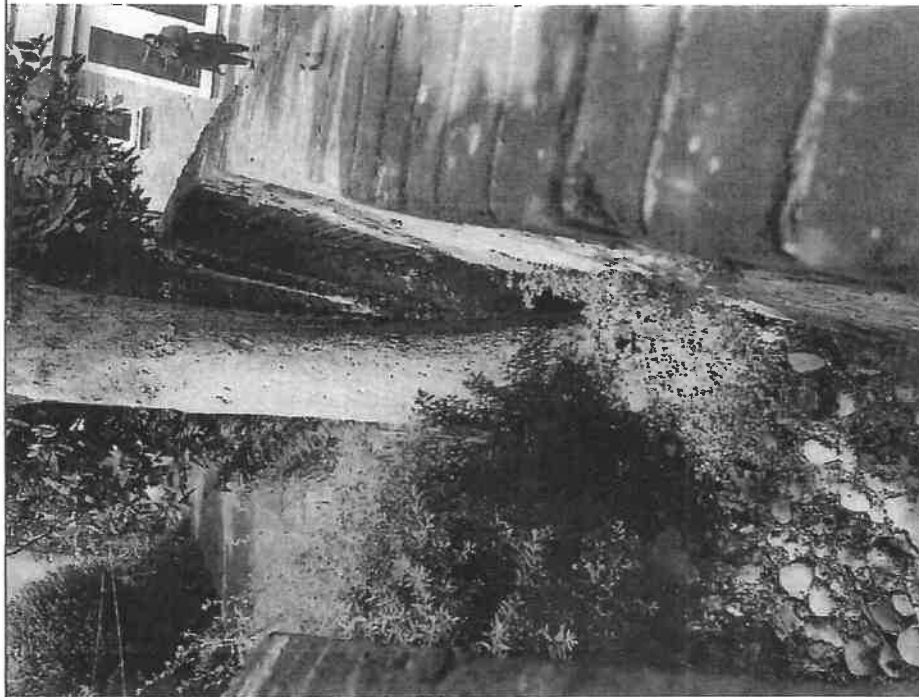
- 5.2.3. From the restricted view looking over the wall (see photo 4) the tree's root flare at the base of the stem appears to be making direct contact with the wall.

- 6.1.1. It is evident that the Ash tree is directly causing the damage to the client's wall and its continued growth will only cause further damage, likely resulting in the eventual collapse of the wall.

Photo 4 (T1 Stem / Wall lean)

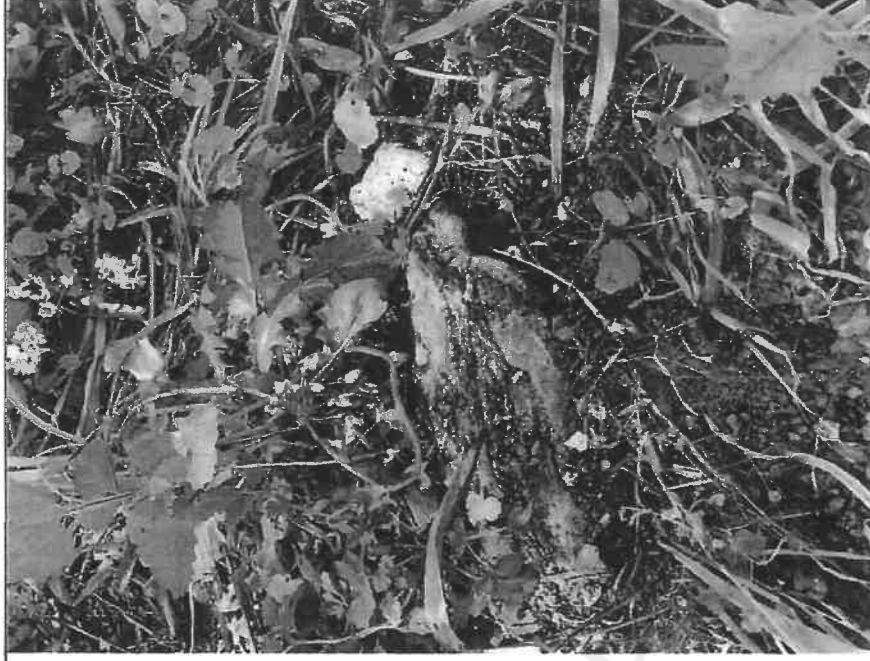
- 5.2.4. A visible root identified to belong to the Ash tree (see photo 6) was found within the client's garden. Approximately 2-3 meters from the wall and Ash stem

- 6.1.2. It is reasonable given the visible root and an estimated 3.6m radius RPA that a large volume of roots belonging to the Ash are located within the client's garden.

Photo 6 (Exposed Ash Root)
