**BS5837 Arboricultural Report and  
Arboricultural Impact Assessment**

| OUR REFERENCE | AC.2024.801 |
| SITE | 13 Stonecroft, Vigo, Gravesend, Kent, DA13 OST |

**Rear extension and internal modifications to the existing detached dwelling, along with garage conversion and canopy on columns at the front.**

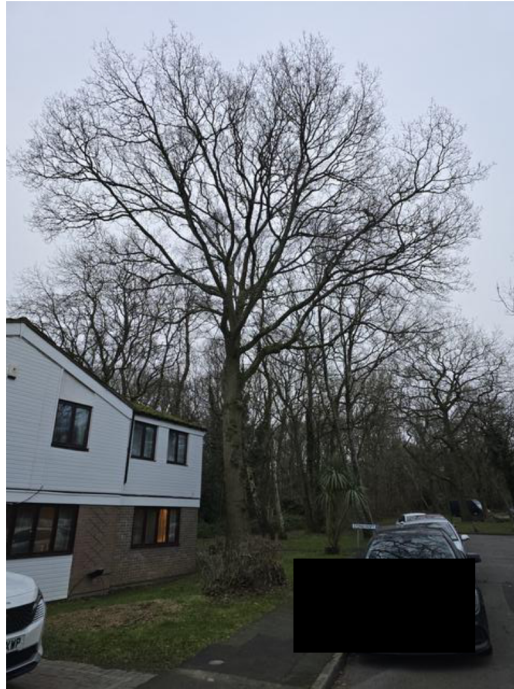
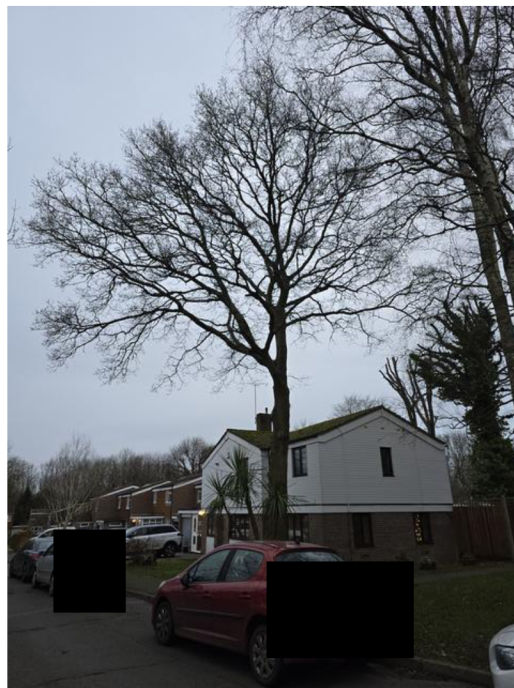
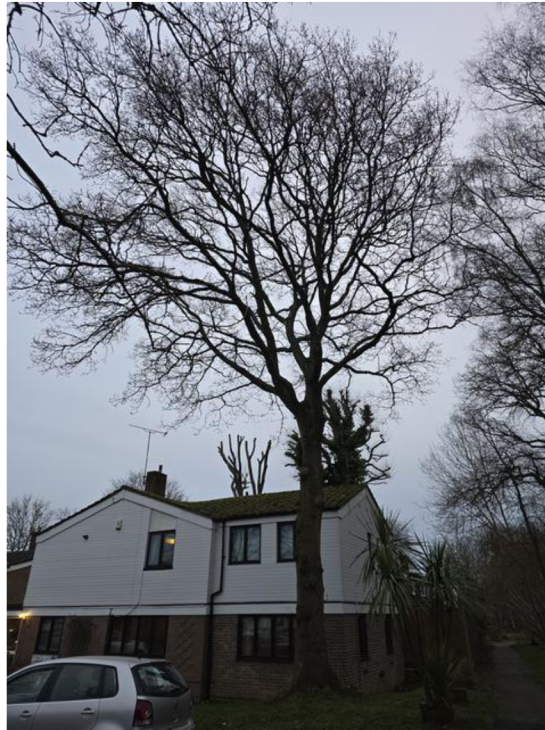
**Image 1** T01 a large oak tree viewed from the north.

**Image 2** T01 a large oak tree viewed from the southwest.

**Image 3** T01 a large oak tree viewed from the west.

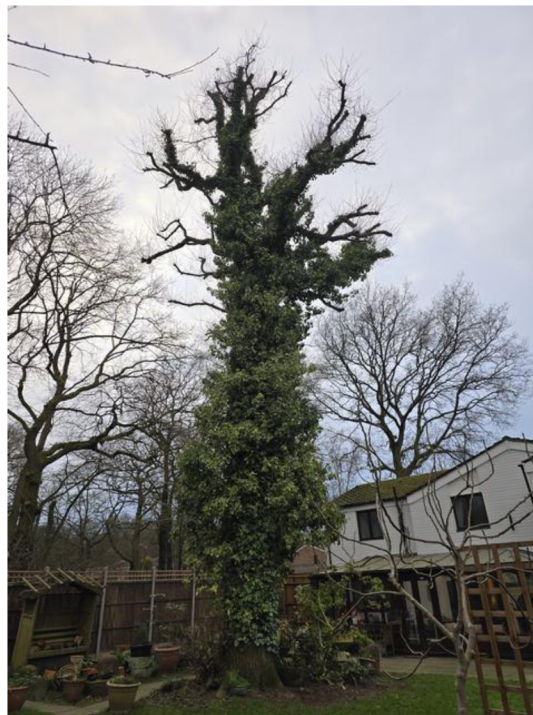
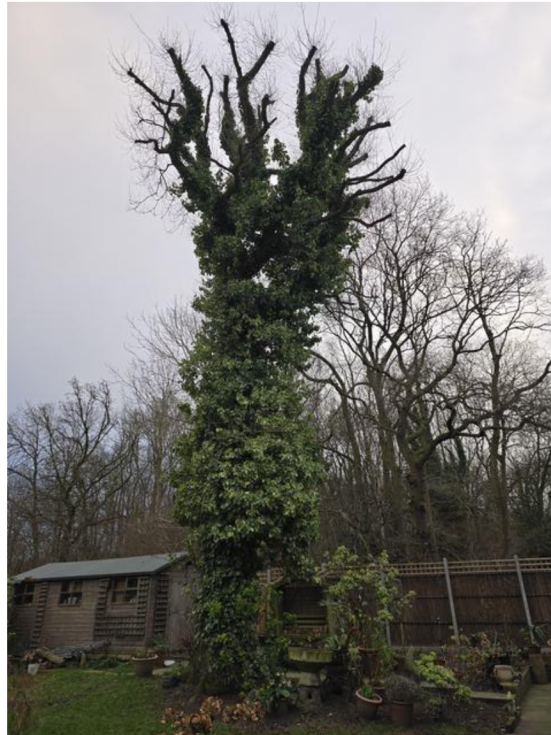
**Image 4** T02 an ivy covered heavily reduced oak tree.

**Image 5** T02 an ivy covered heavily reduced oak tree.

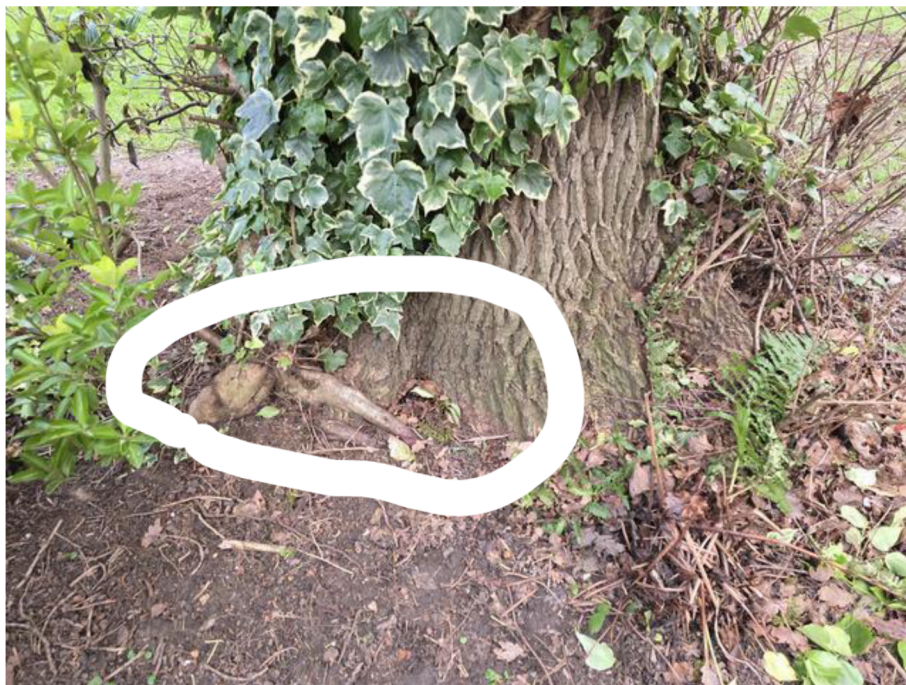
**Image 6** Girdling root at the base of oak tree T02, root to be severed.

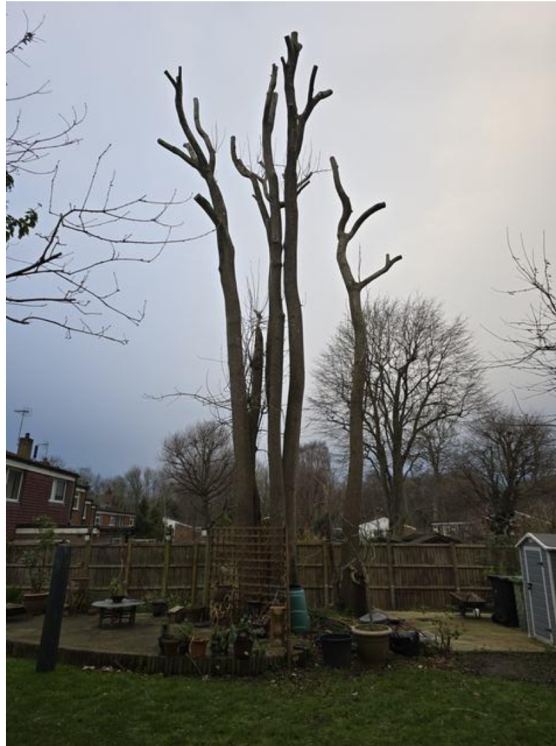
**Image 7** T03 a mostly dead multi stemmed ash tree, approved for removal already.

| Ref | Species | Measurements | Spread | General Observations | Retention Category | RPA | Recommendations | Condition | Reinspect |
|---|---|---|---|---|---|---|---|---|---|
| T03 | Common ash<br>( <i>Fraxinus excelsior</i> ) | Height (m): 14<br>6 stems, avg.(mm): 50<br>Spread (m): 2N, 2E, 2S, 2W<br>Crown Clearance (m): 10<br>Life Stage: Early Mature<br>Rem. Contrib.: <10 years | N:2<br>E:2<br>S:2<br>W:2 | Multi stemmed from the ground.<br>Decay in large pruning wound at the base.<br>Previously topped at around 14 m.<br>Very limited signs of life or regrowth.<br>Approved for removal. | U | Radius: 1.5m.<br>Area: 7 sq. m. | NAR | Physiological Cond: Poor<br>Structural Cond: Decaying<br>Bat Habitat: Low | 3 Yrs. |

**3.2.1** There are no trees proposed for removal as part of this application. T03 a multi stemmed ash tree has been approved for removal as part of an earlier tree work application. Consequently, there will be a minimal effect to the amenity value of the area.

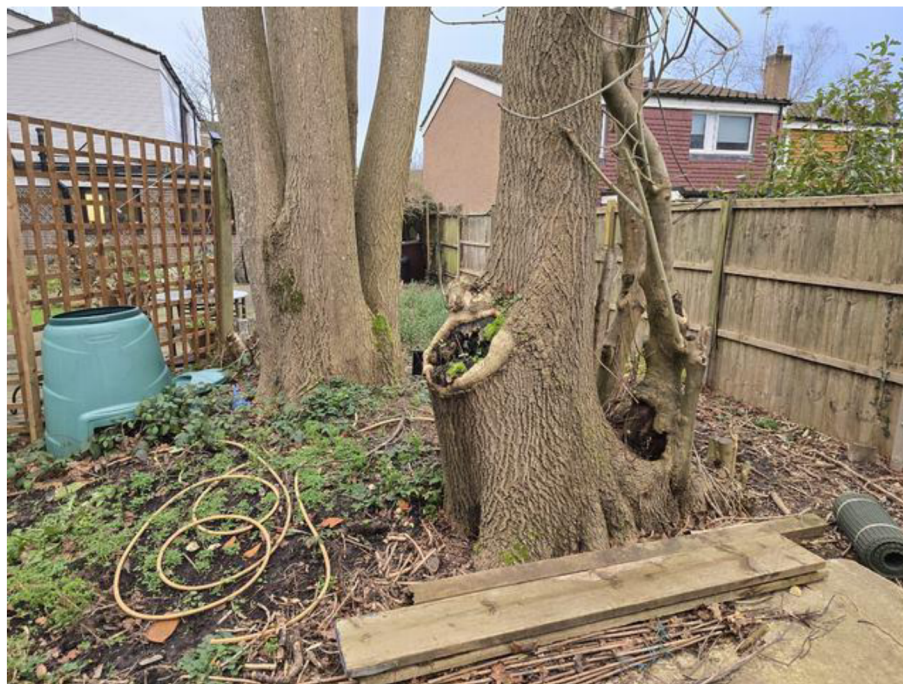
**Image 8** Degradation at the base of the multi-stemmed ash tree, T03.

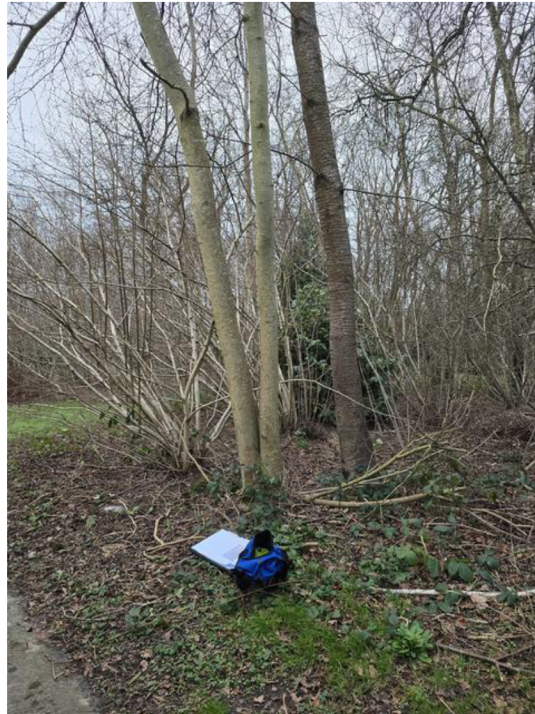
**Image 9**      Nearest trees in the adjacent woodland T04 a twin stemmed ash tree.

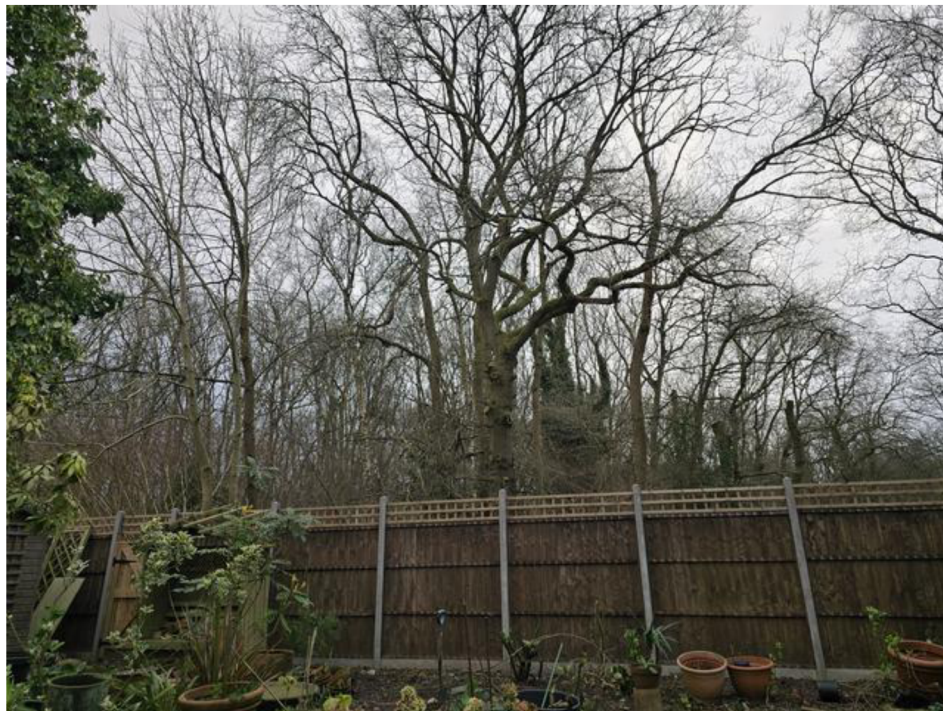
**Image 10**      Nearest trees in the adjacent woodland T05 an oak tree.

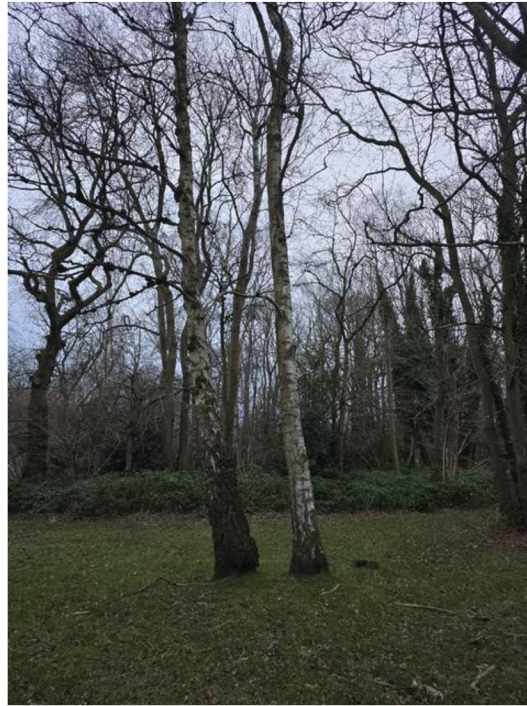
**Image 11** Nearest trees in the adjacent woodland T06 a birch tree, (on left).

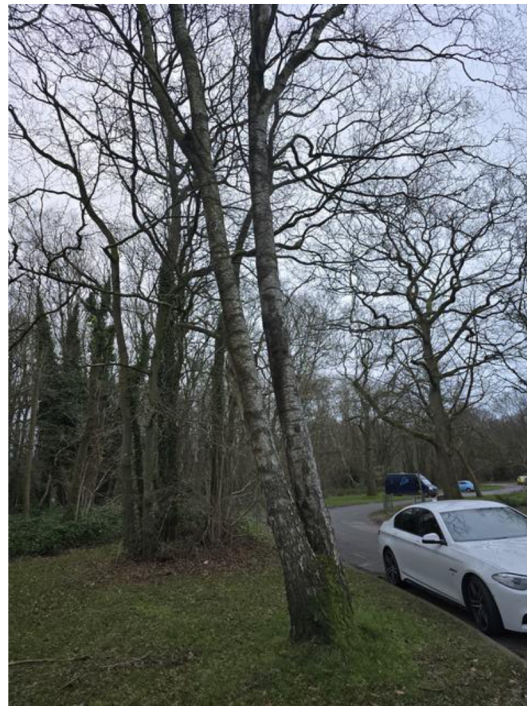
**Image 12** Nearest trees in the adjacent woodland T07 a twin stemmed birch tree.

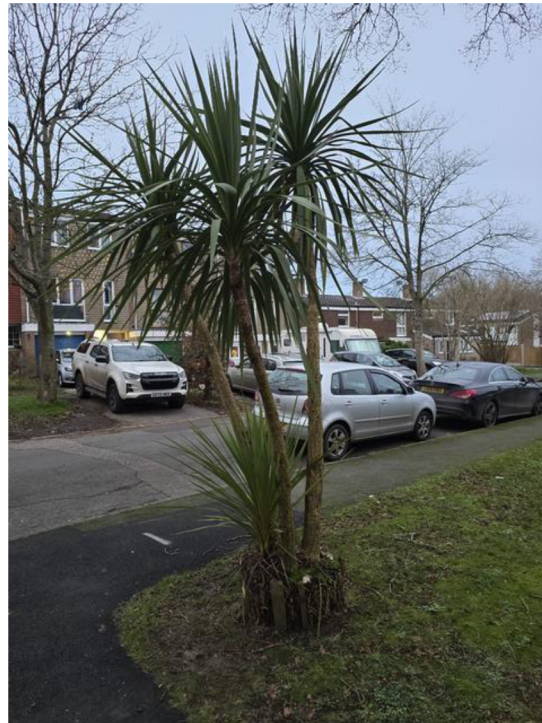
**Image 13** T08 a small cabbage palm tree in the front garden.

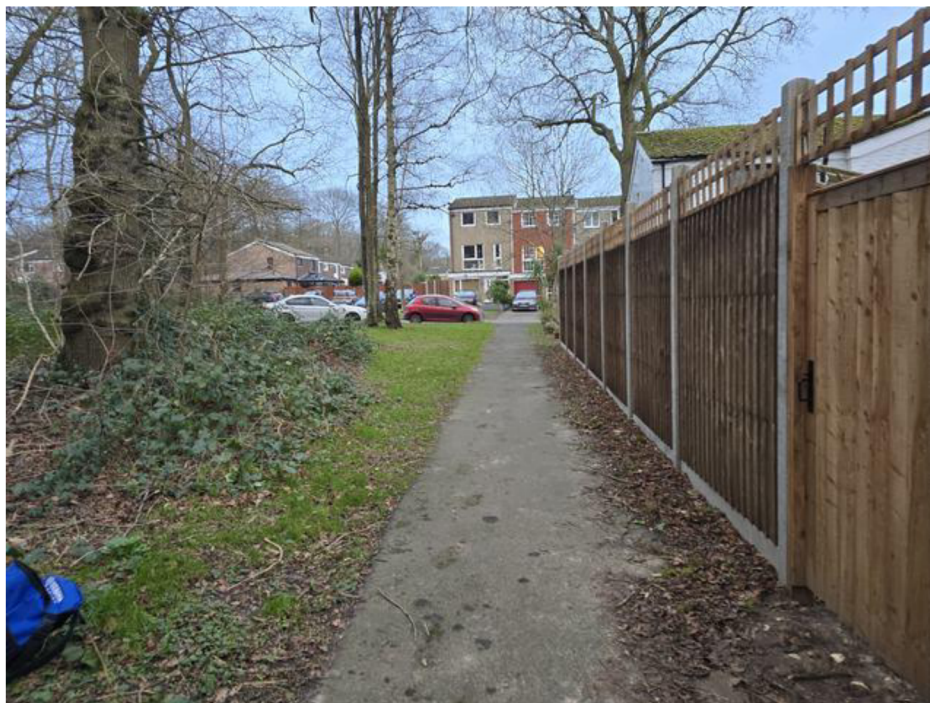
**Image 14** Side gate and existing tarmac path for site access.

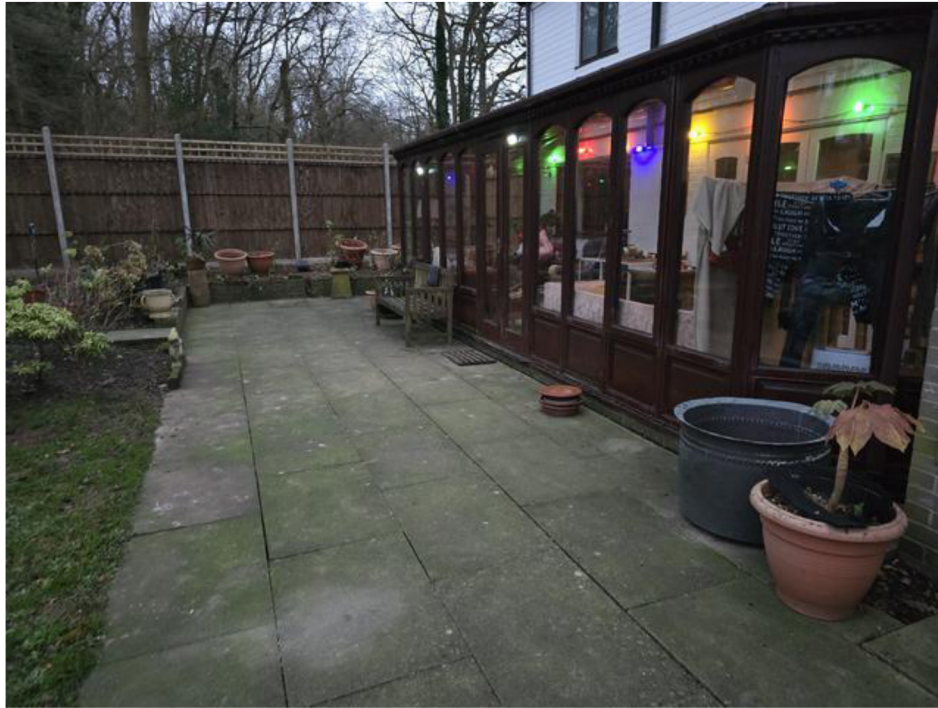
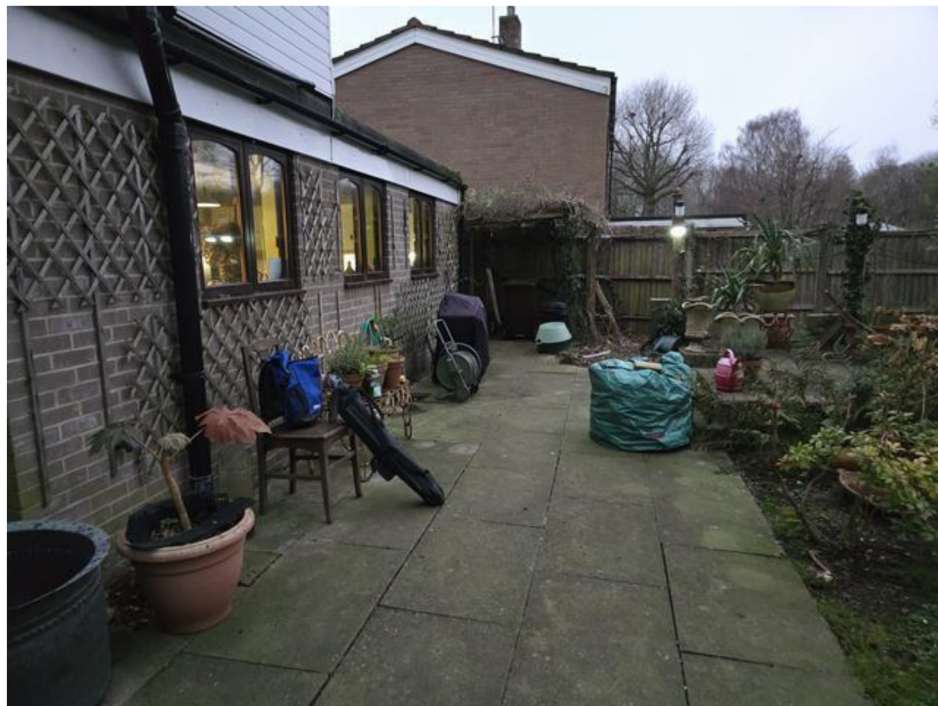
**Image 15** Existing hard standing and no overhanging branches over proposed extension.

**Image 16** Existing hard standing and no overhanging branches over proposed extension.
