# 2 Pelham Road, Gravesend, Kent, DA11 0HW

Tree Condition Survey Report

9 October 2024  
RF22384 DTE TCSR-241009

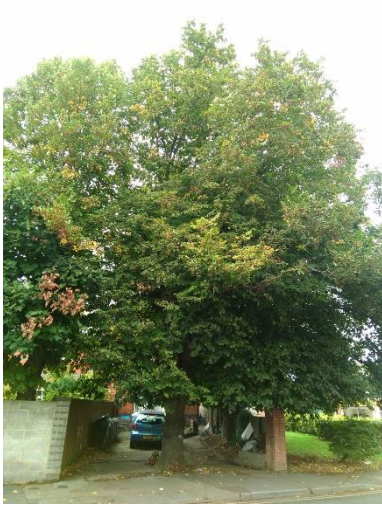
| Tree No. | Species | Height (m) | Stem diameter (mm) | Crown radius (m) | Age class | Physiology | Structure | Observations | Tree part(s) and target | Target occupancy | Likelihood of failure | Likelihood of impact | Likelihood of failure and impact | Con-sequence of failure | Risk rating | Tree work | Residual risk (Post tree work) |
|---|---|---|---|---|---|---|---|---|---|---|---|---|---|---|---|---|---|
| T1 | Common lime<br>( <i>Tilia x vulgaris</i> ) | 16 | 530 | N:5<br>E:5.5<br>S:6<br>W:3 | Early<br>Mature | Normal | Irremediable | Vehicle damage to the surface roots. Surface roots causing significant structural damage to the concrete driveway. There is no sign of fungal decay at the base single trunk with fully occluded pruning wounds. Twin stemmed from 3 meters. Managed as a Pollard at 5.5 meters. Pollarding is overdue, with an estimated 10 years of regrowth since the last prune. Normal size and density of foliage, no distal dieback. There is low foliage over the footpath and the highway, and branches are being hit by high-sided vehicles. | Low foliage damaging traffic and a pedestrian obstruction. | Frequent | Imminent | High | Very likely | Negligible | Low | Pollard. Remove all branches back to the knuckles without cutting into the old wood. Reason: General routine maintenance. Timescale: 09-Apr-2025 (6 Months) | Low |

T1 Common lime (Photo 1) - Low risk. To be pollarded.

- 1.27 *I recommend that the low-risk common lime T1 be re-pollarded by removing all branches back to the parent wood as part of its routine management cycle. The pollarding hasn't been done for probably over ten years and is overdue. The foliage obstructs the footway and highway, and the recommended work will resolve this.*

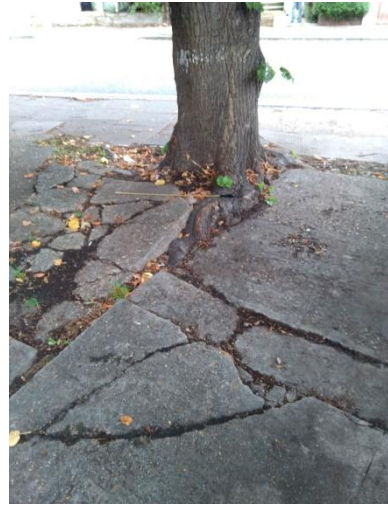
- 1.19 *The common lime (T1) (formerly T3 in the previous Acornarb report) is lifting the concrete driveway, but that could be reinstated. There was no obvious sign of decay or significant structural weaknesses in the crown. The lime (T1) has been managed as a pollard and is overdue re-pollarding. The common lime (T1) has low branches over the footway and highway, but re-pollarding will resolve that.*

T1 Common lime (Photo 2) - Root damage to the driveway

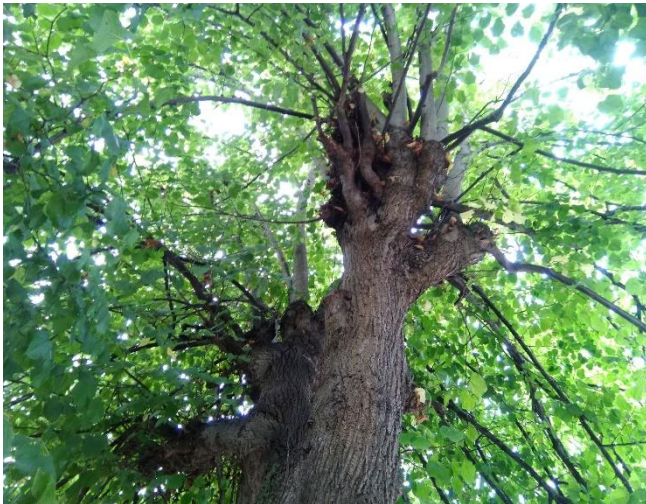
T1 Common lime (Photo 3) - Pollard knuckles

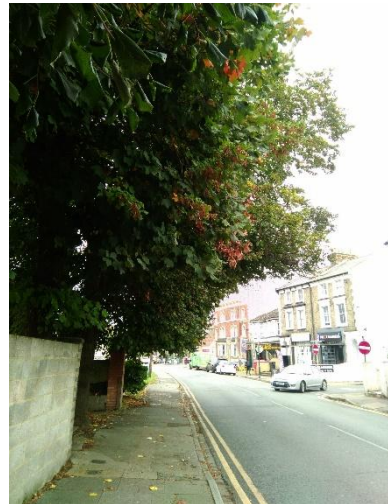
T1 Common lime (Photo 4) - Low foliage over the highway

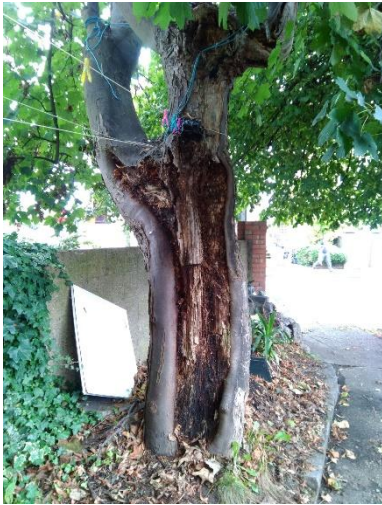
| Tree No. | Species | Height (m) | Stem diameter (mm) | Crown radius (m) | Age class | Physiology | Structure | Observations | Tree part(s) and target | Target occupancy | Likelihood of failure | Likelihood of impact | Likelihood of failure and impact | Con-<br>sequence of failure | Risk rating | Tree work | Residual risk (Post tree work) |
|---|---|---|---|---|---|---|---|---|---|---|---|---|---|---|---|---|---|
| T2 | Sycamore<br>( <i>Acer pseudoplatanus</i> ) | 16 | 500 | N:6<br>E:3<br>S:4<br>W:2 | Early<br>Mature | Low | Unviable | Significant historic fire damage to the western side of the trunk from ground level to over 2 meters. Significant decay throughout. Distal die back in the upper crown. | The largest stem peeling from the decaying trunk and impacting moving traffic or pedestrians. | Frequent | Possible | High | Somewhat likely | Severe | <b>Moderate</b> | The crown will be reduced to where the largest stem divides into three branches at approx. three and a half to four meters height above ground level. Reduce the smaller diameter stem to a similar height of four to five meters and cut back to a small side branch. Reasons for work: to lower the potential risk of uncontrolled failure and possible harm while maintaining the ecological value of the tree with regard to the decay and cavities.<br>Timescale: 09-Apr-2025 (6 Months) | <b>Low</b> |

T2 Sycamore (Photo 1) - Moderate risk. Significant decay.

- 1.28 *I recommend that the moderate-risk sycamore T2 be pollarded for the first time to alleviate strain on the heavily decayed branch forks that lean towards the road.*

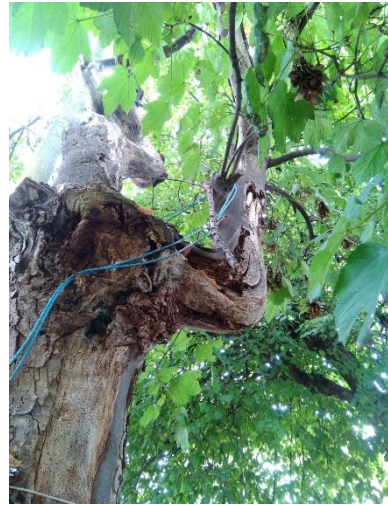
T2 Sycamore (Photo 2) - Decay extending into branches

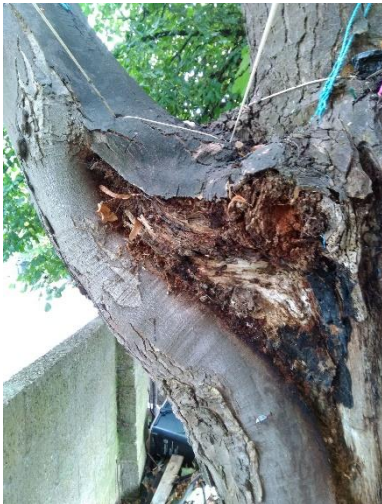
T2 Sycamore (Photo 3) - Decay in the largest stem.

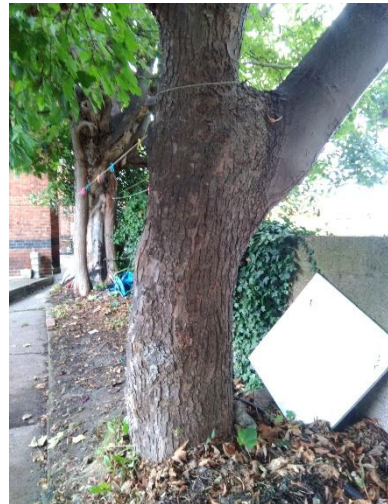
T2 Sycamore (Photo 4) - View of the eastern side of the trunk.

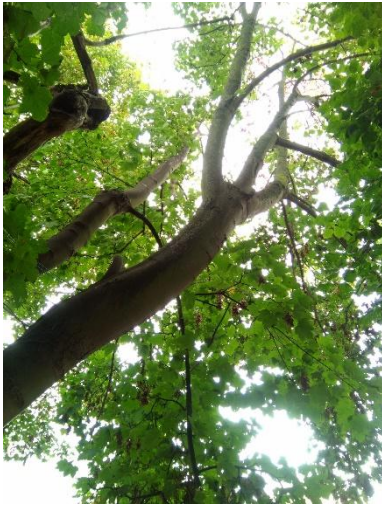
T2 Sycamore (Photo 5) - Pollard where the stem trifurcates.

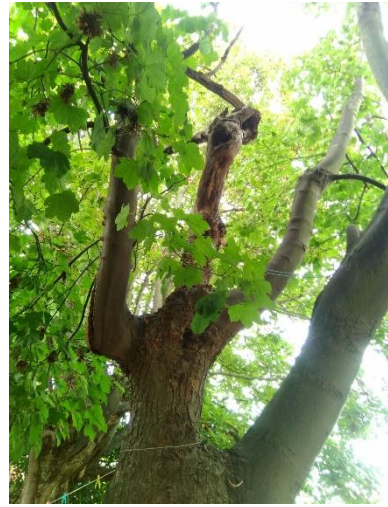
T2 Sycamore (Photo 6) - Decayed branches.

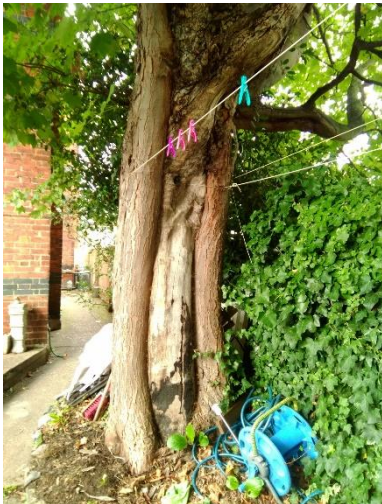
| Tree No. | Species | Height (m) | Stem diameter (mm) | Crown radius (m) | Age class | Physiology | Structure | Observations | Tree part(s) and target | Target occupancy | Likelihood of failure | Likelihood of impact | Likelihood of failure and impact | Con-sequence of failure | Risk rating | Tree work | Residual risk (Post tree work) |
|---|---|---|---|---|---|---|---|---|---|---|---|---|---|---|---|---|---|
| T3 | Sycamore<br>( <i>Acer pseudoplatanus</i> ) | 19 | 700 | N:8<br>E:4<br>S:5<br>W:5 | Early<br>Mature | Normal | Remediable | Significant historic fire damage to eastern side of trunk from ground level to 2.5 meters. Hollow. Significant decay throughout. Foliage brushes against the house roof and side walls. | Branches damaging the roof. | Constant | Probable | High | Likely | Negligible | <b>Low</b> | Reduce branches that grow towards the house walls and roof to provide a separation between the remaining closest foliage and the building of up to two meters. This may involve the removal of whole branches cut back to branch collars at the origin or the removal of secondary branches trimmed back to suitable side growth. The pruning will not harm the health or the public visual immunity value of the tree. Reasons for work: general property maintenance.<br>Timescale: 09-Apr-2025 (6 Months) | <b>Low</b> |

T3 Sycamore (Photo 1) - Low risk. Significant decay.

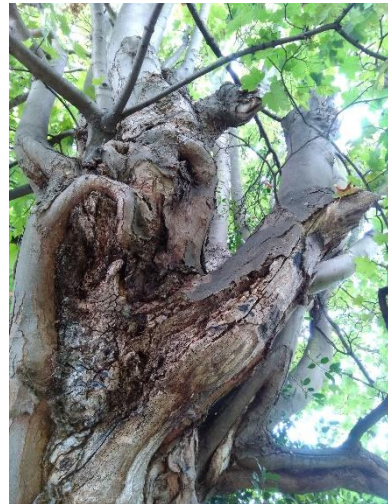
T3 Sycamore (Photo 2) - Decayed bole.`

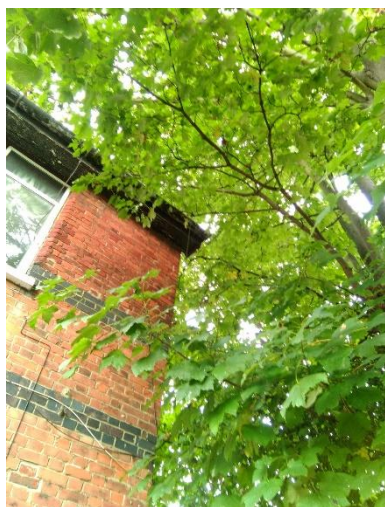
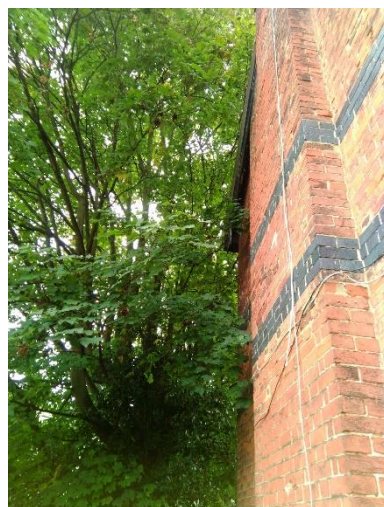
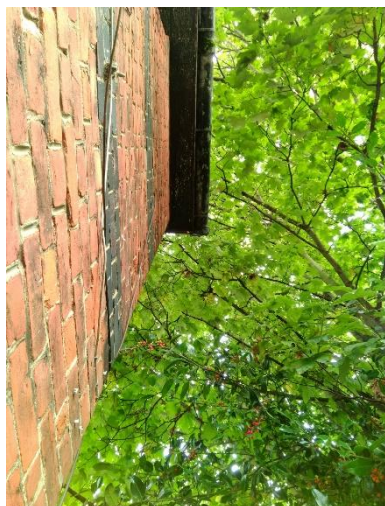
T3 Sycamore (Photo 3) - Foliage smothering building

- 1.29 *The low-risk sycamore T3 also has significant decay but appears to have sufficient supporting wood to make an uncontrolled collapse unlikely. So, I have not recommended work to mediate that. However, its crown smothers the house, and high winds could damage tiles or guttering. So, I have recommended that it be cut back from the house to provide a clearance of two metres.*
