## Engineers Report

**Risk Address** 38 Beech Mast  
Gravesend  
Kent  
DA13 0SX

**360 Reference** DLG-SN-21-003579  
**Insurer Reference** 080336373  
**Policy Holder** Mr Carleton

This document addresses damage notified to insurers to the front porch. All directions are stated when viewing the property from the front.

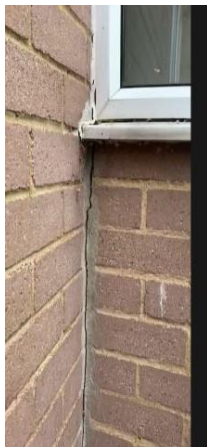
To the left hand elevation of the porch there is a 3mm wide separation gap to the left hand side of the door at the joint between the porch and the front elevation of the house where the porch has rotated away.

Picture 1: Left side of porch

The cause of the localised subsidence affecting the porch appears to be related to clay shrinkage influenced by the roots from the nearby conifer tree, which has resulted in the porch structure rotating away from the main building.

In order to mitigate further subsidence damage occurring, it will be necessary to remove the cause of the problem, which in this case will be to remove the nearby conifer tree.

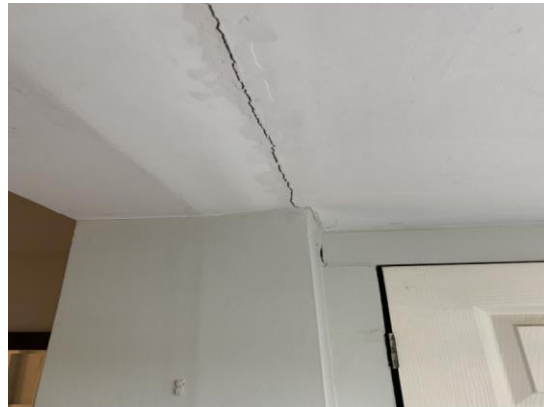
There is a 3mm wide vertical separation gap between the entrance door frame and the front elevation of the main house, whilst there is also localised 3mm wide cracking to the ceiling in the same area.

Picture 2: Inside of porch

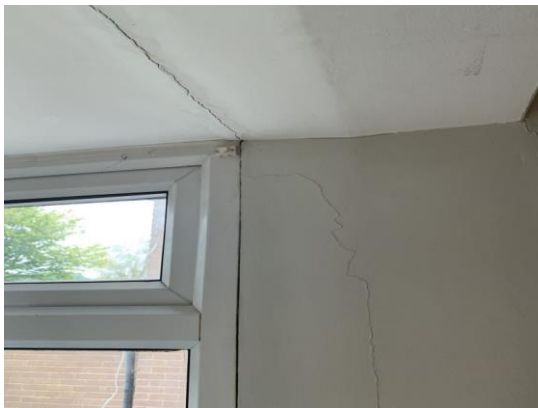
Picture 3: Cracking inside porch

It is common practice to categorise the damage in accordance with B.R.E. Digest 251 "Assessment of Damage in Low-Rise Buildings". In this case, the damage falls into Category 2 "Moderate" as there is cracking up to approximately 3mm wide.

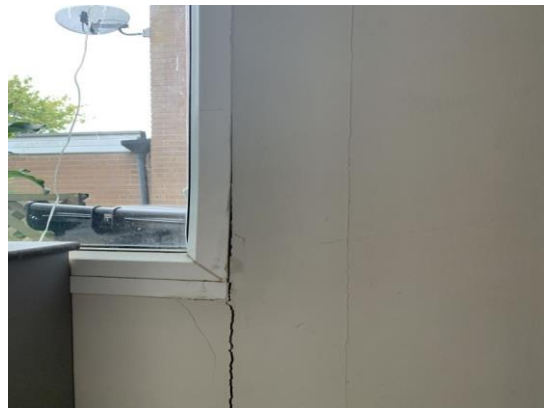
Picture 4: Movement gap in porch
