**CCTV REPORT FOR: 38 BEECH MAST  
KENT  
DA13 0SX**

**Insured:** Mr Robert Carleton  
**Reference:** DLG-SN-21-003579

**Site Visit:** 17-Jan-22  
**Report Date:** 20-Jan-22

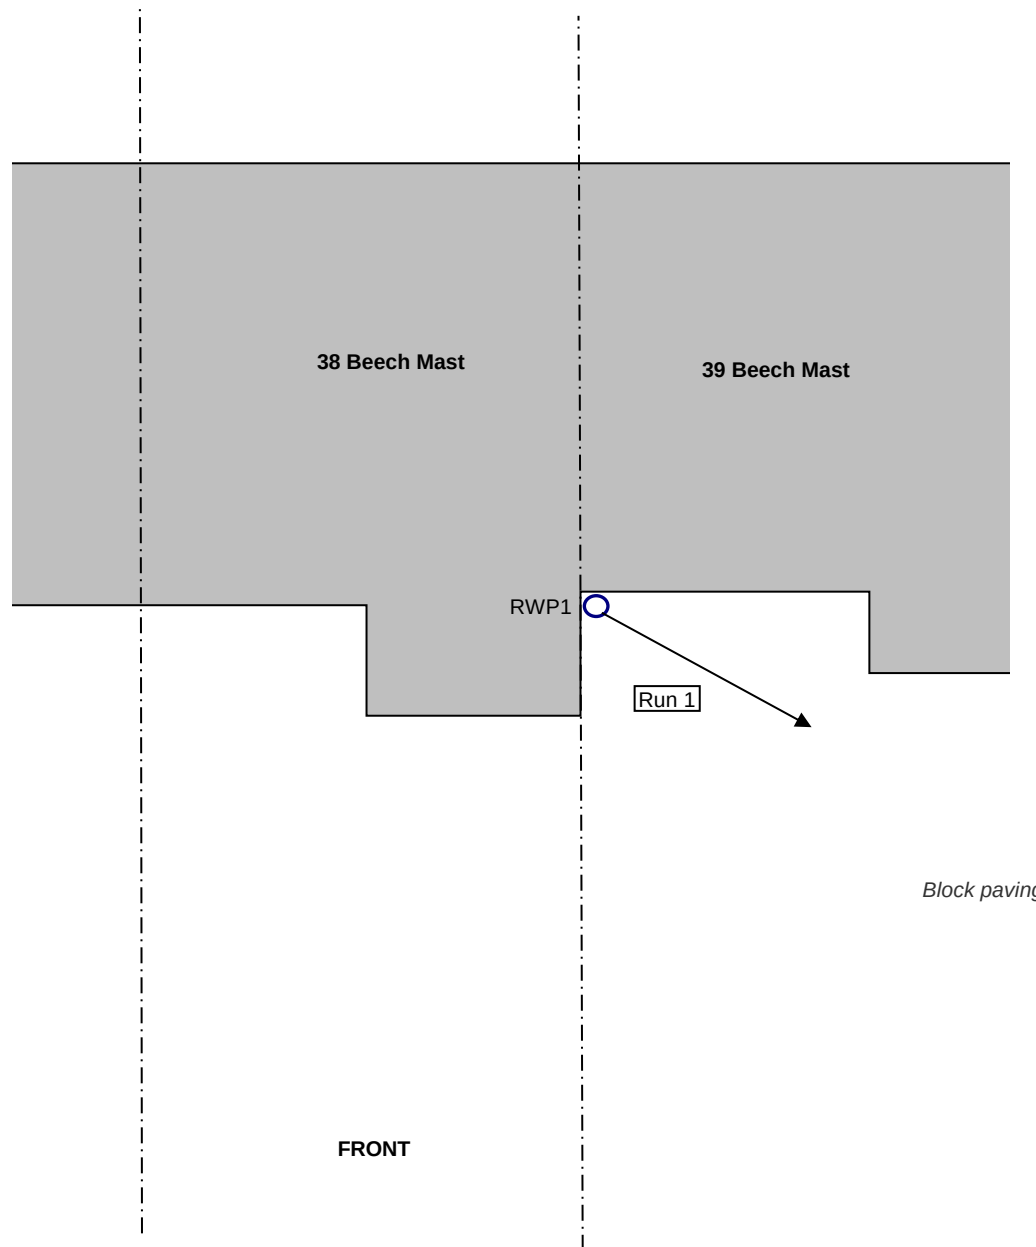
**Note: Runs shown in red have been adopted by the local water authority.**

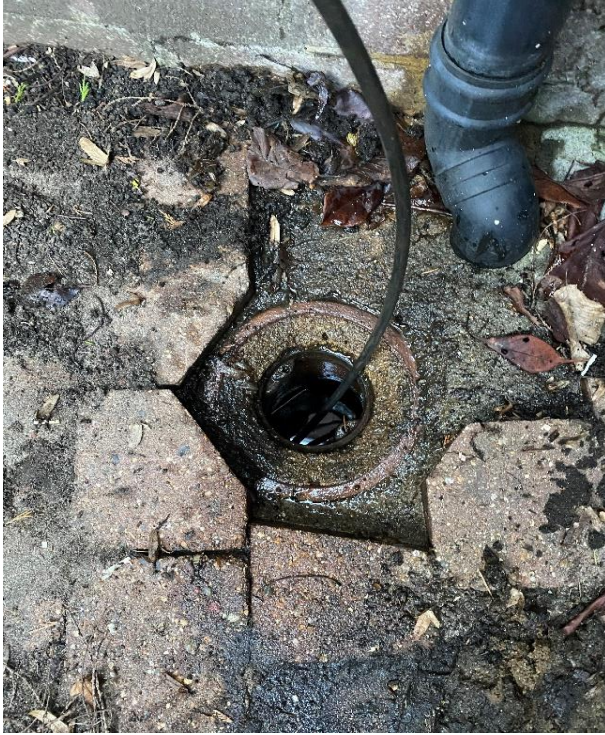
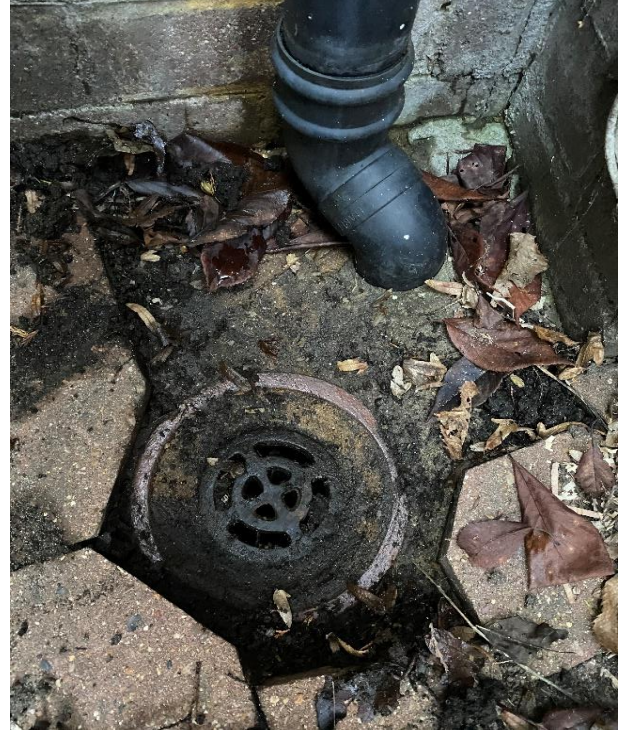
**Run 1 - Storm - Private:**  
Mass roots and open joints

Excavate and replace the rest bend to RWP 1 and 3m downstream

Further CCTV downstream from repairs
