**ARBORICULTURAL REPORT**  
**at**  
**38 Beech Mast**  
**Gravesend**  
**Kent**  
**DA13 0SX**

19319/AM

**38 Beech Mast, Gravesend, Kent, DA13 0SX.**

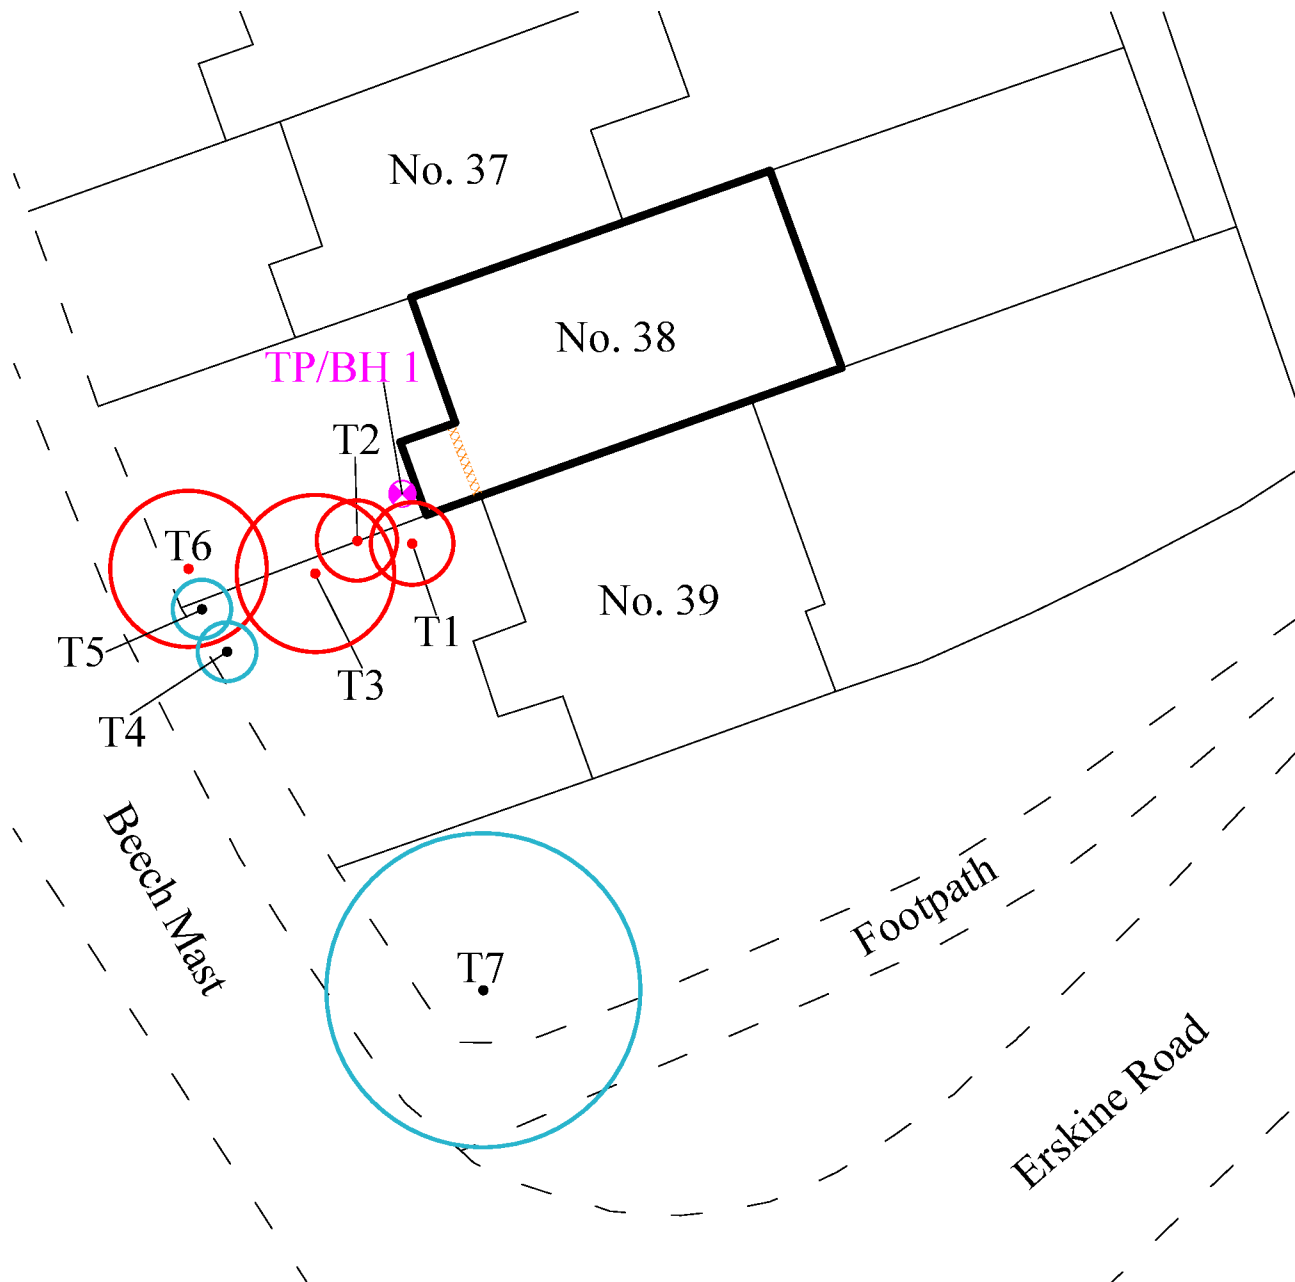
### Appendix 2: Site Plan

- 3.2.1 Please refer to the site plan at **Appendix 2** for an indication of the trial pit/borehole location.
- 3.2.2 **Trial pit/borehole 1** revealed a concrete foundation at a maximum depth of 500mm below ground level.

- 5.1 Descriptions of the surveyed vegetation and all recommended work are detailed in the tables at **Appendix 1**.
- 5.2 Please refer to the site plan at **Appendix 2** for the locations of the vegetation surveyed and all the relevant site features.

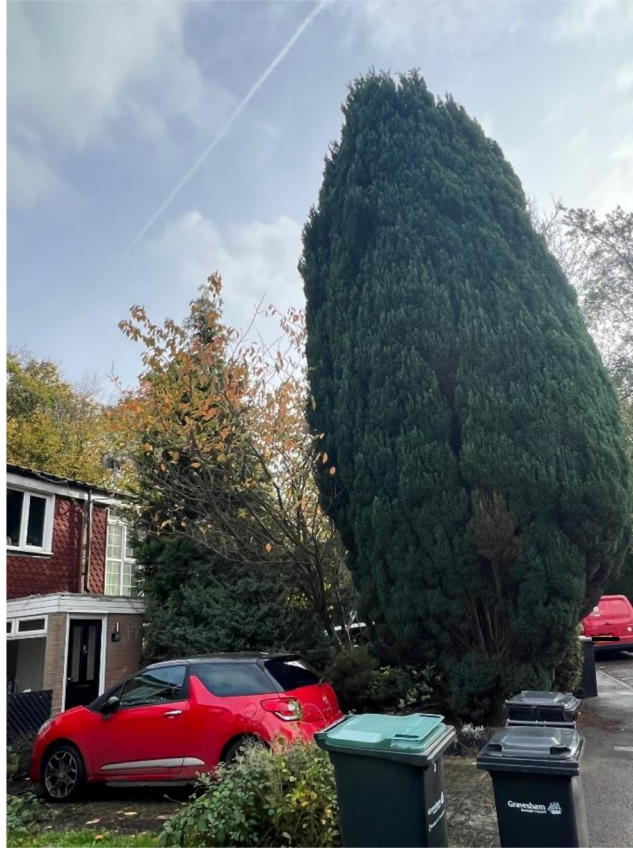
- 6.3 We consider the vegetation identified as **T1, T2, T3** and **T6** to be the most likely cause of the damage observed at the subject property. We have therefore recommended that **T1, T2, T3** and **T6** be removed and that the stump of **T3** be treated to prevent regrowth.

| Tree Ref. | Age<br>Common Name<br><i>Botanical Name</i> | Height (m) | Stem Diameter (cm) | Canopy Spread (m) | Owner / Occupier<br><br>Observations | Condition | Distance to Property (m) | NHBC Water Demand | Life Expectancy (yrs) | Within Potential Influencing Distance | Contributing to Damage | Vegetation Management Option |
|---|---|---|---|---|---|---|---|---|---|---|---|---|
| T 1 | Early-mature<br>Lawson Cypress<br><i>Chamaecyparis lawsoniana</i> | 10 | 15 | 2 | Third Party - 39 Beech Mast<br><br>No recent management noted.<br>Estimated age: 10 - 20 years. | GOOD | 1 | HIGH | 40+ | Yes | Likely | Remove to ground level. |
| T 2 | Early-mature<br>Juniper<br><i>Juniperus sp.</i> | 4 | 15 | 2 | Ownership Unclear<br><br>Situated on the boundary between No. 38 and No. 39 Beech Mast. No recent management noted.<br>Estimated age: 10 - 20 years. | FAIR | 2 | NO DATA | 40+ | NO DATA | Likely | Remove to ground level. |
| T 3 | Mature<br>Cherry<br><i>Prunus sp</i> | 9 | 30 | 4 | Third Party - 39 Beech Mast<br><br>No recent management noted.<br>Estimated age: 20 - 30 years. | FAIR | 3.5 | MOD | 40+ | Yes | Likely | Remove to ground level and treat stump to prevent regrowth. |
| T 6 | Early-mature<br>Lawson Cypress<br><i>Chamaecyparis lawsoniana</i> | 11 | 50 | 4 | Policy Holder<br><br>No recent management noted.<br>Estimated age: 20 - 30 years. | FAIR | 7 | HIGH | 40+ | Yes | Likely | Remove to ground level. |

*Figure 1. T1, T2, T3 and T6 to be removed to ground level.*

| Item | Species | Recommended Action | Location/ Ownership | Planning Restriction |
|---|---|---|---|---|
| T1 | Lawson Cypress | Remove to ground level. | Third Party - 39 Beech Mast | Yes - TPO |
| T2 | Juniper | Remove to ground level. | Ownership Unclear | Yes - TPO |
| T3 | Cherry | Remove to ground level and treat stump to prevent regrowth. | Third Party - 39 Beech Mast | Yes - TPO |
| T6 | Lawson Cypress | Remove to ground level. | Policy Holder | Yes - TPO |

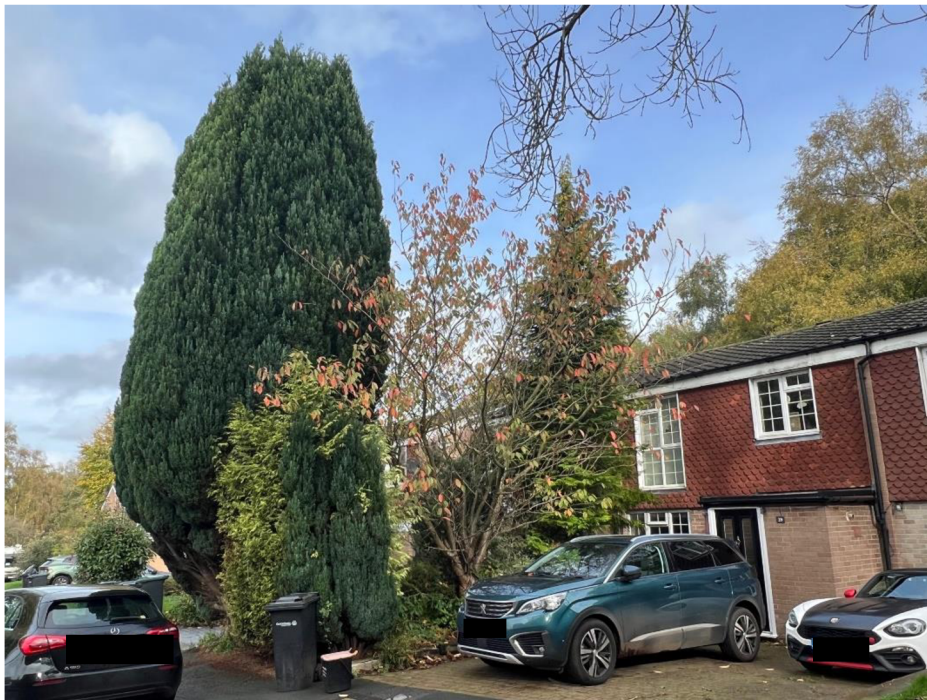
- 6.4 We consider the vegetation identified as **T4, T5** and **T7** to be of possible future concern to the subject property, if left unmanaged. We have therefore recommended that **T4, T5** and **T7** be maintained at their current size. These works are only recommended as a precaution and are not considered a priority to resolve the damage observed at the subject property.

| Tree Ref. | Age<br>Common Name<br><i>Botanical Name</i> | Height (m) | Stem Diameter (cm) | Canopy Spread (m) | Owner / Occupier<br><br>Observations | Condition | Distance to Property (m) | NHBC Water Demand | Life Expectancy (yrs) | Within Potential Influencing Distance | Contributing to Damage | Vegetation Management Option |
|---|---|---|---|---|---|---|---|---|---|---|---|---|
| T 4 | Early-mature<br>Juniper<br><i>Juniperus sp.</i> | 2 | 10 | 1.5 | Third Party - 39 Beech Mast<br><br>No recent management noted.<br>Estimated age: 10 - 20 years. | FAIR | 8 | NO DATA | 40+ | NO DATA | No | Maintain at current height and spread. |
| T 5 | Semi-mature<br>Western Red Cedar<br><i>Thuja plicata</i> | 4 | 10 | 1.5 | Third Party - 39 Beech Mast<br><br>No recent management noted.<br>Estimated age: 10 - 20 years. | FAIR | 7.5 | MOD | 40+ | Yes | No | Maintain at current height and spread. |

*Figure 2. Other side of trees shown in **Figure 1**. T4 and T5 (small trees closest to the pavement) to be maintained at current height and spread.*

| Item | Species | Recommended Action | Location/ Ownership | Planning Restriction |
|---|---|---|---|---|
| T4 | Juniper | Maintain at current height and spread. | Third Party - 39 Beech Mast | Yes - TPO |
| T5 | Western Red Cedar | Maintain at current height and spread. | Third Party - 39 Beech Mast | Yes - TPO |
