Project: Coldharbour Road, Gravesend

## B24030-TLP-03: Arboricultural Site Visit Record

Date: 18<sup>th</sup> February 2026 | Kit Hardy

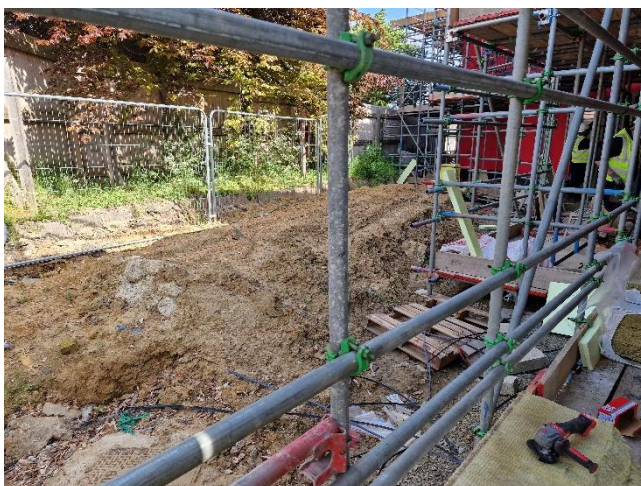
- 1.3 **Protective tree barriers:** site hoarding and Heras panel fencing largely remain in-situ as per the pre-commencement site meeting. The temporary site office has been moved to the north-eastern part of the site away from trees T01 and T02. Figures 1 and 2 below show that mesh-panel protective tree barriers are in position along the inside edge of the former curb line where the former car parking surface has been removed.

- 1.4 **Demolition of existing car park surfaces:** during a site visit in October 2024 to update tree survey data it was noted that the car park surface in relation to T01 and T02 had been demolished. Site levels seen in Figure 1 (May 2025) can be seen to be lower than the adjacent soft landscape associated with the RPA of T01 and retained curb line. The ground appears compacted, as one would expect beneath existing made ground and hard surface, with no roots visibly present. Root investigation by means of excavation was not carried out, however, the extent of rooting from T01 into the site appears to be restricted by the existing made ground and hard surfacing.

Figure 1. Area between T01 and ongoing construction works.

- 1.5 **Temporary ground protection:** the scaffolding mat (foundations) have been installed atop compacted aggregate; however, this is largely outside of RPAs. In areas where there was encroachment into RPAs temporary ground protection has not been utilised. Temporary ground protection was not installed in the area between the protective tree barriers and scaffolding as seen in Figures 1 and 2, as set out in the AIA AMS Report and Drawings.

- 1.6 During the site visit and as part of other communications the following items were discussed:
- Arboricultural monitoring is required during the installation of the 'no-dig' hard surface.
  - Additional tree removal shall only commence following LPA approval.
  - Protective tree barriers need to be adjusted, and the use of temporary ground protection implemented (where necessary).
  - Drainage runs and below ground services need to avoid RPAs.

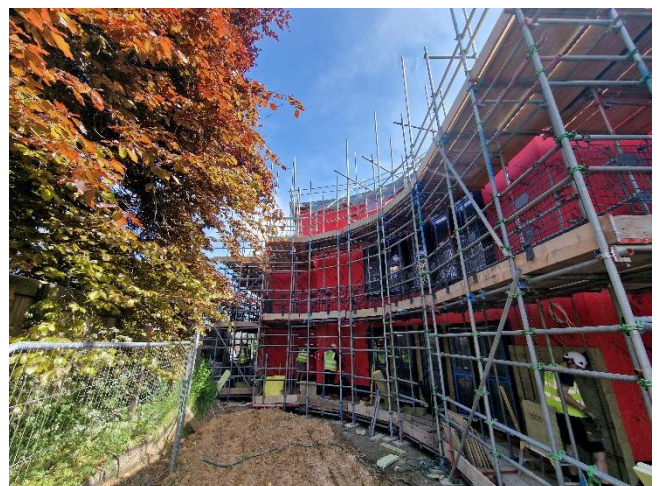
Figure 2. Canopy clearance between T01 and scaffolding.
