Project: Coldharbour Road, Gravesend

## B24030-TLP-01: Arboricultural Site Visit Record

Date: 26<sup>th</sup> April 2024 | Kit Hardy

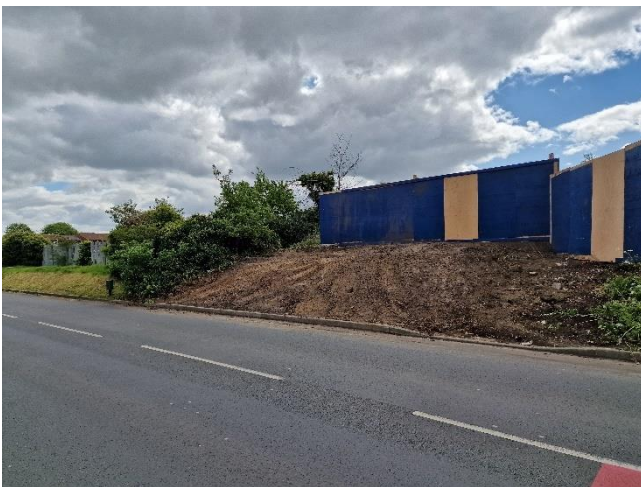
- 1.2 G3 (Category U tree group) located in the northern extent of the site in position of the new access route has been almost entirely removed (*Figure 1*). The approved TS-AIA-AMS report specifies this entire group for removal indicating that the remainder of G3 can be pruned back or removed to allow for the construction of the substation and / or access road. Also identified here was a single dead standing elm (recorded as T4 on the tree schedule to be felled), which can also be removed.

*Figure 1. Location of northern access, and part removal of G3.*

- The remainder of G3 and T4 can be pruned or removed in accordance with the approved TS-AIA-AMS report.
  - The goat willow (T10) is in direct contact with the boundary fence and in an overall 'fair' condition both physiologically and structurally, with neighbourly concerns. Only with permission from the LPA, it is recommended that tree works are carried out; either, (1) 3-4 m crown reduction and removal of ivy cover, or (2) coppice at ground level to promote regeneration.

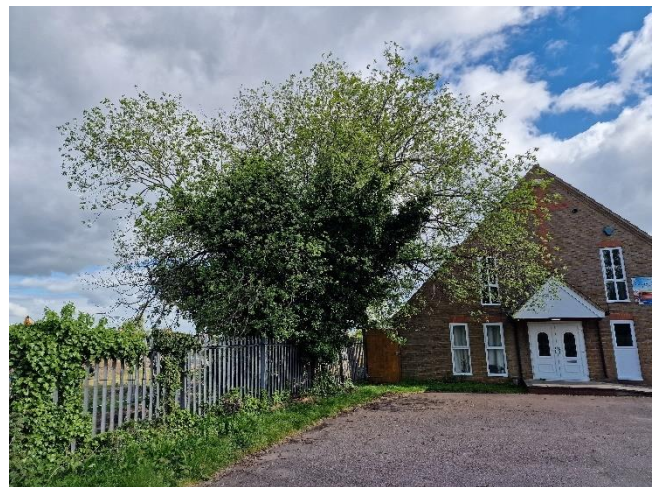
- 1.3 *Figure 4* shows the goat willow (T10) located to the south, along the south-eastern boundary, and has been noted with the following general observations; large main stems with multiple forked unions that appear structurally fair due to dysfunction within the unions / attachment points, eastern stem is in conflict with the boundary fence causing direct damage due to possible stem subsidence, heavy ivy cover into mid / upper crown obscuring visibility and suppressing live growth, and that the eastern stem / branches are within falling distance of the neighbouring building and property. It was also reported by Connie Flynn that the adjacent landowner has raised concerns with the tree and its proximity to the building. It is recommended that the tree is either cleared of ivy and crown reduced by 3-4 m, or that the tree is coppiced to regenerate growth at ground level, as also suggested within the TS-AIA-AMS report. Any proposed works will need to be agreed with the Local Planning Authority.

*Figure 2. Goat willow (T10) to the south in conflict with the fence.*

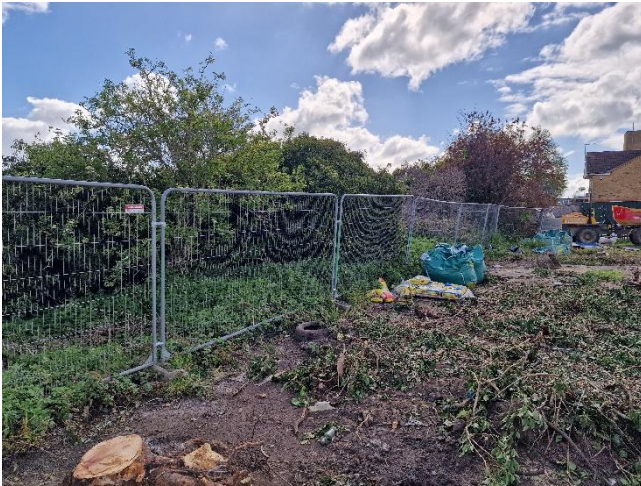
- 1.4 Along the north-eastern boundary the protective tree barriers have been installed (*Figure 3*) with the location of new hard surfacing marked out. The vegetation largely consists of ivy (including large dead sections), a small number of elder, and the cherry plum (T6). *Figure 4* shows the existing hard surface including kerb line in proximity to T6 and within it's RPA. Demolition of existing features and / or construction of the new hard standing can be carried out in this location with minimal detriment to T6. New surfaces shall utilise the existing made ground (surface or undisturbed sub-base material) within the RPA of T6. It may be necessary to temporarily move the protective tree barriers behind the kerb line to allow for access during the works.

*Figure 3. North-eastern boundary protective tree barrier, and vegetation and trees*

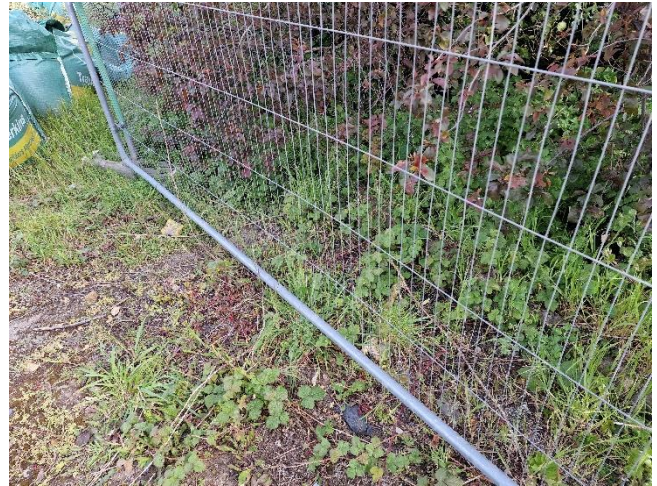
*Figure 4. Existing hard standing and kerb line in proximity to the cherry plum (T6).*

- Existing hard standing within the RPAs of T1, T2, and T6 is currently acting as ground protection. Any requirements for hard standing / kerb demolition within RPAs will be undertaken in a careful manner with protective tree barriers repositioned on completion of works. New hard surfacing shall utilise the existing made ground when forming new surfaces within RPAs.

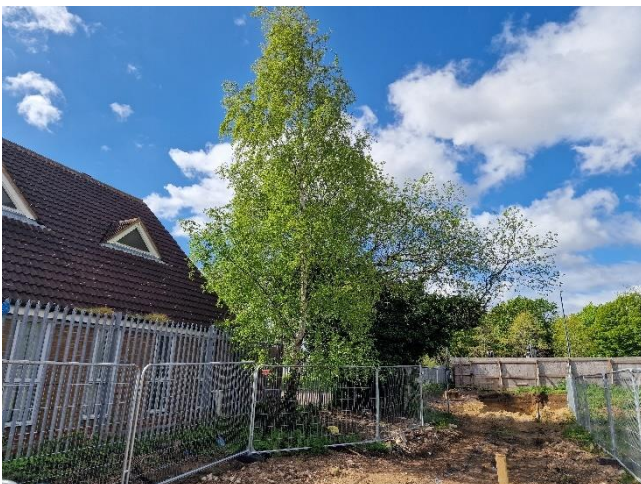
- 1.5 The Category B silver birch (T9) can be seen below in *Figure 5* with existing hardcore / rubble within it's RPA. It was discussed that this area was previously littered with waste materials. On site it was advised that the protective tree barriers around T9 were moved to at least the canopy dripline of the tree to protect the branches and RPA. Protective tree barriers should also be moved to prevent access into the RPA of T10, otherwise temporary ground protection will be required.

*Figure 5. Protective tree barriers around T9 and T10.*

- Protective tree barriers surrounding T9 and T10 should be repositioned to prevent access to their RPAs. If access is required to within their RPAs temporary ground protection will need to be installed.

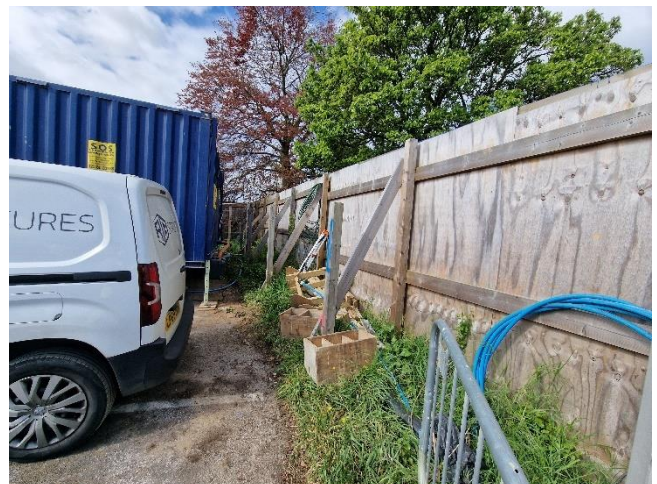
*Figure 6. Existing hard standing, site hoarding, temporary office in relation to the TPO beech tree (T1) and pear tree (T2).*

- 1.6 *Figure 6* shows the temporary site office building in contact with the outer twigs of the TPO beech tree (T1). However, no damage was recorded during the site visit. It is understood that the temporary site office will be moved within 1-2 weeks, to which care must be taken to avoid direct damage to the tree and its branches. A banksman should be in place during the works.

- 1.7 The temporary site office has been positioned on top of the existing hardstanding car park without detriment to the soil environment / RPA associated with T1.

- 1.8 In this area (*Figure 6*), it is likely that the hoarding (erected prior to site acquisition) will need to be moved to the roadside kerb effectively incorporating T1 and T2 into the sites working area. Protective tree barriers will be installed along the edge of the existing kerb line for the protection of T1 and T2, during site works. As per the TS-AIA-AMS report, a new 'no-dig' hard surface has been specified within the RPAs of T1 and T2. The best option for the installation of the new hard surface, subject to any required level changes, will be to utilise the existing made ground to ensure the soil environment and RPA are left undisturbed. If demolition of the existing surface and sub-base are required arboricultural monitoring will be required to assess potential conflict with tree roots.

- The temporary site office currently in contact with the outer branches of T1 will be moved within 1-2 weeks to another part of the site. Care must be taken when moving this structure, as to avoid direct damage to the branches, limbs, or stem of the TPO beech tree (T1).
