**Structural Appraisal  
Report  
on  
195 Parrock Street  
Gravesend  
DA12 1EW**

Gledsdale Associates were appointed by Equanimity Limited, to carry out an inspection of the property and provide a structural appraisal report.

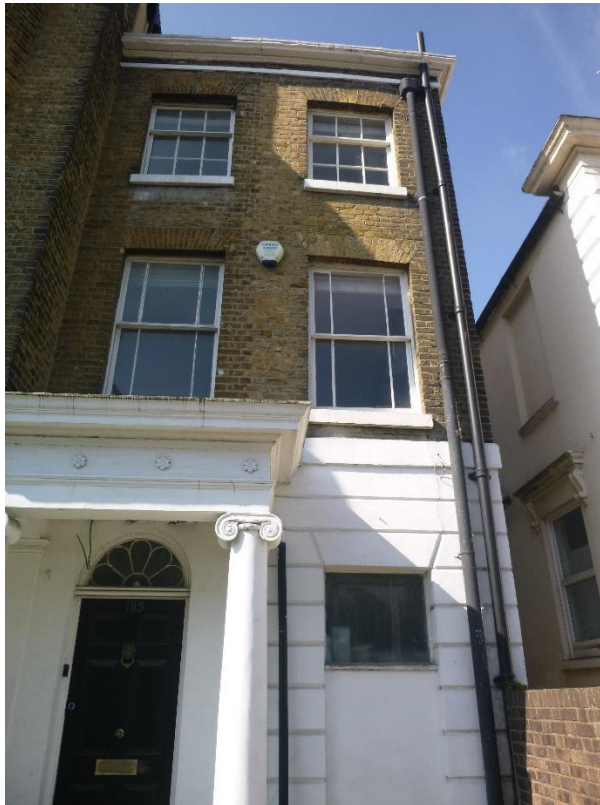
Right hand side of Front Elevation

There is also evidence of long term settlement of the flank wall on the right hand side as the lintels and cills to the windows nearest the flank wall drop down to the right hand side, but the window frames themselves have been repaired or replaced such that the frames are level. There is also some further cracking through the feature stonework extending from the ground floor window up to the cill of the 1st floor window above.

On the front elevation helical tie bars should be inserted into the brickwork on the right hand side of the elevation adjacent to the flank wall. These should be inserted at first and 2nd floor levels and extend from the return at the side of the Bay to the flank wall where they should be returned around the corner.

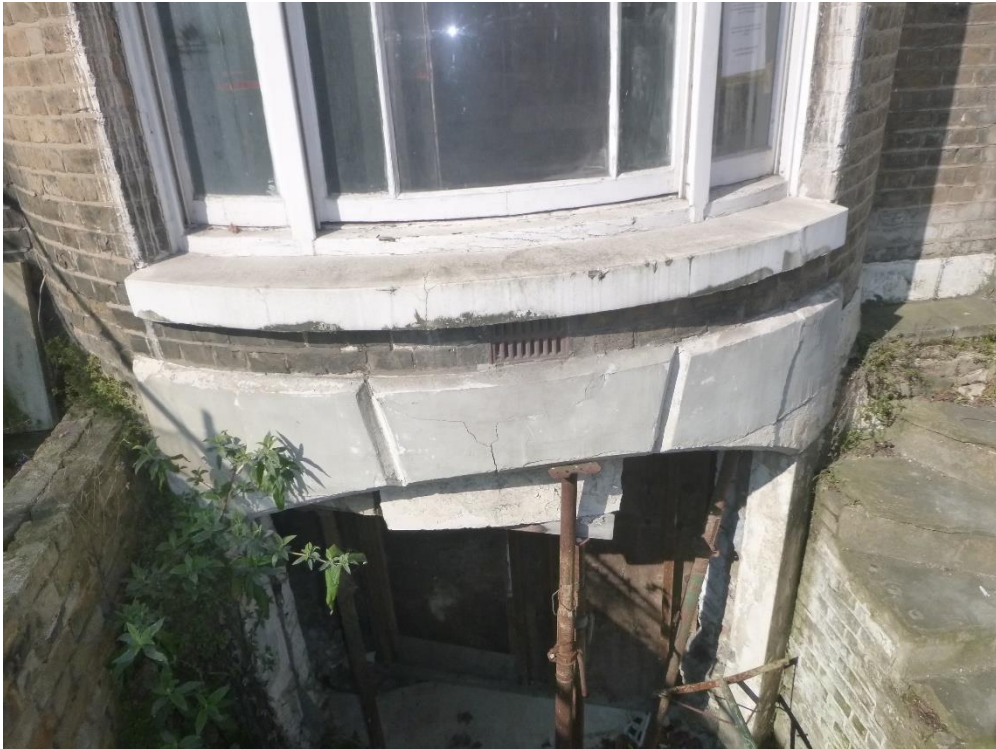
At ground level on the front Bay there is cracking through the stonework over the basement opening. The window below has been removed and there are now temporary props supporting the brick and stonework above.

The cracking to the front Bay at ground floor level appears to be due to failure of the lintel and framework over the basement window. There is no sign of cracking between the Bay brickwork and the main front elevation and there is no evidence of cracking internally, so any major movement or settlement of the Bay foundations is not suspected.

The lintel at ground floor level to the front Bay appears to have failed and the framing to the opening below has now been removed. Temporary support has been provided with the installation of acro props.

Cracking to front bay at ground floor level  
(Frame removed and temporary props under)

A new lintel and support for the feature stonework should be installed at ground floor level on the front bay.

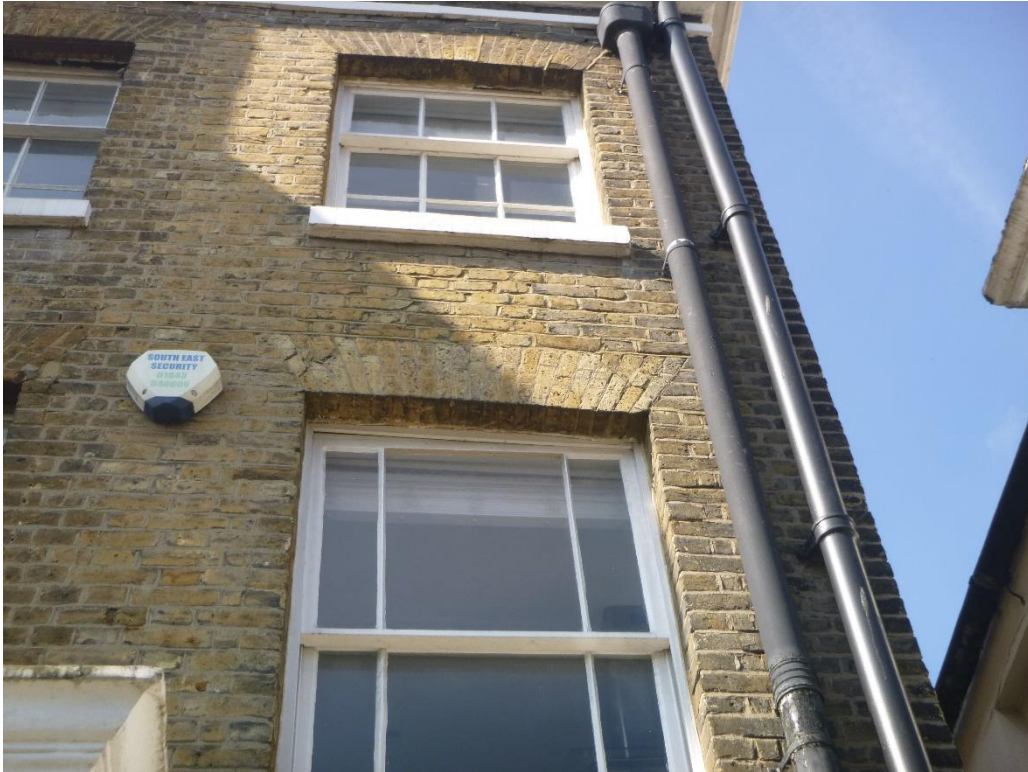
On the right hand side of the elevation there is evidence that the brick lintel over the 1st floor window has slipped and there is cracking to the brickwork above extending up to the cill of the second floor window.

Slipped brick lintel and cracking above on front elevation

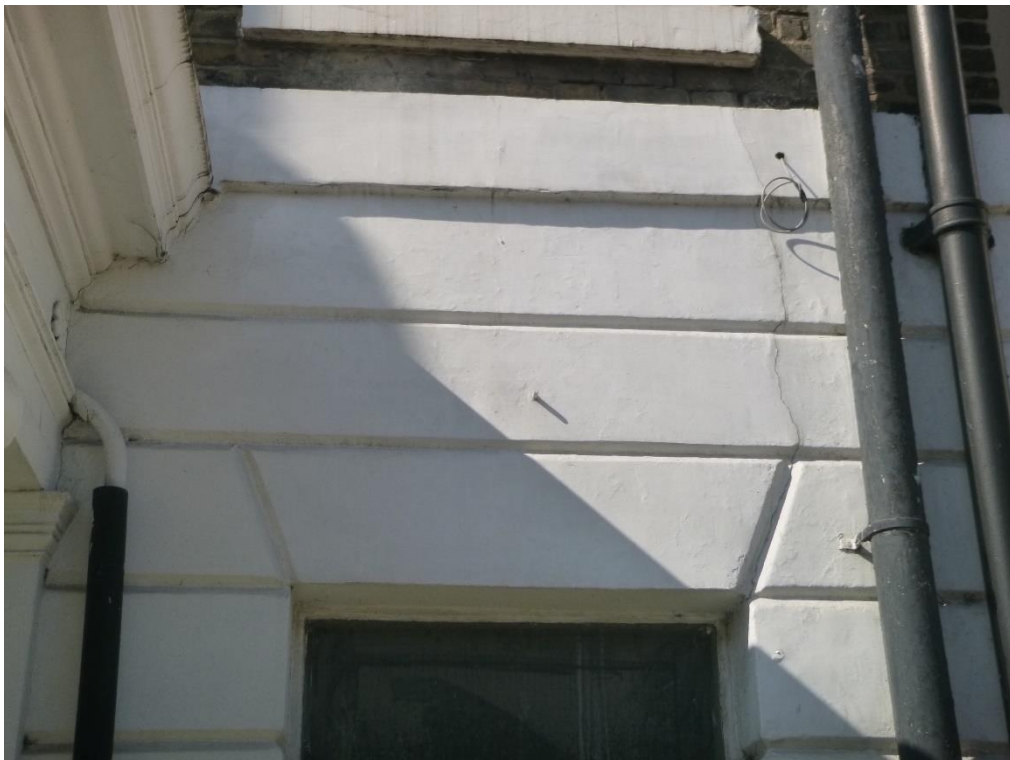
Cracking to stonework at first floor level on right hand side of front elevation

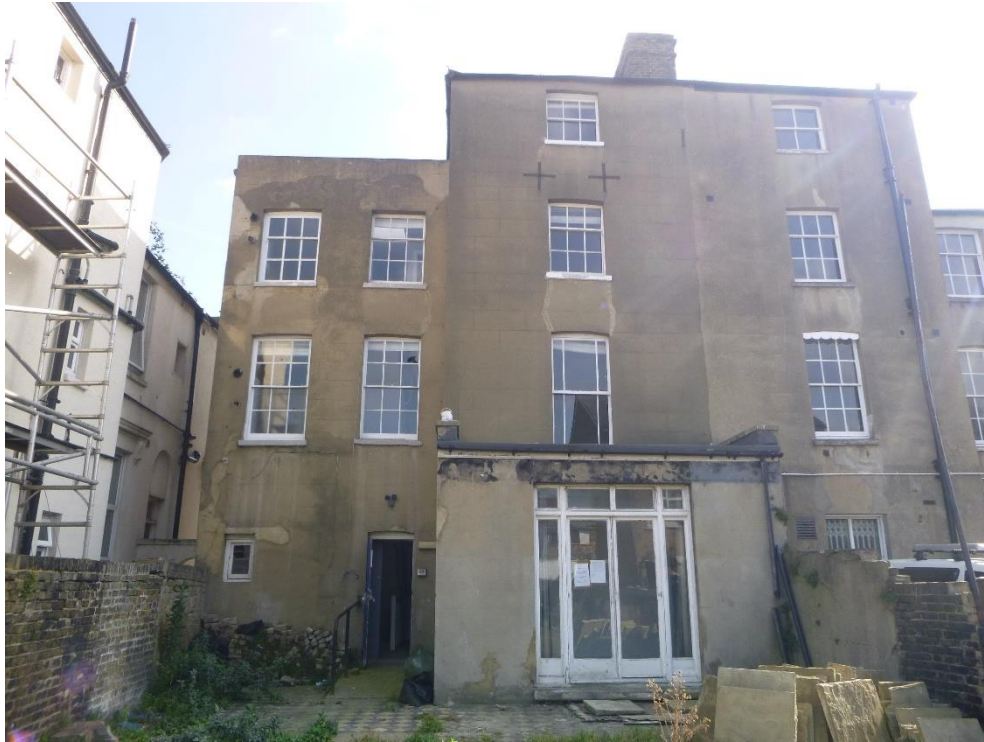
Within the main full story section of the elevation there was evidence of a slight bowing out of the rear wall and at 3rd floor level the metal cross plates forming the anchoring of two ties into the building could be seen. There was vertical cracking in the render extending from the top corners of the 1st floor window up to the cill of the second floor window each side and again the same cracking between the second and third floor windows.

On the rear elevation, the installation of the old steel plate ties at 3rd floor level shows that the bowing in the elevation is historic. The cracking between the windows from first to third floor is most likely due to thermal movement within the brickwork which is occurring at the weak point in the elevation. This movement has probably been exacerbated by the bowing of the wall. The bowing of the wall may be due to lack of tying in of the wall to the floors at each level.

There is evidence of bowing to the rear elevation which may be due to the lack of tying in of the wall at floor levels.

Rear elevation  
(Historic ties at 3<sup>rd</sup> Floor level)

The elevation brickwork should be tied into the floor structure at each of the upper floor levels. This can be achieved with the installation of repair ties inserted through the brickwork and anchored into the floor joists.

Helical bars should also be inserted horizontally into the brickwork on the rear elevation between the windows at first and 2nd floor and again between the windows at second and third floor. Similar bars should be installed between the windows adjacent to the flank wall and returned around the corner to anchor into the flank wall.

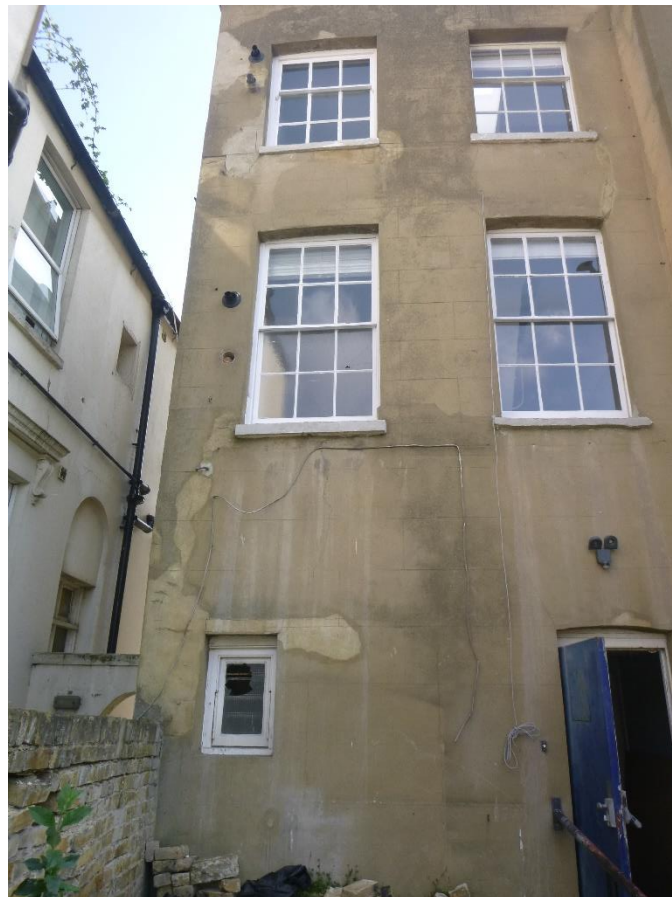
On the three Storey section adjacent to the north flank wall, there was again a similar cracking in the render between the 1st floor and 2nd floor windows. The long term settlement of the flank wall was again evident from the sloping of the sills and window heads on the windows adjacent to the elevation.

The cracking to the render between the windows adjacent to the flank wall is similarly most likely due to thermal movement which has been exacerbated by the historic settlement of the flank wall.

Rear elevation adjacent to flank wall

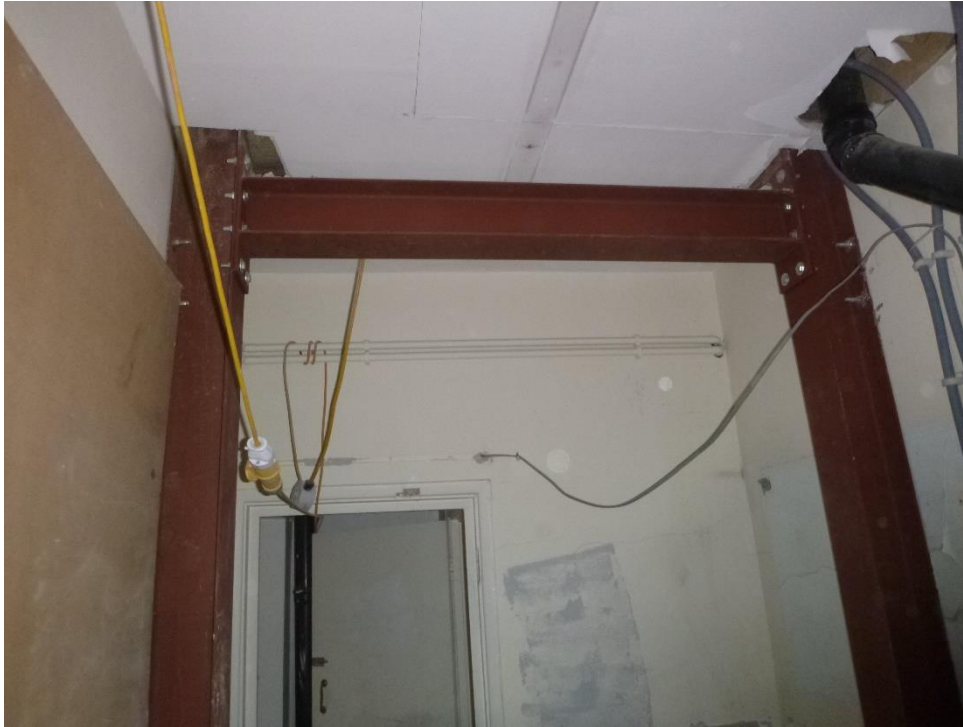
Within the rear room adjacent to the north flank wall, it was noted that a steel frame has been introduced. This frame is a full picture frame with a cross beam just below the 1st floor level and the columns extending up through the floor presumably to the second floor level where it is believed there is an additional cross beam. This upper level of the frame was not visible due to the boxing in and finishes. The frame had bolts connecting into the flank wall just below the 1st floor level.

There is evidence of historic settlement to the north flank wall of the property. This can be seen from the distortion to the window frames at that end on both the front and rear elevations. The steel framing that has been introduced internally adjacent to this elevation may have been installed to provide additional restraint and prevent further outward movement of the elevation. There is no evidence of any current cracking or movement to the flank wall. It was noted that there is the possibility of the drainage running under this section of the building adjacent to the flank wall which may have been a contributing factor to the historic settlement.

Steel frame inserted internally adjacent to flank wall

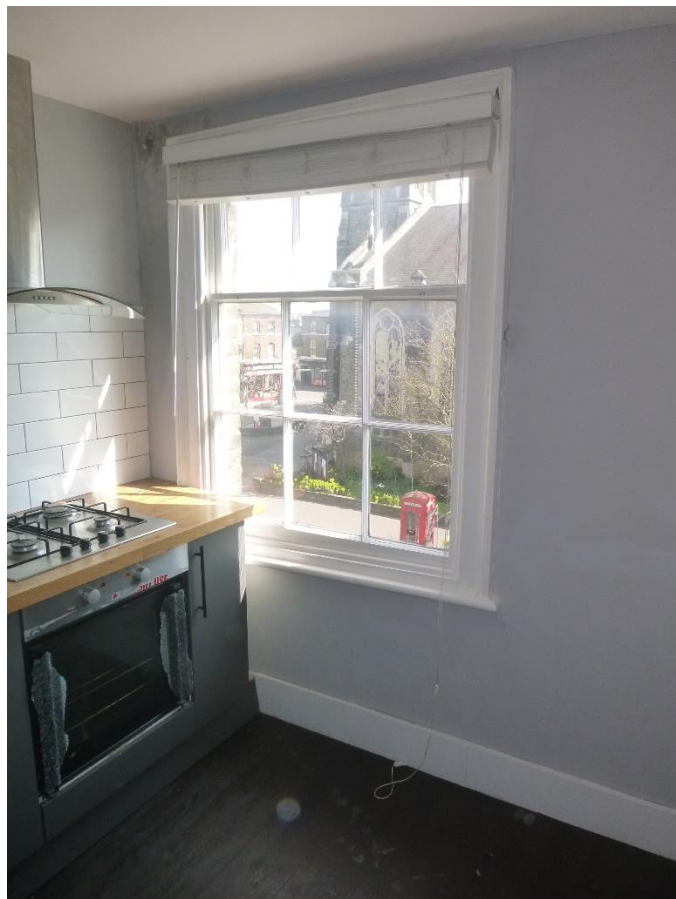
The historic settlement of the flank wall was in evidence from the sloping sill and window head to the window at the front adjacent to the flank wall.

There is evidence of historical settlement to the flank wall on the north side of the building. However, the lack of internal cracking in this area suggests that the movement may no longer be current.

Historic distortion of window cill adjacent to flank wall

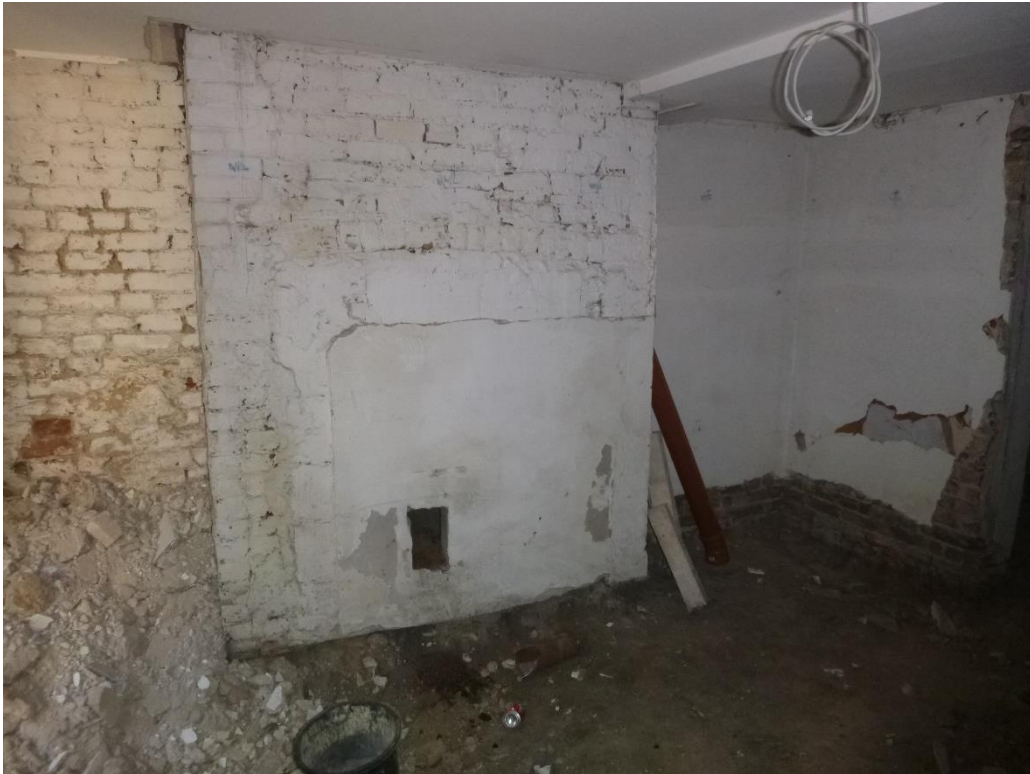
Within the front room with the Bay there has been some shallow excavation at floor level to the chimney on the front wall. This has shown that to the chimney brickwork has little or no foundation below floor level. Similar shallow excavations to the party wall and internal cross walls appear to show the foundation brickwork to the walls extending further down.

Some underpinning of the chimney in the front room on the party wall side may be required due to the shallow depth of the existing footing.

Excavations in basement showing shallow footings to chimney on party wall

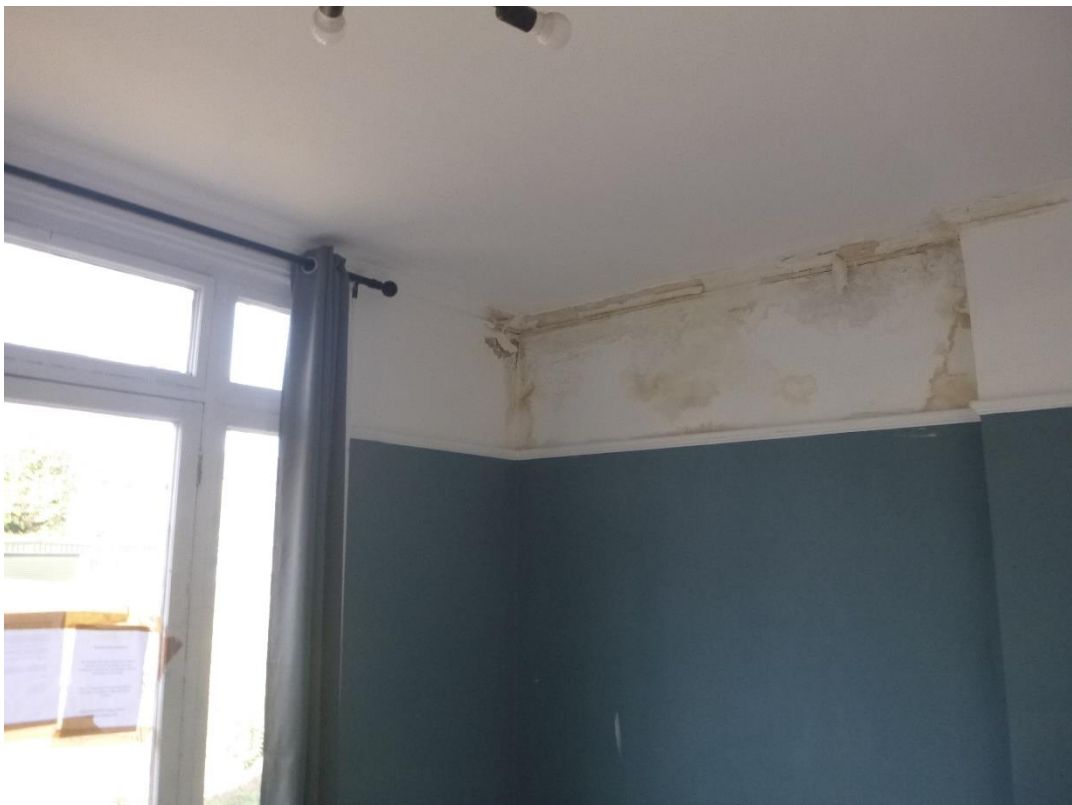
There was evidence of water penetration at high level along the top of the flank wall.

The water ingress noted at high level adjacent to the flank wall is most likely due to failure of the flashing to the flat roof above.

There is evidence of water ingress at high level internally on the flank wall most likely due to the failure of the flashings to the flat roof above.

Damp ingress at top of flank wall
