Our Ref: PM/5291

20<sup>th</sup> March 2023

**RE: NURSTEAD HALL, NURSTEAD LANE, LONGFIELD HILL**

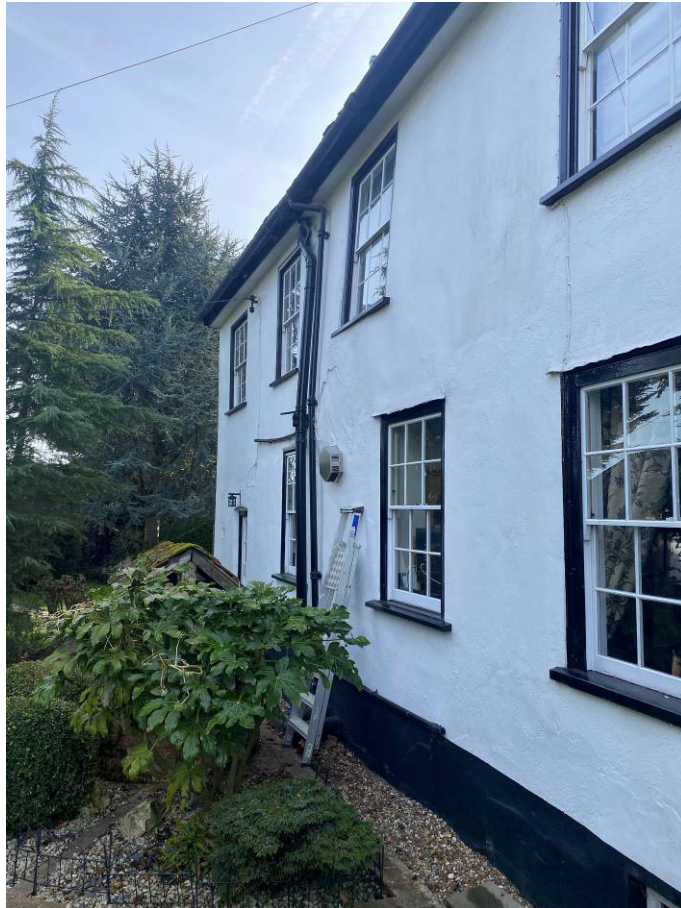
This wall was found to be bowing out significantly adjacent to the kitchen windows at just above first floor level (see plate 1 at the rear of this report). An inspection of the oak frame internally local to this bulge found all timbers to be in reasonable condition, with all joints looking fairly tight and reasonably level. A small inspection hole had been formed externally which revealed that the render has become completely detached from the oak framework behind, leaving a gap of up to 100mm. The lathes were also found to be loose. The small

Plate 1 – Bulge to North Wall

It is therefore clear that the bond between the render and oak frame behind has been completely lost which will require the render finishes to be removed and re-applied. The slight fracture to the soleplate should be reinforced with a 600mm long x 100mm deep x 8mm thick steel strap coach screwed to the outer face of the plate.

Elsewhere around the property, the render was seen to be loose and has become detached from the oak framework behind, so these areas should be investigated further but we feel that it is likely that large areas of render will require replacement.

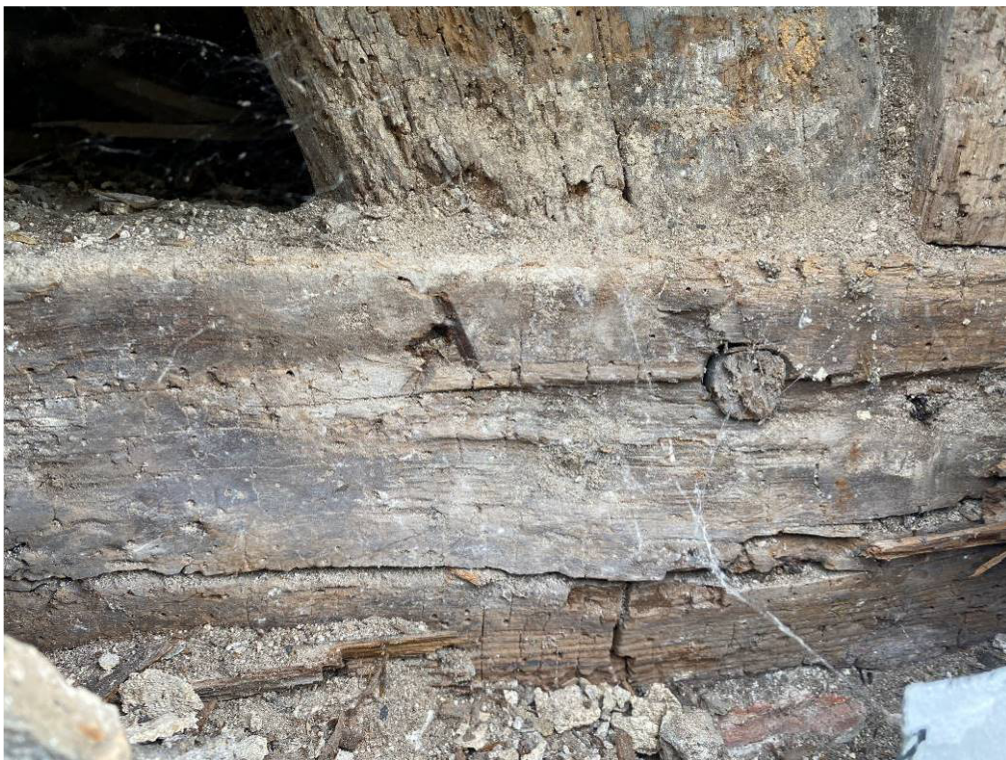
area of studwork that could be seen externally generally looked in reasonable condition, although the first floor soleplate appeared to contain a small fracture (see plate 2).

Plate 2 – Slight Fracture to First Floor Soleplate

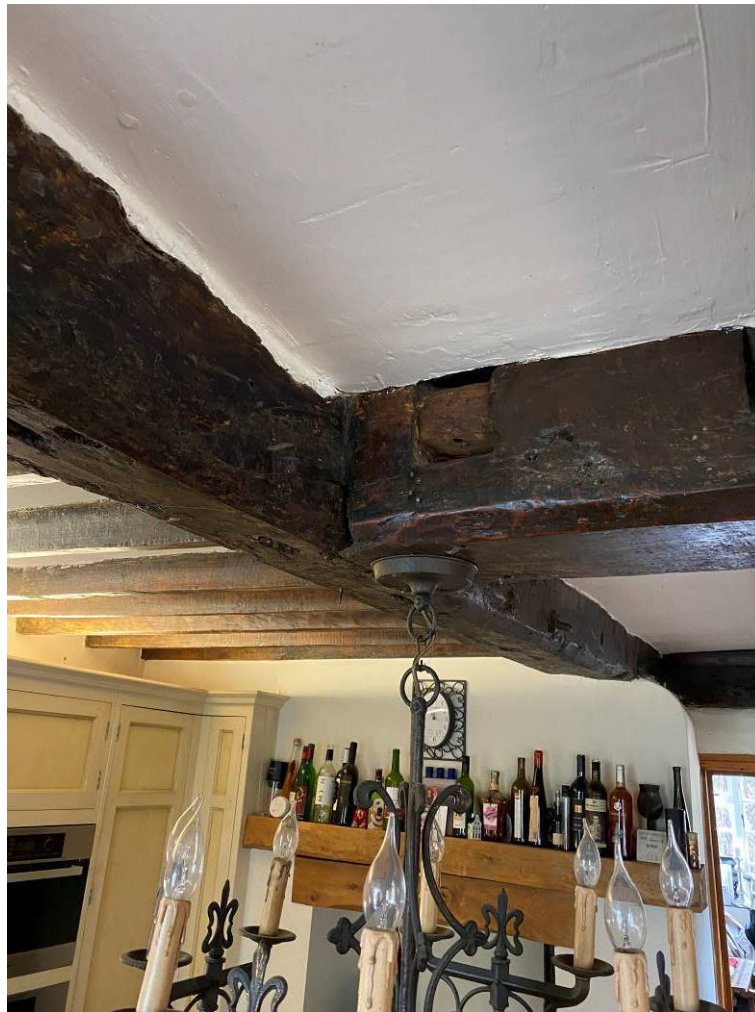
This connection is between a primary and secondary floor beam that has opened slightly (see plate 3). A tenon could be seen entering into the supporting beam and, although there is no evidence to suggest that the tenon is failing, it is also not possible to comment on its condition and adequacy as the vast majority of it can't be seen. We would therefore recommend that the joint is nominally strengthened by installing 100x100x8mm thick x 150mm deep angle cleats to both sides of the supported beam and fixed each leg with 2No.M12 coach screws.

Plate 3 – Slight Opening of Joint Between Kitchen Beams

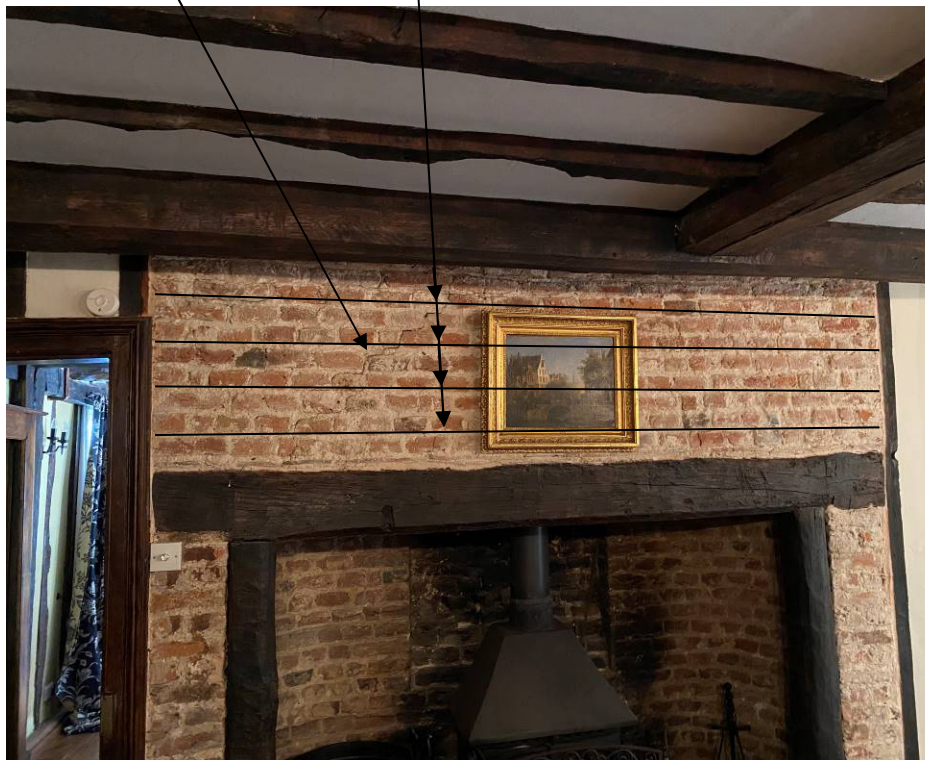
A 200mm deep oak bressummer is present that spans over the open fireplace (see plate 4). As shown in the photo, a diagonal crack has opened up above the bressummer. This is likely to be due to shrinkage of the oak beam, together with deflection caused by the weight of masonry above. The timber beam appeared to be in sound condition although its inside face could not be seen due to a fire guard.

Cracking through masonry

Indicates Proposed 4No. courses of Heli-bar repairs.

Plate 4 – Cracking Above Lounge Fireplace Bressummer

We would therefore recommend that the cracked section of brickwork is strengthened by installing 4No. rows of stainless steel heli-bars at 150mm vertical centres for the entire panel length (see also plate 4) and re-pointed with lime mortar to match the composition of the existing.

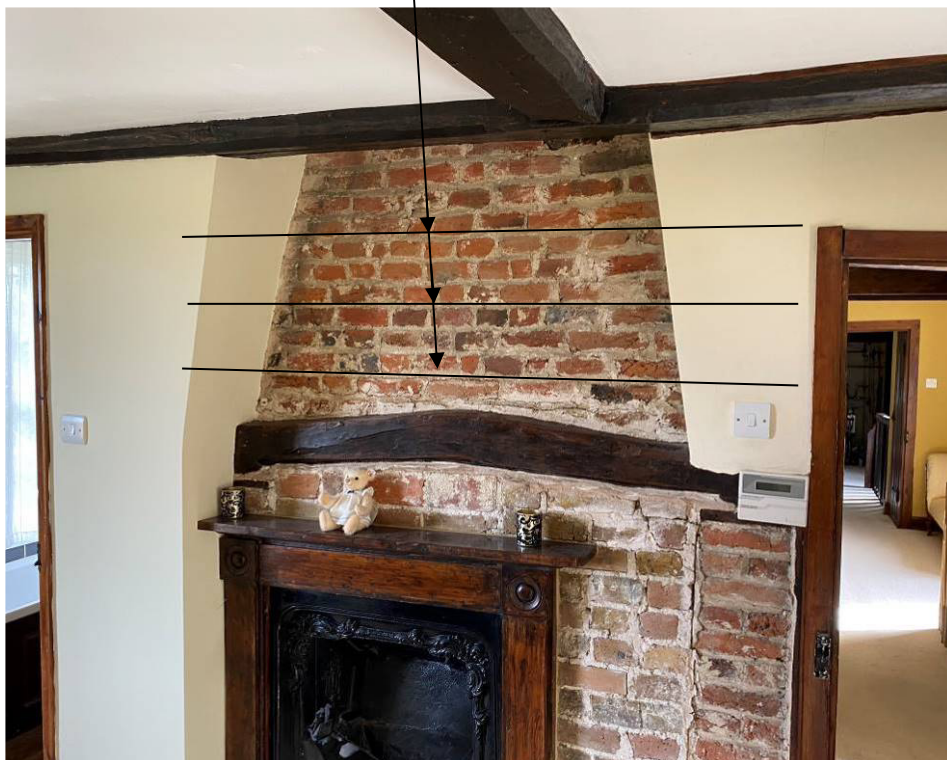
This again contains some cracking above the timber bressummer, although the cracking in this instance is only hairline in nature. We would still recommend that this is strengthened by installing 3No rows of stainless steel heli-bars at 225mm vertical centres for the entire panel length (see plate 5) and re-pointed with lime mortar to match the composition of the existing. The mortar is loose in places to the other faces of this stack so local re-pointing will be required.

A section of brickwork below the bressummer has been previously infilled and this has become very loose and will require re-bedding.

Indicates Proposed 3No. courses of Heli-bar repairs.

Plate 5 – Slight Cracking Above First Floor Fireplace Bressummer and Loose Infill Masonry

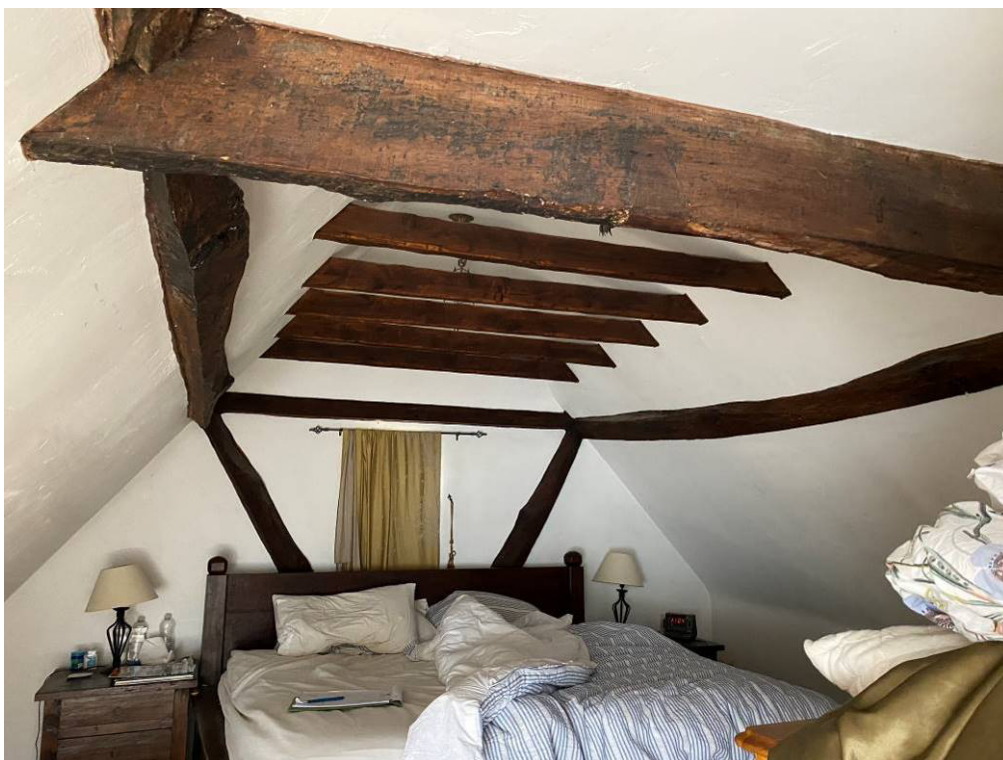
This purlin is located within the second-floor attic room of the property (see plate 6). The purlin spans approximately 3.4metres between the west elevation gable wall and a large collar. The purlin has a fracture along its length (see plate 7).

Plate 6 – Bowed Purlin to Second Floor Loft Room

Although the purlin is over-deflected, collars are present at a slightly higher level (as shown in plate 6) which will relieve the purlin of some weight. Due to the fracture, we would however recommend that a steel plate (8mm thick), profiled to suit the shape of the purlin is added and fixed alongside with coach screws at 400mm centres in order to regain its integrity.

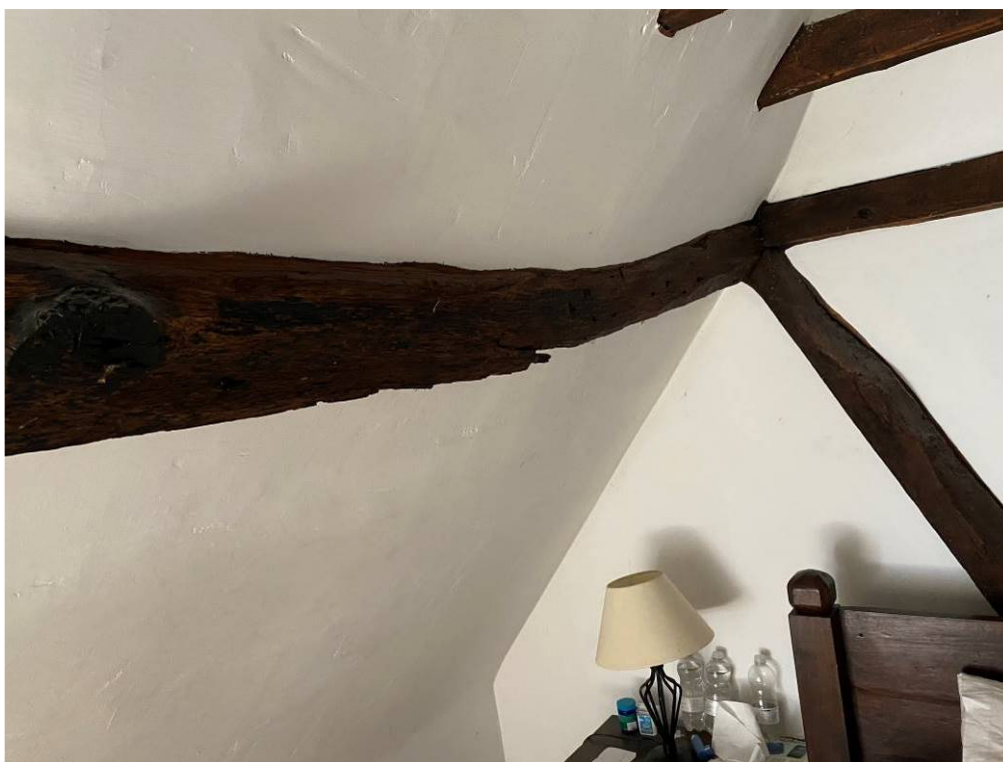
Plate 7 – Fracture to Second Floor Loft Room Purlin

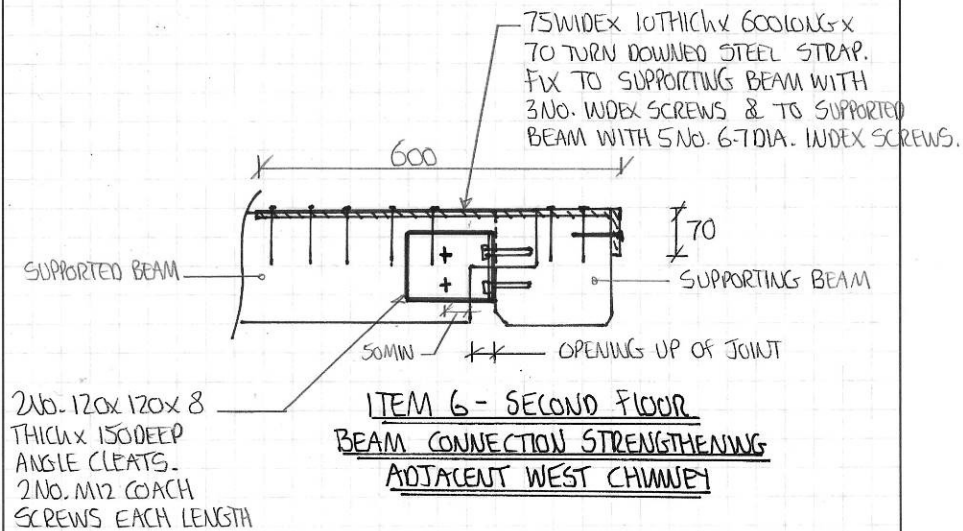
This connection is between a primary and secondary floor beam that has opened up. A tenon could be seen entering into the supporting beam and, although there is no evidence to suggest that the tenon is failing, it is also not possible to comment on its condition and adequacy as the vast majority of it can't be seen. As with the kitchen beam, we would recommend that the joint is nominally strengthened by installing 120x120x8mm thick x 150mm deep angle cleats to both sides of the supported beam and fixed each leg with 2No.M12 coach screws. As this joint has opened up more than the kitchen beam, we would also recommend that a strap is added to the top of both beams which will require the local removal of some floor boards above. Refer to plate 8 at the very rear of this report for sketch detail.

Plate 8 – Sketch Showing Angle Strengthening Detail
