Convent of Mercy Phase 3,  
Hillside Drive,  
Gravesend  
DA12 1NY

Flood Risk Assessment and  
Drainage Strategy Report

C1477 / November 2024

| Document Status | | |
|---|---|---|
| Document Reference: B2240-FRA & Drainage Strategy | | |

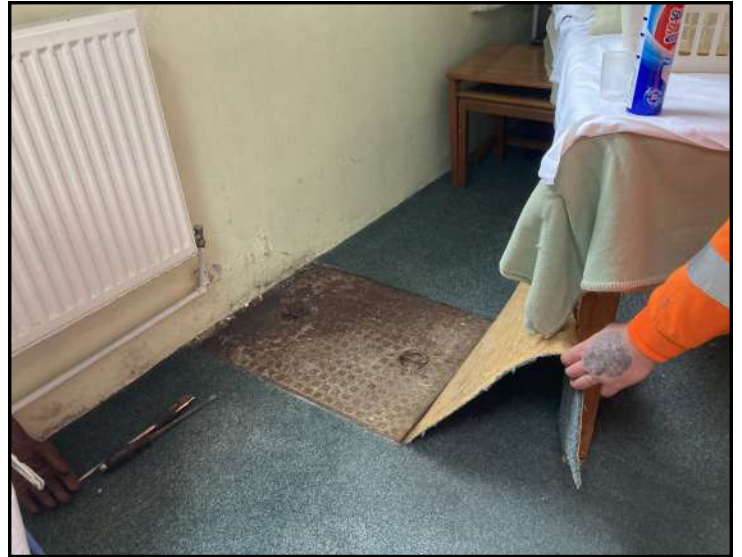
IC7. INTERNAL.  
UNABLE TO LIFT - COVER SEIZED

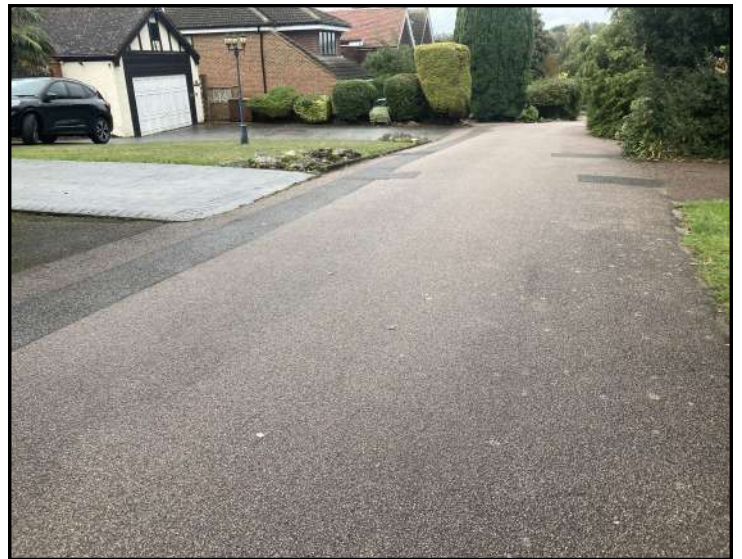
6804. UNABLE TO LIFT -  
BURIED / COVERED OVER

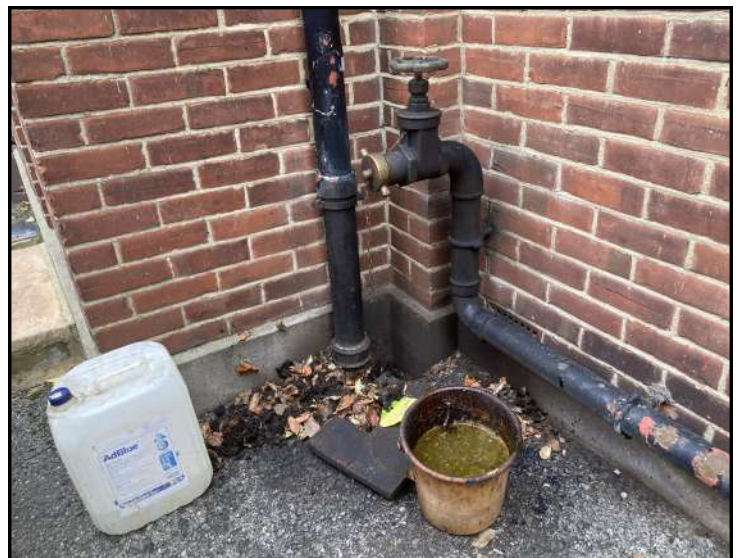
RWP + GULLY 1.  
DEBRIS FILLED

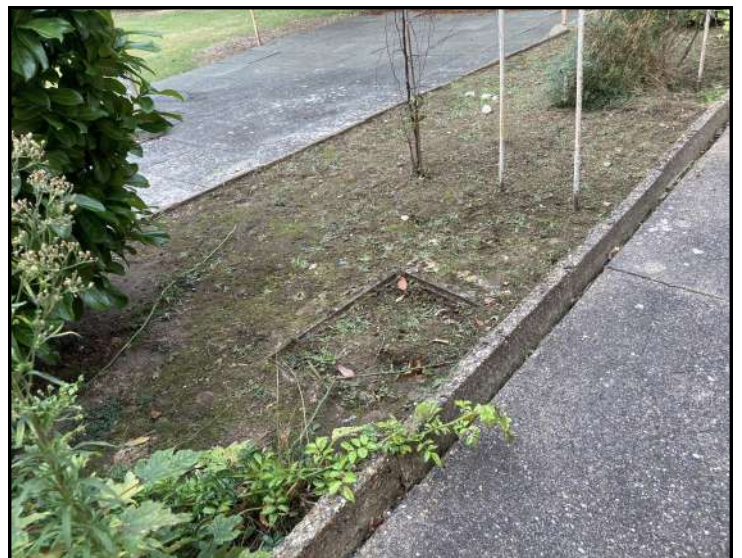
MH1.  
CHAMBER FILLED IN

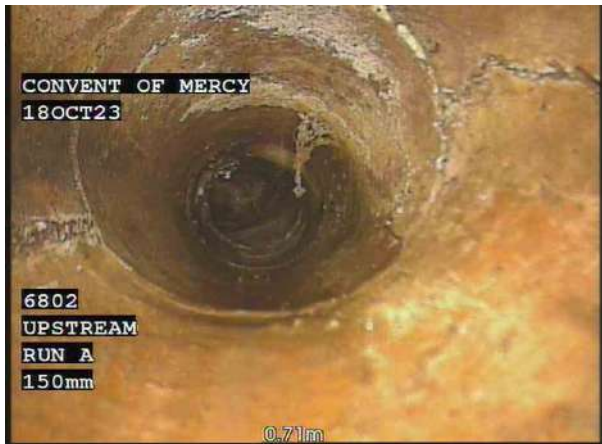
| Item No. | Inspection Direction | PLR | Client's Job Ref | Contractor's Job Ref |
|---|---|---|---|---|
| 1 | Upstream | 6802-AX | TV231025 | |

1, 00:00:16, 0.71 m  
Fracture, longitudinal at joint at 3 o'clock

| Section number | Upstream manhole | Flow direction | Downstream manhole | Recommendations / Notes |
|---|---|---|---|---|
| 1 | 6802-A | Upstream | 6802 | Repair defect(s) by lining |

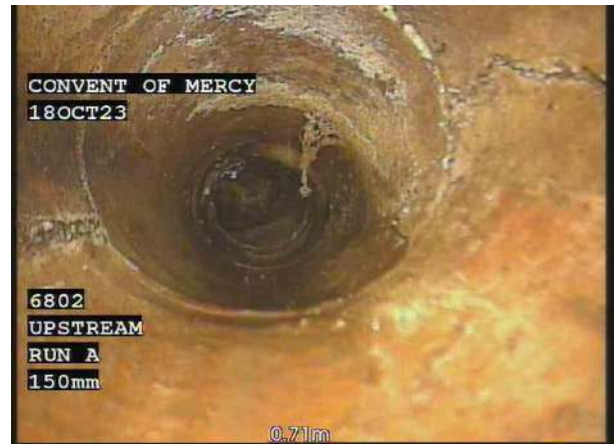
2, 00:00:23, 0.71 m  
Fracture, longitudinal at joint at 8 o'clock

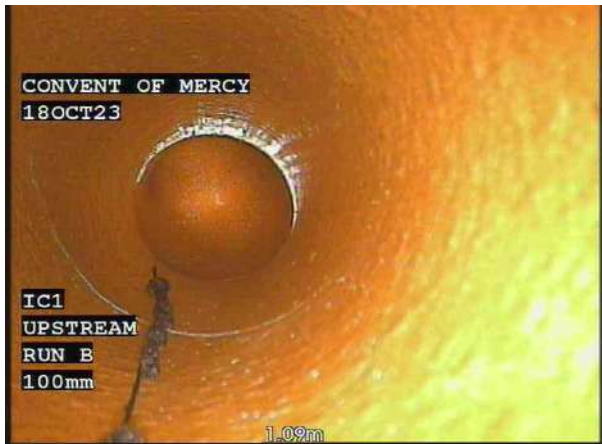
| Item No. | Inspection Direction | PLR | Client's Job Ref | Contractor's Job Ref |
|---|---|---|---|---|
| 8 | Upstream | IC1-BX | TV231025 | |

1, 00:00:17, 1.09 m  
Crack, circumferential from 04 o'clock to 09 o'clock

| Section number | Upstream manhole | Flow direction | Downstream manhole | Recommendations / Notes |
|---|---|---|---|---|
| 8 | IC1-B | Upstream | IC1 | Repair defect(s) by lining |

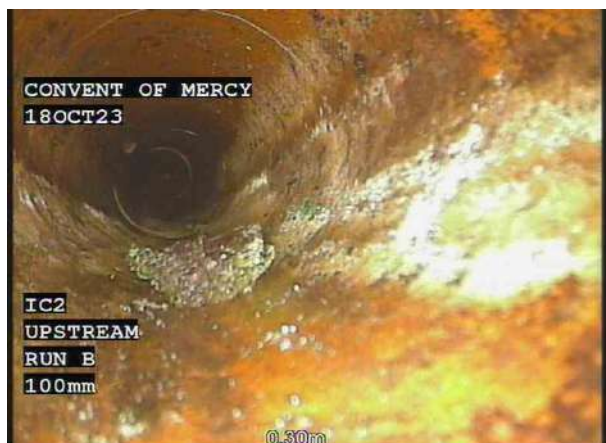
| Item No. | Inspection Direction | PLR | Client's Job Ref | Contractor's Job Ref |
|---|---|---|---|---|
| 12 | Upstream | IC2-BX | TV231025 | |

1, 00:00:08, 0.30 m  
Crack, circumferential from 10 o'clock to 02 o'clock

| Section number | Upstream manhole | Flow direction | Downstream manhole | Recommendations / Notes |
|---|---|---|---|---|
| 12 | IC2-B | Upstream | IC2 | Repair defect(s) by lining |

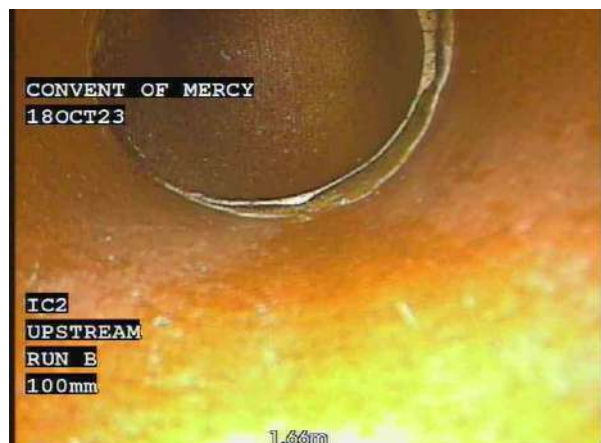
2, 00:00:38, 1.66 m  
Crack, circumferential at joint from 02 o'clock to 07 o'clock

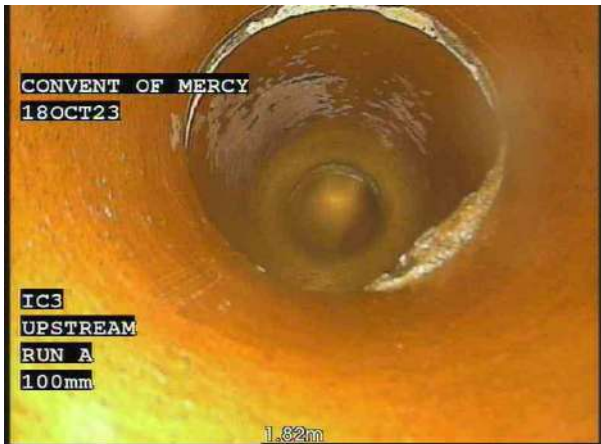
| Item No. | Inspection Direction | PLR | Client's Job Ref | Contractor's Job Ref |
|---|---|---|---|---|
| 16 | Upstream | IC3-AX | TV231025 | |

1, 00:00:20, 1.82 m  
Crack, circumferential at joint from 09 o'clock to 02 o'clock

| Section number | Upstream manhole | Flow direction | Downstream manhole | Recommendations / Notes |
|---|---|---|---|---|
| 16 | IC3-A | Upstream | IC3 | Repair defect(s) by lining |

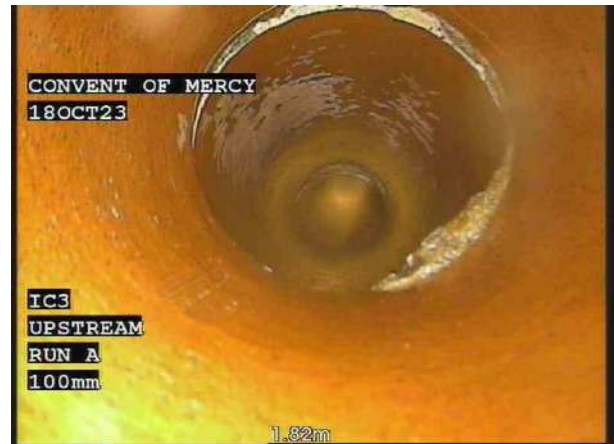
2, 00:00:28, 1.82 m  
Attached deposits, encrustation at joint from 03 o'clock to 06 o'clock, 5% cross-sectional area loss
