**INTERMEDIATE STRUCTURAL  
PLANNING SURVEY**

Rutherford Stables  
r/o Hilary Cottage  
Hermitage Road  
Higham  
Kent  
ME3 7NE

**REPORT NUMBER** FC2015/209

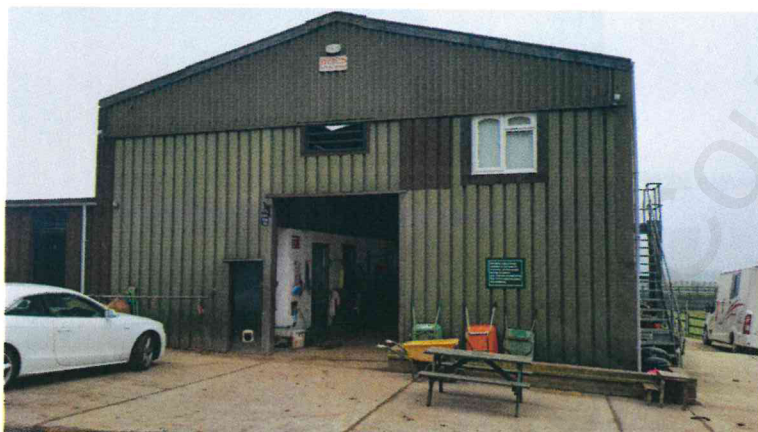
1. Front elevation.

The premises are generally as previously described, being a steel portal frame agricultural style shed, used as a stabling building with ancillary services and tack rooms and mezzanine accommodation. The building is clad with fibre cement sheet over the roof and single skin metal profile sheet to external walls on a masonry sub-structure. The building is approximately 25.5 metres long x 15.6 metres wide being approximately 7.2 metres to ridge and 5.5 metres to eaves. Fig.1.

External examination indicates the building to be of good line and level, showing no deviation in horizontal or vertical alignment to suggest any neither recent nor past settlement or subsidence effects.

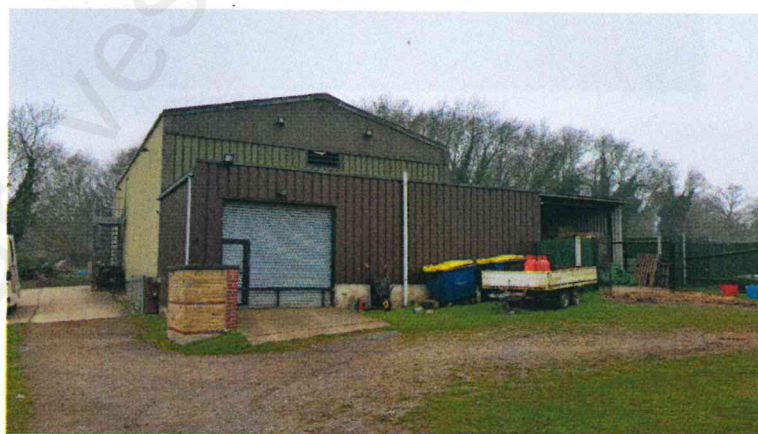
3. Rear elevation.

The property has a number of timber personnel doors and hand operated roller shutter door serving the main stabling area. The rear extension is partially open and also fitted with galvanised roller shutter door all in good order. Fig 3 The PVC rainwater goods are generally found to be in satisfactory condition and windows are serviceable.

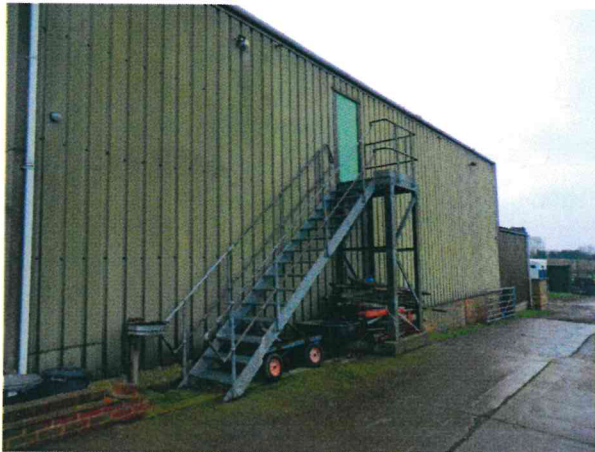
4. Right elevation and access stair

The structure has a number of windows at high level with numerous personnel and large access doors with galvanised steel fire escape serving the mezzanine level off the right-hand elevation. Fig.4.

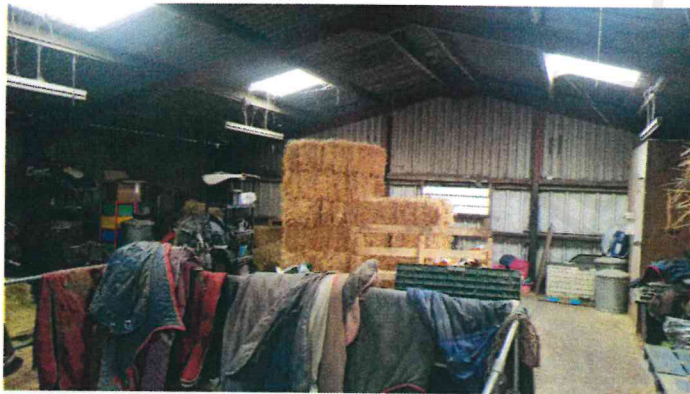
5. Internal above mezzanine level.

The addition of the mezzanine accommodation was made at or around 2006 and provides self-contained facilities, all internally plastered and decorated and generally found to be in good condition. Ground floor welfare facilities are all functional and in also in satisfactory condition.

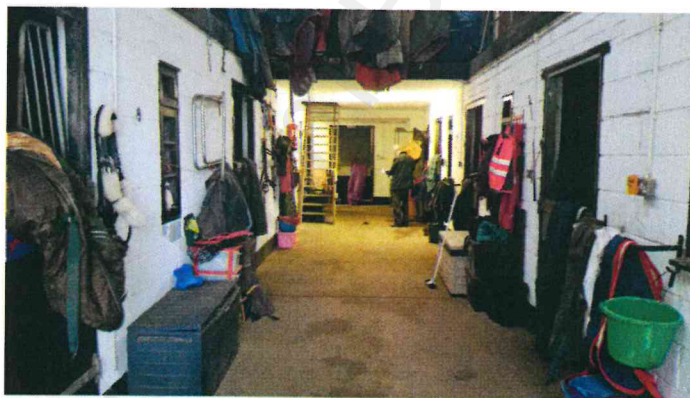
6. Internal at ground floor stable block level.

Internal walls generally comprise 140mm dense concrete blockwork which were found to be of good line and level and these support the mezzanine timber deck which was found to be structurally adequate. The unit has an in situ concrete floor slab which again is of acceptable line and level and appears structurally sound. Fig.6. The floor steps in alignment between the side offshot and main stabling area.

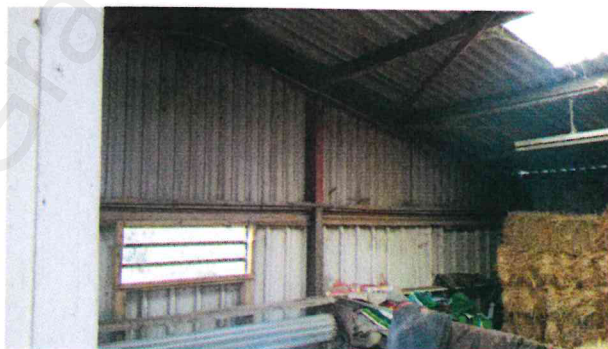
7. Typical steel frame.

Internal examination confirms a series of steel portal frames at approximately 3.6 metre centres comprising 254mm x 146mm UB columns with 178mm x 102mm UB rafter sections in turn carrying five timber purlins per roof slope and frame braced by 76mm diameter steel tubing within the end bay. The roof accommodates eight translucent roof lights. Fig.7.

Examination of the structural steelwork shows no evidence of significant corrosion to cause loss of metal or weakness within the frame with some areas displaying minor surface corrosion in need of simple mechanical cleaning and localised repainting.
