ITEMS FROM STRUCTURAL ENGINEER'S REPORT - pma5291-letter report 01.

PLANNING DRAWINGS

| DESCRIPTION | |
|---|---|
| SECOND FLOOR PLAN AS PROPOSED | |
| LOCATION<br>NURSTEAD HALL | DRG No.<br>PP-18Q-05 |

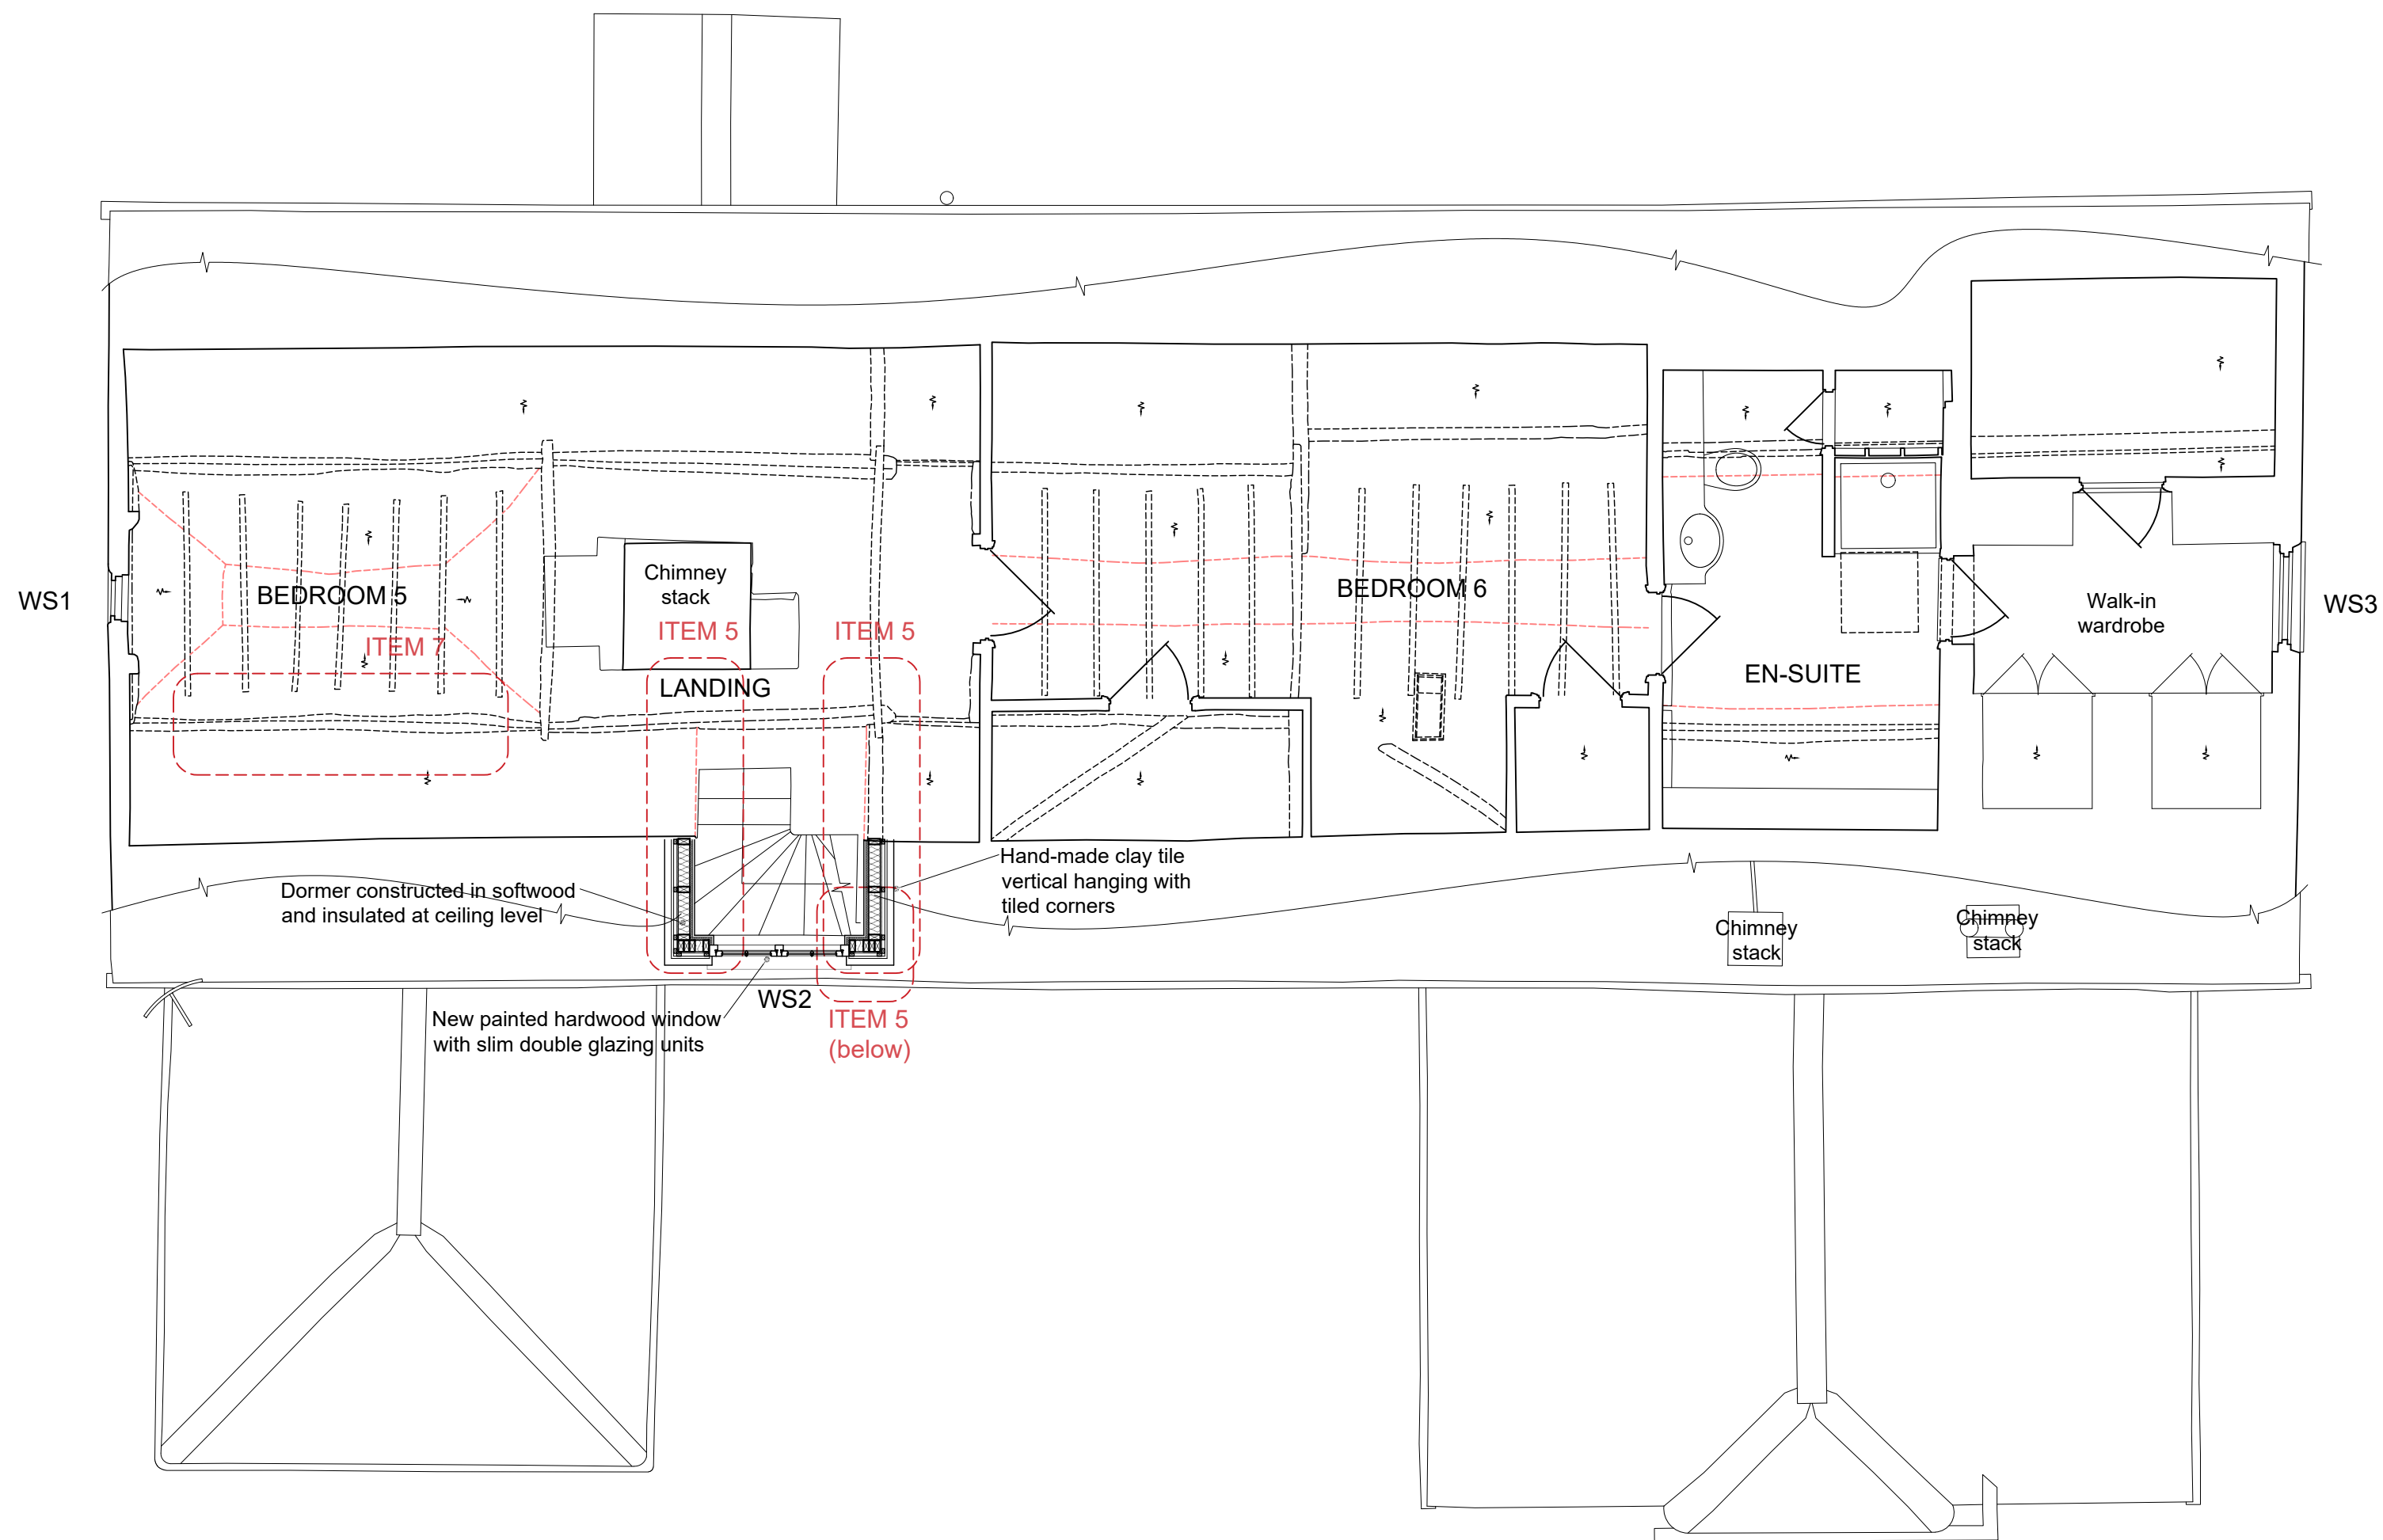
SECOND FLOOR PLAN OF PROPOSED REPAIR / REINFORCEMENT AND  
PROPOSED REPLACEMENT DORMER  
SCALE 1:50

**Item 5 – Possible Replacement Roof Dormer to South Elevation**  
We understand that it is proposed to construct a replacement dormer. The dormer is currently supported on the eaves wall plate, which contains a joint immediately below. As before, it is difficult to comment on the condition of the joint as the majority is concealed, so we would recommend that a small panel of the modern plasterboard below the beam is removed to ensure that the beam is adequate supported by the studwork frame below. Once the roof finishes are removed, the trimming rafters beneath the dormer cheeks should be checked for adequacy.

**Item 7 – Over deflected Roof Purlin with fracture to West End of Building**  
This purlin is located within the second-floor attic room of the property. The purlin spans approximately 3.4metres between the west elevation gable wall and a large collar. The purlin has a fracture along its length. Although the purlin is over-deflected, collars are present at a slightly higher level which will relieve the purlin of some weight. Due to the fracture, we would however recommend that a steel plate (8mm thick), profiled to suit the shape of the purlin is added and fixed alongside with coach screws at 400mm centres in order to regain its integrity.

Whilst walking around the property, it was also noted that the top of the west elevation gable wall projects out from the verge, which is enabling water to penetrate behind the render. This area will need further investigation when an access scaffold is installed and is likely to require some sections of render to be removed to check the condition of the oak framework behind. The verge detail will however need to be modified in any event to ensure the roof line projects behind the face of the wall in order to protect the top of the wall from water ingress.

**WS 1**  
Replace existing window like-for-like in hardwood painted.

**WS 3 - Pivot Casement Window**  
Complete some minor filling and repair putty.  
Prepare the surfaces of the existing window removing loose paint only and lightly sand to provide a key.  
Re-paint the window internally and externally with Superdec paint or similar breathable paint.

**Replacement dormer construction and WS2**  
Replacement dormer to be constructed from treated softwood. The roof will be pitched to match the house with a hipped end and finished in hand-made tiles to match the house. The roof is proposed to be insulated at ceiling level and the walls insulated between studs and over the inside of the studs. Both the ceiling and walls will be plaster-boarded and skimmed with gypsum plaster internally. The dormer cheeks and dormer front are proposed to be vertically tile-hung in hand-made clay tiles with clay corner tiles.  
WS2 is proposed to be constructed in hardwood with slim double-glazing units between glazing bars, painted internally and externally with Superdec paint or similar breathable paint.
