**CUSTOM HOUSE, THE TERRACE, GRAVESEND, DA12 2BW**

**BRICK WALL AND TIMBER GATES REPAIR WORK TO FRONT OF CUSTOM HOUSE**

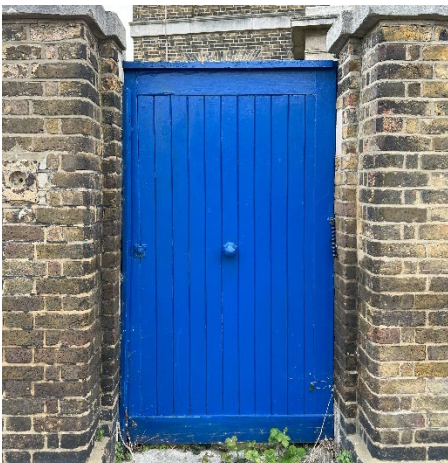
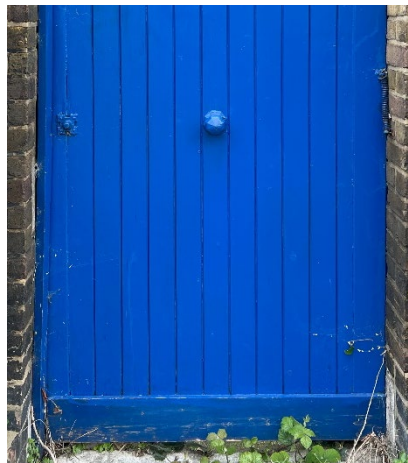
The single timber gate which will form the private access to unit 5 appears in reasonable condition with only minor repair works visible to the posts and bottom section of the gate.

*Single timber gate.*

Initial repair works will start by cleaning of the wooden gate to remove any buildup of dirt. While cleaning, the gate will be inspected for any further signs of damage such as cracks, decay and hinge suitability.

Following the cleaning and inspection process, a sequence of remedial works will take place, listed below;

- Gate to be sanded down, smoothing any rough surfaces and working this into any areas of chipped paintwork.
- Protective wood coating to be applied to timber gate to prolong lifespan and reduce risk of rot.
- Timber gate to be painted in blue colour to match existing.
- All existing ironmongery to be checked and remedial works to take place where required to provide a secure and functioning access gate.
- Existing access / lock system to be removed as broken, and to be replaced with new metal latch and lock system to provide security to private access.

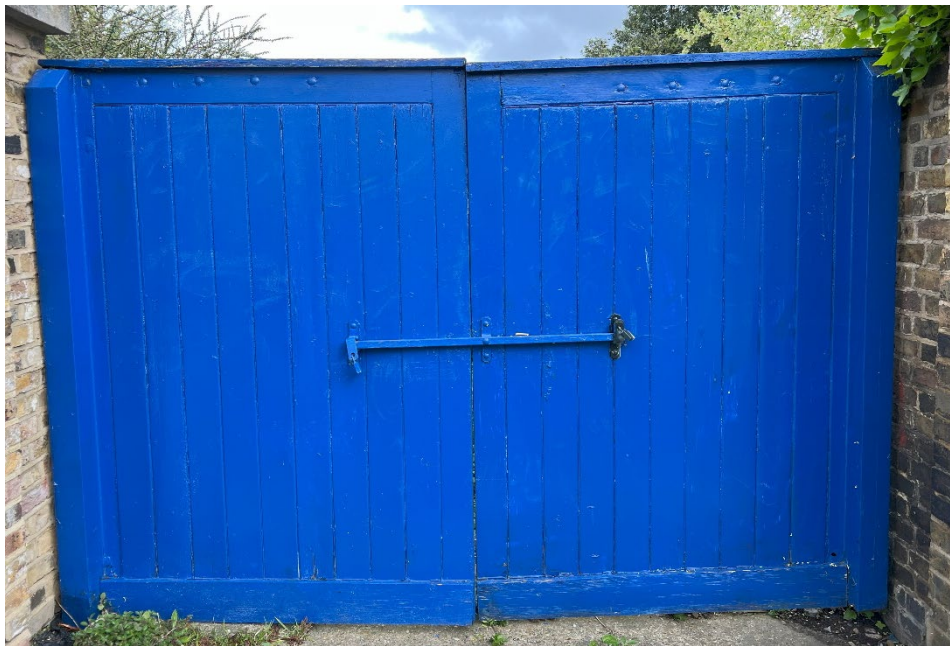
The double gate which will provide the private access to unit 4 has more visible wear and tear to the paintwork than the single gate. One side of the gate is also visibly lower than the other. The double gates have an external bar with padlocks to keep the gates together and fixed shut. The main frame posts appear in good condition and require minimal remedial works.

*External view of double timber gates fronting The Terrace.*

Initial repair works will start by cleaning of the wooden gates to remove any buildup of dirt. While cleaning, the gates will be inspected for any further signs of damage such as cracks, decay and hinge suitability.

Following the cleaning and inspection process, a sequence of remedial works will take place, listed below;

- Gates to be sanded down, smoothing any rough surfaces and working this into any area of chipped paintwork.
- Protective wood coating is to be applied to timber gates to prolong lifespan and reduce the risk of rotting.
- Existing metal bar to be removed, areas of fixings to be made good.
- Timber gates to be painted in blue colour to match existing.
- All existing ironmongery to be checked and remedial works to take place where required to provide a secure and functioning access gate.
- Gates to be rehung / hinge altered to align the two gates and make them level.
- New metal latch and lock system to be installed, creating a secure and usable private access into unit 4.

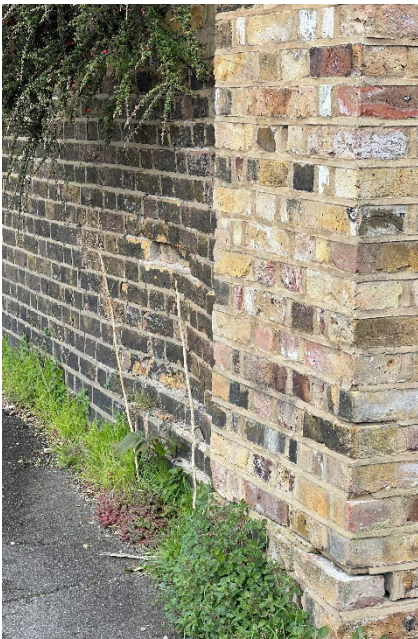
As can be seen from images of the brick wall to the front of Custom House there appears to have been some repair works undertaken previously as one of the brick piers and some of the wall adjacent appear to be lighter than that of the original brickwork, which is more weathered.

The original areas of wall, although heavily weathered appears to be in better condition than the repair work that has been done previously. Some areas of brickwork are damaged, and the mortar has eroded.

*Damaged existing brick wall.  
Visible cracking to newer brick pier.*

- Clear vegetation around wall.
- Inspect full extent of damage to wall following vegetation clearance. In areas where significant cracking and settlement issues appear, instruct a structural engineer to undertake a detailed survey pertaining to the structural stability of the wall prior to any further remedial works.

- Providing it has been established that the wall is structurally sound and any movement has stopped the cracked/detached areas will need tying together with horizontal support.

- Any cracked or broken brickwork to be cut out and replaced with matching brickwork bedded in lime mortar to match existing.
- Brickwork to be repointed in matching mortar.

- Areas of old mortar that requires repointing to have old mortar joints raked out. After removal of existing mortar, joints to be thoroughly cleaned and wetted immediately before filling. Mortar joint finish to be as per existing appearance of wall.

- All work and making good of wall to be finished to match the existing original wall in respect of material, colour, texture, profile, including existing bond and pointing.

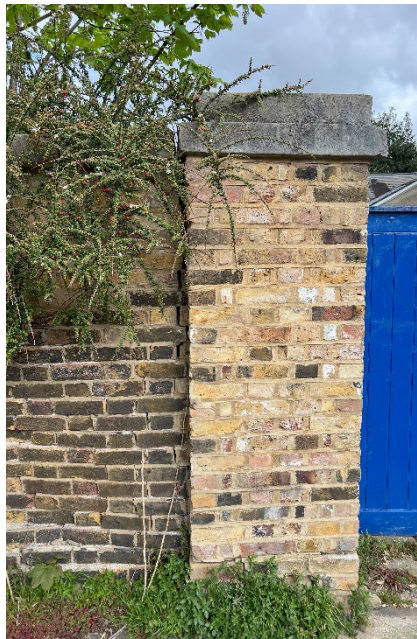
*Visibly dented and damage wall.  
Cracks and missing brick in places.*

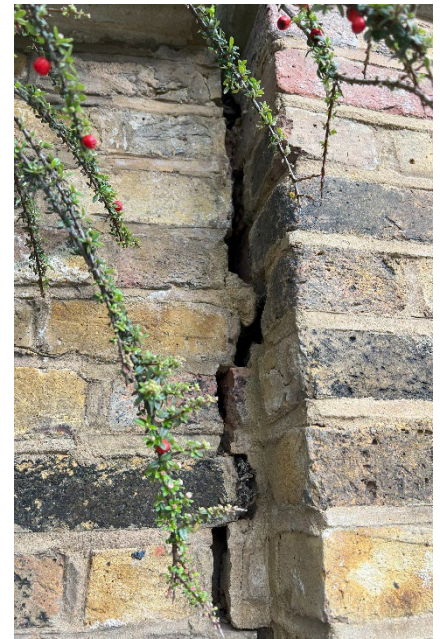
*Large cracks between wall and pier.*

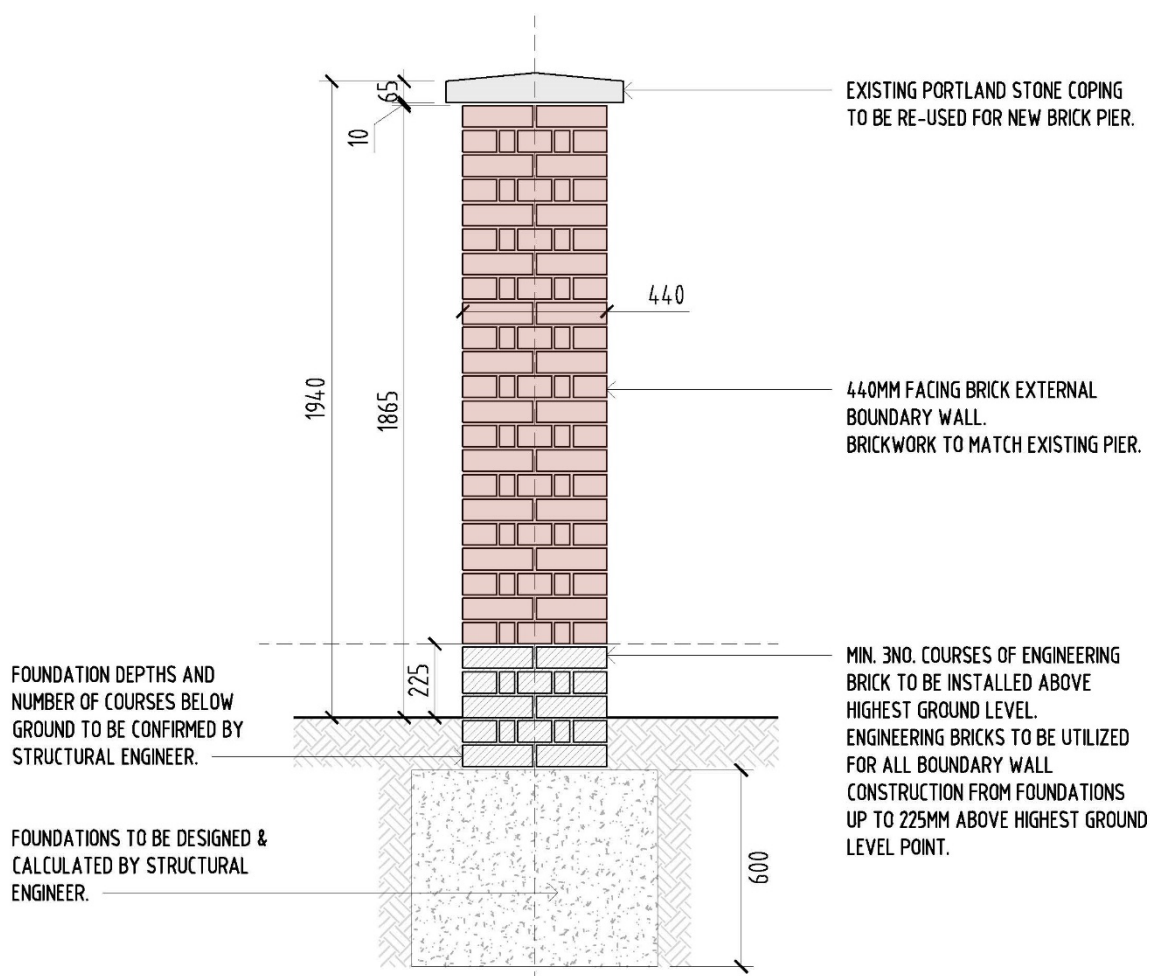
Detail of new brick pier shown below:

A new brick pier is being formed at the entrance to the site from the road. An existing pier and small section of wall is to be demolished in this area to widen the entrance opening. The new pier will abut an external wall and pier junction.

The existing brick pier and wall section being demolished are to be carefully taken down, sorting and stacking the undamaged bricks to be re-used to repair the existing areas of wall that need repairing or to form the new brick pier. The existing Portland stone coping will be removed, cleaned and reused for the new brick pier.
