## **CUSTOM HOUSE, THE TERRACE, GRAVESEND, DA12 2BW**

### **LEAD WORKS**

This statement formally sets out the methodology of the repair works required to the existing lead flashing and guttering across the Custom House site.

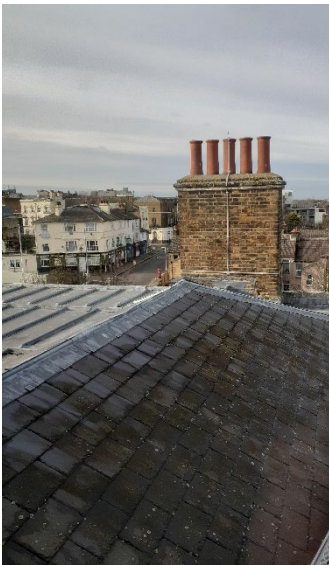
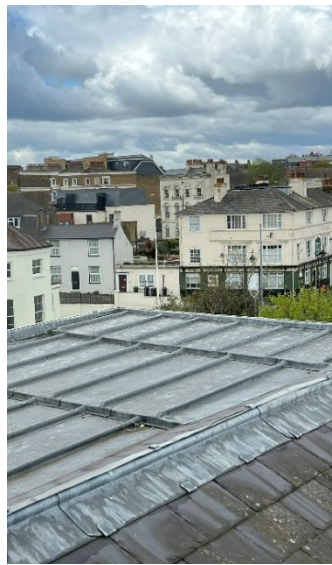
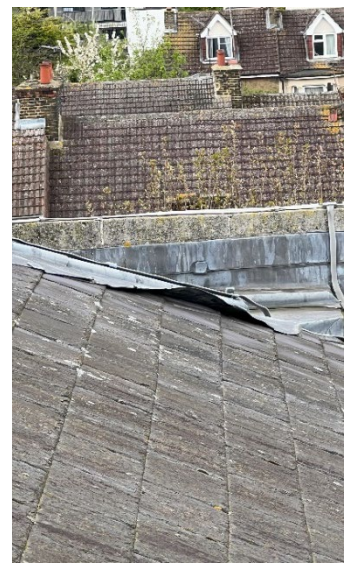
The existing lead flashing and guttering to the main house is generally in a good condition, there is no visible areas of leakage that has been found. The minimal repair works will only be required in concentrated areas where noticeable lifting has taken place. This will be a simple fixing down and lapping process to tie in with the surrounding lead detailing.

*Leadwork to hips, ridges, gutters and flat sections of main roof. Concentrated areas of leadwork have lifted and require being fixed back down.*

The contractor will undertake a condition survey of all existing lead works across the main house, including general cleaning / clearing of debris build up. This will reinforce the general good condition and provide clarity of any minor remedial works required to specific areas.

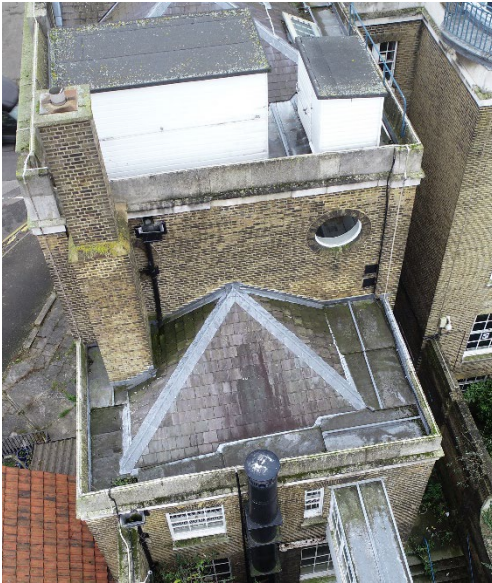
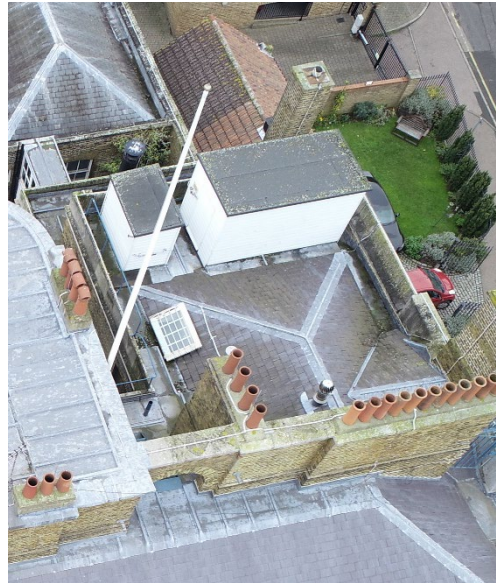
Most of the main house roof is being left as existing, with minimal changes or requirement of remedial works due to the general good condition, however a small section of the roof is having some of the old plant removed. In these areas, the condition of the roof will need to be established once the plant is removed, to understand the build-up and whether any remedial works are required.

In areas of flat roof where it has a lead sheet covering, any plant removed from these areas will require making good to achieve a matching appearance to the other areas of the roof. Until removal of the plant has taken place it is unknown whether this has been fixed over existing lead sheet coverings or removed.

*The images highlight areas of plant (white sheds) and a chimney stack being removed. Making good of all leadwork around these areas required.*

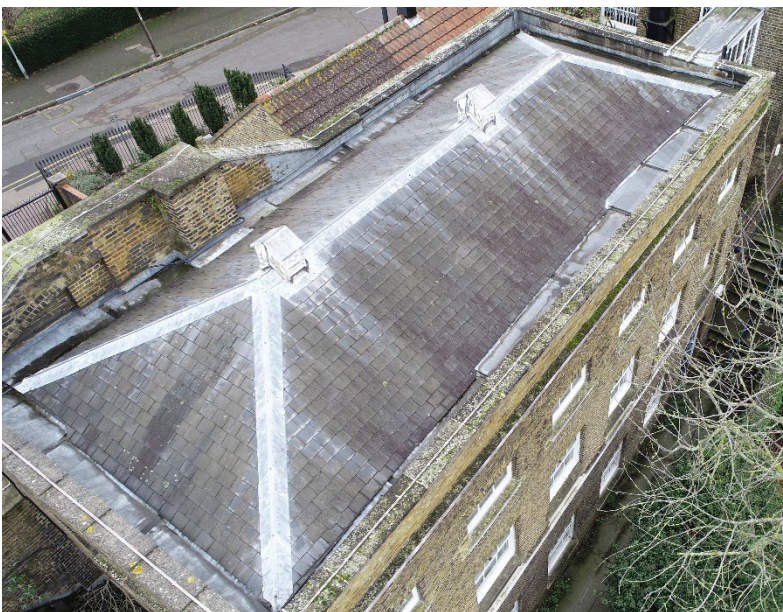
Only two of the outbuilding roofs are being kept, with the middle section of outbuildings having extensions and new roof material added, therefore the leadwork is limited to the outbuilding nearest the main house and the outbuilding closest to the flood defence wall. Both of these roofs and leadwork are in good condition and will be maintained as such.

*Outbuilding nearest the main house roof.*

The approach to the outbuilding lead flashing and guttering are similar to the main house. The leadwork is generally in a good condition, no areas of failure are visible from initial inspection. A roof inspection, including cleaning and clearance of debris will be undertaken to establish the full amount of remedial works required.

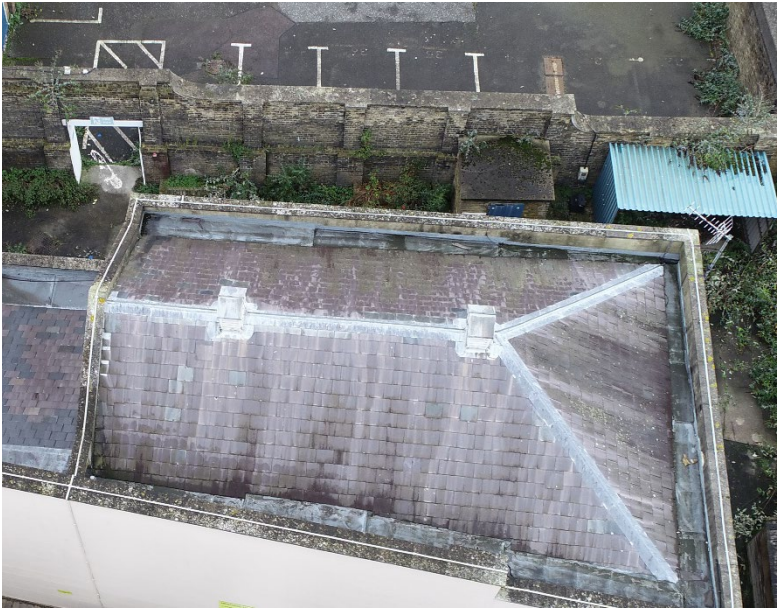
*Outbuilding nearest the flood defence wall roof.*

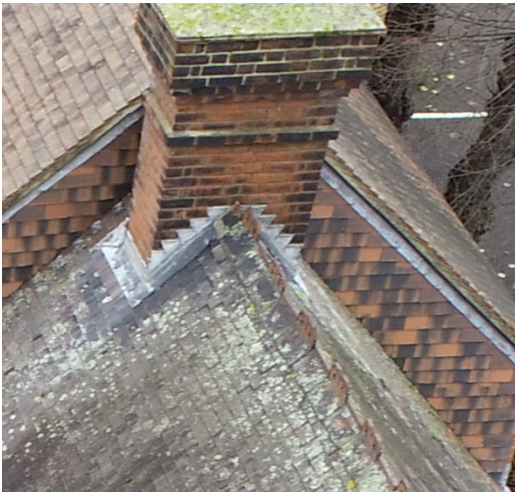
The boathouse has a lead flashing to the chimney and roof section, which will remain and be locally repaired where required, however appears in good condition and no visible defects.

*Lead flashing to chimney junction.*

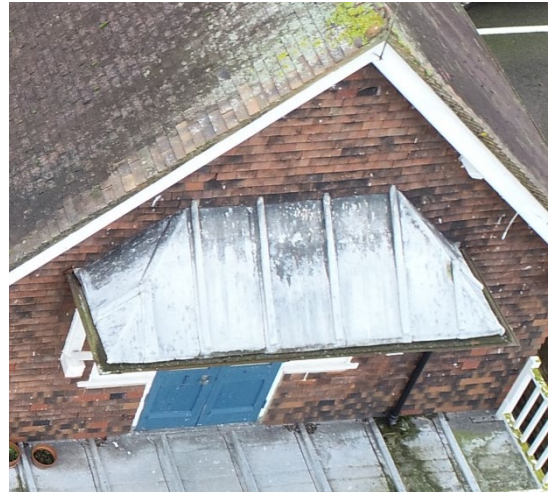
*Lead roof over balcony.*

A small lead roof sits above the first-floor balcony. This is to remain, to be cleaned and inspected for any defects. Repair works will be undertaken as necessary to the leadwork, keeping the appearance as existing.

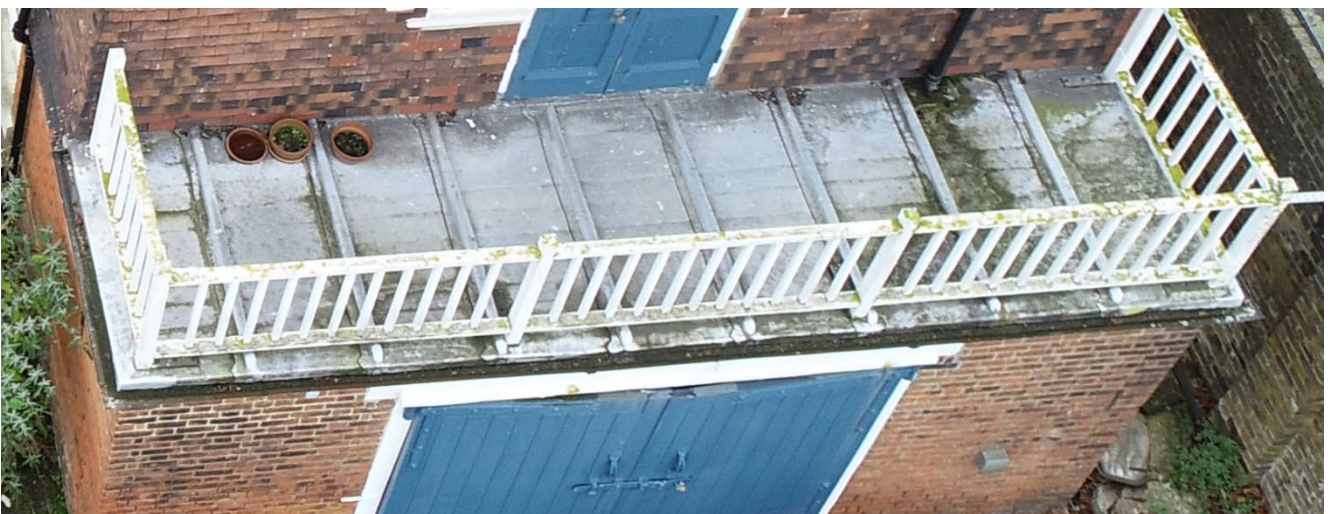
The leadwork to the balcony floor is to be removed. The current structure and finish are not suitable for a working balcony. A new detail has been provided to improve the structure and finish, making the balcony space usable. A lead capping is proposed to the balcony parapet.

*Lead floor finish to balcony.*
