**CUSTOM HOUSE, THE TERRACE, GRAVESEND, DA12 2BW**  
**RAILING REPAIR WORKS**

This statement formally sets out the methodology of the repair works required to the railings across the Custom House site.

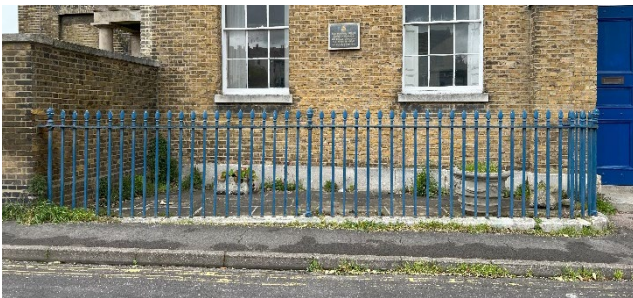
*Main entrance railings 01 – The Terrace.*

The cast iron railings to the front of Custom House, surrounding the lightwells, appear to be in a generally good condition with only concentrated areas of paint damage and corrosion. Remedial work in accordance with the specific railing condition will be focussed on preserving the surface integrity of the ironwork without damaging it.

- All railing surfaces to be cleaned with a damp cloth to remove excess dirt.
- Any light areas of corrosion to be rubbed down by hand using emery paper depending on specific condition.
- Any more extensive areas of corrosion to be rubbed down by hand using a wire brush and chisel and hammer.
- Areas of chipped paintwork to be sanded down using emery paper and worked into good surrounding paintwork.

- All areas to be rubbed and wiped down, removing all dust and dirt in preparation for paint application.
- Apply suitable paint to prepared railings. Blue paint colour applied to match the existing external appearance of Custom House.

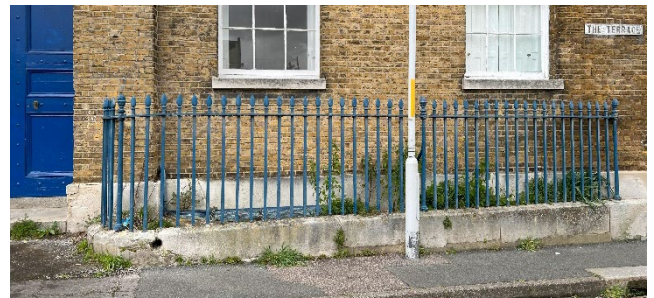
*Main entrance railings 02 – The Terrace.*

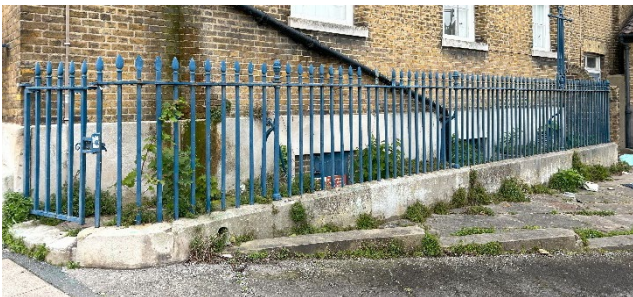
*Main entrance railings 03 – Commercial Place.*

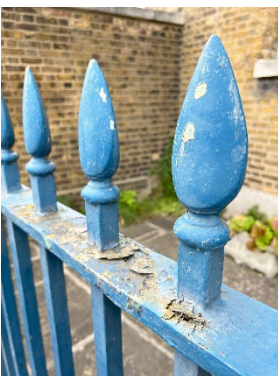
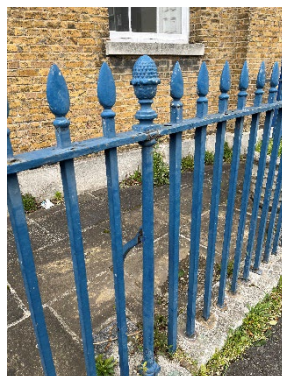
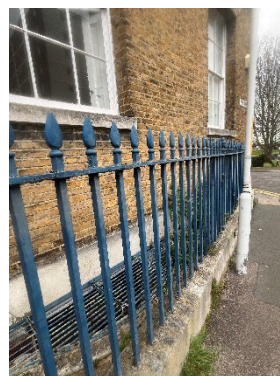
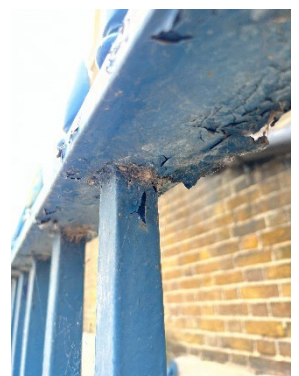
*Images of railing corrosion and paint damage.*

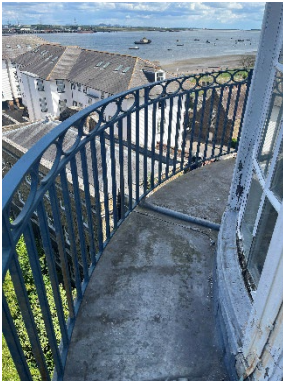
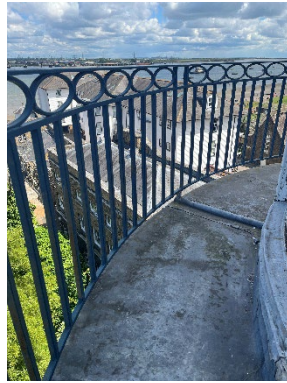
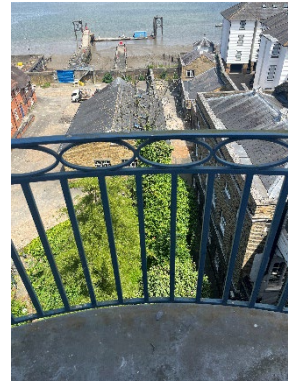
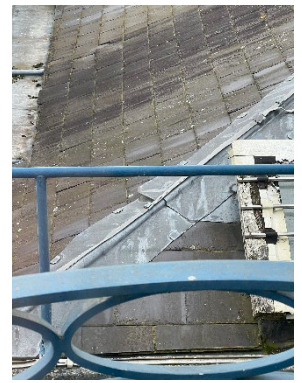
*Images of third floor lookout cast iron railings.*

The cast iron railings to the third-floor lookout, appears to be in a good condition with minimal areas of paint damage and corrosion. Remedial work will be focussed on preserving the surface integrity of the ironwork without damaging it prior to repainting.

- All railing surfaces to be cleaned with a damp cloth to remove excess dirt.
- All light areas of corrosion to rubbed down by hand using emery paper.
- Areas of chipped paintwork to be sanded down using emery paper and worked into good surrounding paintwork.
- Finally, all areas are to be rubbed and wiped down, removing all dust and dirt in preparation for paint application.
- Apply suitable paint to prepared railings. Blue paint colour applied to match the existing.

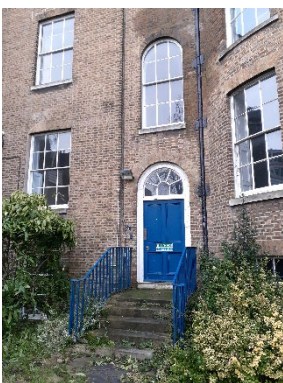
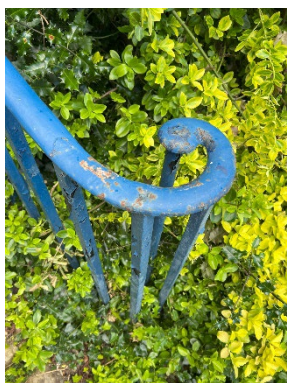
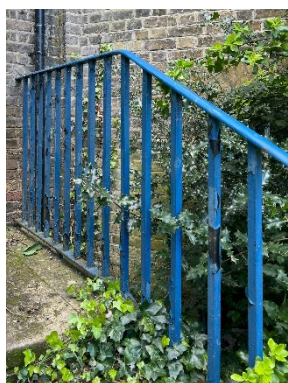
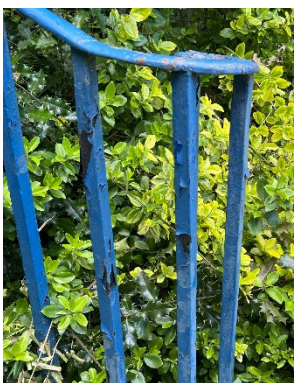
*Images of main building rear entrance railings.*

The cast iron railings to the front of Custom House, surrounding the lightwells, appear to be in a generally good condition with only concentrated areas of corrosion and larger areas of paint damage and flaking. Remedial work in accordance with each railings condition will be focussed on preserving the surface integrity of the ironwork without damaging it.

- All railing surfaces to be cleaned with a damp cloth to remove excess dirt.
- All light areas of corrosion to be rubbed down by hand using emery paper.
- All flaking paint areas to be removed and scrapped off.
- All areas of paintwork to be sanded down using emery paper and worked into good surrounding paintwork.
- Finally, all areas are to be rubbed and wiped down, removing all dust and dirt in preparation for paint application.
- Apply suitable paint to prepared railings. Blue paint colour applied to match the existing.

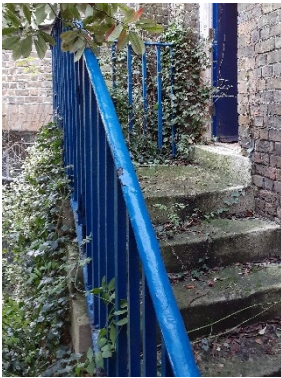
*Images of coach house rear entrance railings.*

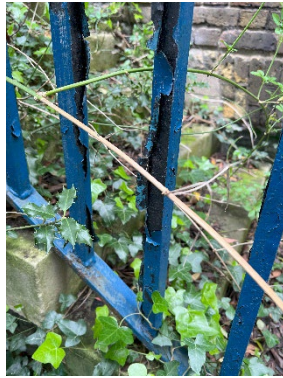
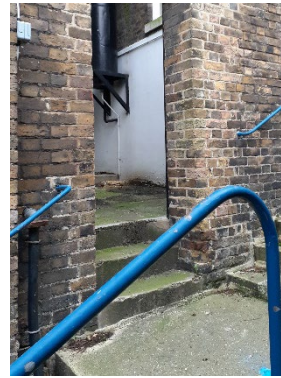
*Images of railing for steps along spine wall.*
