**CUSTOM HOUSE, THE TERRACE, GRAVESEND, DA12 2BW**  
**REPAIR WORKS TO EXISTING ORIGINAL FEATURES**

This statement formally sets out the methodology details of all repair works to the existing original features within Custom House. This method statement includes the repair work information relating to existing original skirting, architraves, cornicing, fireplace and staircases.

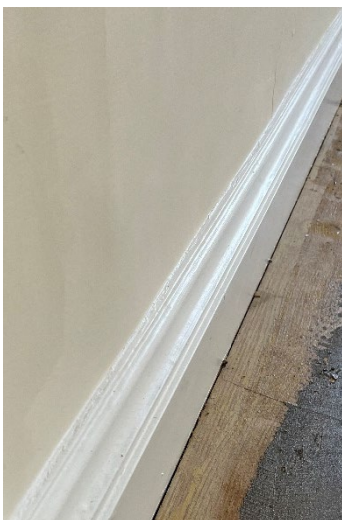
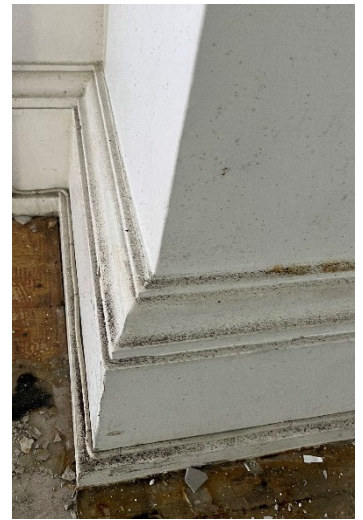
*Images of existing original skirting profile, to be retained and repaired.*

The skirtings that have been highlighted on the drawings as original skirting are considered either original or period features following consultation with the heritage consultant. All skirting highlighted will be carefully retained, rubbed down removing paint surface, repaired where required and redecorated.

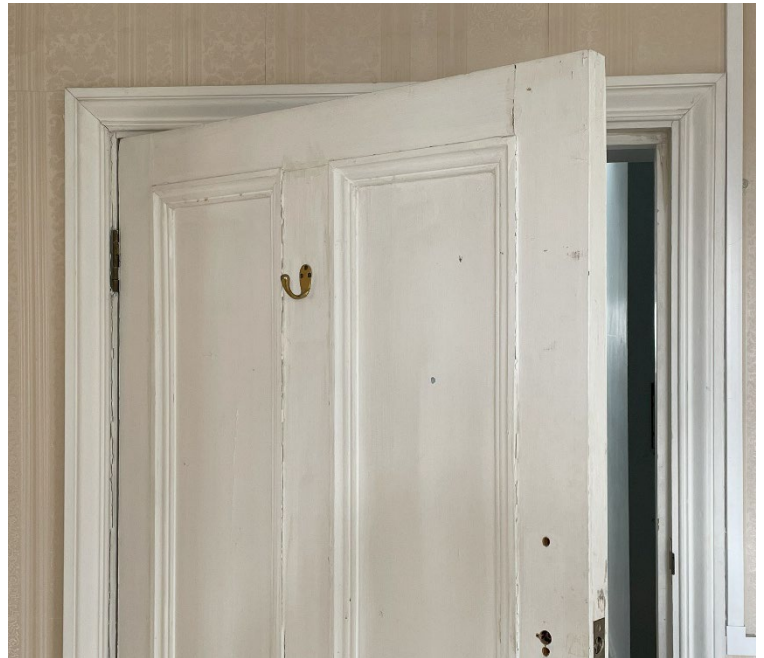
*Examples of varying original architraves to be retained across the main house.*

Initial repair works will start by cleaning of the architraves. While cleaning, the woodwork will be inspected for any further signs of damage such as cracks and chipped areas. Following the cleaning and inspection process, the architraves will be sanded down, smoothing any rough surfaces and working this into any area of chipped paintwork, priming the woodwork for new paint to be applied.

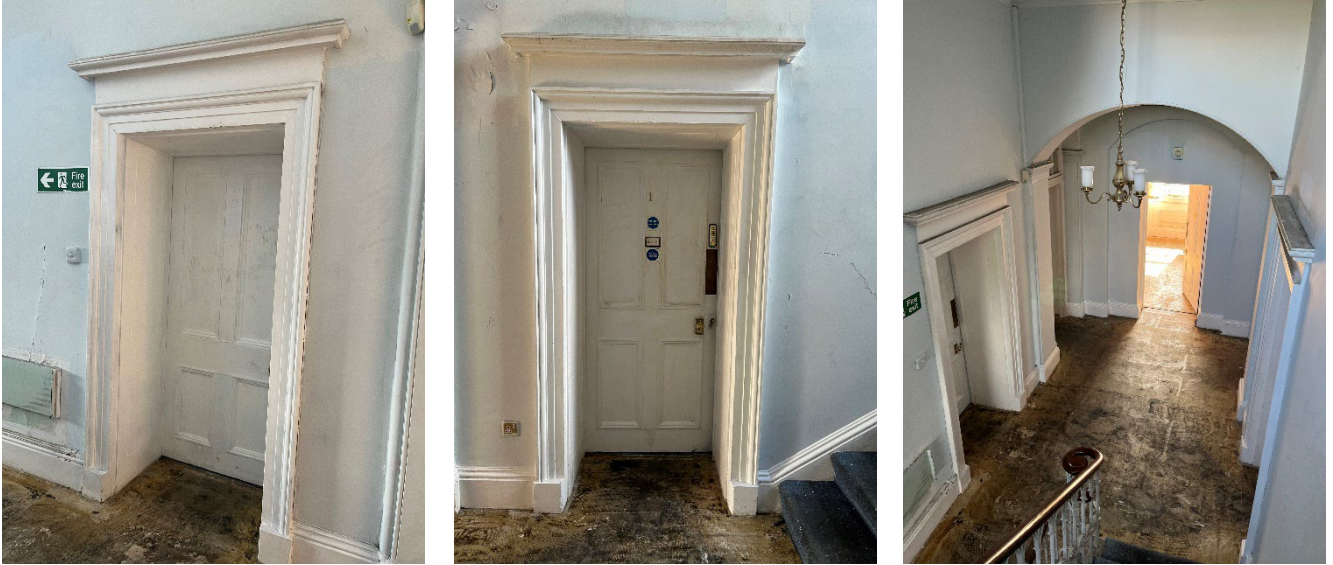
*Original doors and architraves on landing of main staircase to remain but become fixed shut with wall behind.*

Ex. ironmongery to be removed and finish 'made good', door to be fixed to new party wall construction, to maintain internal hallway aesthetic.

Ex. architraves to be retained and repaired and/or repainted where necessary.

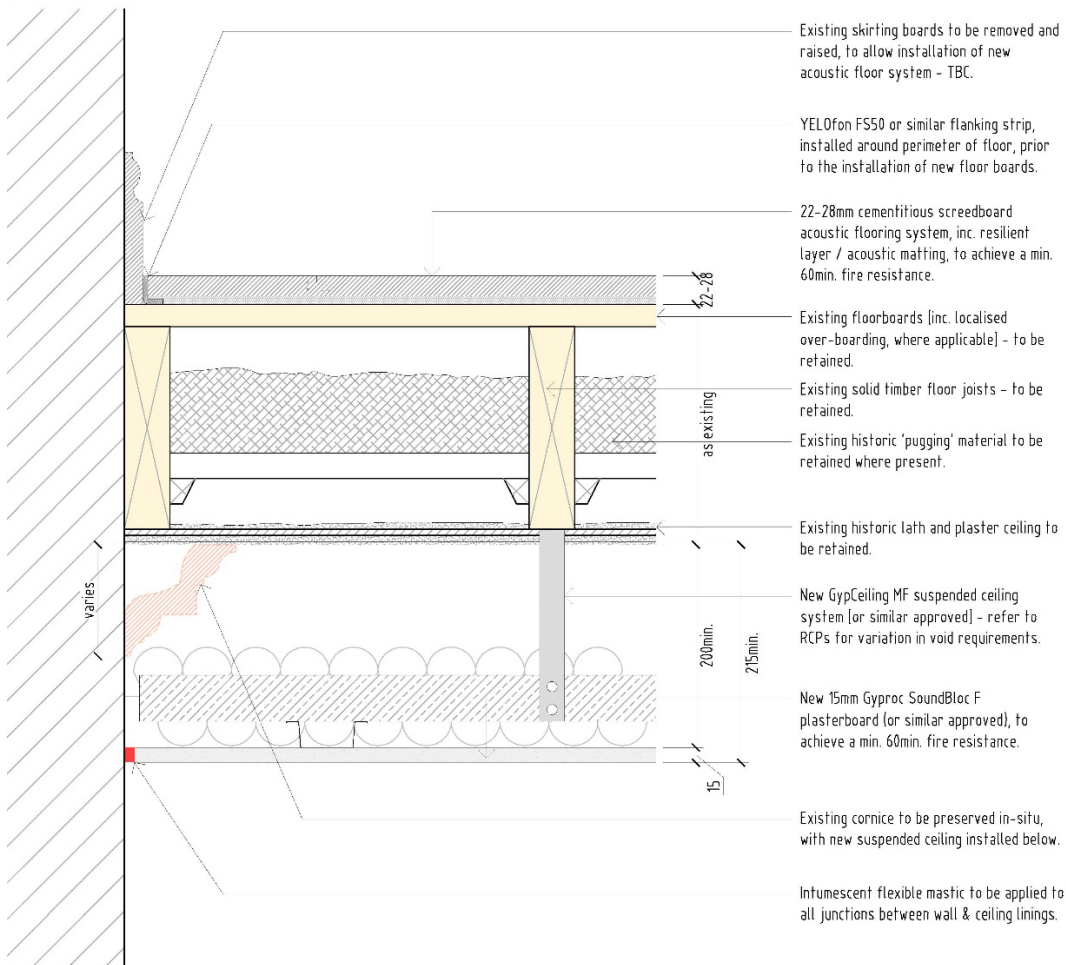
*Proposed suspended ceiling and cornice preserving detail.*

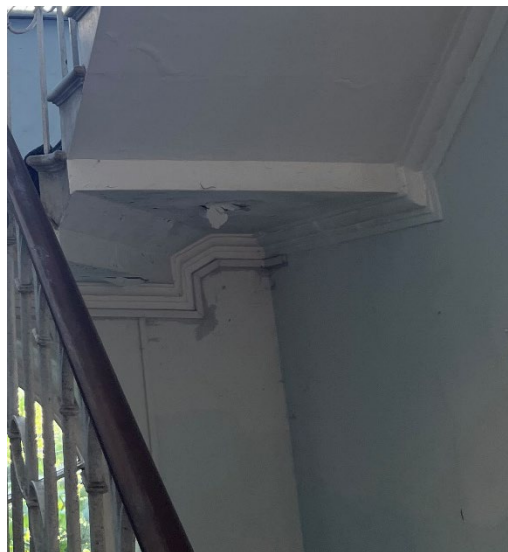
*Staircase cornice details found on the main staircases throughout the main house.*

Existing cornice to the stair areas highlighted on the reflected ceiling plans and images below will be carefully retained, rubbed down removing current paint surface and flaking, repaired where required and redecorated.

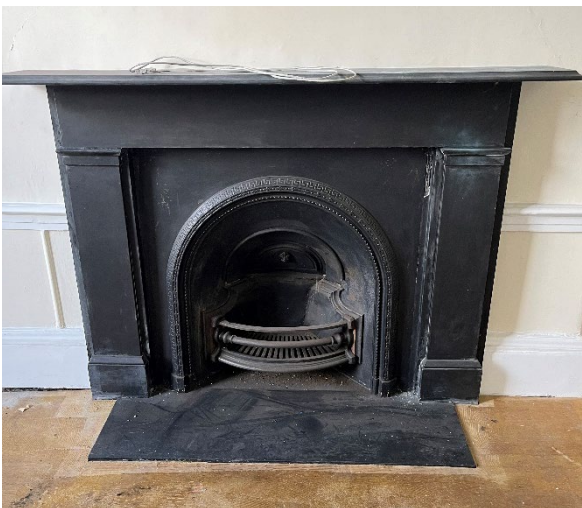
The fireplace is generally in a good condition however there is some discolouration to the surround and insert. There is also some minor visible damage where the insert abuts the surround in the top corner.

*Front elevation to fireplace to Unit 6.*

The slate surround, insert grate and stone hearth will be carefully cleaned with material specific appropriate cleaning products, inspecting any remedial work requirements during the process. Following the cleaning process, the discolouration to the slate surround will be repaired to restore colour uniformity. The cast iron insert and grate will be polished /blacked where required. Any components for repair shall be carefully removed, if possible, repaired as necessary and refitted carefully. Any stone hearth repair work to be undertaken in-situ wherever possible.

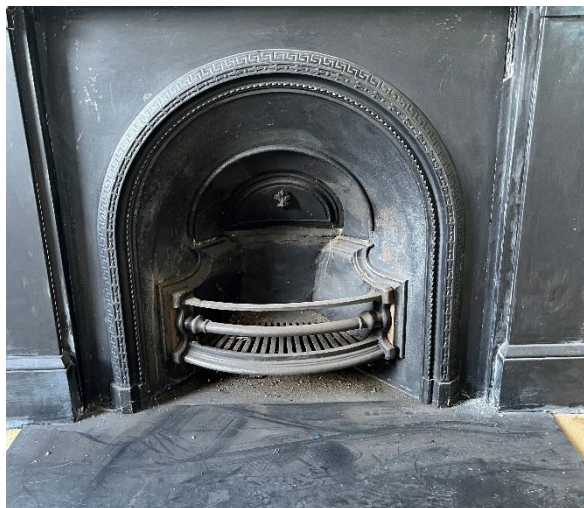
*Minor damage where insert abuts the surround.*

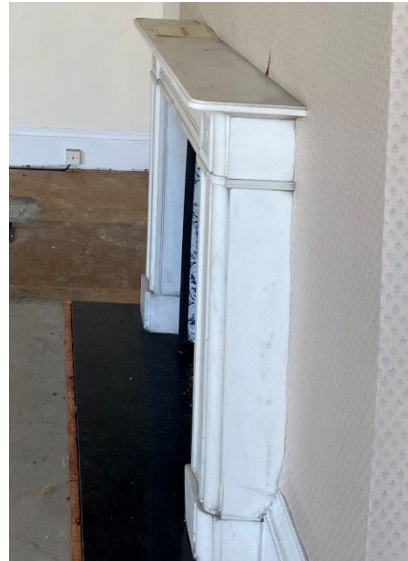
*Side view of fireplace.*

products, inspecting any remedial work requirements during the process. If any remedial work is discovered this will be repaired carefully, minimising any conflict with the other good condition areas.

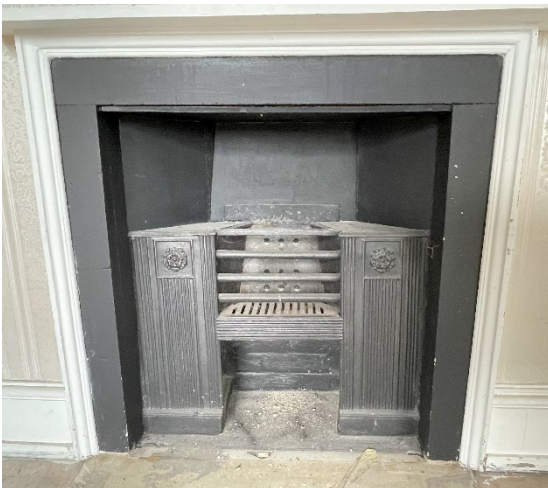
*Close up of early 19<sup>th</sup> century grate.*

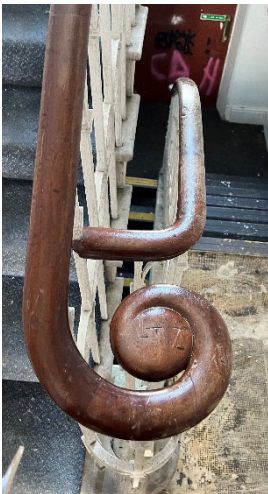
Staircase 1.

*Staircase 1 – Main Staircase Central to building.* Varnished wood, with curved wood and ornate detailing. Banister to be cleaned, carefully rubbed down and varnish to be reapplied to match existing appearance in colour.

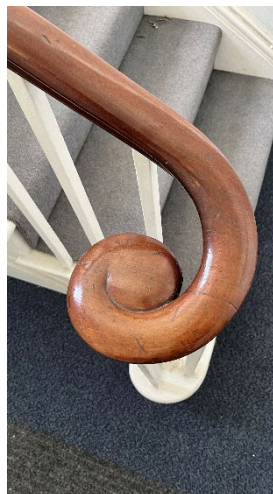
Staircase 2.

*Staircase 2 – Commissioners Staircase West of building.* Varnished wood, with curved wood and ornate detailing. Banister to be cleaned, carefully rubbed down and varnish to be reapplied to match existing appearance in colour.

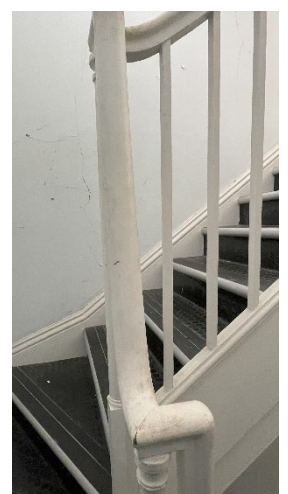
Staircase 4.

*Staircase 4 – Staircase to observatory.* White painted curved timber banister. Banister to be cleaned, carefully rubbed down and paint finish reapplied to match existing white colour.

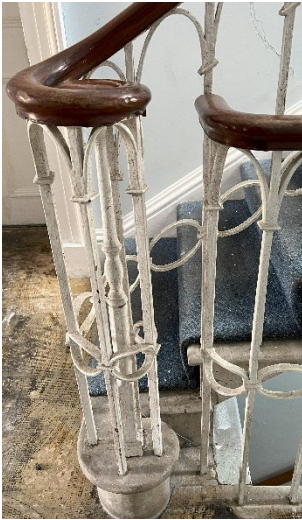
Staircase 1.

*Staircase 1 – Main Staircase Central to building.* White painted metal baluster with ornate detailing fixed into stone risers. Balusters to be cleaned, carefully rubbed down and paint finish reapplied to match existing white colour.

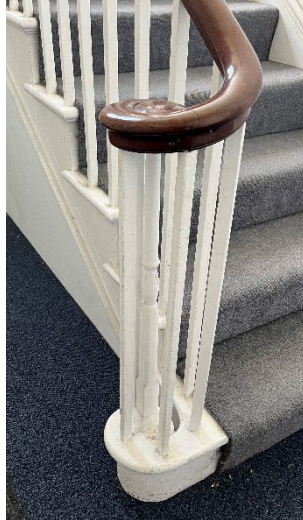
Staircase 2.

*Staircase 2 – Commissioners Staircase West of building.* White painted square timber balusters. Balusters to be cleaned, carefully rubbed down and paint finish reapplied to match existing white colour.

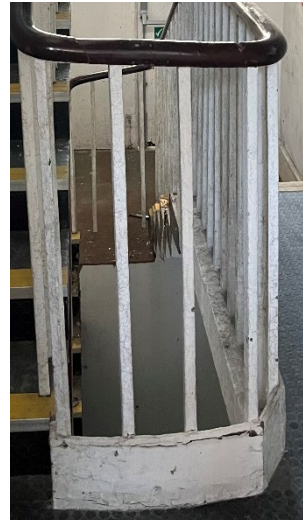
Staircase 3.

*Staircase 3 – Surveyors Staircase East of building.* White painted square timber balusters. Balusters to be cleaned, rubbed down to remove all flaking paint and reapply paint finish to match existing white colour.

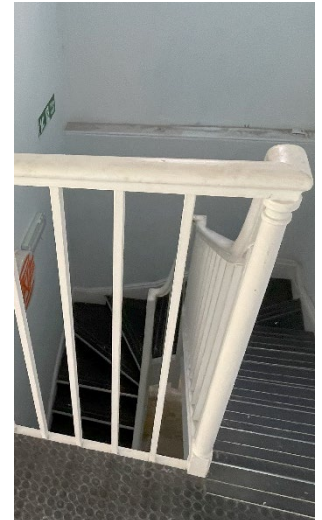
Staircase 4.

*Staircase 4 – Staircase to observatory.* White painted square timber balusters. Balusters to be cleaned, carefully rubbed down and paint finish reapplied to match existing white colour.

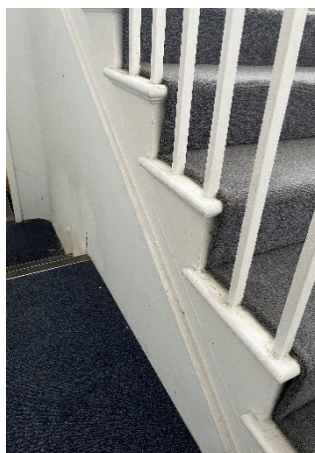
Staircase 2.

**Staircase 2 – Commissioners Staircase West of building.** White painted timber stair treads and risers. Existing carpet floor finish and underlay to be removed. Extent of proposed carpet floor finish applied to stair is found on the floor finishes drawings. Visible areas of treads and risers to be carefully cleaned, rubbed down, and paint finish reapplied to match existing white colour.

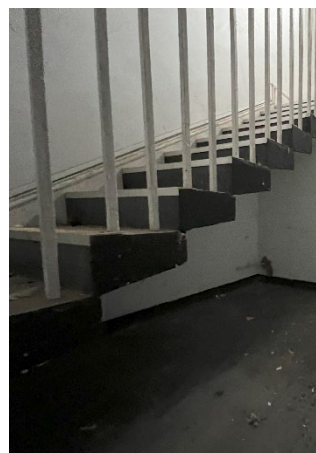
Staircase 3.

**Staircase 3 – Surveyors Staircase East of building.** Stone treads and risers. Vinyl existing floor finish to be removed. Extent of proposed carpet floor finish applied to stair is found on the floor finishes drawings. Visible areas of treads and risers to be carefully cleaned and rubbed down, removing build-up of dirt and black paint. Paint finish to be applied to visible areas.
