# HB Archaeology & Conservation Ltd

MILTON MOUNT CHURCH,  
CLARENCE PLACE, GRAVESEND,  
KENT, DA12 1LD

## LEVEL 3 HISTORIC BUILDING RECORD

Prepared by HB Archaeology & Conservation Ltd  
Project No. 2023535  
December 2023

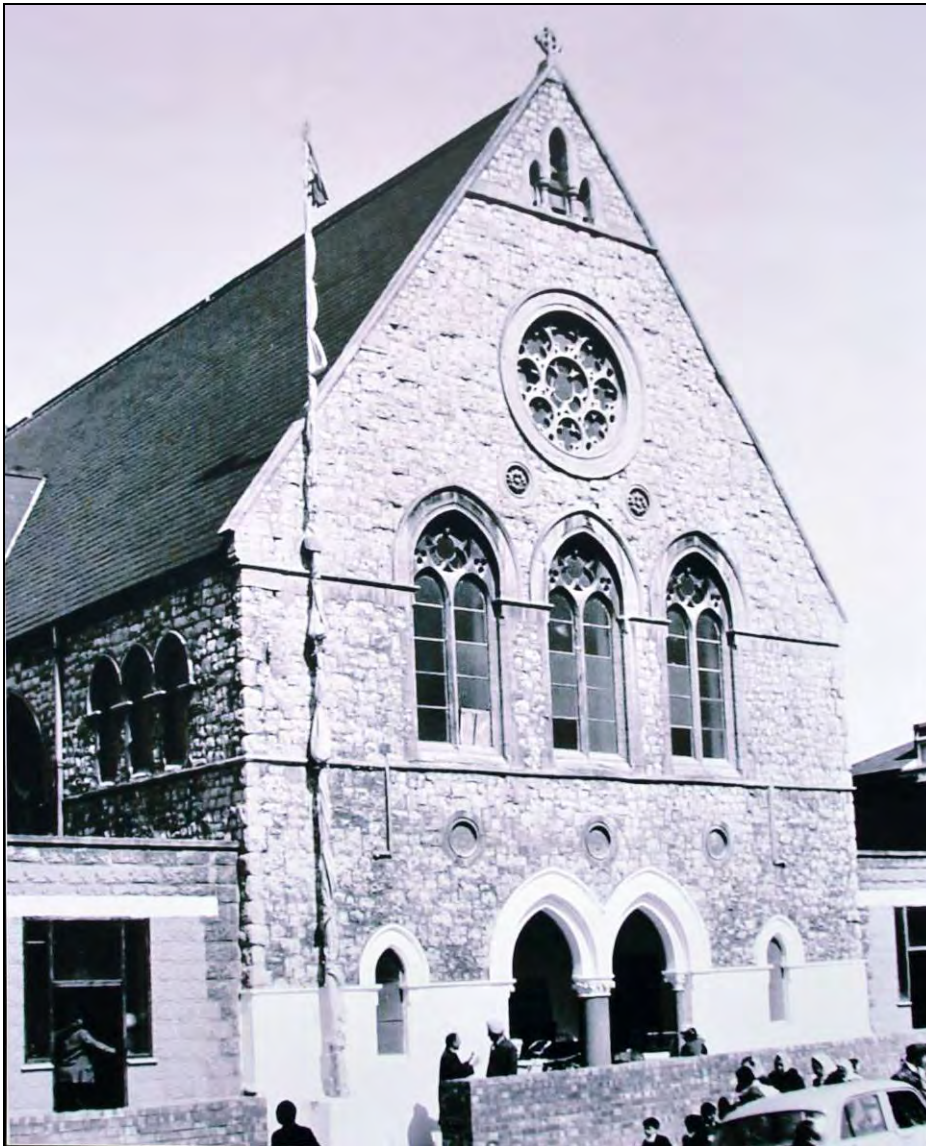
- 6.1.17 The first extensions to the group were the southern additions to the two aisles: these were added by Wholesale Trading Supplies Ltd in 1955 as loading bays. The loading bays were converted to cloakrooms in 1968 as part of the Sikh temple facilities, soon after they took ownership of the site in 1967. Extracts of the planning proposals show the layout and the associated alterations to the ends of the aisles to accommodate them (Plate 3).

Plate 3: A view of the Clarence Place elevation showing the two loading bay extensions added in 1955 *in situ*, converted to cloakrooms in 1968

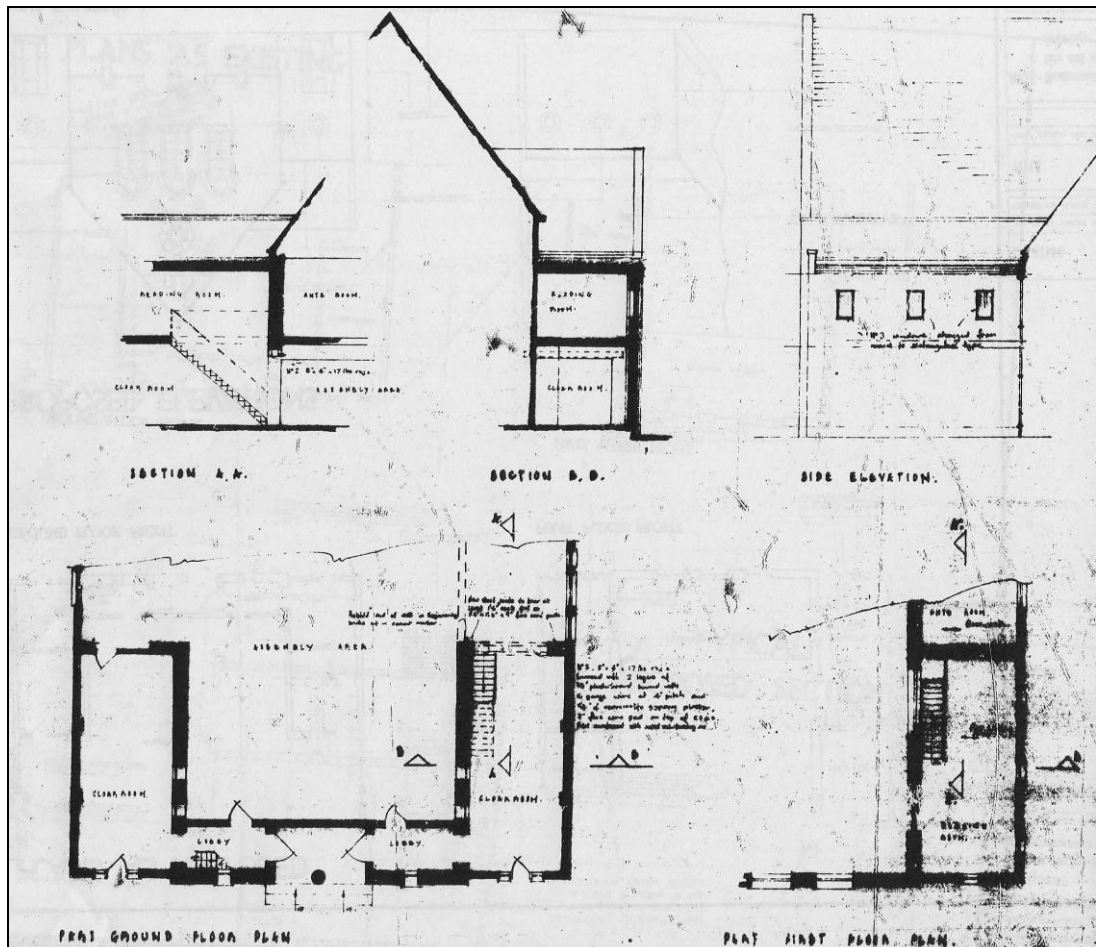
- 6.1.19 First floor rooms were added to the loading bay extensions in 1975, blocking the arch-headed windows in the church (Plates 3 and 5).

Plate 5: The first floor additions to the two former loading bays as permitted in 1975

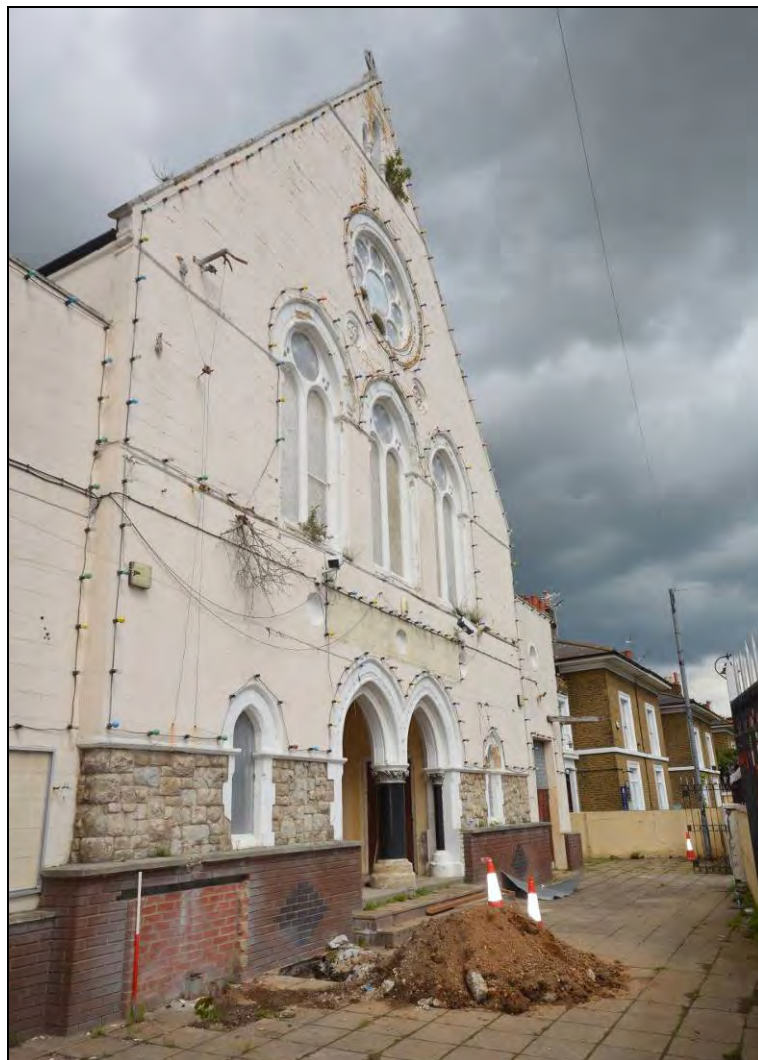
- 6.2.1 The south elevation of the building is the gabled end of the church, fronting onto Clarence Place. The centre of the elevation at ground floor level comprises the arcaded entrance: two pointed-arched openings raised above external ground level and accessed via a short flight of steps (Plate 9). The entrance arcade includes a central pillar and side shafts of red Aberdeen granite, the arrangement is flanked by a pair of single-light, pointed arch-headed windows that light the lobbies within the entrance area (Plate 9; Figure 2).
- 6.2.2 The original ragstone rubble masonry walls are partially exposed, concealed from the window sill level to the ground surface by applied brick plinths of 20<sup>th</sup> century origin (Plate 9). The remainder of the elevation is under render, except the Bath stone dressings to the openings.

Plate 9: The front (south) elevation of the church looking northeast (scale 1.00 metres)

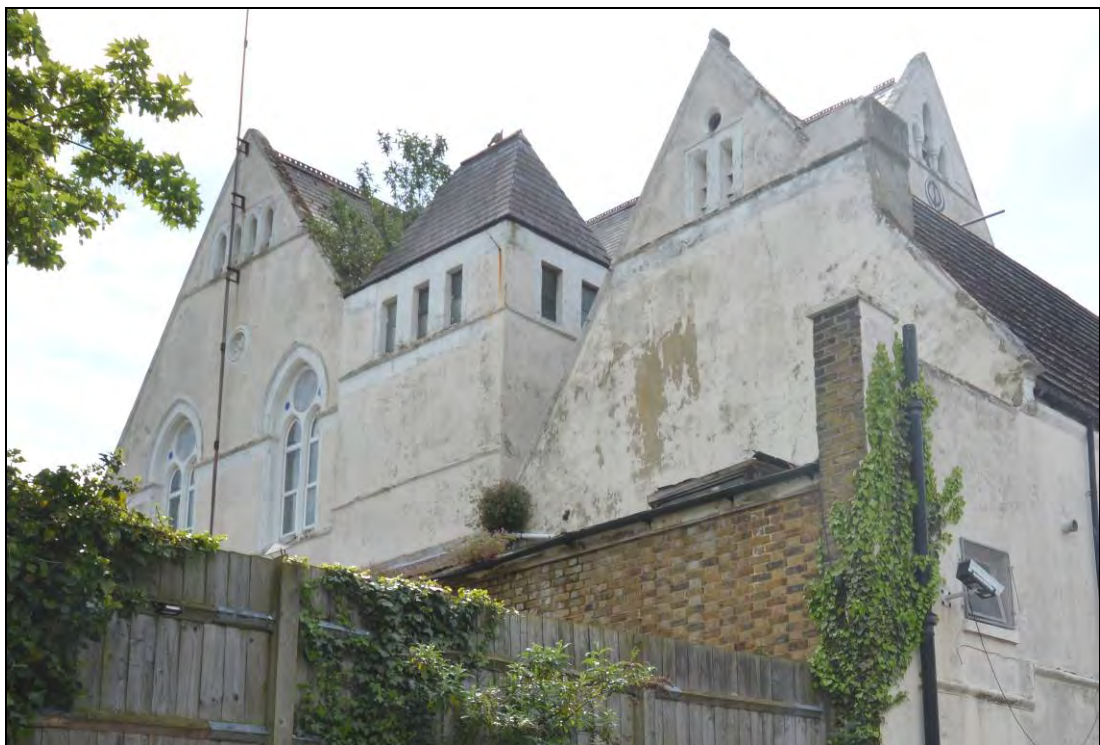
Plate 15: The north end of the east elevation showing the contrast in the rendered finish to the principal buildings and the exposed Flemish bond brickwork of the WC block

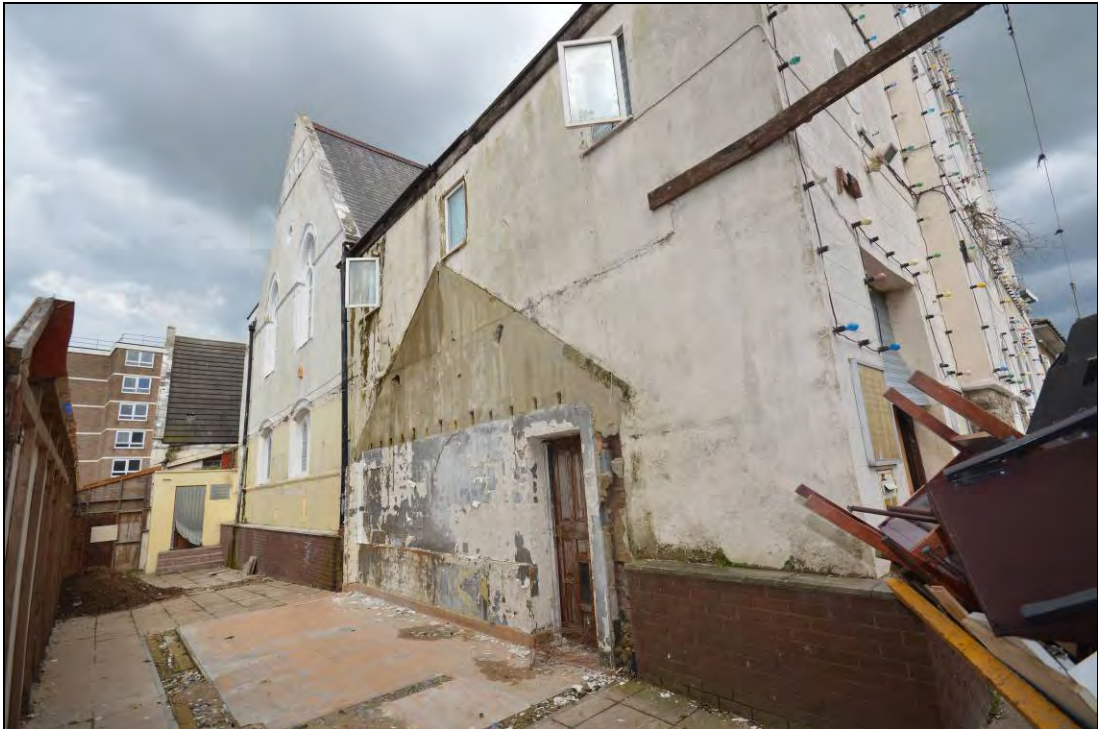
Plate 21: The southwest extension and the scars left by the addition made in 1982 to accommodate new WC facilities

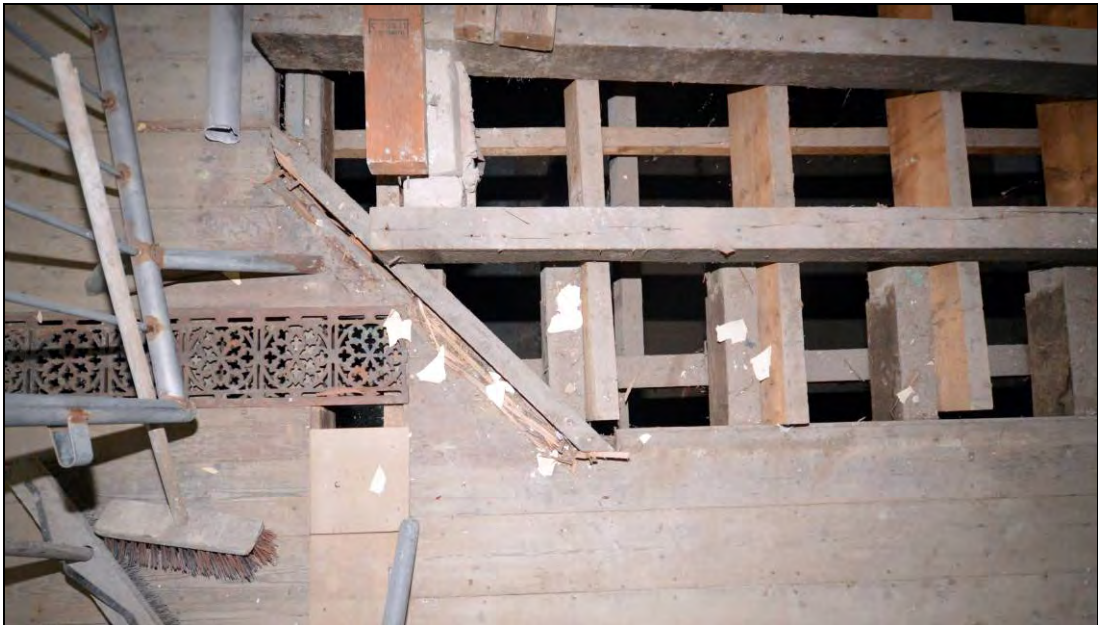
Plate 29: Detail of the canted southwest corner of the dais platform, the joist arrangement and the integral grilles, part of the heating system

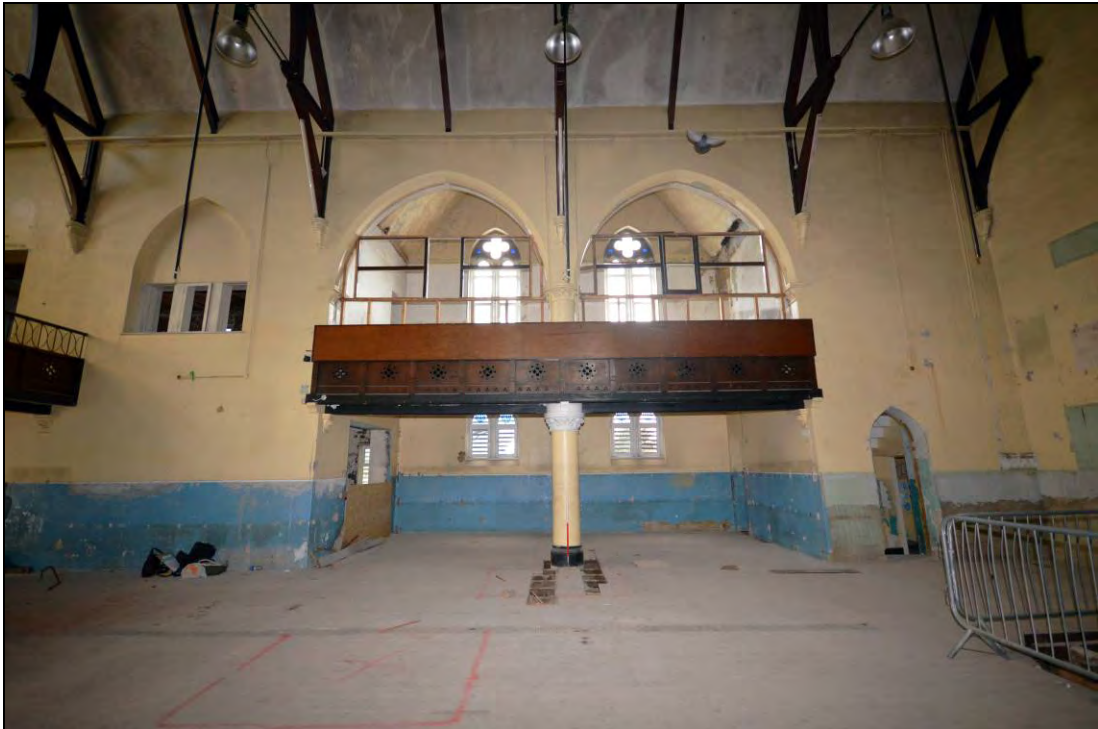
Plate 30: The west aisle arcade and the blocked high-set window to the south of it illustrating the extent of natural light that would have suffused the church at the date of construction

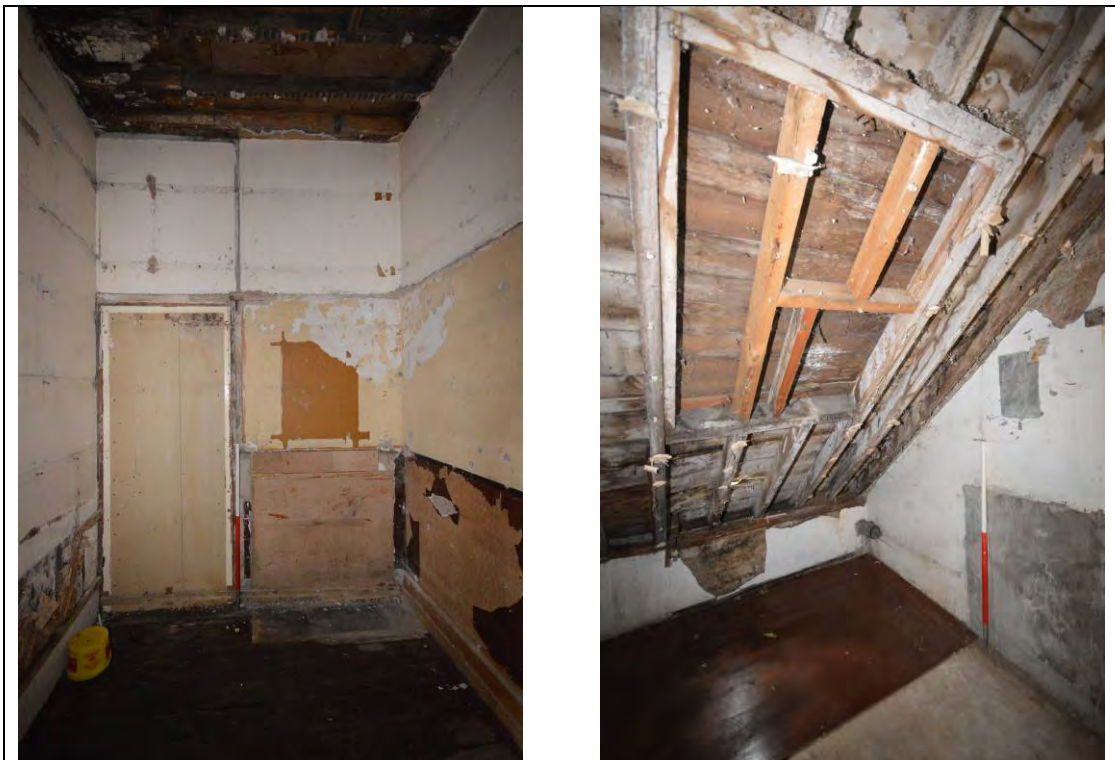
Plate 38: The blocked fireplace in the north wall of the former minister's vestry at the base of the east stair turret and the blocked rooflight in the chamber above

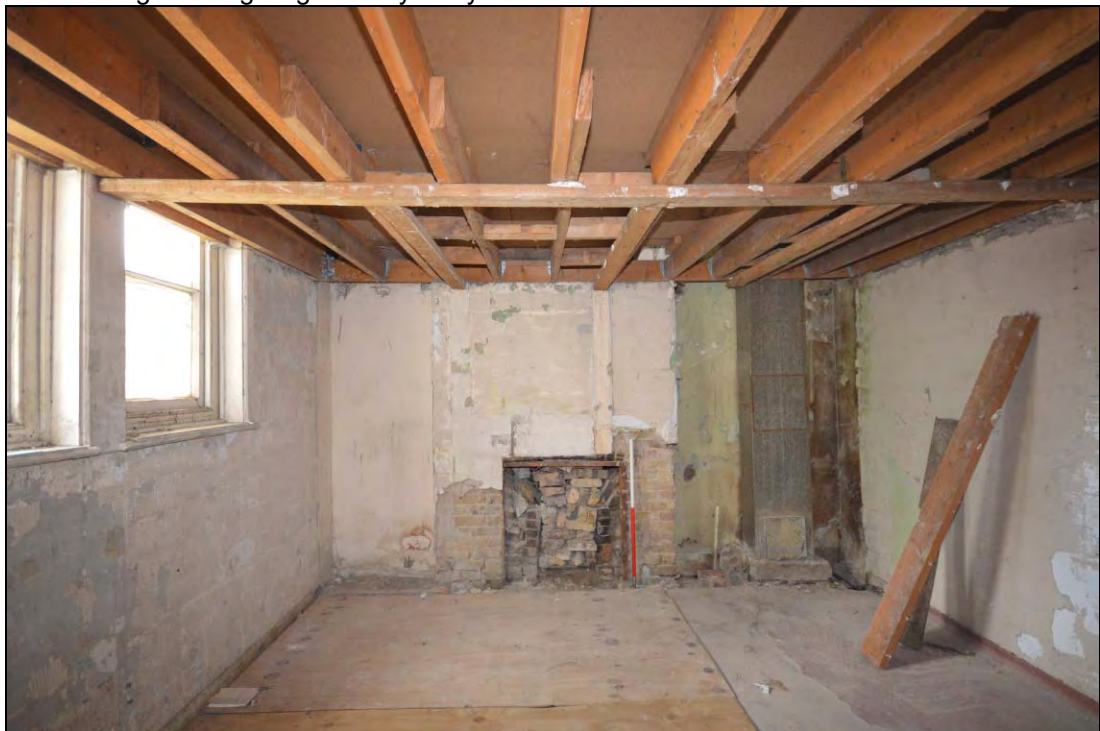
Plate 44: The northeastern room of the school house with its fireplace and windows bisected by the inserted floor structure

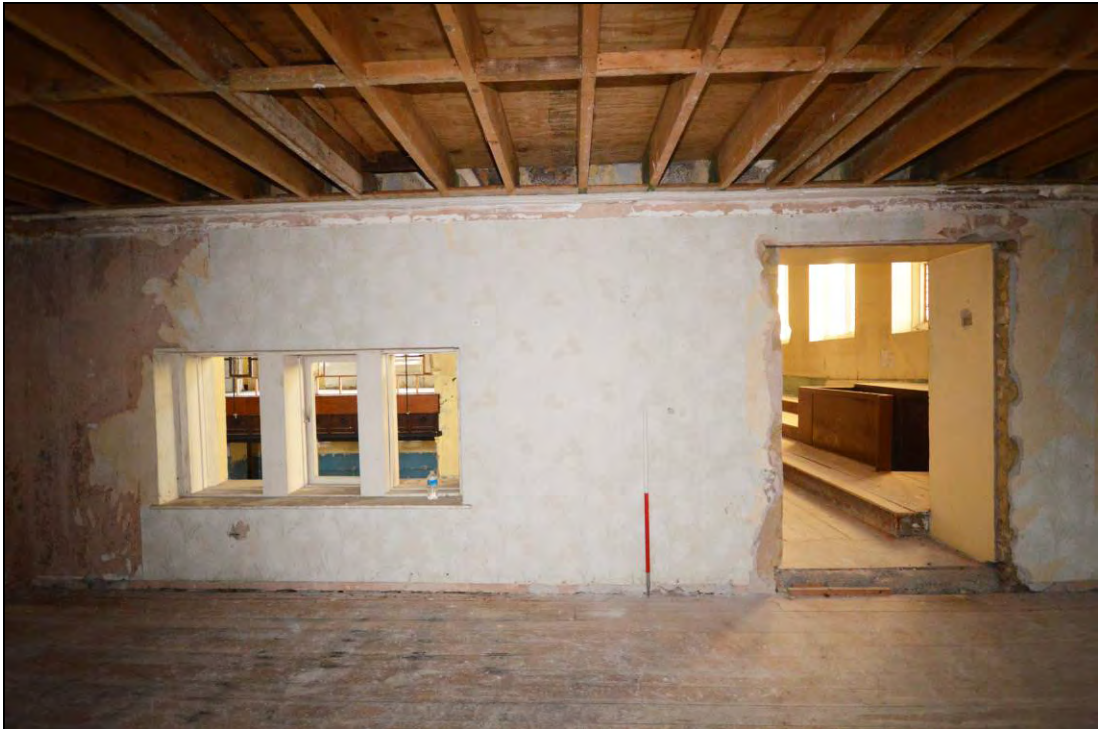
Plate 61: The east wall of the southwest extension; the three-light window is within infill of an original larger high-set pointed-arch-headed window lighting the nave to the north of the south gallery. The doorway was inserted, replacing part of the tripartite window that had occupied that position prior to extension
