*Project ref: TV251125*

SITE: 3 High View

# ***CCTV Survey Report***

## Section Inspection - 17/11/2025 - IC1X

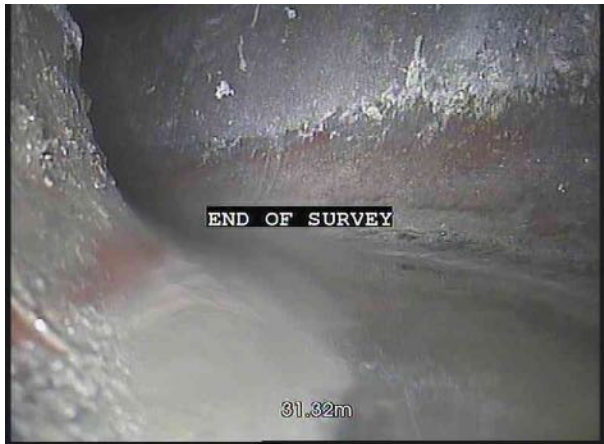
1, 00:07:31, 31.32 m  
Finish node, manhole, reference: 2603, Unable to lift no  
access
