# Trosley Country Park, Waterlow Rd, Gravesend DA13 0SG

Tree Condition Report

7th February 2025

| Report reference: | DTE #RF23463 |

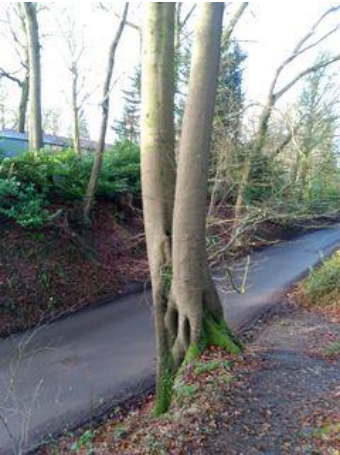
| Tree no.<br>(with<br>Google<br>map link) | Species | Attributes | Survey notes | Physiological<br>Condition | Structural<br>Condition | Risk Assessment | Risk<br>Rating | Tree work<br>recommendations | Photo |
|---|---|---|---|---|---|---|---|---|---|
| <a href="#">T1</a> | Common<br>beech<br>( <i>Fagus<br/>sylvatica</i> ) | Height (m): 22<br>Crown Radius (m): 6<br>DBH (mm): 900<br>Stems: 2<br>Life Stage: Mature | Major deadwood.<br>Slime flux visible on<br>base of stem on West<br>Side. Some decay<br>visible on east side.<br>Tree has unusual<br>buttress root<br>formation, likely<br>caused by soil erosion<br>over time. Sounding<br>mallet did not signify<br>any significant decay.<br>Tree appears to be<br>stable. | Normal | Manageable | Likelihood of Failure: Imminent<br>Likelihood of Impact: Medium<br>Failure x Impact: Likely<br>Consequences: Significant<br>Risk Rating: High | High | Remove deadwood over<br>road - greater than 25 mm. | |

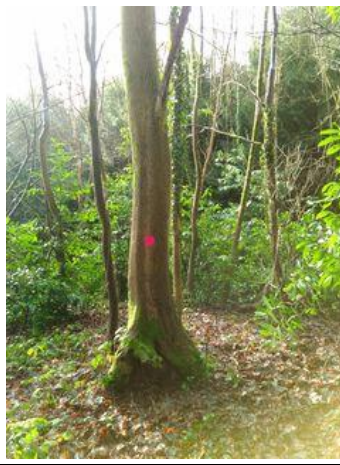
| Tree no.<br>(with<br>Google<br>map link) | Species | Attributes | Survey notes | Physiological<br>Condition | Structural<br>Condition | Risk Assessment | Risk<br>Rating | Tree work<br>recommendations | Photo |
|---|---|---|---|---|---|---|---|---|---|
| <a href="#">T2</a> | Common ash<br>( <i>Fraxinus<br/>excelsior</i> ) | Height (m): 17<br>Crown Radius (m): 4<br>DBH (mm): 450<br>Life Stage: Mature | Sparse crown,<br>significant dieback.<br>Large open cavity at<br>base with extensive<br>decay. Tree is leaning<br>towards the road. Ash<br>Dieback Health Class 3<br>- 50%-25% remaining<br>canopy | Low | Irremediable | Likelihood of Failure: Probable<br>Likelihood of Impact: Medium<br>Failure x Impact: Somewhat likely<br>Consequences: Severe<br>Risk Rating: Moderate | Moderate | Fell tree. | |

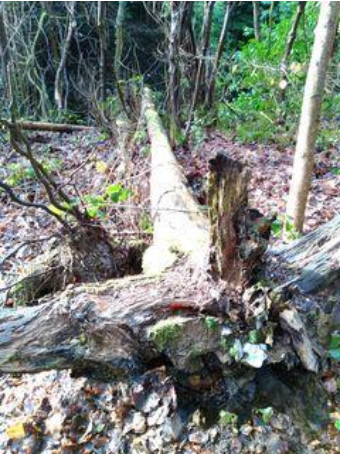
| Tree no.<br>(with<br>Google<br>map link) | Species | Attributes | Survey notes | Physiological<br>Condition | Structural<br>Condition | Risk Assessment | Risk<br>Rating | Tree work<br>recommendations | Photo |
|---|---|---|---|---|---|---|---|---|---|
| <a href="#">T3</a> | Common ash<br>( <i>Fraxinus<br/>excelsior</i> ) | Height (m): 15<br>Crown Radius (m): 2<br>DBH (mm): 350<br>Life Stage: Early<br>Mature | Fallen tree that is<br>balanced on the edge<br>of the bank, and dead<br>branches are hanging<br>over the highway. | Dead | Critical | Likelihood of Failure: Possible<br>Likelihood of Impact: Medium<br>Failure x Impact: Unlikely<br>Consequences: Significant<br>Risk Rating: Low | Low | Cut and clear fallen tree. | |

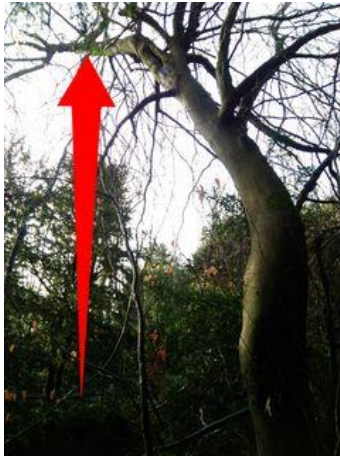
| Tree no.<br>(with<br>Google<br>map link) | Species | Attributes | Survey notes | Physiological<br>Condition | Structural<br>Condition | Risk Assessment | Risk<br>Rating | Tree work<br>recommendations | Photo |
|---|---|---|---|---|---|---|---|---|---|
| <a href="#">T4</a> | Common<br>beech<br>( <i>Fagus<br/>sylvatica</i> ) | Height (m): 15<br>Crown Radius (m):<br>3N, 3E, 6S, 3W<br>DBH (mm): 450<br>Life Stage: Early<br>Mature | Tree is leaning heavily<br>over highway. Major<br>deadwood. Large<br>longitudinal cavity on<br>stem at 6-7m,<br>approximately 1.5m in<br>length and appears to<br>be extensively<br>decayed. The tree has<br>formed significant<br>reaction wood. Cavity<br>is a potential bat roost<br>habitat. | Normal | Manageable | Likelihood of Failure: Probable<br>Likelihood of Impact: Medium<br>Failure x Impact: Somewhat likely<br>Consequences: Severe<br>Risk Rating: Moderate | Moderate | Reduce stem in height,<br>removing as much as<br>possible whilst retaining as<br>much as possible of the<br>cavities (see photo). | |

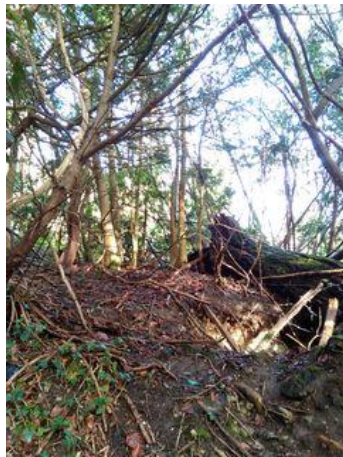
| Tree no.<br>(with<br>Google<br>map link) | Species | Attributes | Survey notes | Physiological<br>Condition | Structural<br>Condition | Risk Assessment | Risk<br>Rating | Tree work<br>recommendations | Photo |
|---|---|---|---|---|---|---|---|---|---|
| <a href="#">G5</a> | Common ash<br>( <i>Fraxinus<br/>excelsior</i> ) | Height (m): 11<br>Crown Radius (m): 2<br>DBH (mm): 200<br>Life Stage: Young | Several young Ash<br>trees are dead and<br>dying, some have failed<br>and are leaning against<br>adjacent trees, others<br>are still standing. Ash<br>Dieback Health Class 4<br>- 25%-0% remaining<br>canopy | Dying | Critical | Likelihood of Failure: Possible<br>Likelihood of Impact: Medium<br>Failure x Impact: Unlikely<br>Consequences: Significant<br>Risk Rating: Low | Low | Fell all dead/dying Ash<br>trees. | |

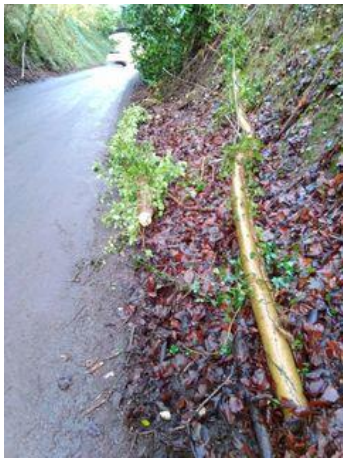
| Tree no.<br>(with<br>Google<br>map link) | Species | Attributes | Survey notes | Physiological<br>Condition | Structural<br>Condition | Risk Assessment | Risk<br>Rating | Tree work<br>recommendations | Photo |
|---|---|---|---|---|---|---|---|---|---|
| <a href="#">T6</a> | Common ash<br>( <i>Fraxinus<br/>excelsior</i> ) | Height (m): 13<br>Crown Radius (m): 1<br>DBH (mm): 150<br>Life Stage: Young | Fallen tree on edge of<br>road. | Dead | Critical | Likelihood of Failure: Possible<br>Likelihood of Impact: Medium<br>Failure x Impact: Unlikely<br>Consequences: Minor<br>Risk Rating: Low | Low | Cut and clear fallen tree. | |

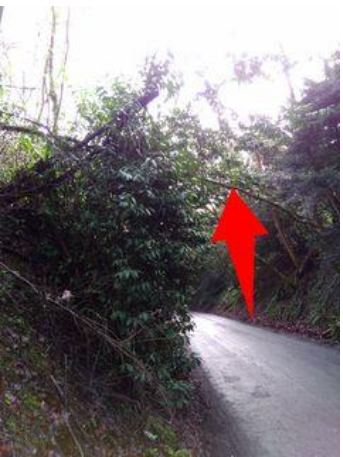
| Tree no.<br>(with<br>Google<br>map link) | Species | Attributes | Survey notes | Physiological<br>Condition | Structural<br>Condition | Risk Assessment | Risk<br>Rating | Tree work<br>recommendations | Photo |
|---|---|---|---|---|---|---|---|---|---|
| <a href="#">T7</a> | Not identified<br>( <i>Not identified</i> ) | Height (m): 13<br>Crown Radius (m): 1<br>DBH (mm): 100<br>Life Stage: Young | Dead tree has fallen<br>and is overhanging the<br>highway. | Dead | Critical | Likelihood of Failure: Imminent<br>Likelihood of Impact: Medium<br>Failure x Impact: Likely<br>Consequences: Significant<br>Risk Rating: High | High | Remove fallen tree. | |
