**Ref: 4198/25R**

**PROPOSED CHANGE OF USE AT  
WALNUT HILL NURSERY,  
WALNUT HILL ROAD,  
ISTEAD RISE, KENT DA13 9HL.**

**CONTAMINATION ASSESSMENT**

**Revised: April 2025**

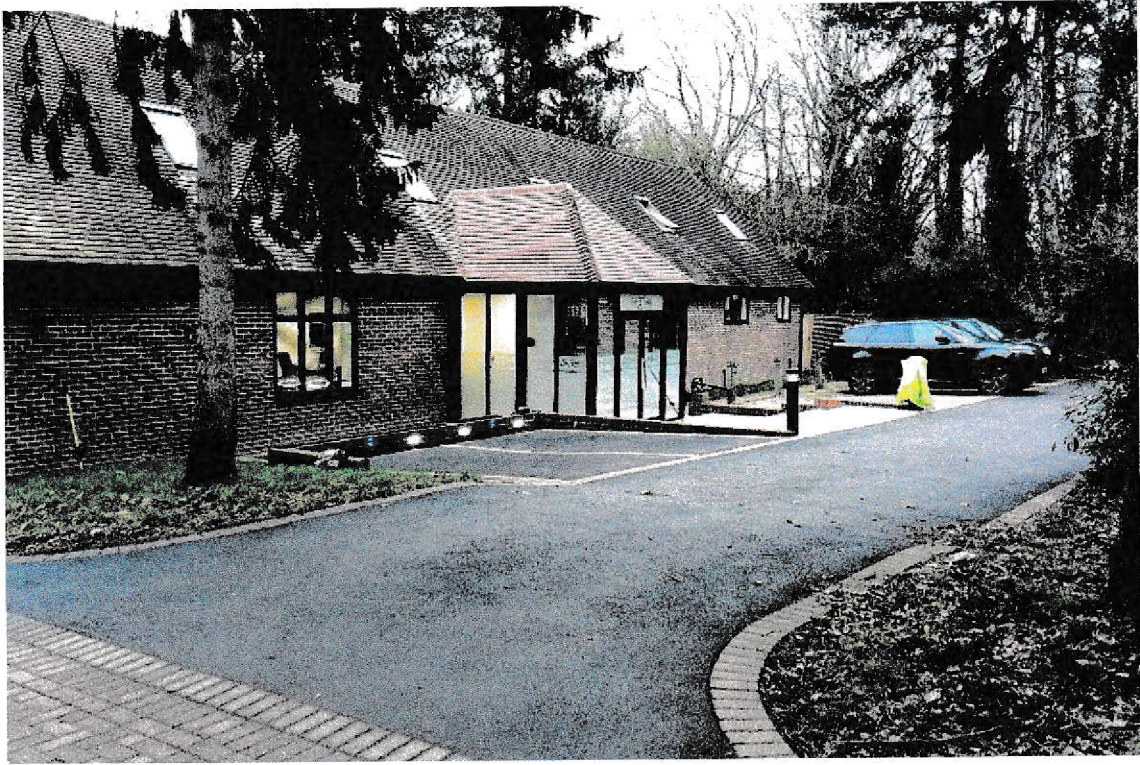
**Plate 1**

- 6.3 A single storey, refurbished brick building containing office facilities was present at the front of the site, accessed by a tarmac drive (Plate 1). Ornamental borders and designated staff parking spaces were located to the front of the building.

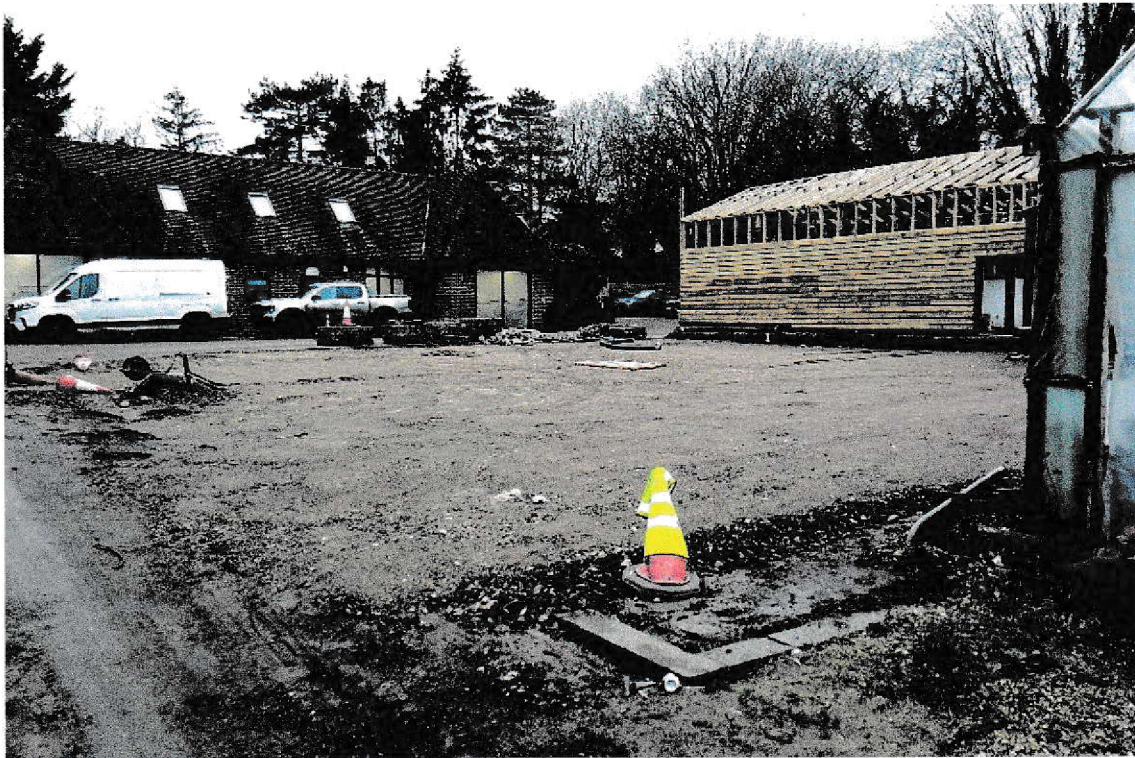
**Plate 2**

- 6.4 A drive formed from paving blocks passed along the west side of the site to the rear of the office building, an area of compact granular surfacing being under construction for the parking of light vans (Plate 2). Construction of a timber building was in progress to the west of the granular surfacing, planning permission for which is understood to have already been granted.

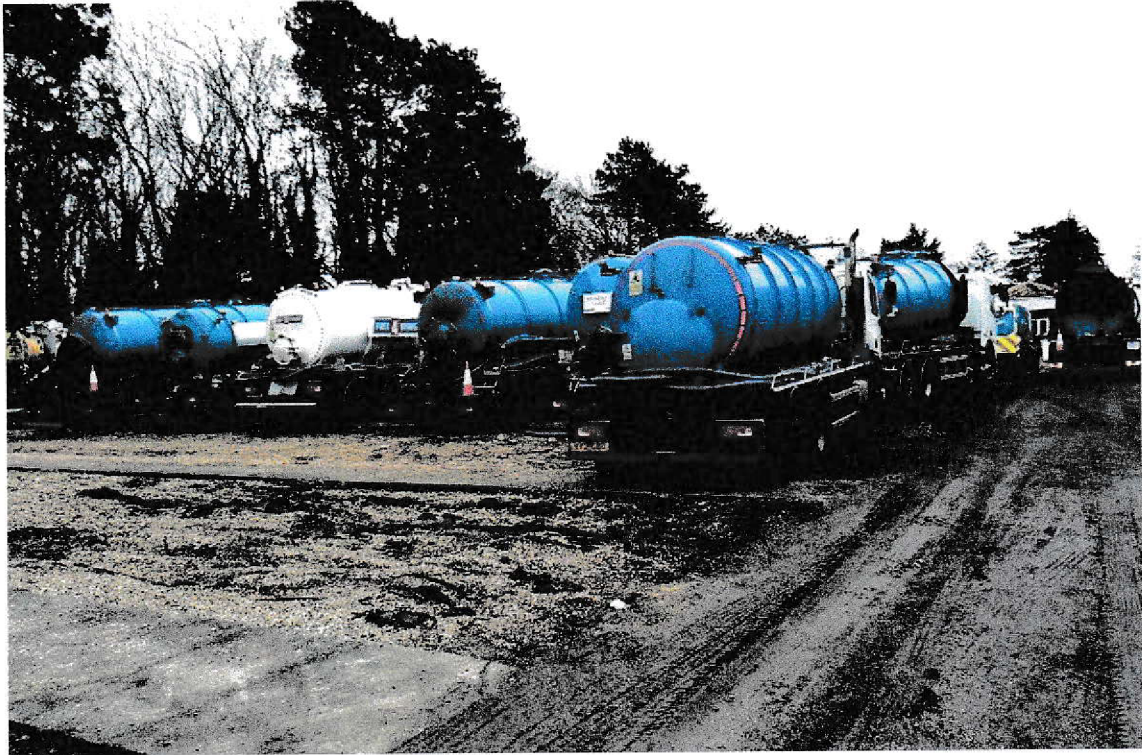
**Plate 3**

- 6.5 The rear of the site contained an area of compact granular surfacing on which were parked a number of HGV tanker lorries. Sections of former horticultural bays intersected by concrete paths and polythene greenhouses remained at the north end of the site.
