## Arboricultural Report

### Tree Condition Assessment

**46 Timber Bank  
Vigo  
Kent  
DA13 0SE**

Ref: SA/01/22

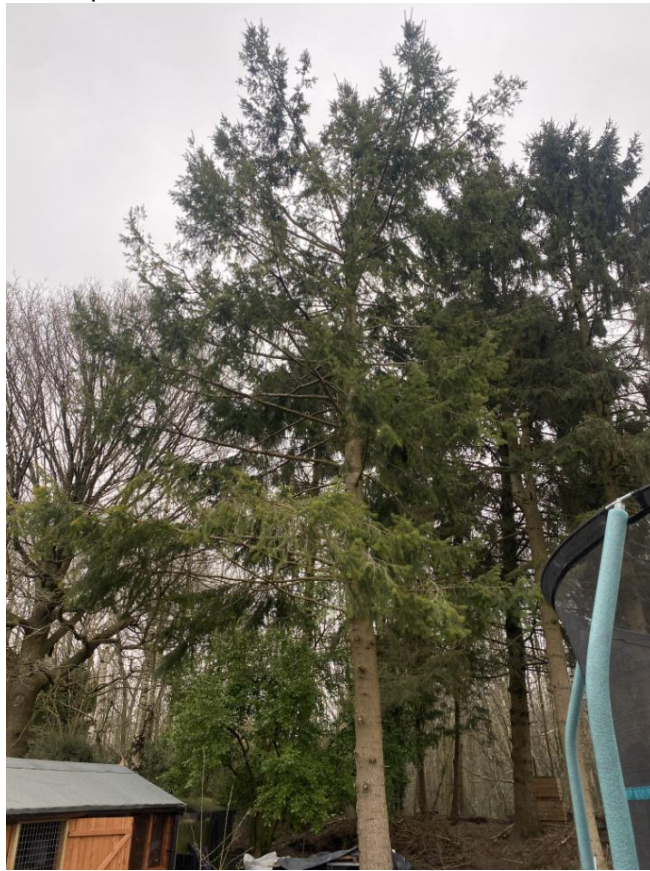
- 4.1.3 This particular tree has had the original top removed at 12m (either due to storm damage or pruning), with side branches now beginning to form multiple vertical leaders from the topping point.

- 4.1.4 This serves to establish a poor structural form that will present the risk of branch failures as these side branches develop to become multiple sub-stems from 12m.

| TPO ID No | SPECIES | HEIGHT (m) | STEM DIA. | AGE CLASS | NOTES / CONDITION | RECOMMENDED MGT. | WORK PRIORITY | INSPECTION FREQUENCY |
|---|---|---|---|---|---|---|---|---|
| T1 | Douglas Fir | 15 | 390 | Semi-mature | <ul style="list-style-type: none"> <li>- Top relatively recently lost at 12m, with whorl of branches beginning to take apical dominance.</li> <li>- Potential for significant growth development.</li> <li>- Bark damage to buttresses to S.</li> <li>- Will outgrow location.</li> </ul> | <ul style="list-style-type: none"> <li>• Fell</li> </ul> | L | 2 |

Photo 1: Tree T1 - Lost top at 12m.

| Tree No. | Species | Recommended Works | Reasons for Works |
|---|---|---|---|
| T1 | Douglas Fir | - Fell and grind stump. | <ul style="list-style-type: none"> <li>The tree is of poor form and will require ongoing management that will be detrimental to the structure and visual amenity of the tree.</li> <li>Will come to outgrow location.</li> </ul> |

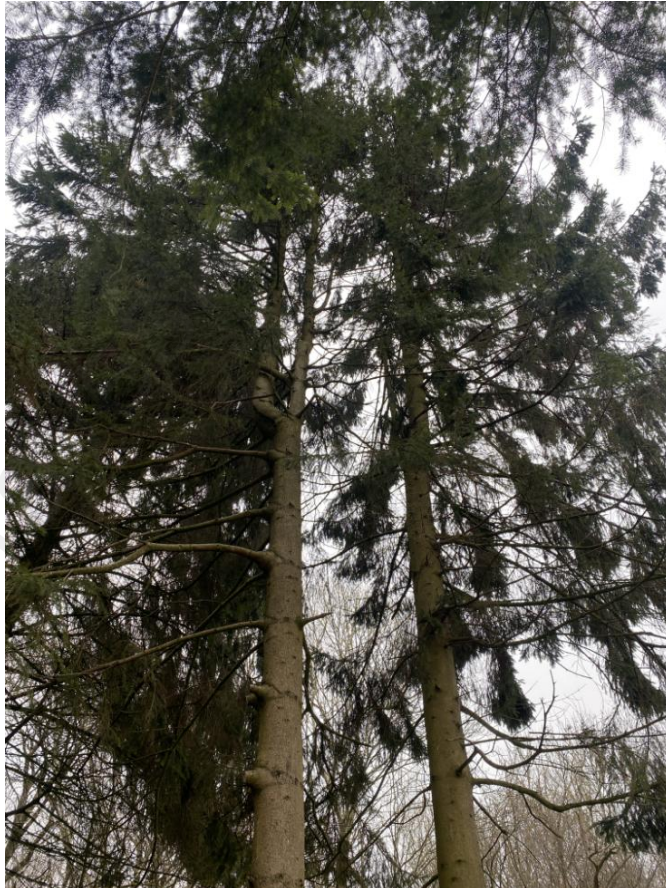
- 4.2.3 The main stems of both T2 and T3 have historically been lost at 8m (either due to storm damage or pruning), from which point two sub-stems have since developed to a current height of approx. 19-20m.

| TPO ID No | SPECIES | HEIGHT (m) | STEM DIA. | AGE CLASS | NOTES / CONDITION | RECOMMENDED MGT. | WORK PRIORITY | INSPECTION FREQUENCY |
|---|---|---|---|---|---|---|---|---|
| T2 | Norway Spruce | 19 | 370 | Semi-mature | <ul style="list-style-type: none"> <li>- Top historically lost at 8m, 2 x sub-stems developing to 19m.</li> <li>- Companion tree with T3.</li> <li>- Poor form.</li> <li>- Will outgrow location.</li> </ul> | <ul style="list-style-type: none"> <li>• Fell</li> </ul> | L | 2 |
| T3 | Norway Spruce | 20 | 350 | Semi-mature | <ul style="list-style-type: none"> <li>- Top historically lost at 8m, 2 x sub-stems developing, one being of more dominance and reaching 20m.</li> <li>- Companion tree with T2.</li> <li>- Poor form.</li> <li>- Will outgrow location.</li> </ul> | <ul style="list-style-type: none"> <li>• Fell</li> </ul> | L | 2 |

Photo 2: T2 & T3 - Bifurcated at 8m.

| Tree No. | Species | Recommended Works | Reasons for Works |
|---|---|---|---|
| T2-T3 | Norway Spruce x 2 | - Fell and grind stumps. | <ul style="list-style-type: none"> <li>These trees are of poor form and will require ongoing management that will be detrimental to their structure and visual amenity.</li> <li>Will come to outgrow location.</li> </ul> |

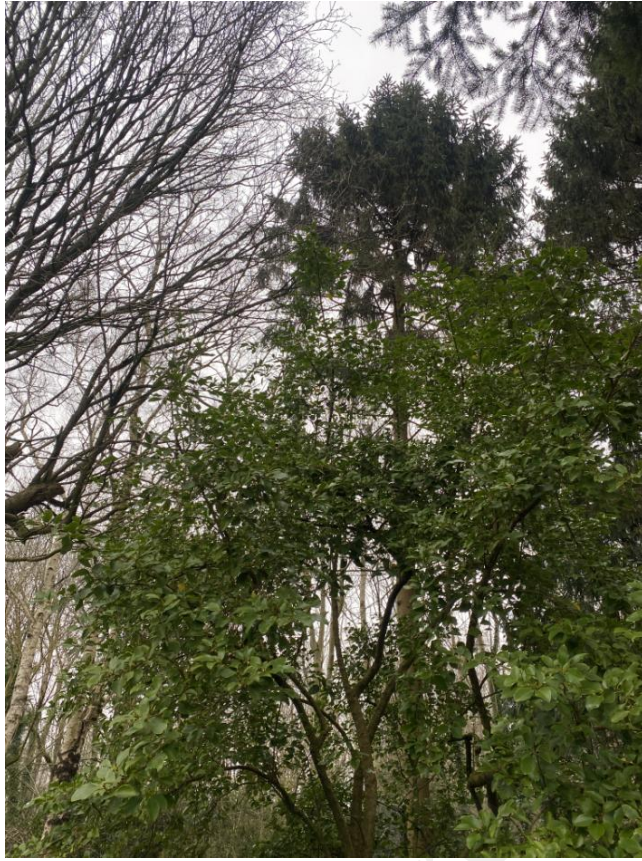
- 4.3.4 The proximity of this tree to the adjacent oak has resulted in the development of the oak canopy being suppressed. This is likely to become more pronounced as T4 continues to develop through to maturity. The further growth of T4 will also increasingly detract from the visual prominence of the higher value oak.

| TPO ID No | SPECIES | HEIGHT (m) | STEM DIA. | AGE CLASS | NOTES / CONDITION | RECOMMENDED MGT. | WORK PRIORITY | INSPECTION FREQUENCY |
|---|---|---|---|---|---|---|---|---|
| T4 | Norway Spruce | 18 | 370 | Semi-mature | <ul style="list-style-type: none"> <li>- Impacting on development of adjacent high value oak tree.</li> <li>- Significant growth potential.</li> <li>- Will outgrow location.</li> </ul> | <ul style="list-style-type: none"> <li>• Fell</li> </ul> | L | 2 |

Photo 3: T4 - Impacting on development of adjacent oak, will come to dominate.

| Tree No. | Species | Recommended Works | Reasons for Works |
|---|---|---|---|
| T4-T5 | Norway Spruce x 2 | - Fell and grind stumps. | <ul style="list-style-type: none"> <li>Will come to significantly outgrow the setting and dominate the small garden setting.</li> </ul> |

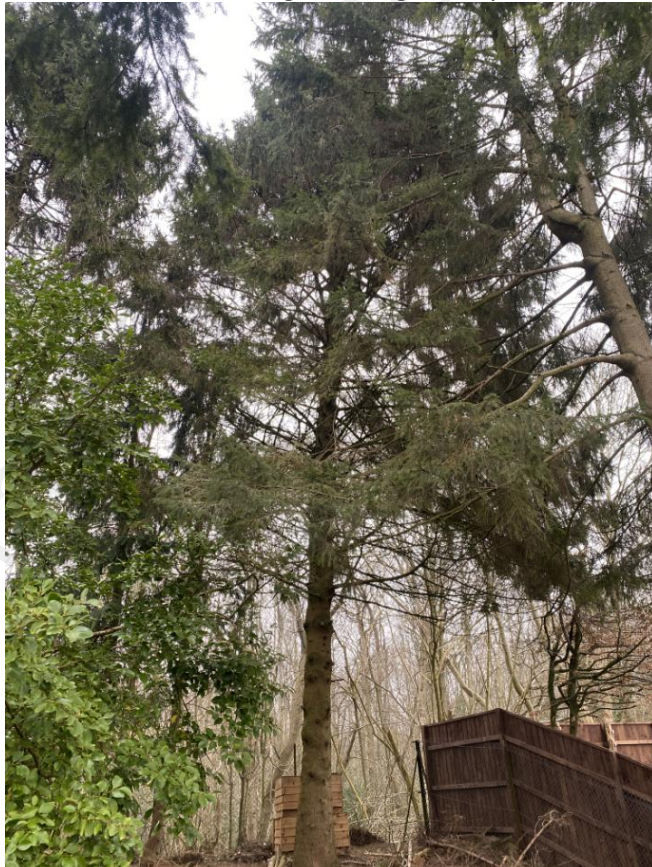
- 4.4.3 T5 is the most dominant tree of the five trees in the garden, being of good form and vigorous physiological condition. This suggests that there would be no reason to expect the tree to not attain full height potential at maturity.

| TPO ID No | SPECIES | HEIGHT (m) | STEM DIA. | AGE CLASS | NOTES / CONDITION | RECOMMENDED MGT. | WORK PRIORITY | INSPECTION FREQUENCY |
|---|---|---|---|---|---|---|---|---|
| T5 | Norway Spruce | 18 | 530 | Semi-mature | <ul style="list-style-type: none"> <li>- Dominant and vigorous individual with significant growth potential.</li> <li>- Will outgrow location.</li> </ul> | <ul style="list-style-type: none"> <li>• Fell</li> </ul> | L | 2 |

Photo 4: T5 - Large dominant tree with significant growth potential.
