**wright**  
landscape and arboriculture

**RE: Tree removal and pruning at The Mill House, Mill Hill Lane, Shorne DA12 3HA**

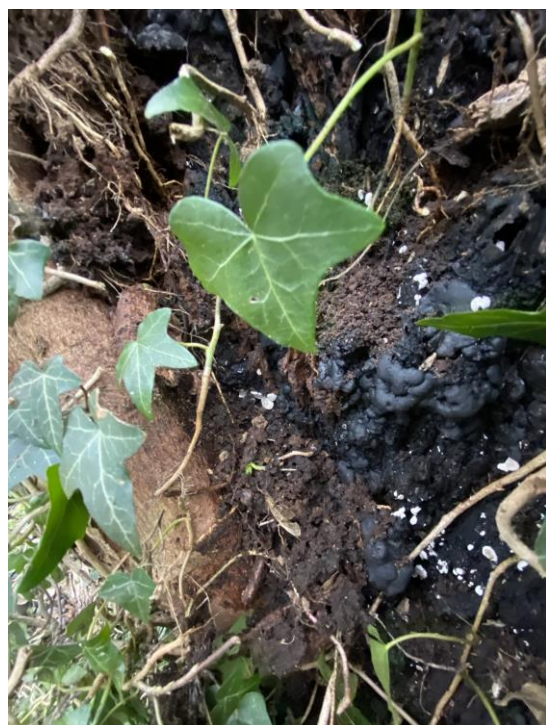
In general terms, the trees are healthy with the exception of two trees at the southern edge of this group. One of these trees hosts a large cavity at the base and this cavity is filled with both mature and immature fruiting bodies of the wood decay pathogen, *Kretzschmaria deusta*. This fungus causes rapid decay in wood cells, leading to brittle fracture of the stem often without warning. Failure of the tree is foreseeable and unfortunately the tree directly adjacent to it has grown so bent and suppressed in the shadow of the decayed tree that retention would be impossible once the other tree is removed; the sudden wind loading of this tree being likely to lead to immediate failure.

Figure 1; Fungal fruiting bodies of *Kretzschmaria deusta* on G1 sycamore. Cavity is approx.. 11" wide and 8" deep

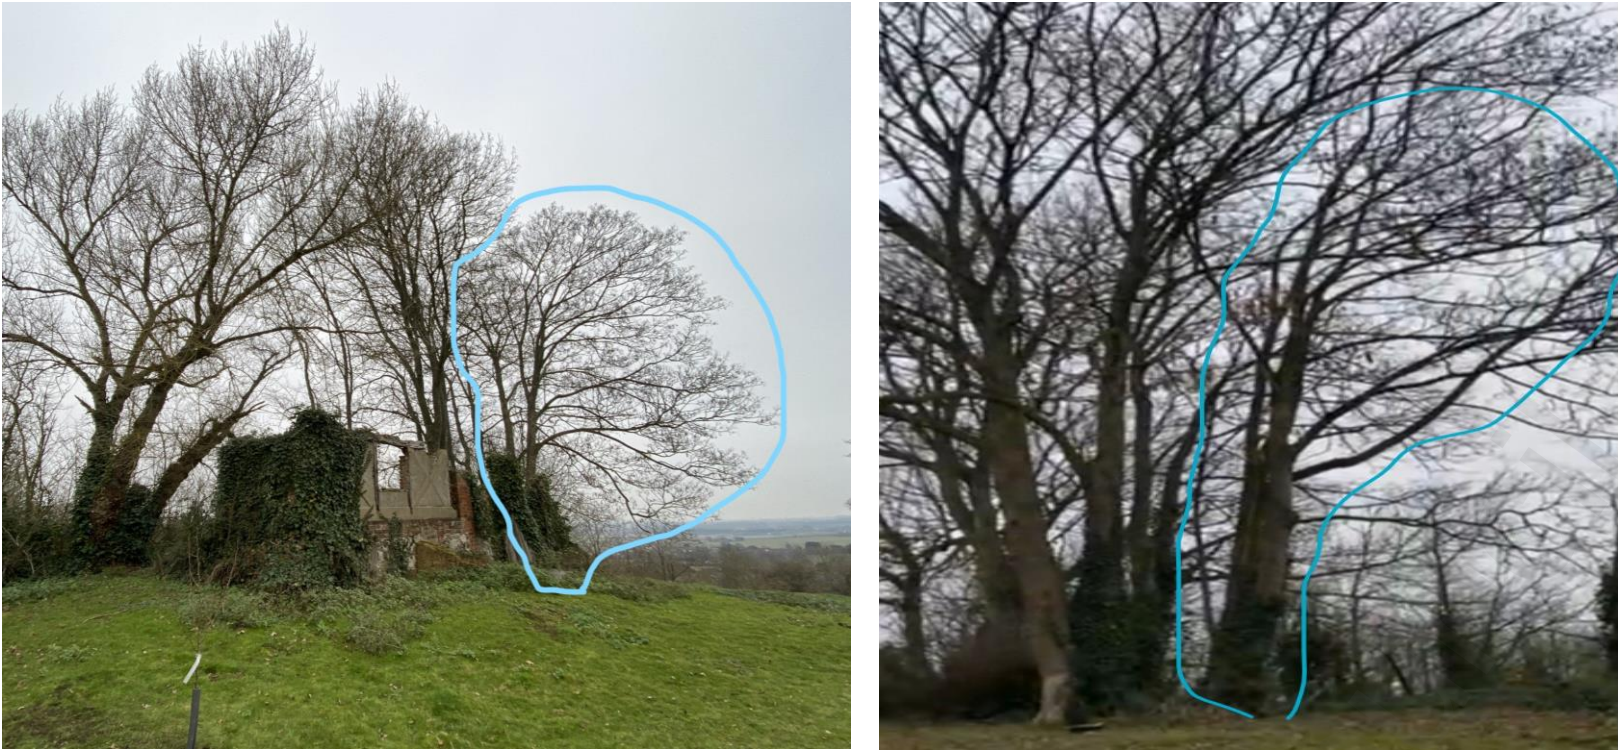
Of the trees I inspected, three individual trees and two tree groups are in urgent need of works. The first tree group, labelled G1 on the attached plan, consists of a number of sycamores. These trees have self-seeded at the side of the old mill. The conservation area boundary map indicates these trees may be outside of the conservation area, but these trees have been included within this notification in the interests of completeness.

Fig.2; Group G1 (left) with blue circle annotating trees which are affected. (Right) blue annotation around second of the two trees, showing canopy bias away from decayed tree and vulnerability from exposure when the decayed tree is removed.

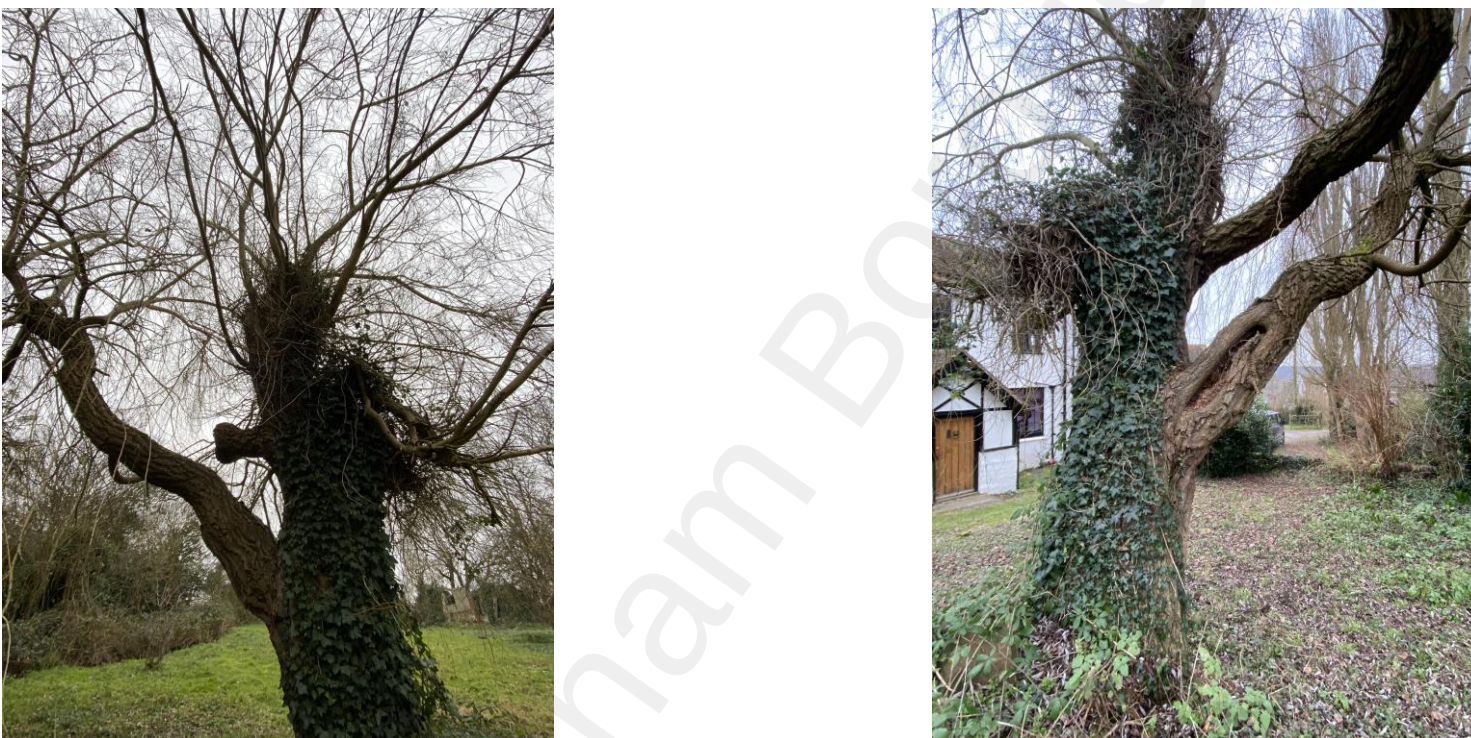
Tree T3 is a mature weeping willow. At some point in this tree's life, the top has snapped out and has left the tree with a large wound on the main stem. The willow, in attempts to grow a replacement canopy, has put its growth efforts into a side branch. Unfortunately, this side branch has a large cavity (approximately 20" long) and there is evidence of extensive decay within. The limb is so extensively decayed that failure is foreseeable, and my concern is that once this limb fails the wound created by this loss will be so large that the structural integrity of the remainder of the tree will be at risk. I recommend that the tree is felled and replaced.

Fig.3; Willow T3. Left image shows lost leading branch and predominance of subordinate lateral branch (decayed). Right image shows decay in that limb and the size of the limb relative to the main stem.

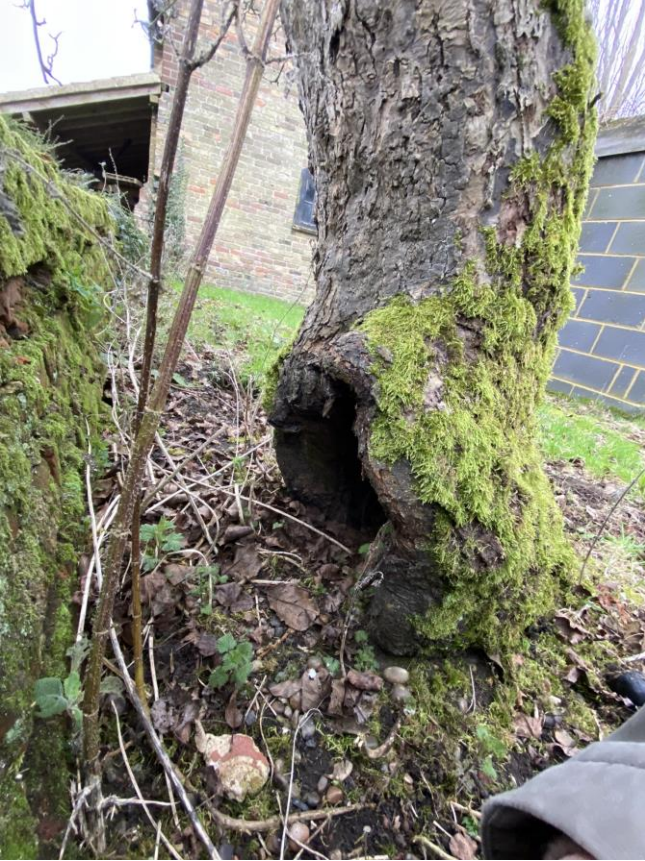
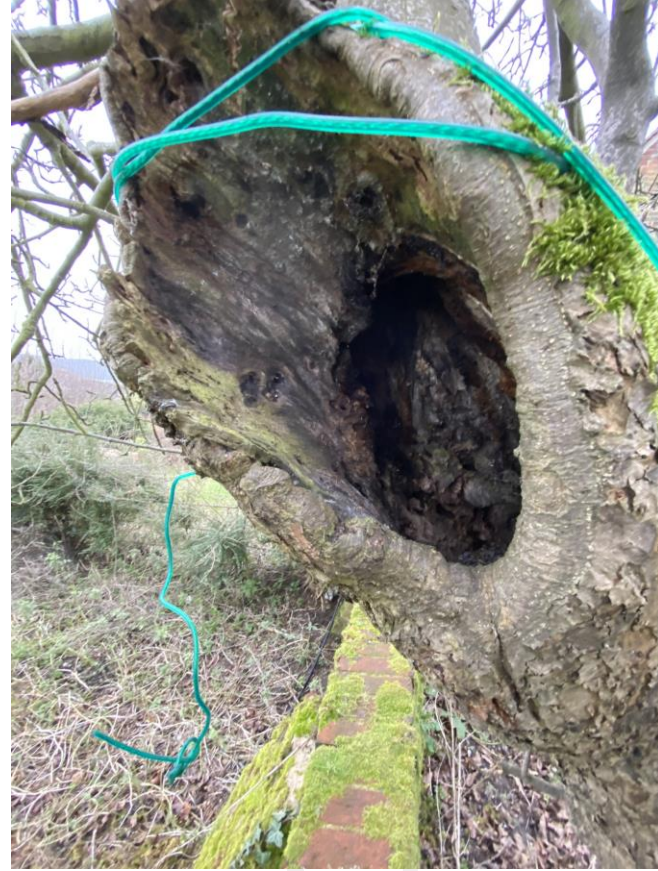
Tree T4 is an over mature apple. The tree has a large cavity at the base on the east side of the stem; this cavity stretches up the stem to crown break at approximately 5', where it joins with an old pruning wound. Whilst apple is a species which is known for compartmentalising decay, there is little live sapwood which survives and unfortunately failure of this tree is foreseeable. My client seeks to remove the tree and is happy to replace it with another heritage apple species.

Fig.4; T4 apple. Left – cavity at the base joining (right) cavity just below crown break.

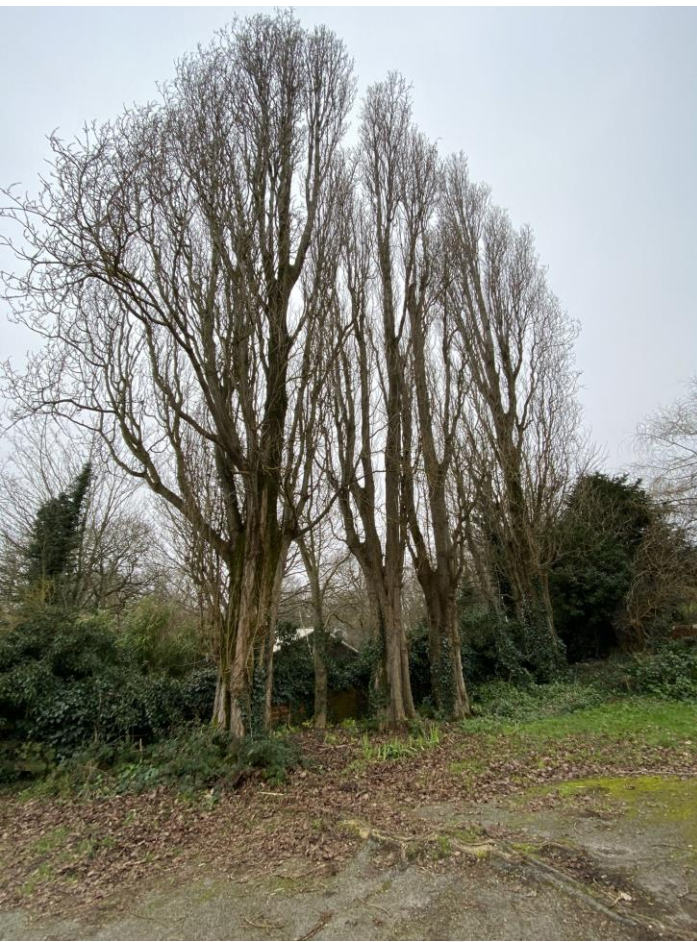
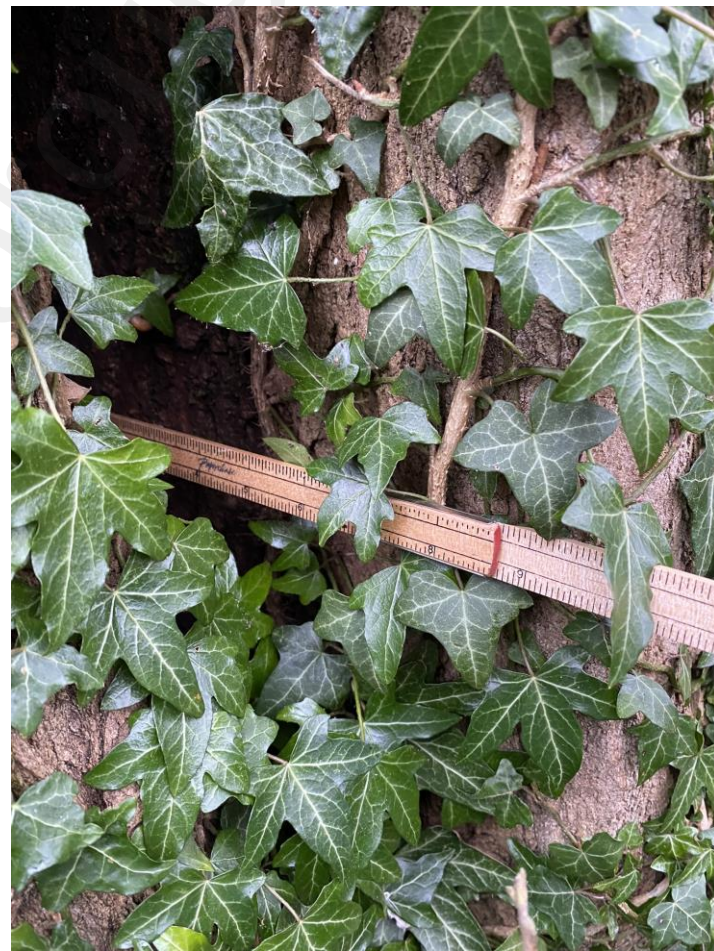
Most concerning of all my inspections is group G5, consisting of five mature Lombardy poplars. The trees border the driveway and the scout hut to the west. Being very close to property, I gave these trees a close inspection and found extensive decay, cavities and hollow stems in all but the last (northern-most) tree of the group. Poplar wood is not resistant to the spread of decay, and it is advised that the decayed trees are removed at the earliest opportunity. Once the four decayed trees are removed, the remaining fifth tree will also need to be removed; its sudden exposure following the felling of adjacent trees will subject this tree to wind loading from directions to which it has not grown accustomed.

Fig.5; Group G5 poplars. Left image showing trees within the group and ash tree growing on boundary between first and second trees. Right image showing cavity (second poplar) approx. 7" deep at base of stem.

This uneven and sudden wind loading will lead to failure of the tree; this is commonly seen in stands of trees following thinning operations and given that this tree is the closest to property and to the scout hut the risk of retaining it outweighs what remaining benefit the tree would provide. Once the group is removed, the trees can be replaced with species more befitting the rural nature of the conservation area. Growing at the property boundary (and underneath the canopy of G5) is a semi-mature ash tree. Once the poplars are removed, this ash will have the space and resources to grow and will assist the replacement trees in recovery of screening lost by the removal of the poplars.
