**INTERMEDIATE STRUCTURAL  
PLANNING SURVEY**

Rutherford Stables  
r/o Hilary Cottage  
Hermitage Road  
Higham  
Kent  
ME3 7NE

**REPORT NUMBER** FC2015/209

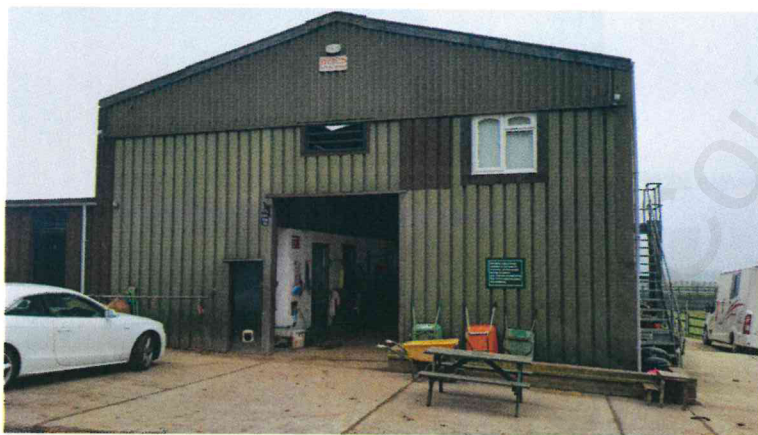
The premises are generally as previously described, being a steel portal frame agricultural style shed, used as a stabling building with ancillary services and tack rooms and mezzanine accommodation. The building is clad with fibre cement sheet over the roof and single skin metal profile sheet to external walls on a masonry sub-structure. The building is approximately 25.5 metres long x 15.6 metres wide being approximately 7.2 metres to ridge and 5.5 metres to eaves. Fig.1.

External examination indicates the building to be of good line and level, showing no deviation in horizontal or vertical alignment to suggest any neither recent nor past settlement or subsidence effects.

1. Front elevation.

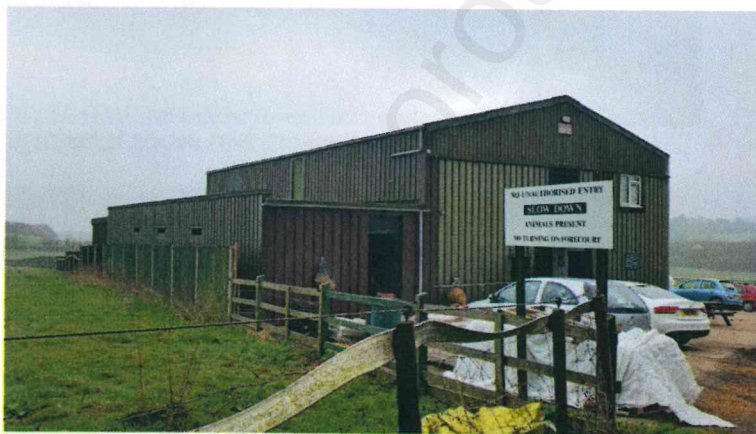
2. Left side elevation.

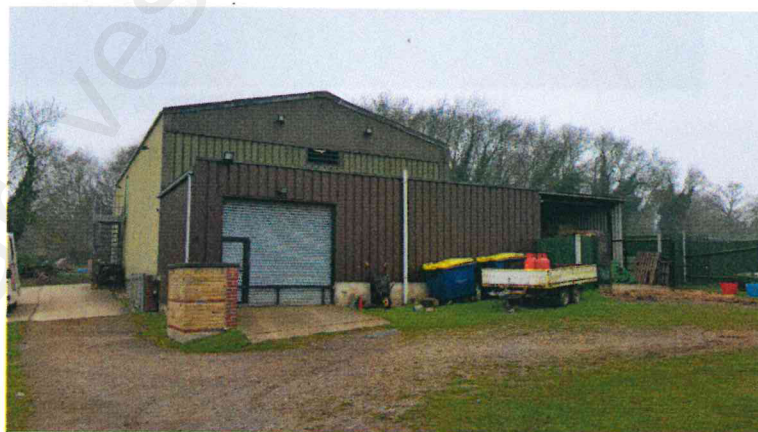
The property has a number of timber personnel doors and hand operated roller shutter door serving the main stabling area. The rear extension is partially open and also fitted with galvanised roller shutter door all in good order. Fig 3 The PVC rainwater goods are generally found to be in satisfactory condition and windows are serviceable.

3. Rear elevation.

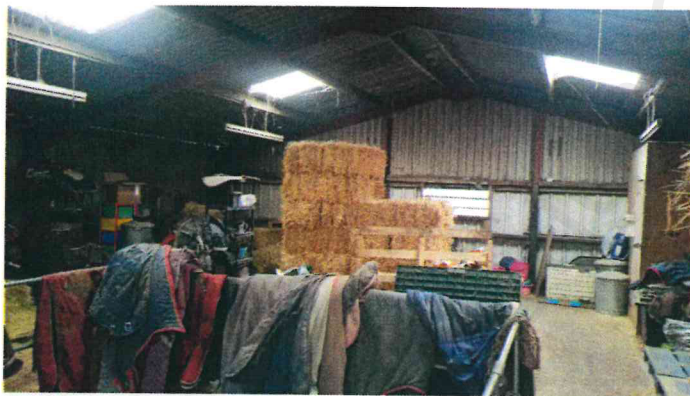
5. Internal above mezzanine level.
