**PROPOSED REDEVELOPMENT AT  
UNIT K6, LOWER ROAD, NORTHFLEET,  
KENT DA11 9BL.**

**PHASE I GEO ENVIRONMENTAL DESK STUDY  
AND PRELIMINARY RISK ASSESSMENT**

**March 2022**

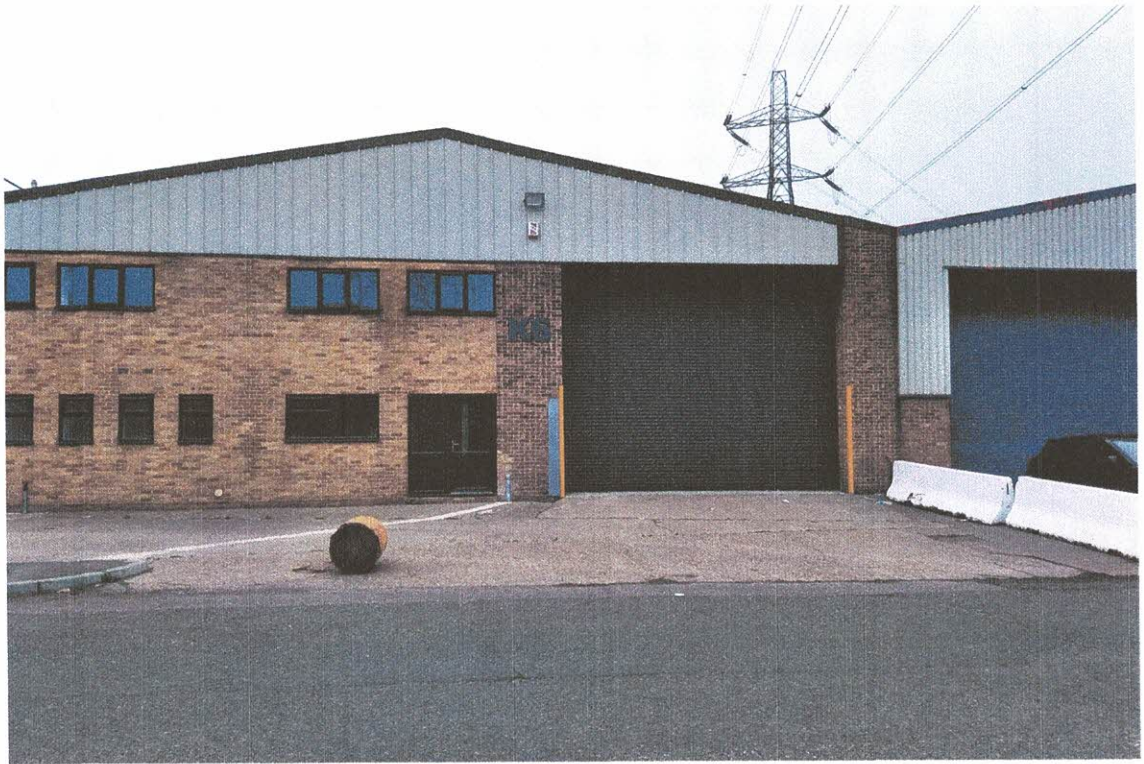
**Plate 1**

- 7.3 The site comprised a vacant unit of brick and steel construction contained within a larger rectangular block of similar commercial premises (Plate 1). The east section of the unit supported two-storey office accommodation, with a roll-over commercial vehicle entry point to the west. Access into the building was unavailable.

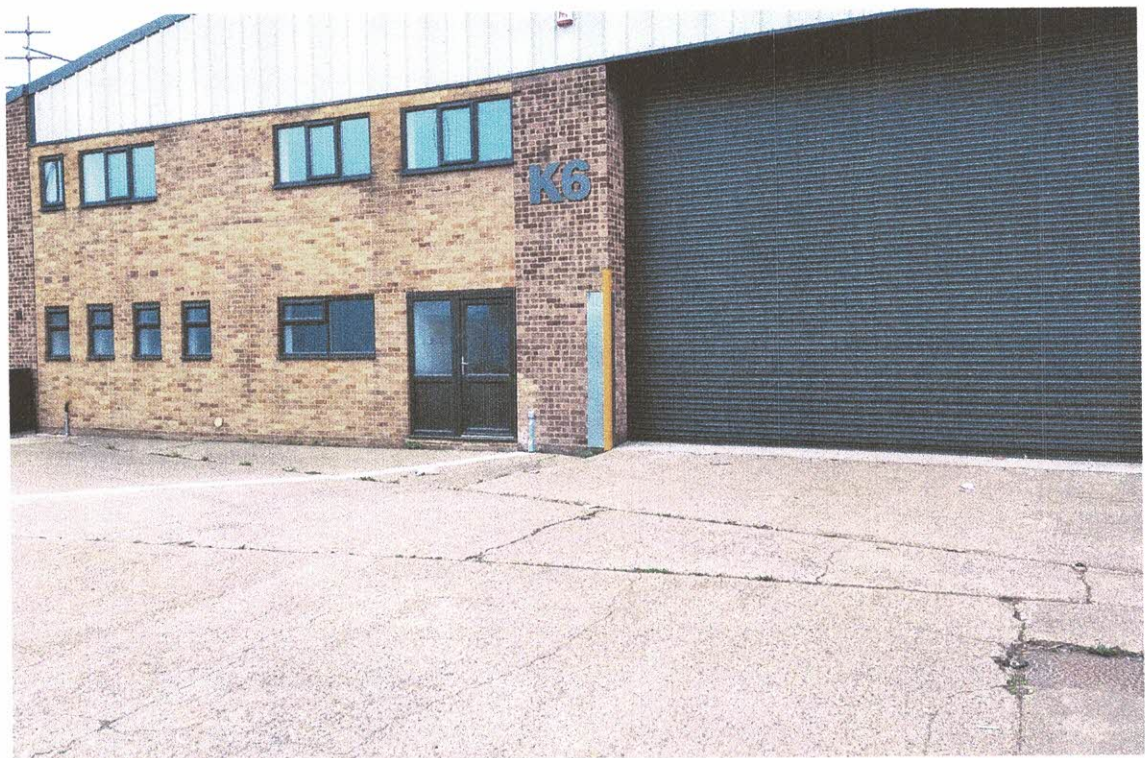
**Plate 2**

- 7.4 Concrete surfacing of an unstained appearance was present at the front of the building, adjacent to the estate road (Plate 2). A trailer was parked on the roadside to the front of the building.

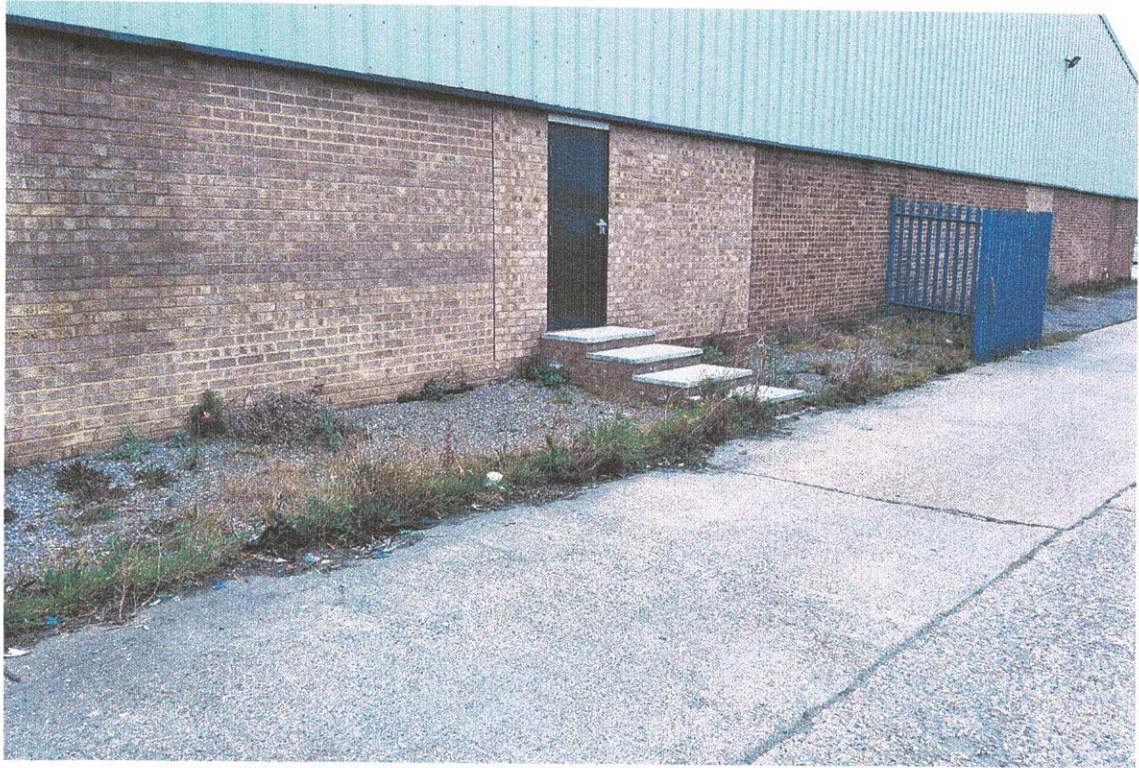
**Plate 3**

- 7.6 Access to the rear of the site was gained via a concrete road which led from the end of the estate road around the east end of the main block and alongside the rear of the units. The rear elevations of the units were of brick construction under a steel roof. A single door accessed via a short flight of steps was present on the rear elevation of the subject unit (Plate 3). Compact granular surfacing approximately 2m in width with patches of emergent weeds formed the ground surface between the concrete road and the rear elevation of the unit.

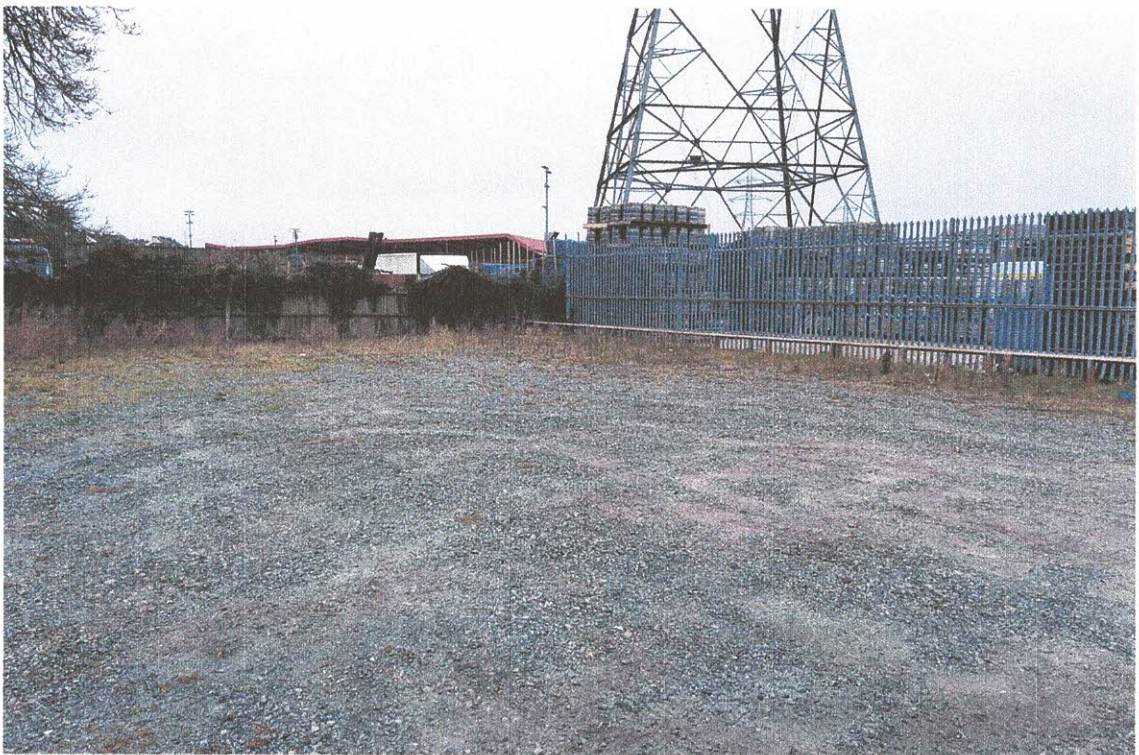
**Plate 4**

- 7.7 The rear section of the site comprised a vacant, roughly square area of compact granular surfacing located on the south side of the concrete road and enclosed on its east and west sides by steel railings. A panelled timber fence formed the south boundary of the site (Plate 4 to Plate 6). The southeast corner of the site contained a mature Oak tree.

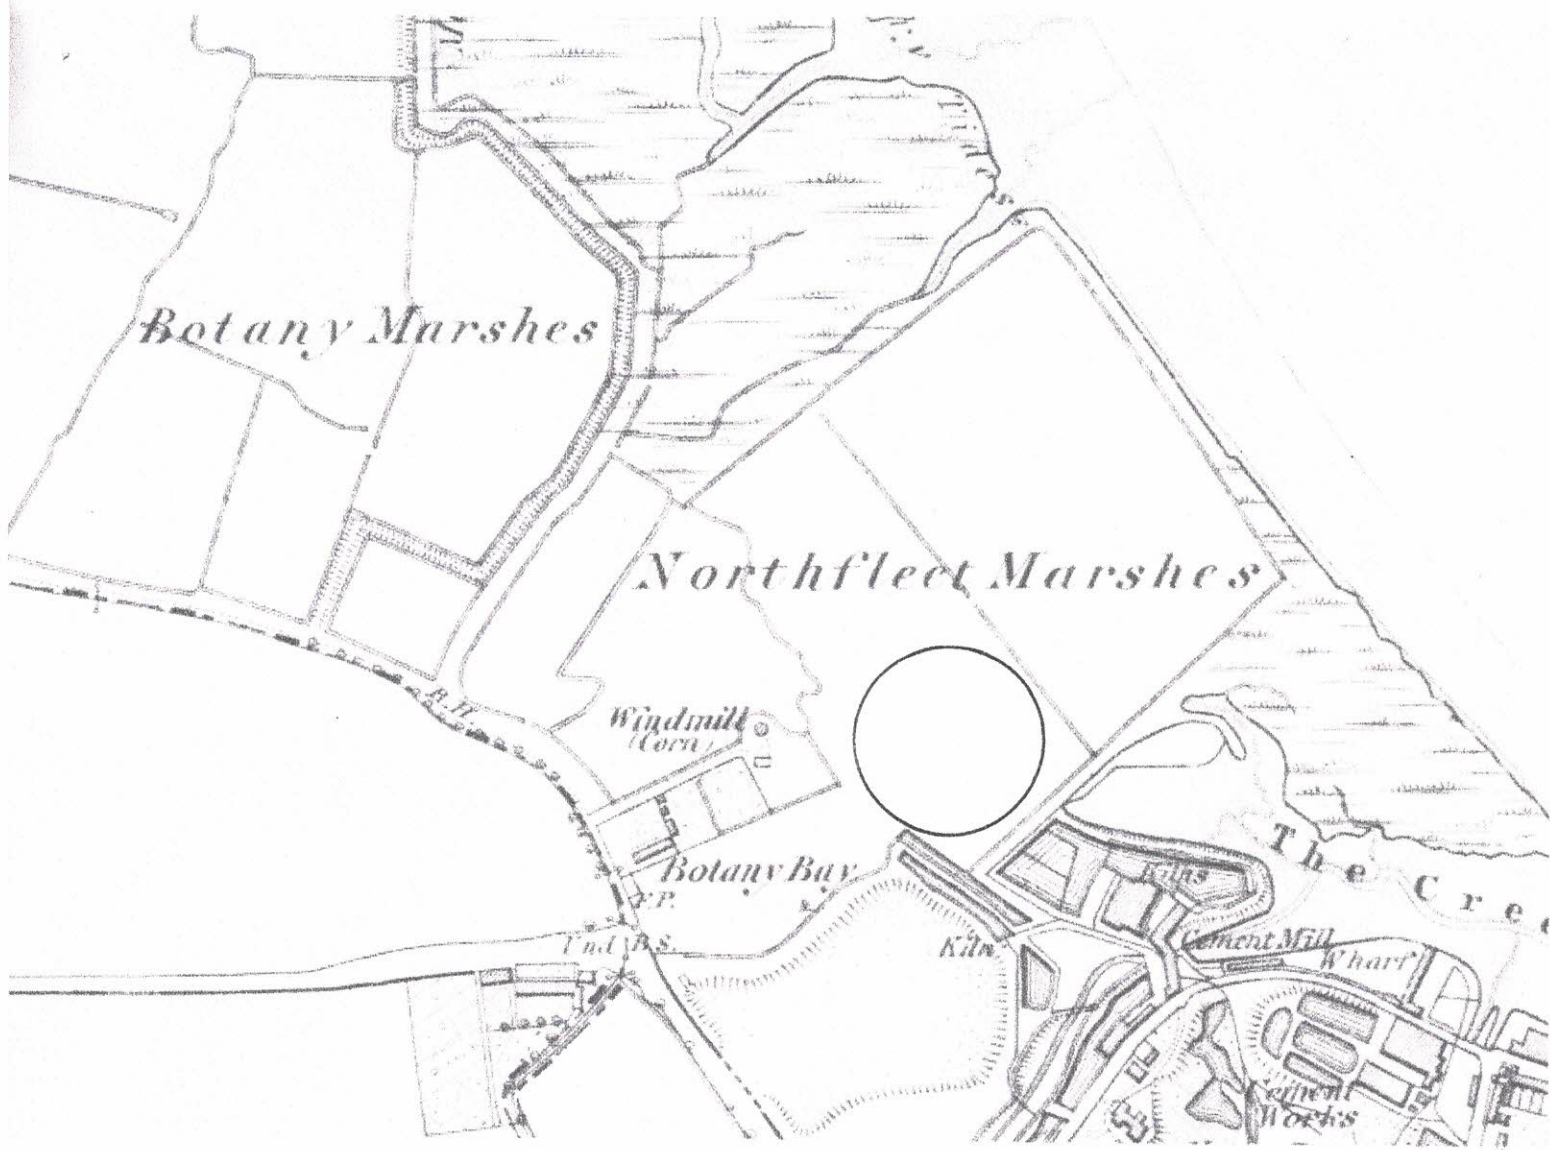
**Unit K6 Lower Road, Northfleet.**  
**OS map scale 1:2500 1869.**

marshes. A drainage ditch passes roughly west to east across the site, discharging into a meandering surface watercourse to the north.

**Off site:** A corn windmill and an associated building are located adjacent to the northwest corner of the site. An additional surface watercourse is present within 10m to the northwest. Kilns are denoted within 100m to the south and southeast, a quarry also being in evidence within 100m to the southwest. Cement Works are located within 200m to the southeast of the site.

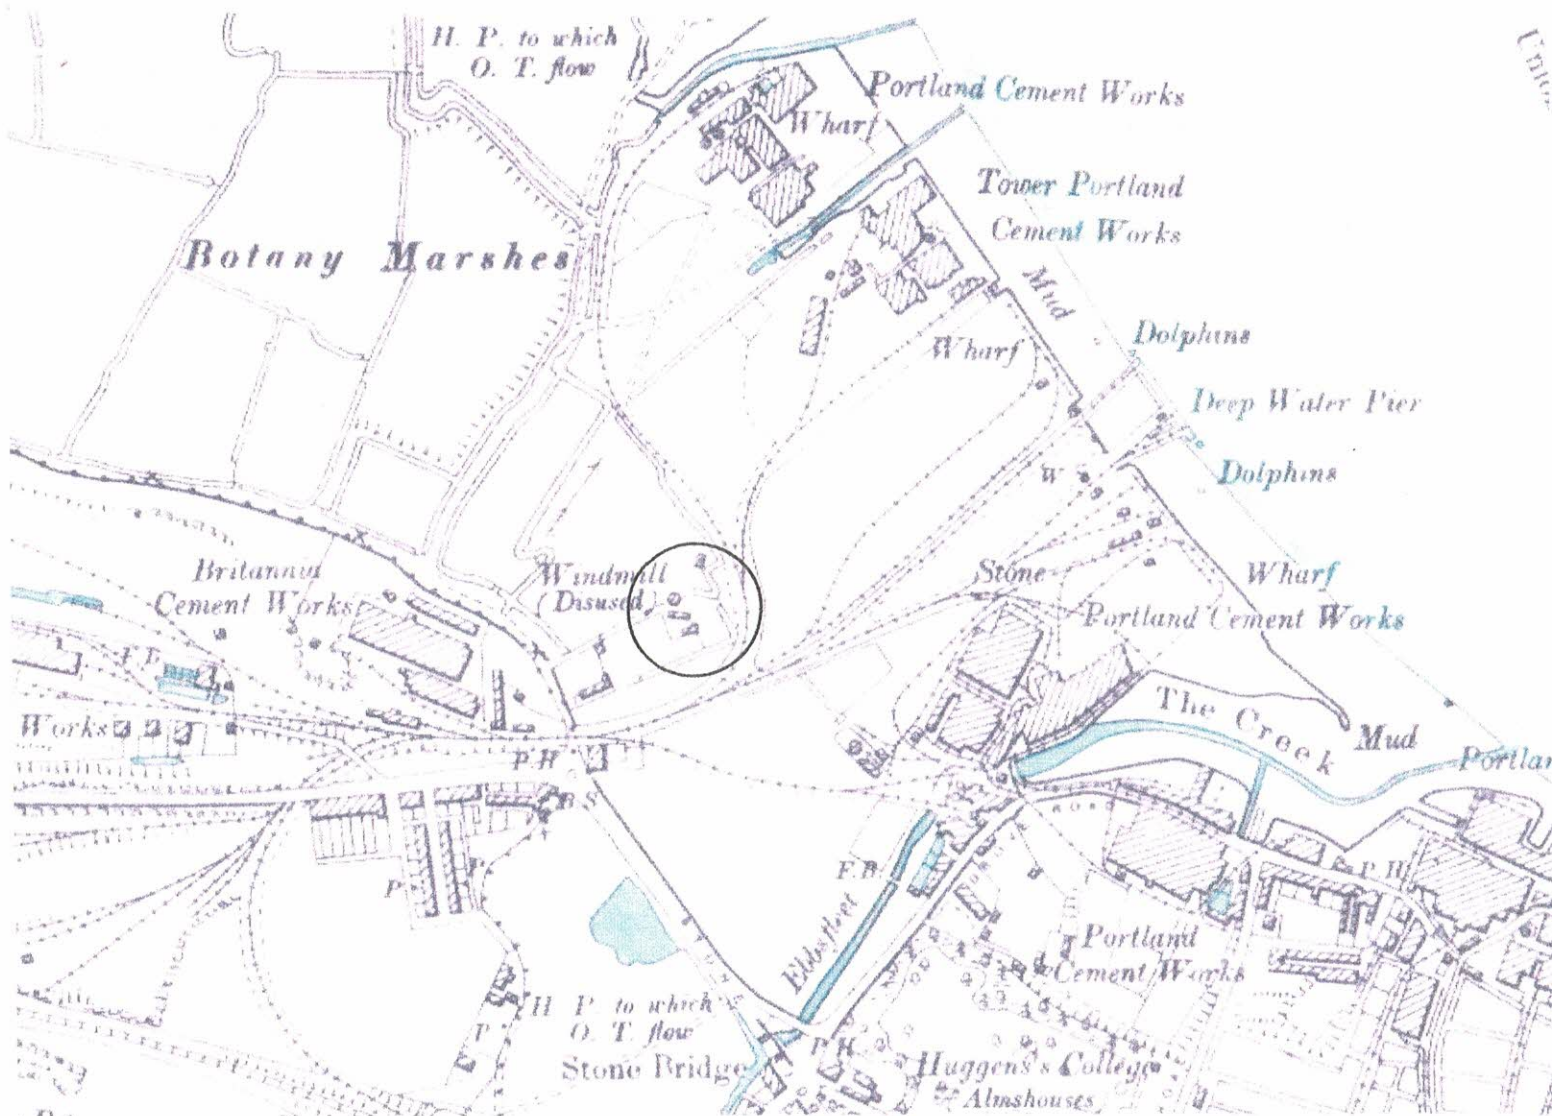
Unit K6 Lower Road, Northfleet.  
OS map scale 1:2500 1898.

**On site:** Tramways have been installed within the local area and appear to cross the southeast corner of the site.

**Off site:** An additional building has been constructed next to the windmill, though the windmill is now disused. Additional cement works and associated tramways have been installed within 200m to the west of the site and within 400m to the northeast, a quarry associated with the former cement works being located within 250m to the west. A flooded quarry is in evidence within 200m to the southwest. Wharfs have been installed alongside the estuary to the northeast. The quarry to the south is no longer denoted.

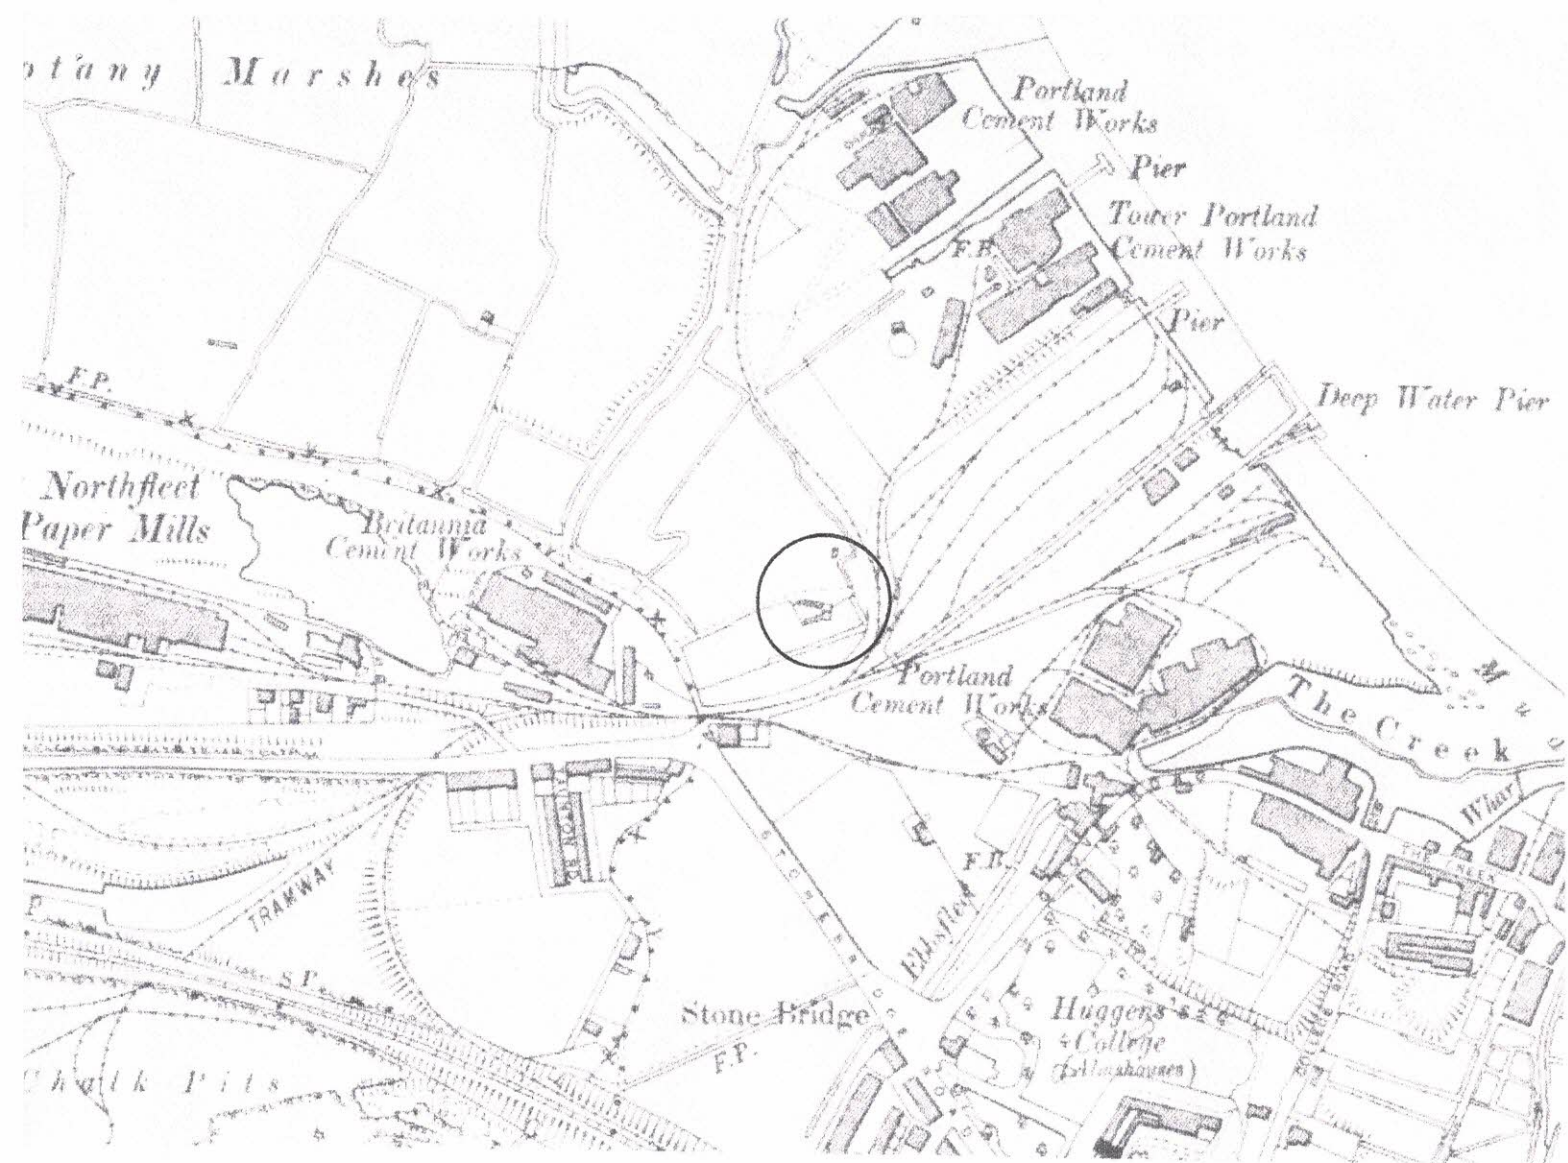
**OS map scale 1:2500 1910.**

**On site:** No significant change.

**Off site:** The windmill has been demolished, though the pair of adjacent buildings remain. The flooded quarry to the southwest has been infilled. Northfleet Paper Mills have been established within 300m to the west of the site.

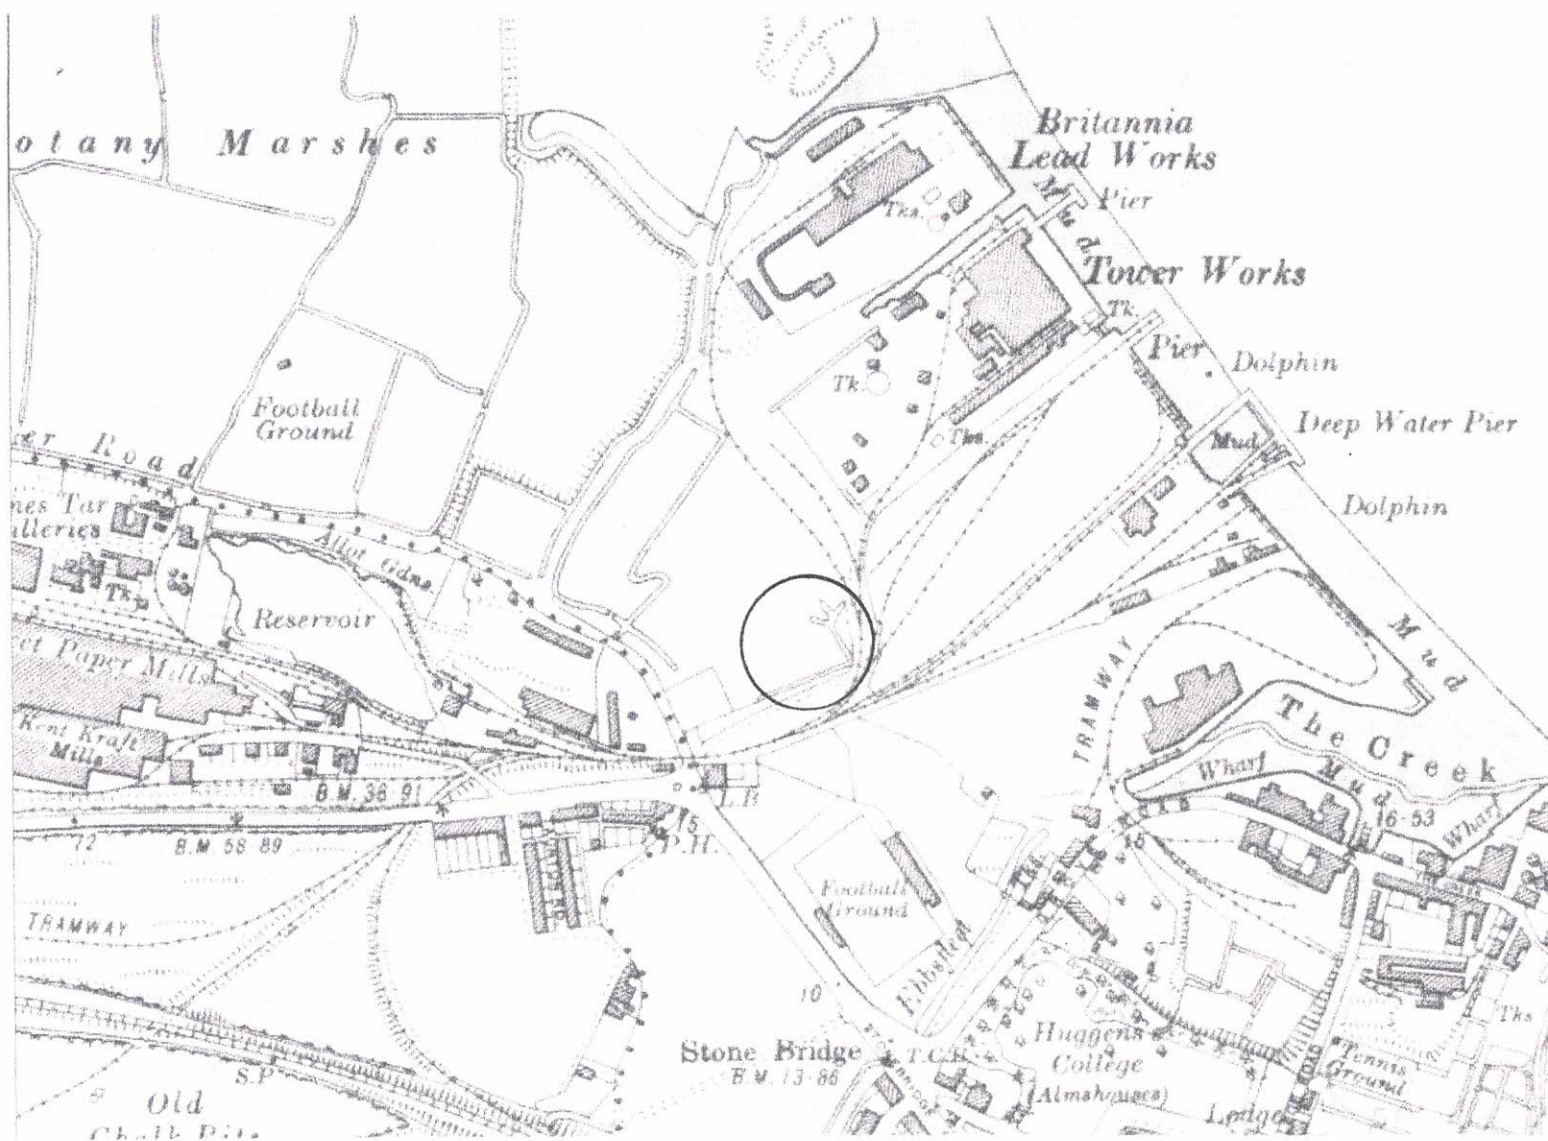
Unit K6 Lower Road, Northfleet.  
OS map scale 1:2500 1934.

**On site:** No significant change.

**Off site:** The quarry to the west is now referred to as a reservoir. The Britannia Lead Works are denoted within 400m to the northeast of the site.

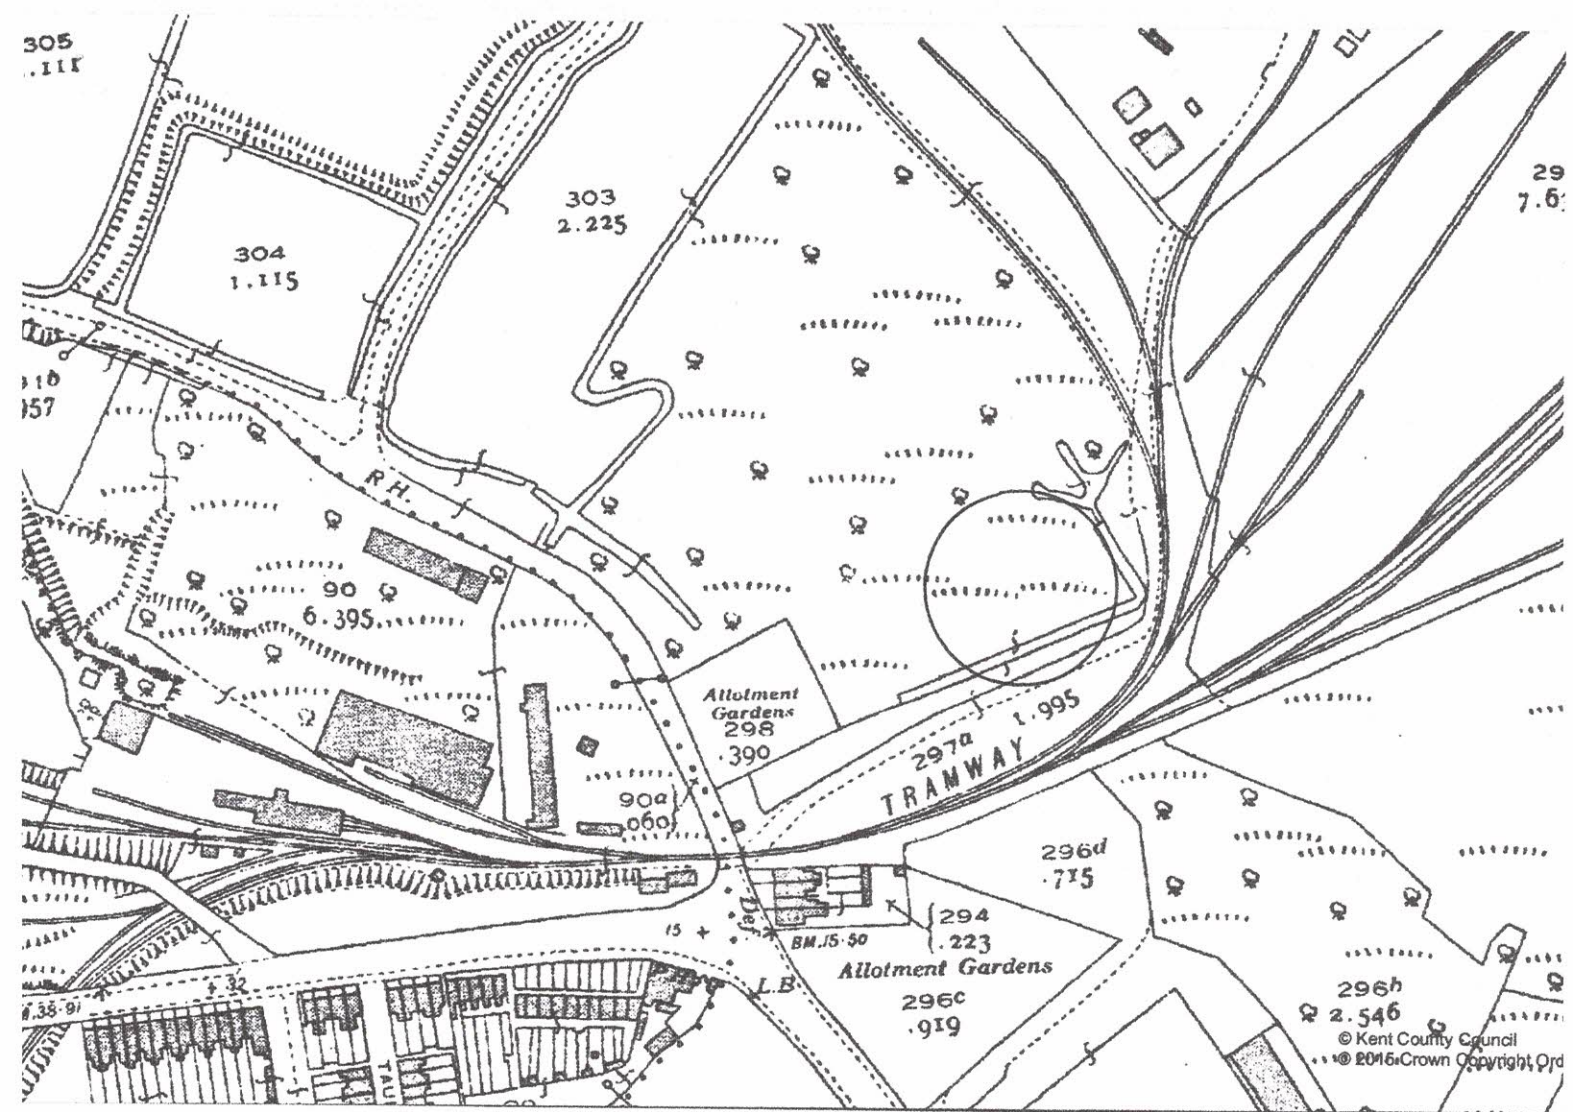
Unit K6 Lower Road, Northfleet.  
OS map scale 1:2500 1929-1952.

**On site:** No significant change.

**Off site:** Allotment gardens are denoted within 25m to the west of the site.

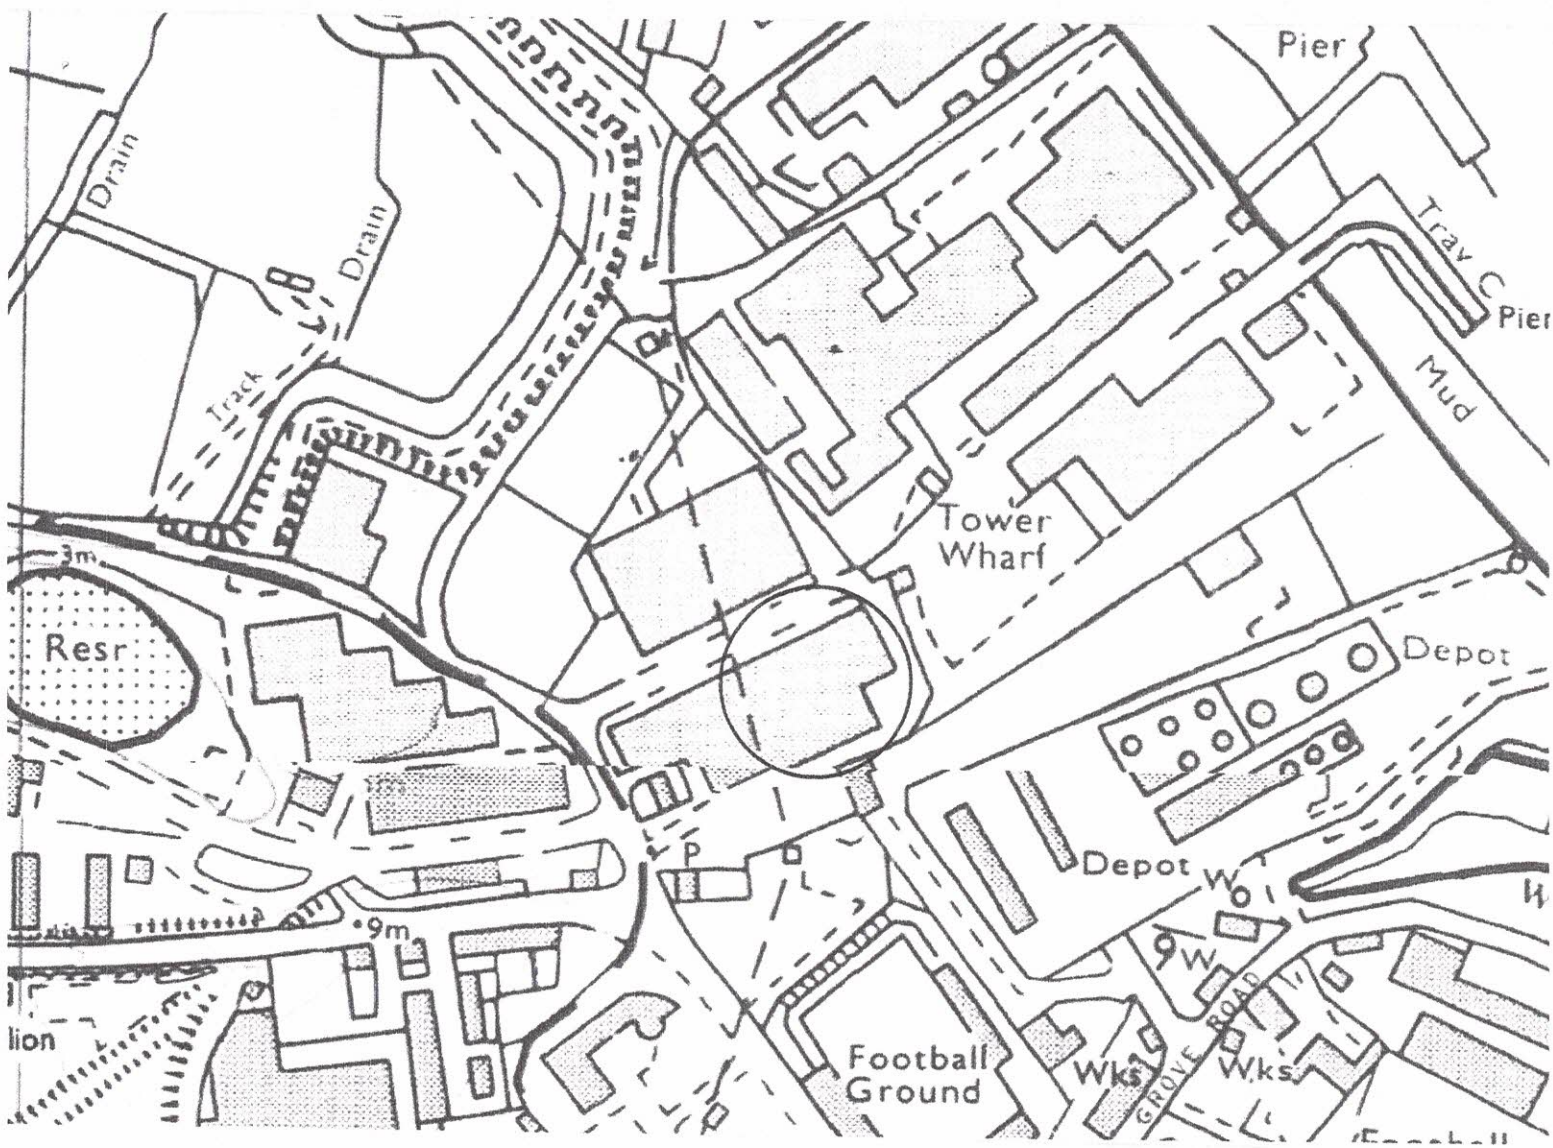
**Unit K6 Lower Road, Northfleet.**  
**OS map scale 1:10000 1991-1993.**

**On site:** A large building incorporating the existing unit is now present on the site, extending across the former allotments to the west.

**Off site:** The tramways have been removed and the surrounding area extensively developed with buildings of commercial appearance. Depots are denoted within 100m to the south and southeast. Works are also located within 200m to the southeast. The football ground remains to the south.
