# **PHASE 1 DESK STUDY AND PHASE 2 SITE INVESTIGATION REPORT**

**CASCADES LEISURE CENTRE,  
THONG LANE, GRAVESEND,  
KENT DA12 4LG**

**WILLMOTT DIXON CONSTRUCTION LTD**

**25/13244/KJC REV 1**

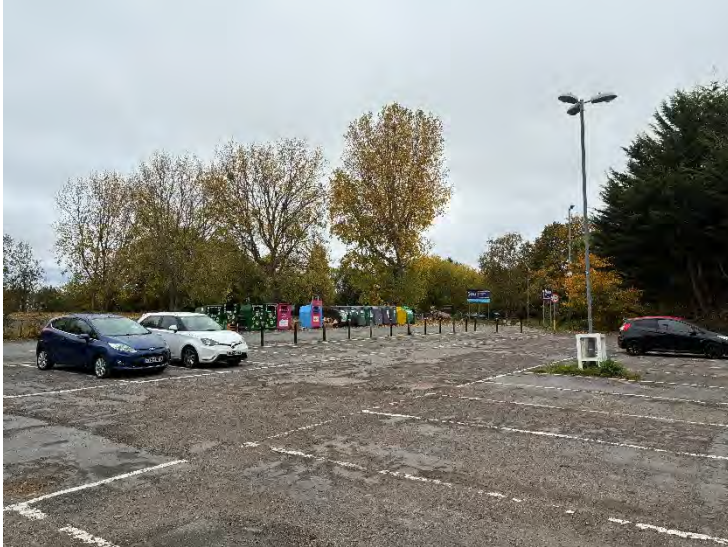
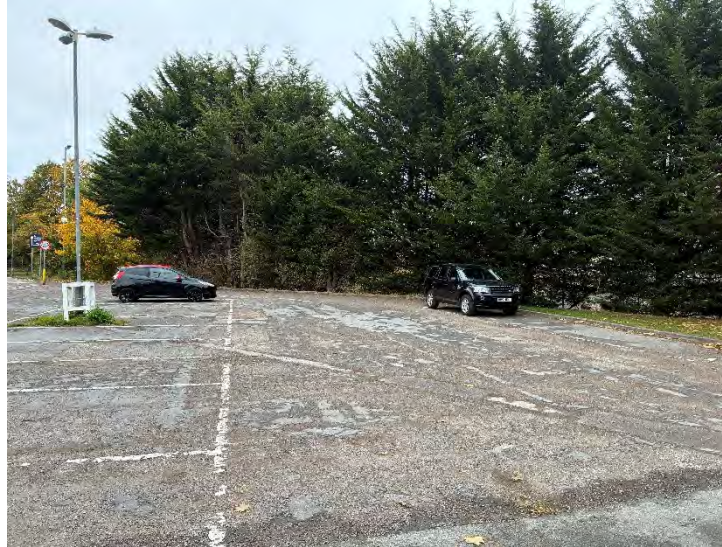
Car park in north west corner

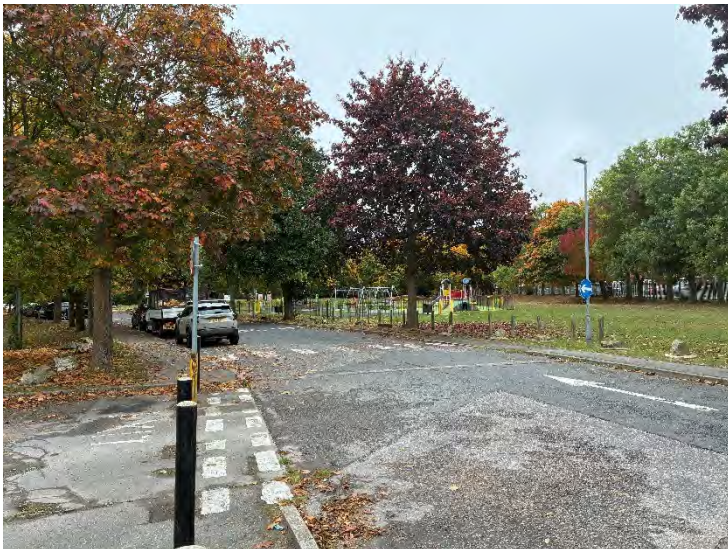
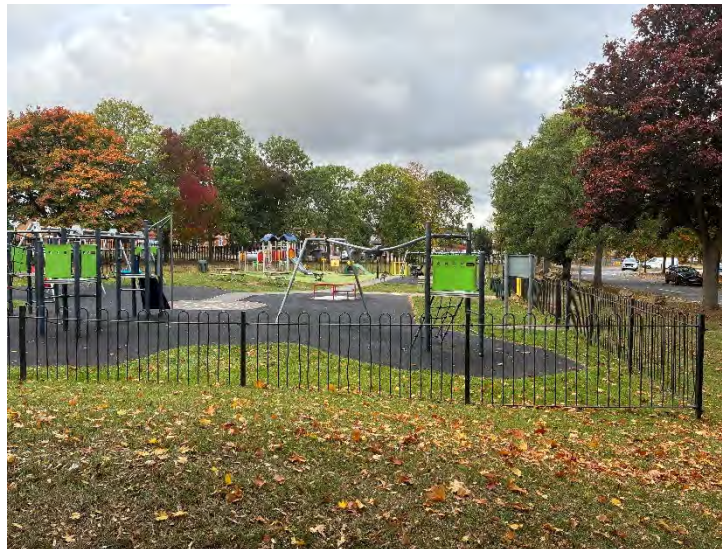
Existing children's play area

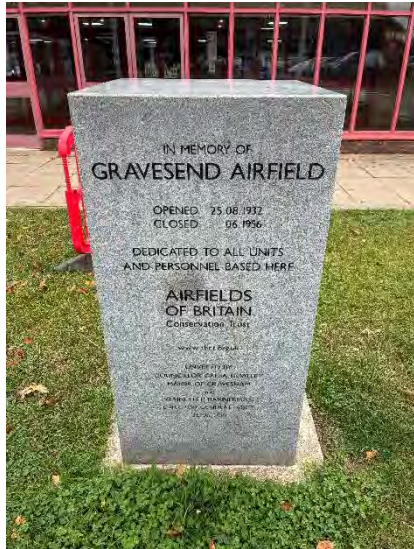
WWII Memorial stone

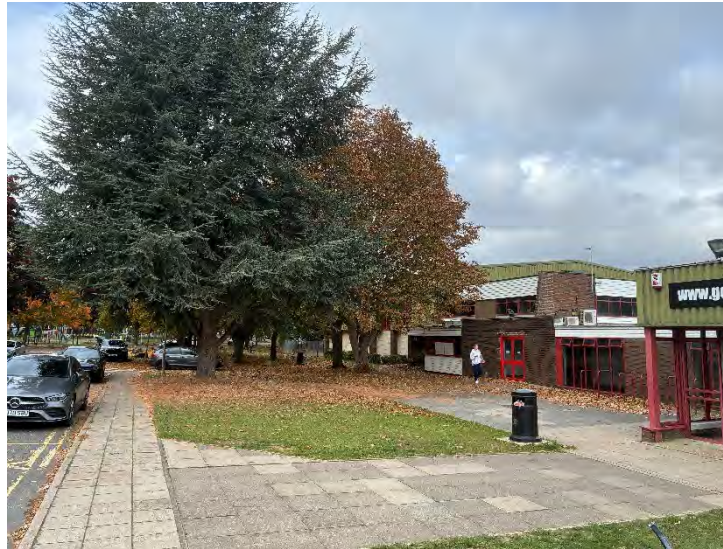
Front of Leisure Centre

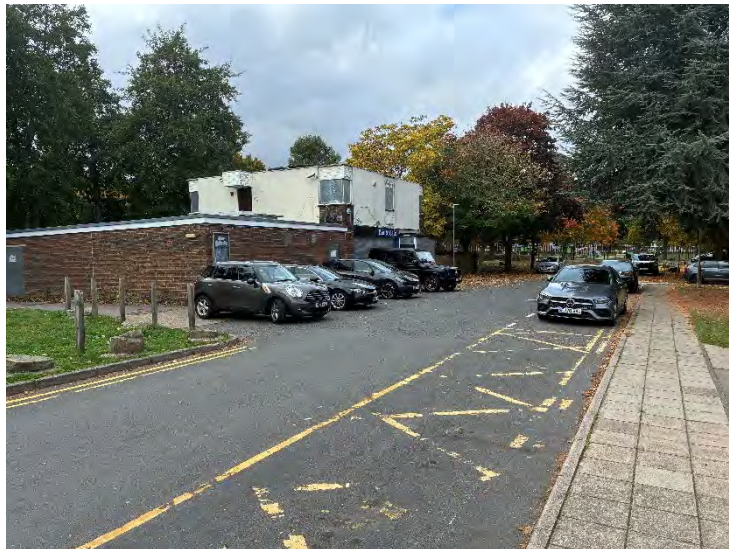
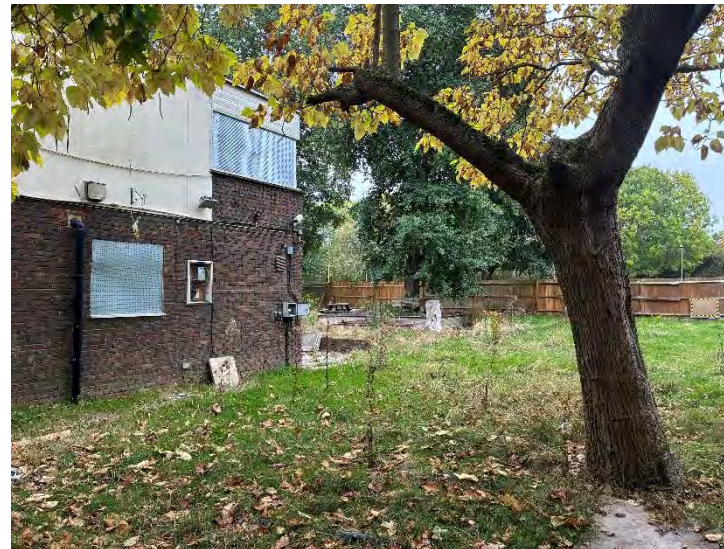
Disused Cafe

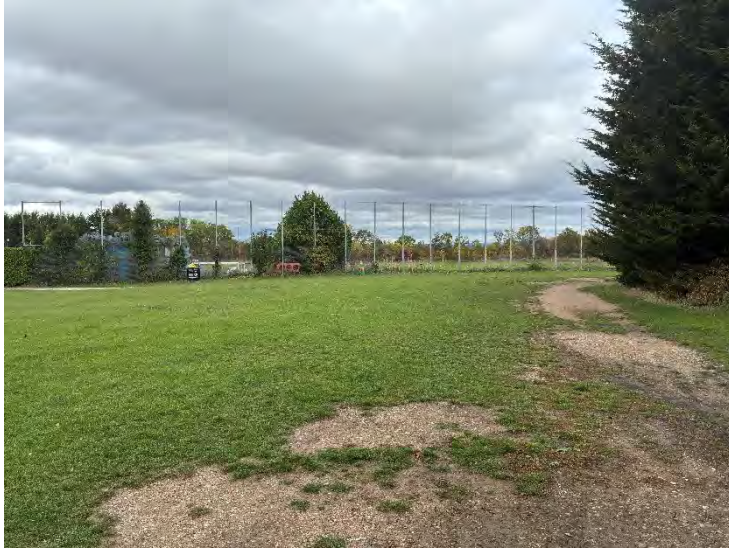
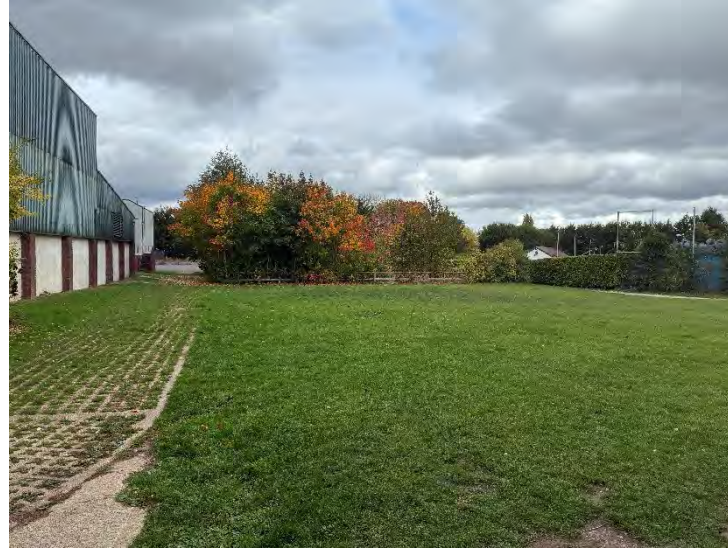
North west corner

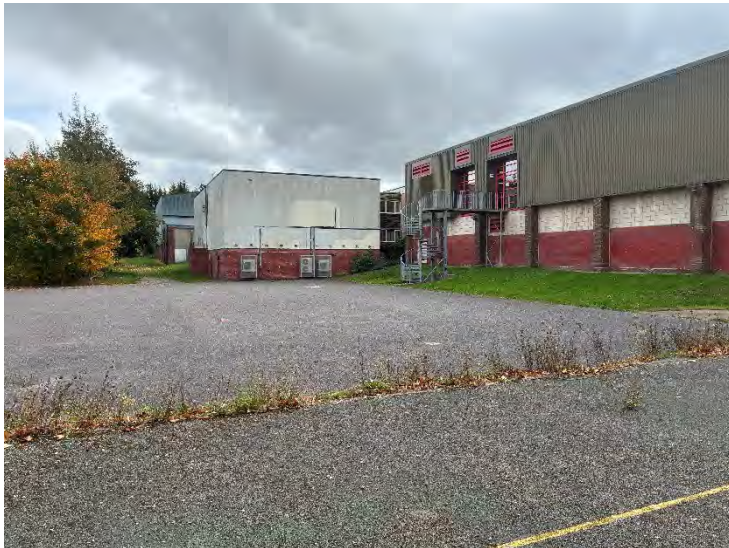
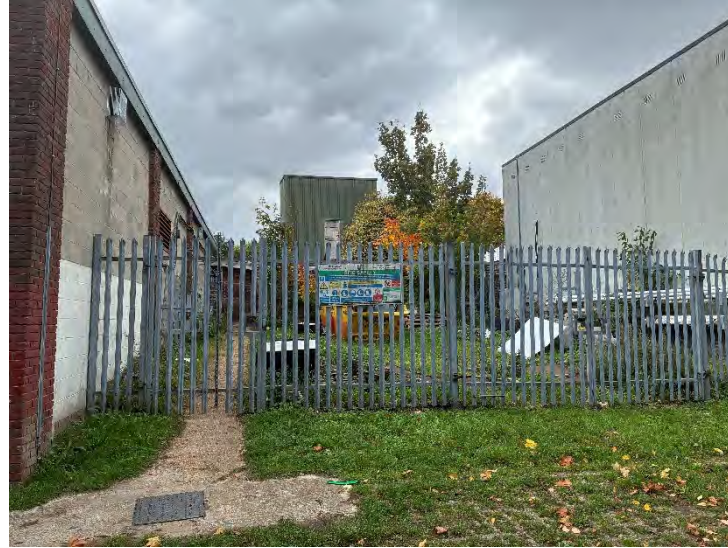
Rear of Leisure Centre

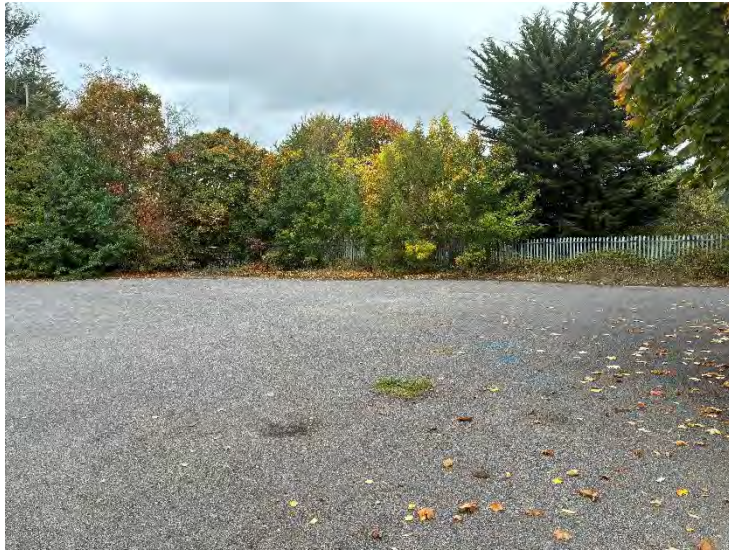
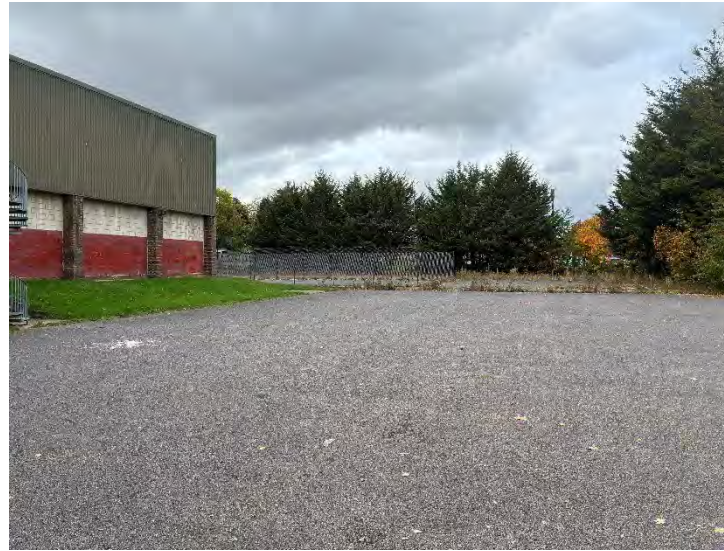
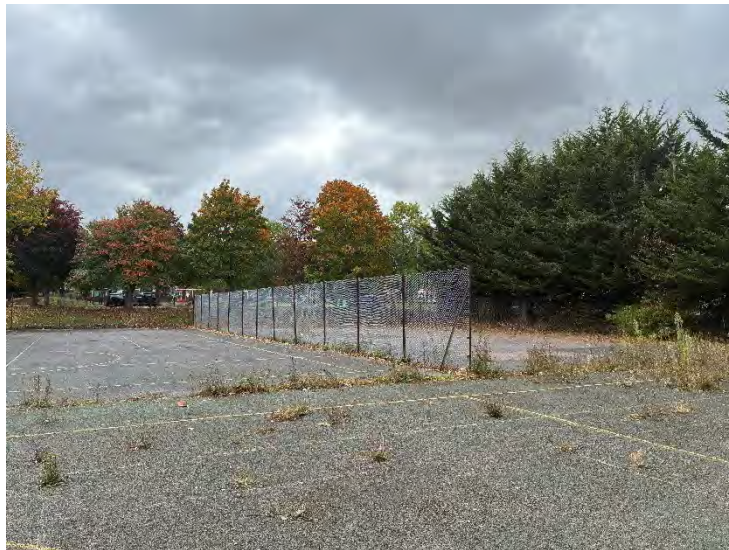
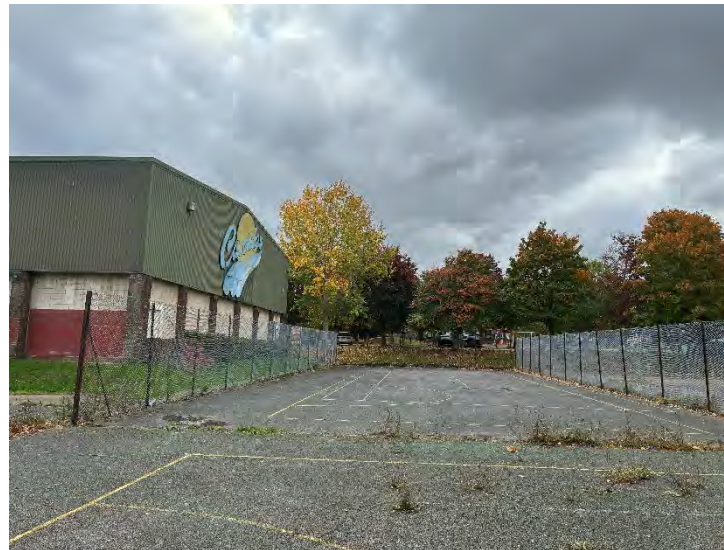
Play areas and tennis courts

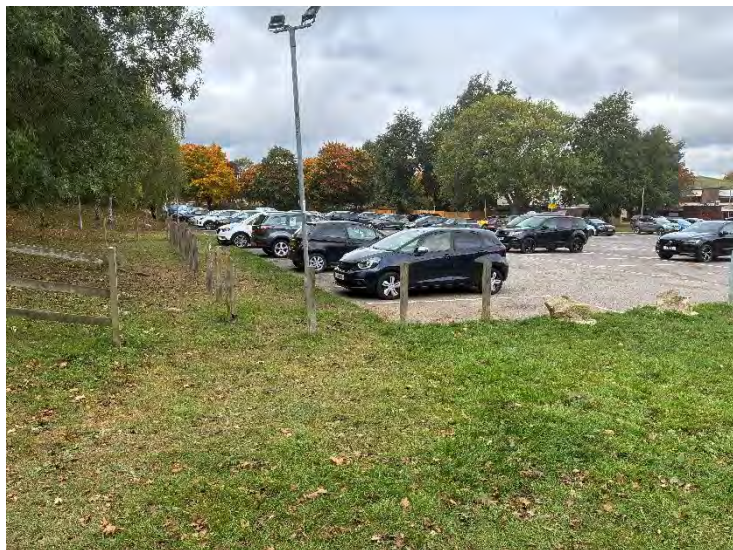
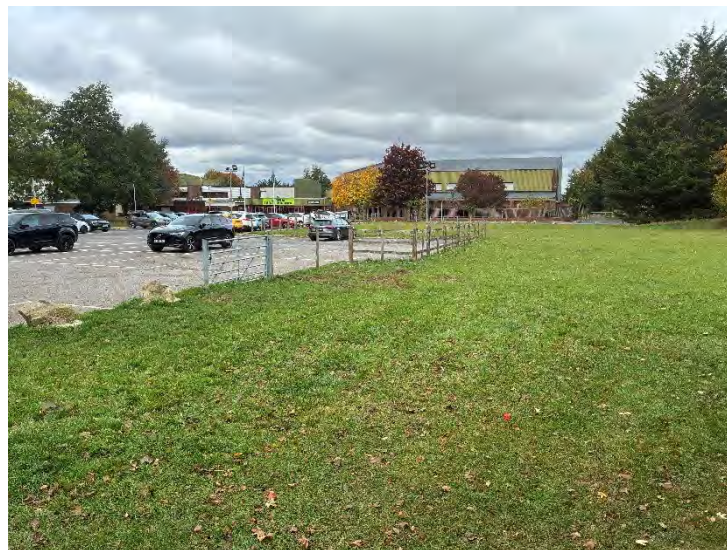
No visual or olfactory evidence of contamination was noted during the siteworks with the exception of borehole 20, where a slight odour of hydrocarbons was observed from 0.40m to 0.70m. This location is within a car park. Hence, the slight odour may be associated with leakages from vehicles using this area.

Southern car park

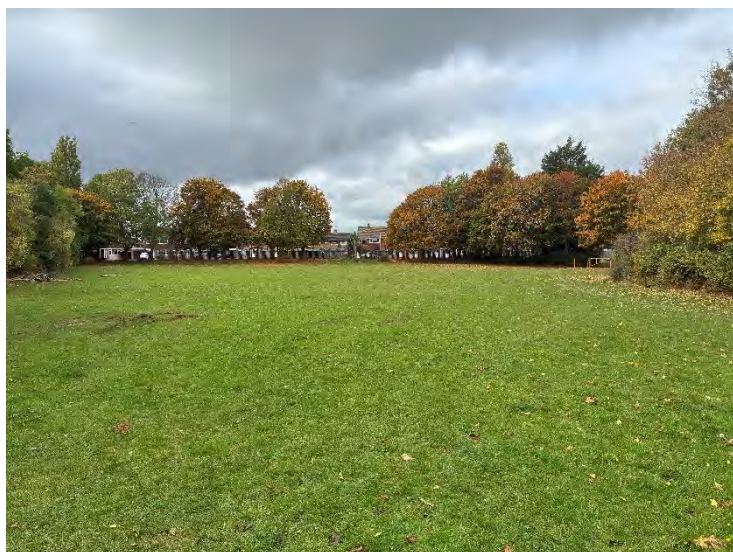
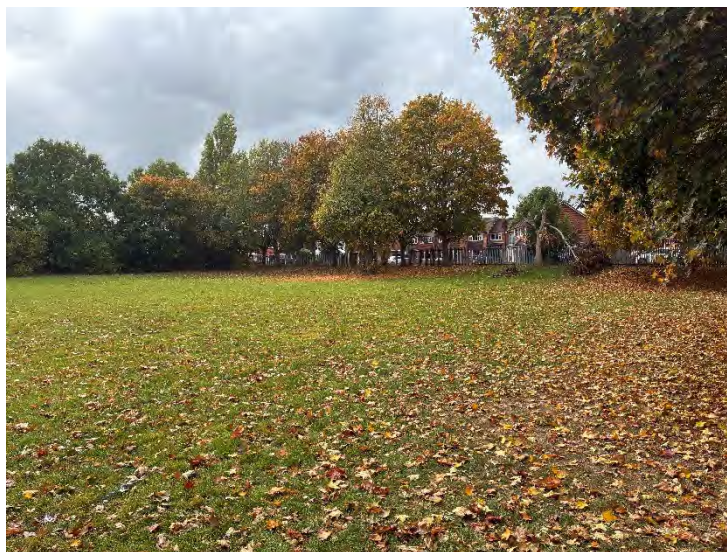
Southern part of site
