**REPORT ON STRUCTURAL CONDITION**  
**OF**  
**TOLLGATE HOTEL, WATLING STREET, NORTHFLEET,**  
**NR GRAVESEND, KENT DA13 9RA**  
**FOR**  
**BP PULSE**

**DATE OF INSPECTION:** 24 November 2022

**DATE OF REPORT:** 5 December 2022

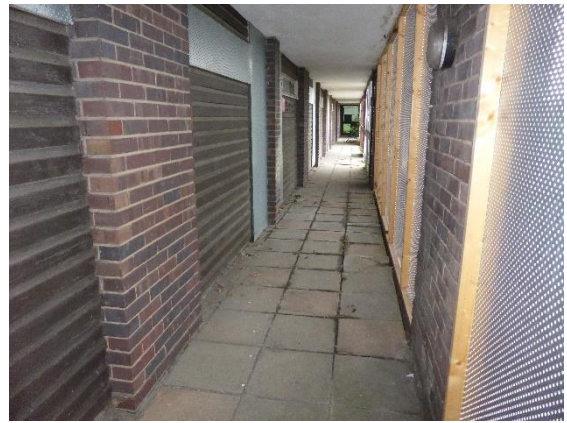
*Photograph 10. Walkway to Accommodation Block.*

Only the ground floor walkways, the edges of the upper walkways, and the staircases within the accommodation blocks could be inspected. These floors are concrete. The floor to the upper walkway has an asphalt finish. This is in a poor state and is in need of replacement. There are concrete paving slabs laid to the ground floor walkways and steps. There are various broken, loose and otherwise defective slabs. Vegetation is growing between slabs. Concrete is spalling and there is corrosion to exposed reinforcement steel to the edges and underside of the upper walkways. Specialist concrete repairs are necessary.

There is extensive damage to the boarded timber soffits of the upper semi-external walkways to the accommodation blocks due to rainwater penetration through the flat roofs. Repairs are required.

Glazing is broken and missing from the balustrade protecting the edges of the semi-exposed ground and upper floor walkways and staircases to the accommodation blocks. Balustrade framework is weathered and damaged in part. Defective balustrade is in need of replacing.

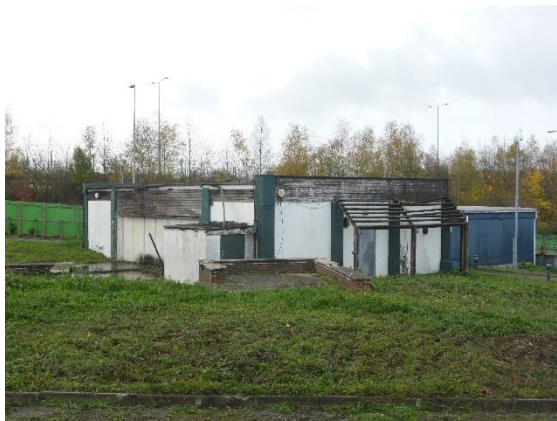
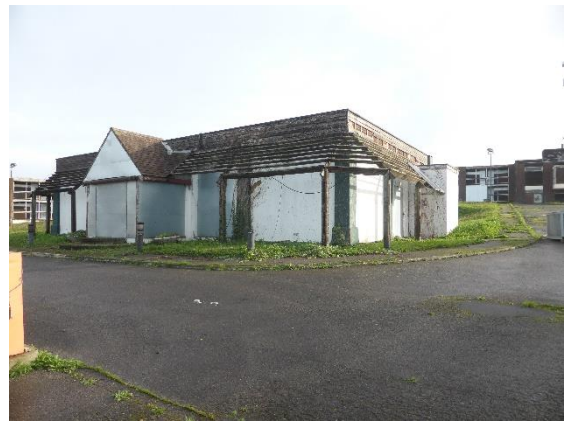
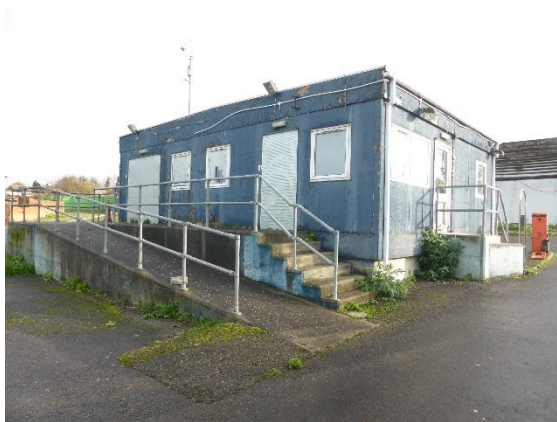
*Photograph 11. Outbuilding.*

The walls to the function room outbuilding are brick, clad with timber boarding. Cladding is in a very poor state with sections missing. Cladding is in need of replacement. The roof over the outbuilding is largely flat with a felt covering. There is a small pitched and tiled roof to the west entrance. The felt roof coverings appear in very a poor condition and in need of replacement. Tiling repairs are necessary to the pitched roof. There are timber framed windows and doors. These are decayed and in a poor state. They are in need of overhaul and repair or replacement. Inspection was limited as boarding has been fixed over windows and doors.

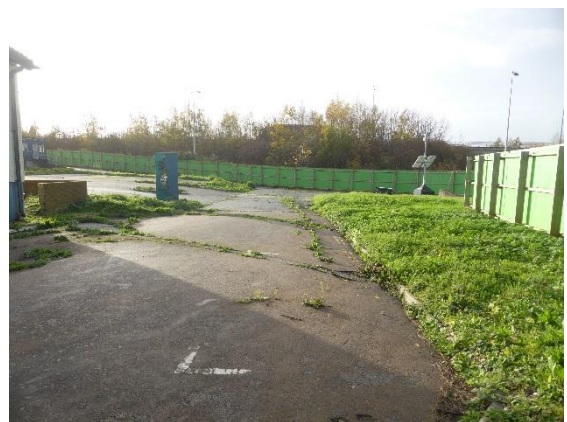
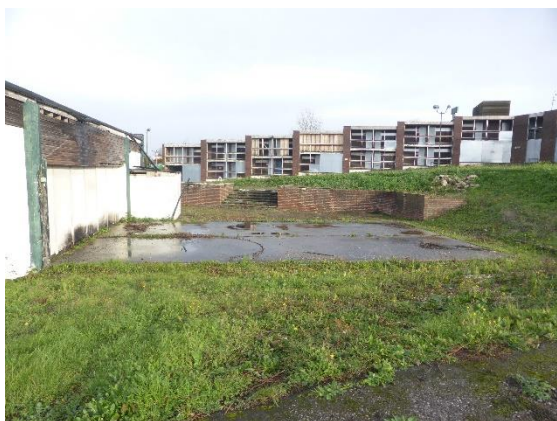
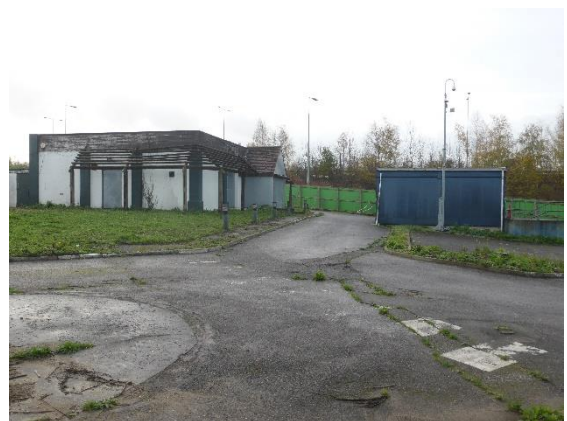
*Photograph 14. External areas.*

The external areas are generally in a poor state and are in need of significant repair and improvement. The vehicular entrance and car parking areas are generally surfaced with tarmac. The hard standings adjacent to the buildings are surfaced with concrete paving bricks and concrete paving slabs. There are brick garden and retaining walls. Boundary fencing is largely concealed by vegetation growth and it was not therefore inspected.

Damaged paving, fences, garden walls, steps etc. should be appropriately repaired. Circulation roads and car parking areas are in need of repair and resurfacing.
