**REPORT ON STRUCTURAL CONDITION**  
**OF**  
**TOLLGATE HOTEL, WATLING STREET, NORTHFLEET,**  
**NR GRAVESEND, KENT DA13 9RA**  
**FOR**  
**BP PULSE**

**DATE OF INSPECTION:** 18 April 2024

**DATE OF REPORT:** 23 April 2024

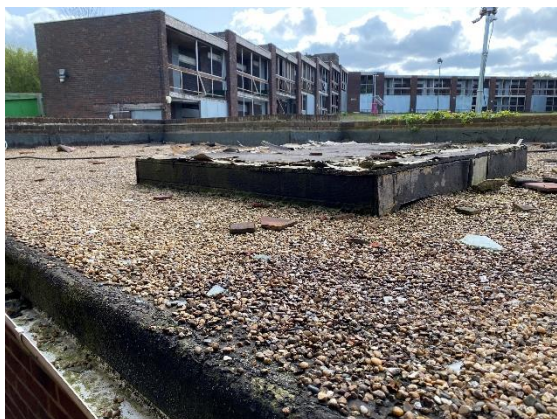
*Photograph 7. Flat roof over extension to Principal Building.*

The felt roof coverings over the flat roofs are deteriorating and are likely to be at the end of their serviceable life and should be replaced. There is evidence of rainwater penetration. Roof flashings are in need of repair or replacement.

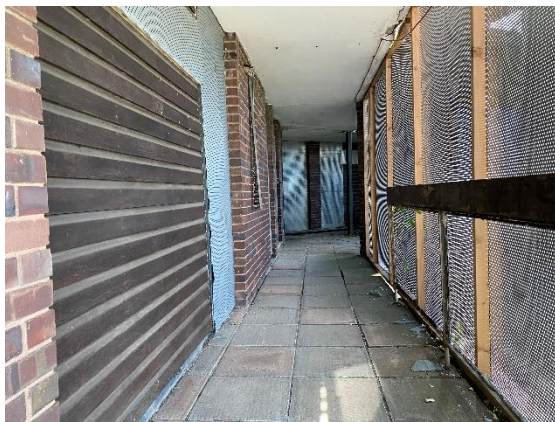
*Photograph 13. Walkway to Accommodation Block.*

Only the ground floor walkways, the edges of the upper walkways, and the staircases within the accommodation blocks could be inspected. These floors are concrete. The floor to the upper walkway has an asphalt finish. This is in a poor state and is in need of replacement. There are concrete paving slabs laid to the ground floor walkways and steps. There are various broken, loose and otherwise defective slabs. Vegetation is growing between slabs. Concrete is spalling and there is corrosion to exposed reinforcement steel to the edges and underside of the upper walkways. Specialist concrete repairs are necessary.

There is extensive damage to the boarded timber soffits of the upper semi-external walkways to the accommodation blocks due to rainwater penetration through the flat roofs. Repairs are required.

Glazing is broken and missing from the balustrade protecting the edges of the semi-exposed ground and upper floor walkways and staircases to the accommodation blocks. Balustrade framework is weathered and damaged in part. Defective balustrade is in need of replacing.

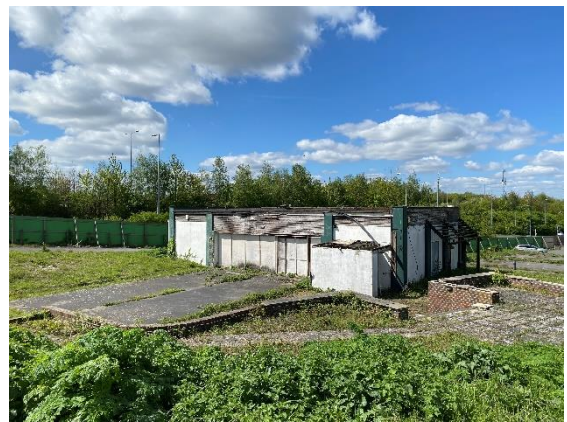
*Photograph 14. Function Room.*

The walls to the function room outbuilding are brick, clad with timber boarding. Cladding is in a very poor state with sections missing. Cladding is in need of replacement. The roof over the outbuilding is largely flat with a felt covering. There is a small pitched and tiled roof to the west entrance. The felt roof coverings appear in very a poor condition and in need of replacement. Tiling repairs are necessary to the pitched roof. There are timber framed windows and doors. These are decayed and in a poor state. They are in need of overhaul and repair or replacement. Inspection was limited as boarding has been fixed over windows and doors.

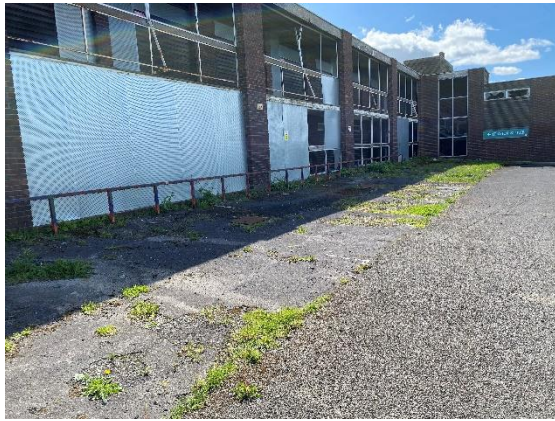
*Photograph 19. Car park to Eastern Accommodation Block*

The external areas are generally in a poor state and are in need of significant repair and improvement. The vehicular entrance and car parking areas are generally surfaced with tarmac. The hard standings adjacent to the buildings are surfaced with concrete paving bricks and concrete paving slabs. There are brick garden and retaining walls. Boundary fencing is largely concealed by vegetation growth and by temporary timber fencing and it was not therefore inspected.

Damaged paving, fences, garden walls, steps etc. should be appropriately repaired. Circulation roads and car parking areas are in need of repair and resurfacing.
