Project: Coldharbour Road, Gravesend

## **B24030-TLP-04: Arboricultural Site Visit Record**

Date: 18<sup>th</sup> February 2026 | Kit Hardy

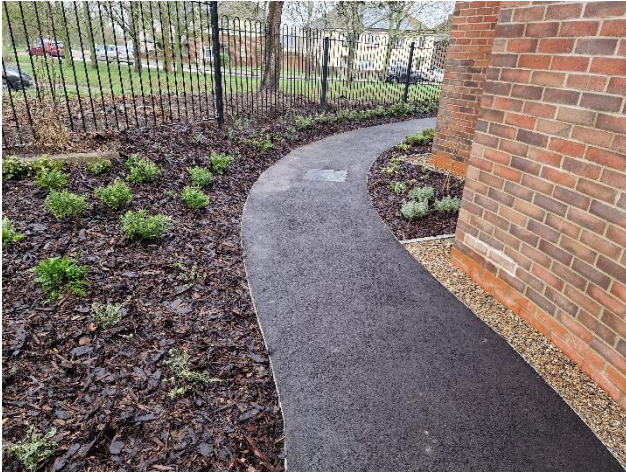
- 1.4 **No-dig hard surface – footpath in relation to T01 and T02:** an arboricultural site visit with the monitoring of 'no-dig' hard surface installation did not take place. Figure 1 shows the area of footpath adjacent to T01 and T02 containing a drainage cover / service run. Figure 2 shows concrete sub-base / haunching along the edge of the footpath. Following the site meeting Craig Greig confirmed via email that the footpath had been excavated (i.e., not built using 'no-dig' principles or a cellular confinement system).

- 1.5 As highlighted in previous arboricultural site visit reports the retained curb line and former car park surface and made ground is thought to have restricted root growth from T01 into the site. Thus, impacts to the tree could remain low if only a small number of tree roots were affected.

Figure 1. Footpath between T01 and T02 and the new building.

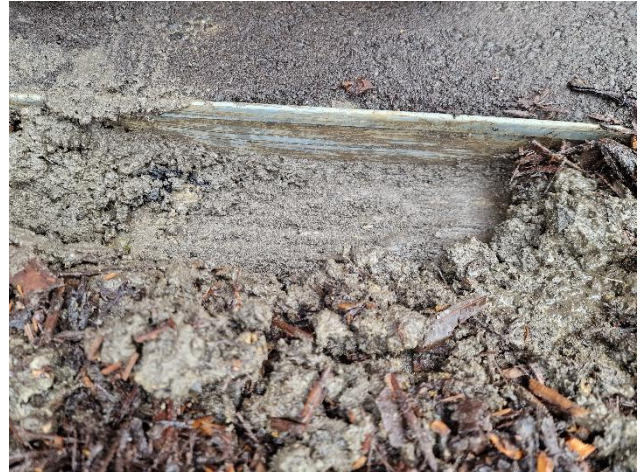
Figure 2. Footpath concrete sub-base or haunching.

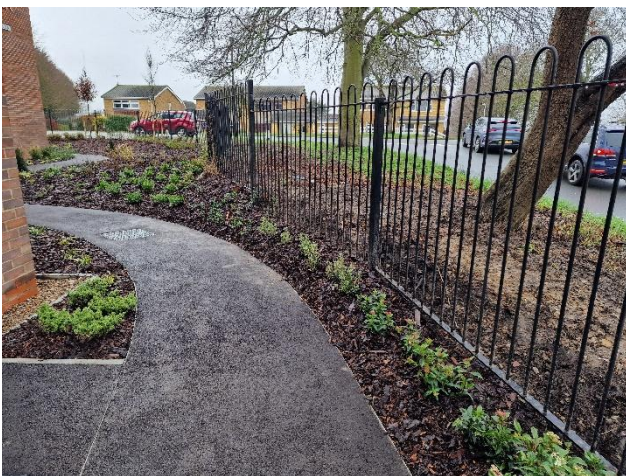
- 1.6 **Careful installation of fence posts:** Figure 3 shows the location of the boundary fence in relation to T01 and T02. The location varies from the landscape design layout used to form the AIA AMS Report and Drawings. The proposed boundary treatment / fence line was shown curving radially around T01 just inside the canopy dripline but it has been installed along the retained curb.

- 1.7 Figures 3 and 4 also show where ground disturbance around the base of T02 has formed slightly increased levels around the base of the tree. Minor root damage was also noted in relation to the fence post foundation installed closest to T02.

Figure 3. New fence post adjacent to T02 with evidence of root severance.

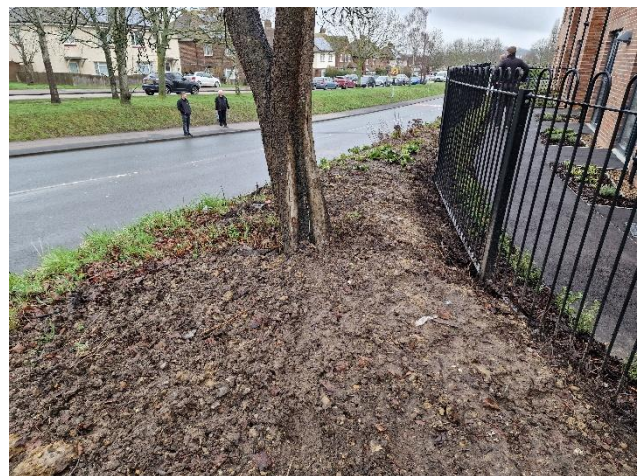
Figure 4. Ground disturbance around T02 with a small amount of soil heaped up against the tree's stem.
