## Proposed Chimney and associated Roof Works – Design and Access Statement with Heritage Statement

**Project:** Repair and maintenance of chimneys and associated roof works

**Location:** The Mill House, Mill Hill Lane, Shorne. Gravesend. DA12 3HA

**Date:** 4<sup>th</sup> August 2022

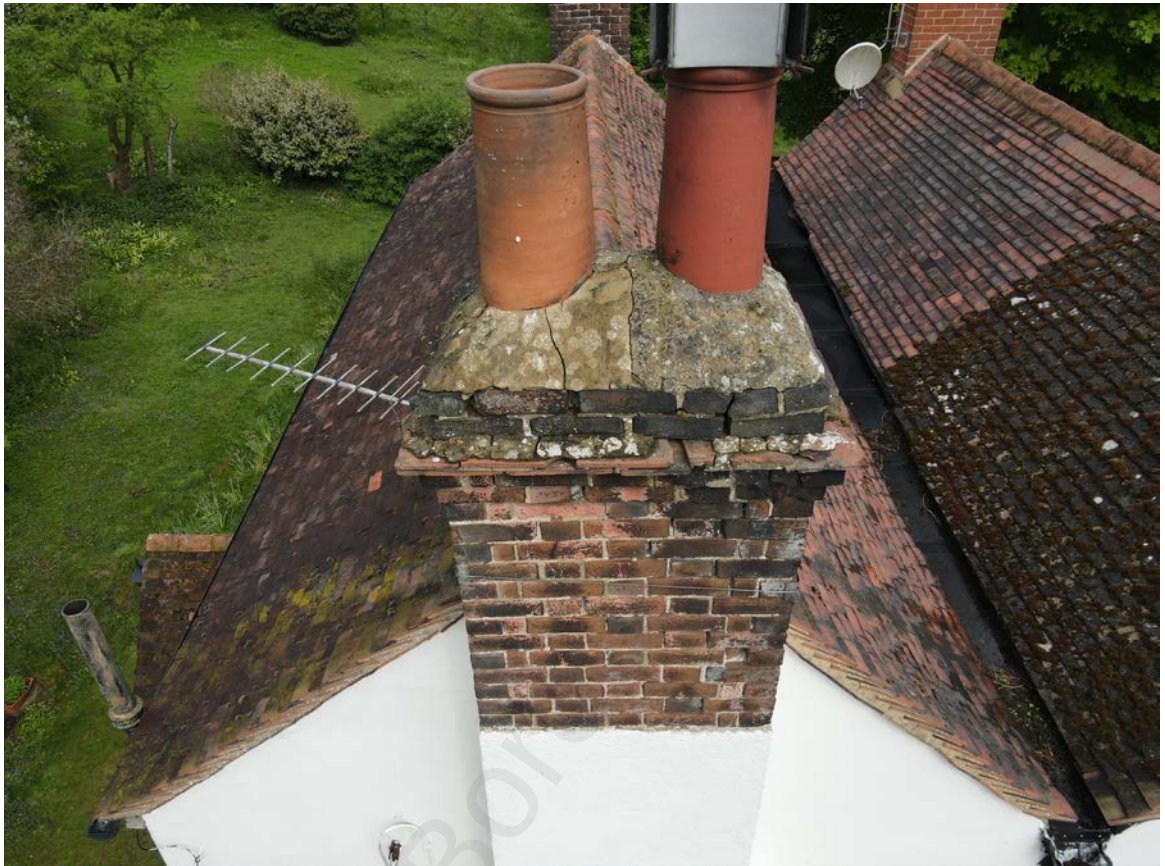
2.15 Chimney 1 - Front

- 3.02 Chimney stacks 1 and 2 are suffering from neglect and from the photos can clearly be seen as unstable from the corbelling upwards as are the pots with cracked and missing mortar. Chimney 3 has been re-built at some point, but the pots have become more unstable in the recent storms. (Photos taken prior to the storms).

- iv. Re-build Chimney 1 above line of existing render in reclaimed matching brickwork to same height complete with corbelled brickwork and tile creasing detail, new flaunching to bed original pots. Mortar colour and joint style to match existing.

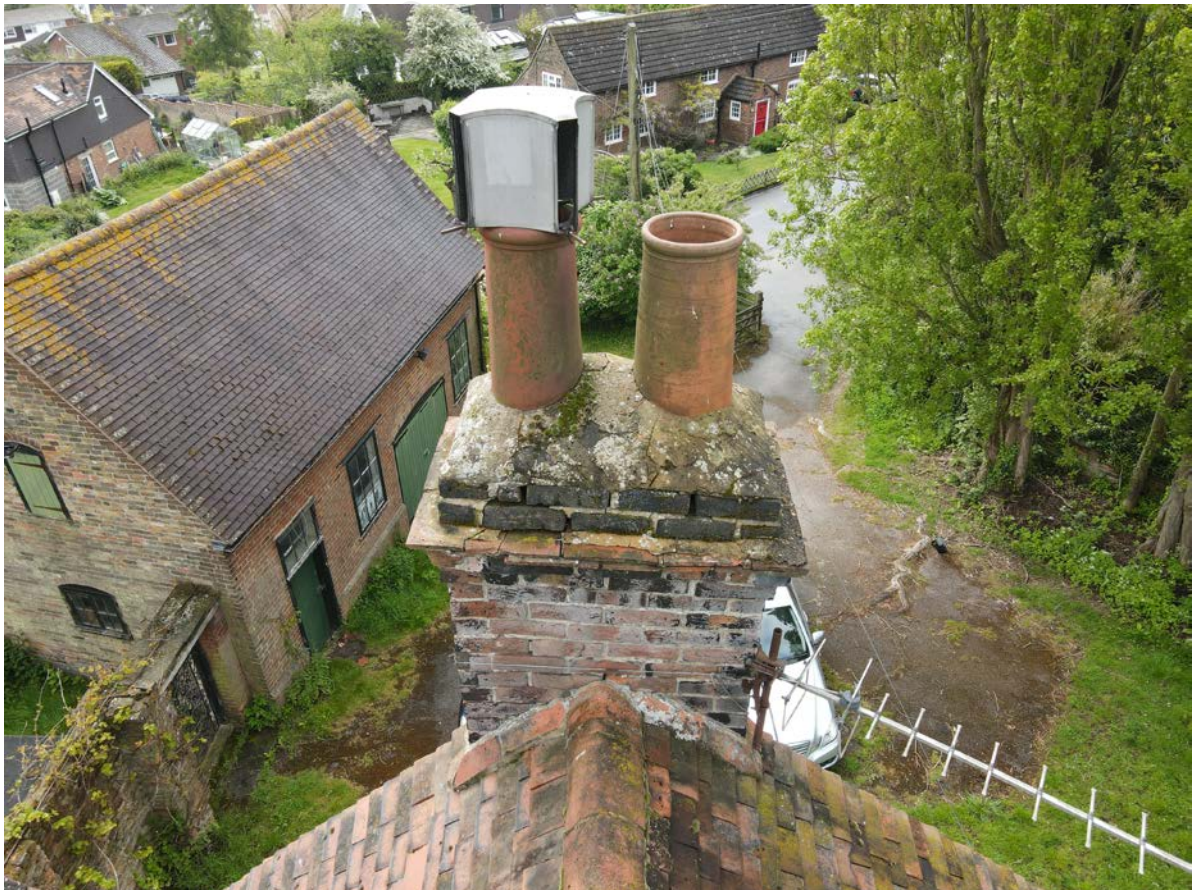
2.16 Chimney 1 – Rear showing bedded tile flashing detail

- 2.03 The flashing detail between chimney stack and roof tile is a cut roof tile bedded on mortar, this detail has a short life expectancy of 10 years with the mortar prone to cracking from movement caused by weathering. The detail is out of normal view and as such difficult to see and maintain. By replacing with traditional lead flashing the life expectancy is increased to a minimum of 50 years and in doing so reduces the risk of water ingress to the roof structure below.

- v. To reset chimney pots on Chimney 3 due to movement
  - vi. To provide vents to all reset chimney pots to stop bird and insect invasion
  - vii. To remove tile flashing detail between roofs and chimney stacks and replace with code 4 lead flashing dressed into stacks and beneath tiled roofs with lead soakers to provide long lasting weather tight detail

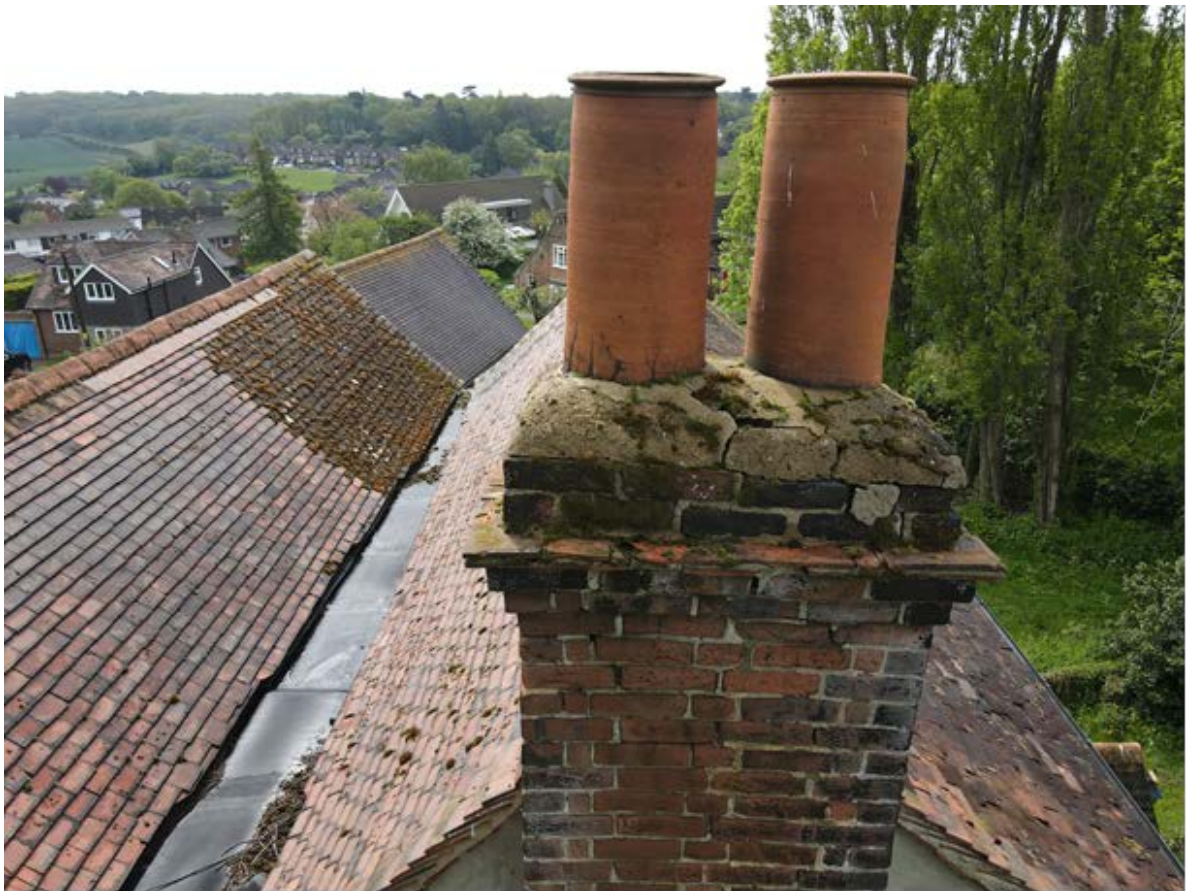
2.16 Chimney 2 – Front

- i. Carefully removed chimney pots setting aside for reinstallation
  - ii. Take down chimney brick work to roof level to Chimney 1 and Chimney 2
  - iii. Re-use bricks from both Chimney 1 & 2 to re-build Chimney 2 complete with corbelled brickwork and tile creasing detail, new flaunching to bed original pots (replace 1 cracked pot with reclaimed matching pot). Mortar colour and joint style to match existing.

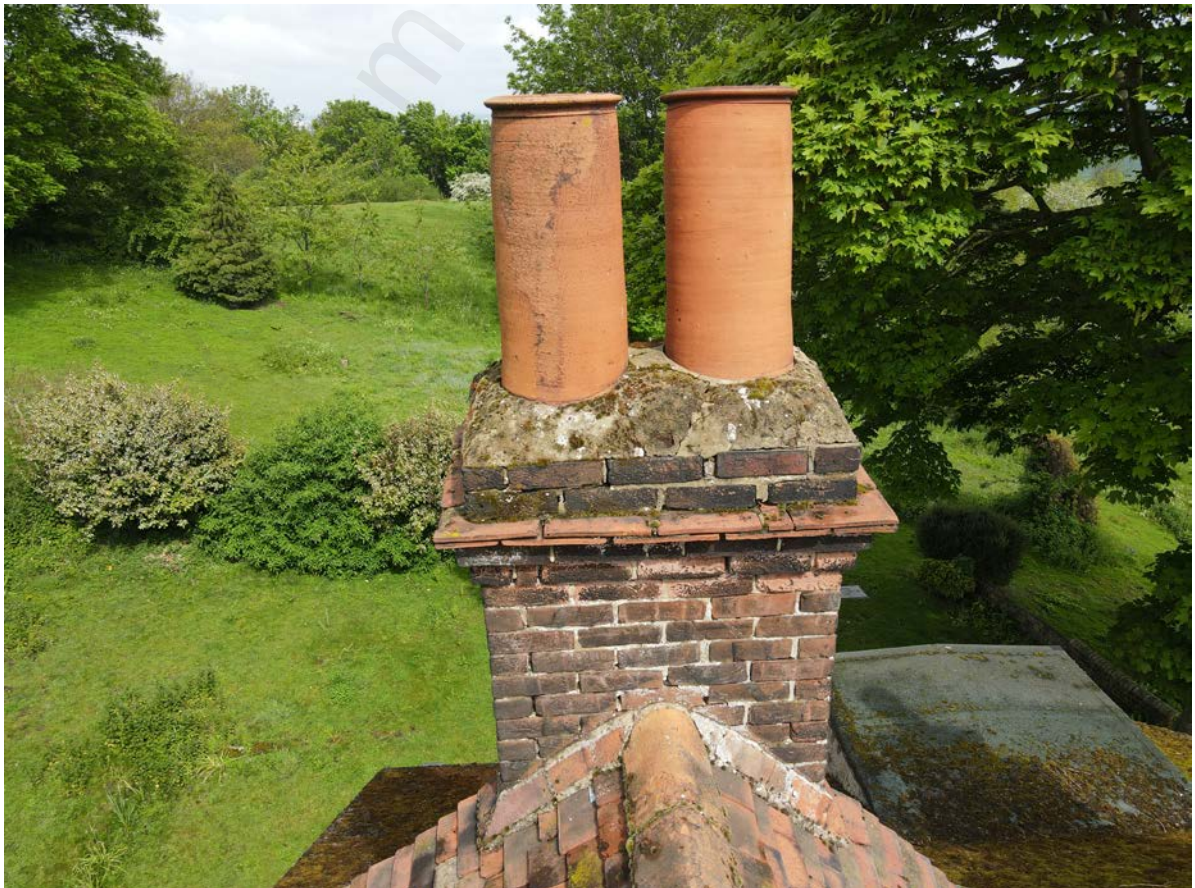
2.17 Chimney 2 - Rear showing bedded tile flashing detail

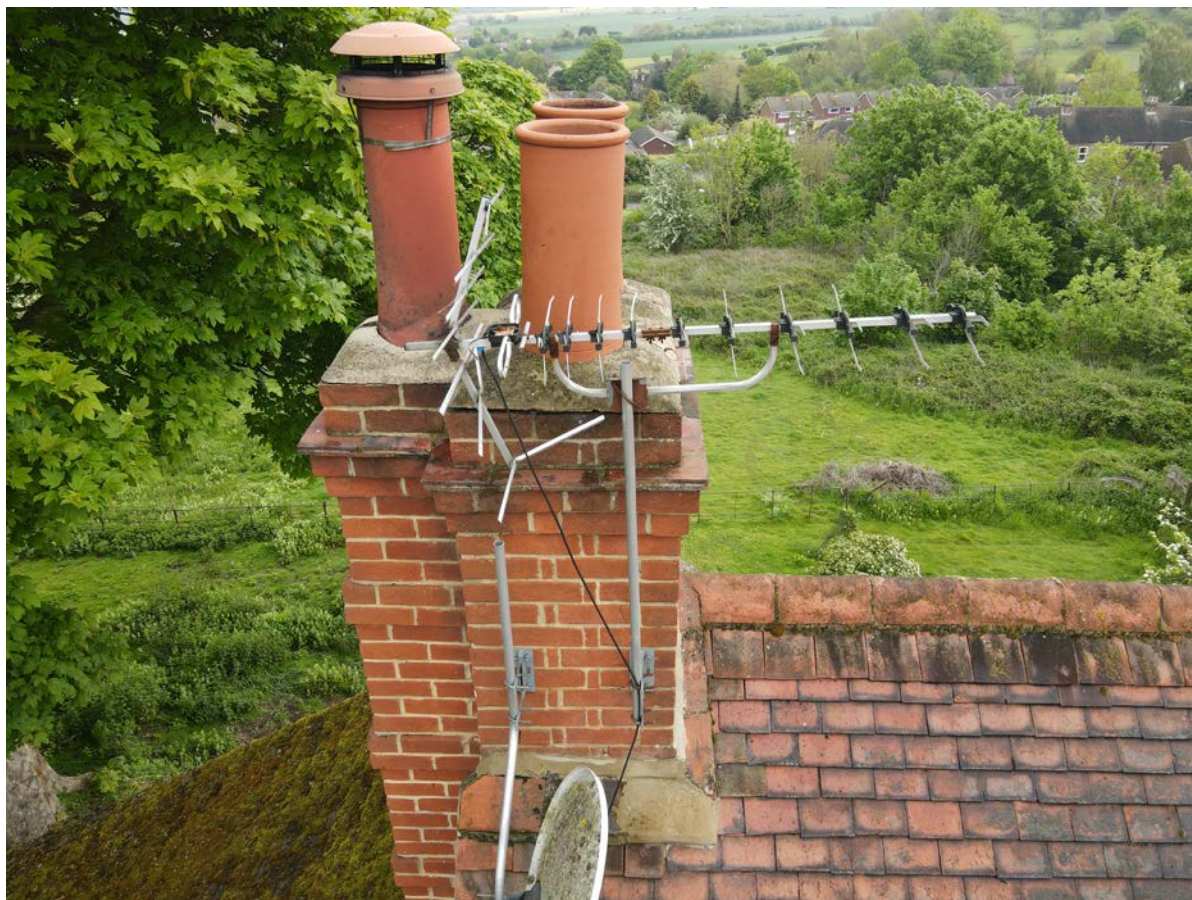
2.17 Chimney 3 – Side

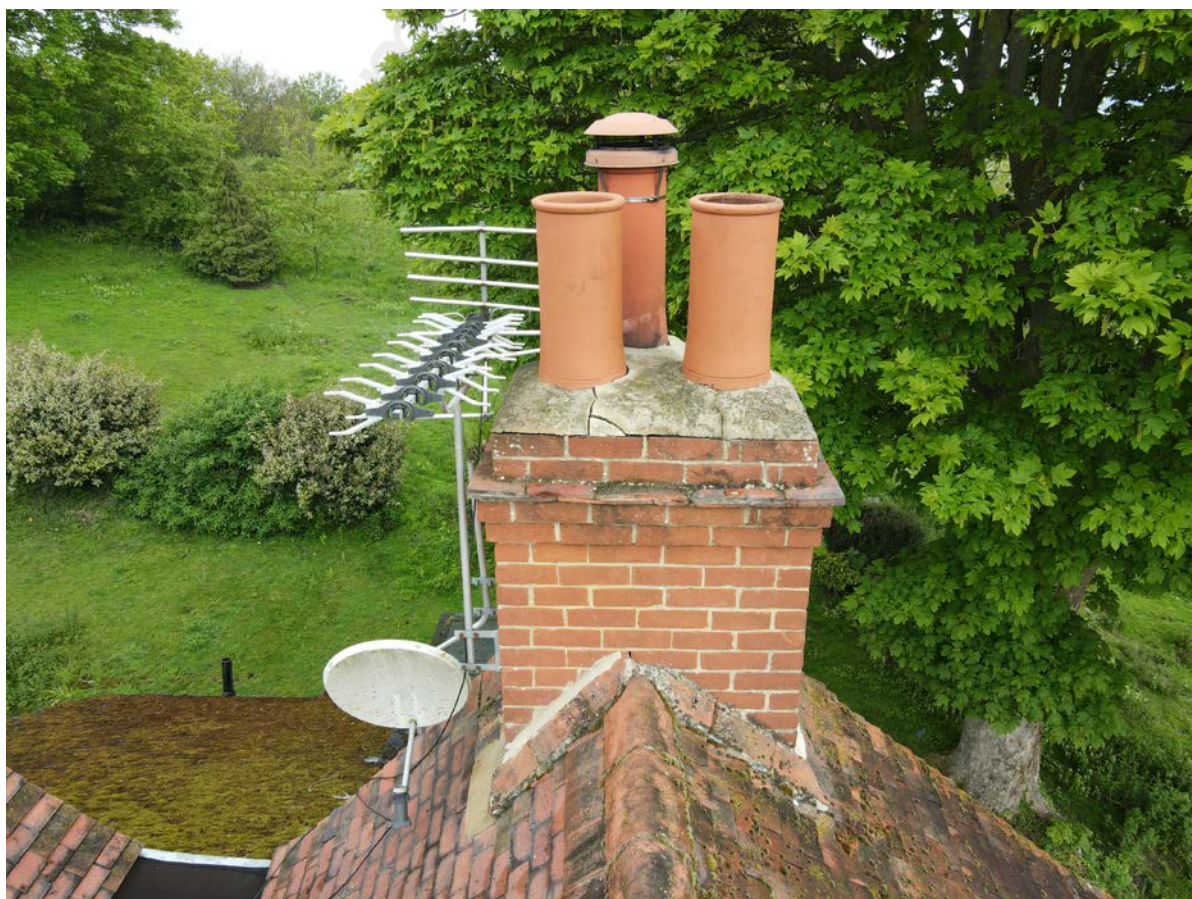
2.17 Chimney 3 – Rear showing bedded tile flashing detail
