**FAO: Tree Officer  
Gravesham Council**

**RE: Tree inspection at The Mill House, Mill Hill Lane, Shorne DA12 3HA (Shorne Village Conservation Area)**

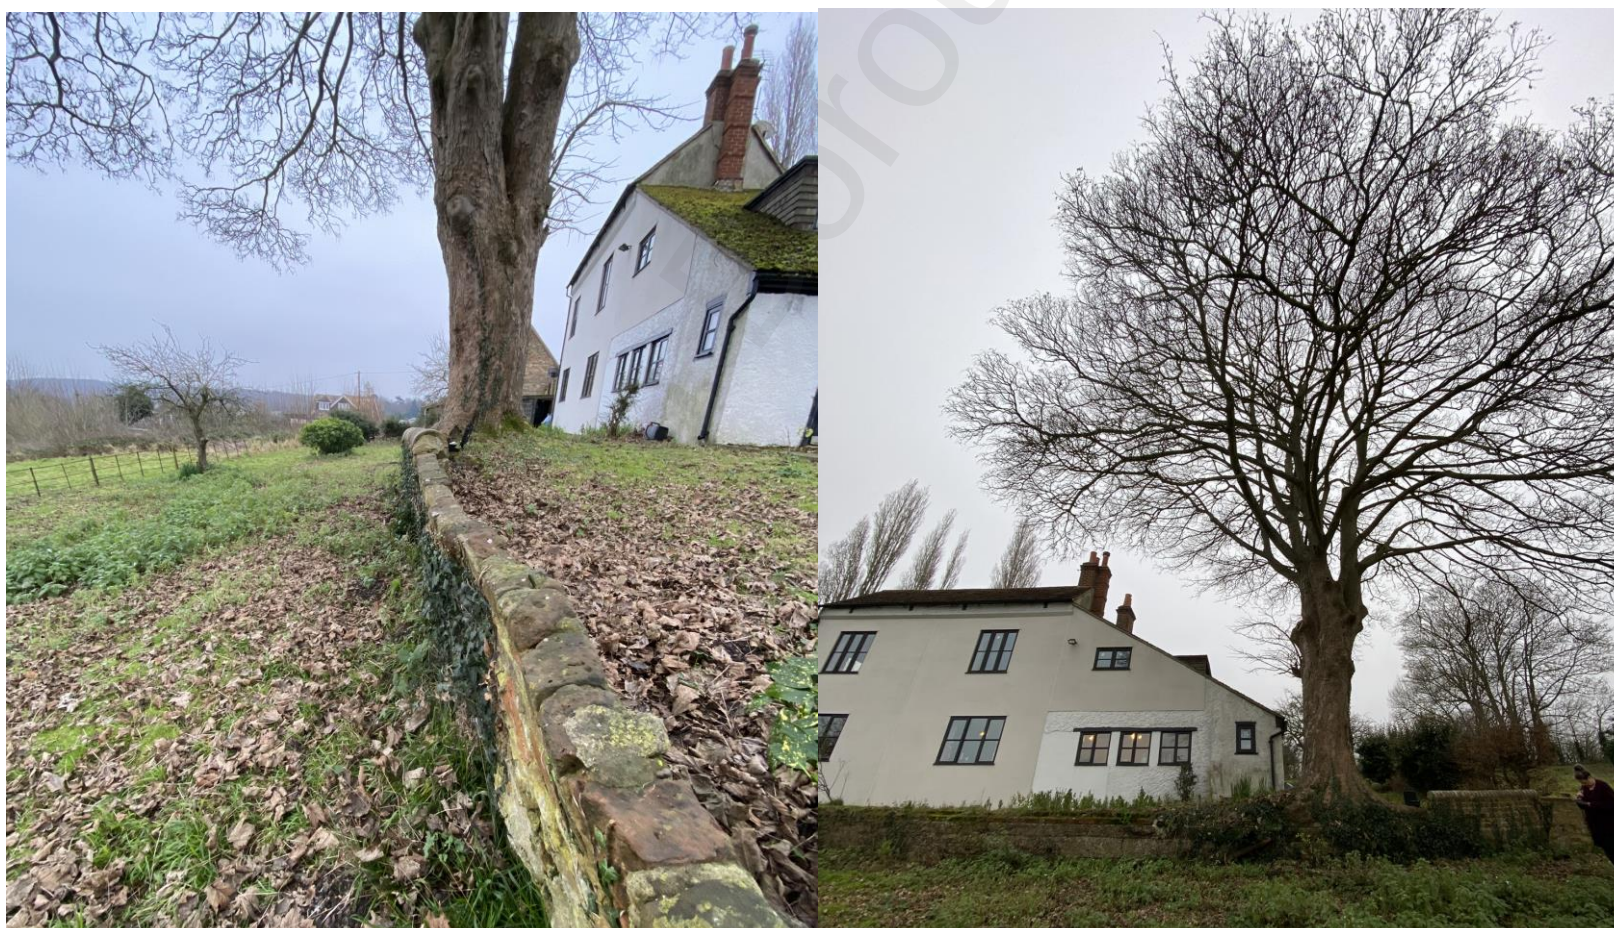
The sycamore grows on the terrace of The Mill House, adjacent to the retaining wall and lean-to extension (fig.1). The tree has a large, open grown canopy and is approximately 100 years old. The tree is generally healthy for its age though there are some aerial cavities and signs of structural decay within previous pruning points; this is not an immediate safety concern as the species is known for being resistant to decay.

*Figure 1; Sycamore T1 growing against the retaining wall. Note the displacement and bulging of the wall and displacement of the capping bricks.*

Whether the tree was planted or self-seeded, the trunk bole of the sycamore has grown so large that it is now in contact with the concrete retaining wall in several places. The wall has distorted and cracked as a result of this direct pressure, and the wall is displaced for several metres along its length. Further to the damage caused by the trunk, roots of the tree have spread through cracks in the concrete and have displaced it further (fig.2).

My client has consulted a structural engineer whose advice is that a trench is excavated at the rear of the retaining wall to allow construction of concrete buttresses. These buttresses will stabilise the cracked concrete wall, pulling it back in line and allowing replacement of the brick capping and returning the wall to its original position.

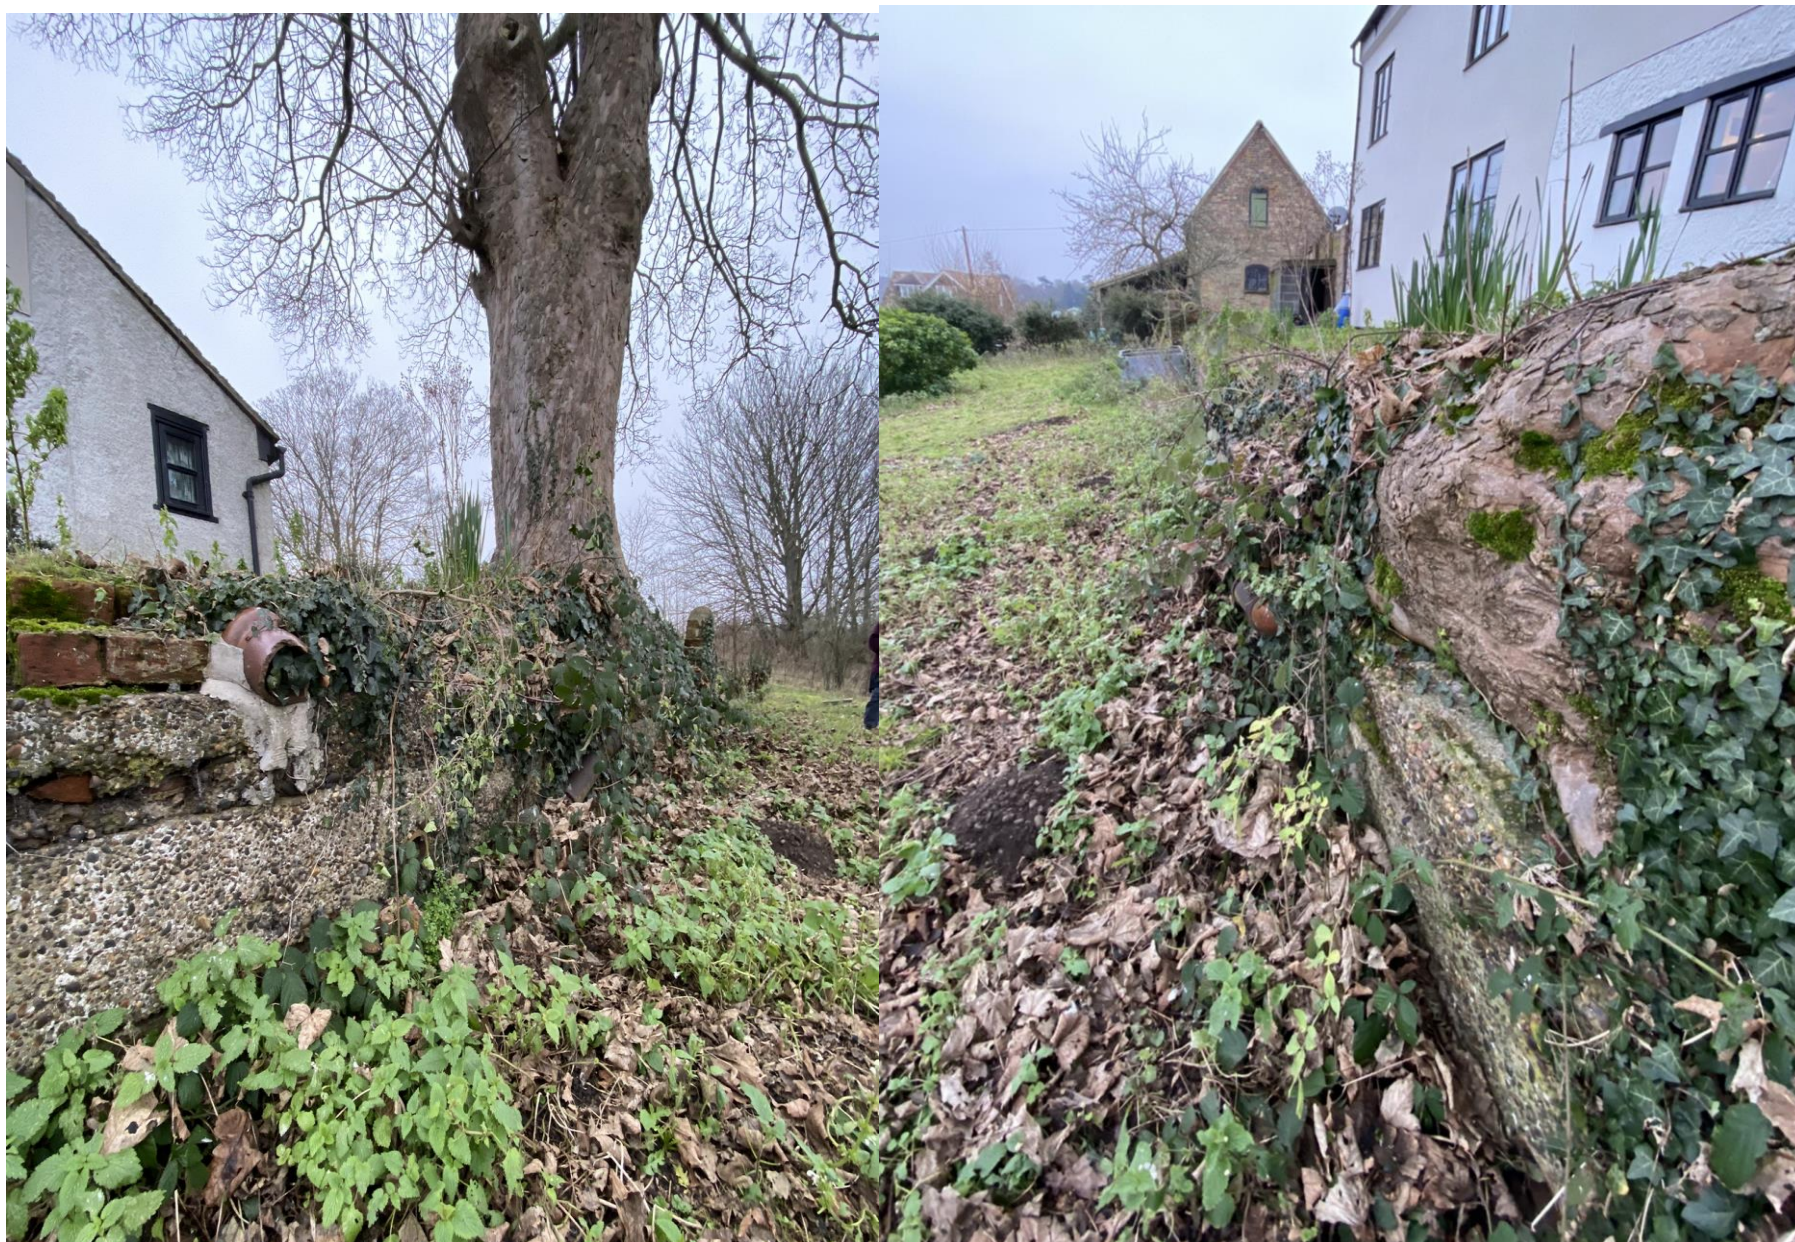
*Fig.2; Sycamore T1. Large structural roots at the base of the bole having entirely displaced capping. Rebuilding wall to this level would require severance or trimming of these roots leading to structural instability and large wounds as entry points for decay*

Repairs present several issues for the tree. Firstly, trench excavations behind the retaining wall will likely encounter large structural roots and root masses. Secondly, the installation of concrete buttresses will likely require severance of those roots and thirdly, pulling the wall back to its original position would require severance of the large roots that have grown through the concrete and the sections of trunk bole that are now in contact with that wall (fig.2 & fig.3). In simple terms, it is not possible to rebuild the wall 'plum' and straight with the tree in place, and severance of any large roots or sections of root bole will be so harmful to the health of the tree that the structural stability of the tree would be jeopardised.

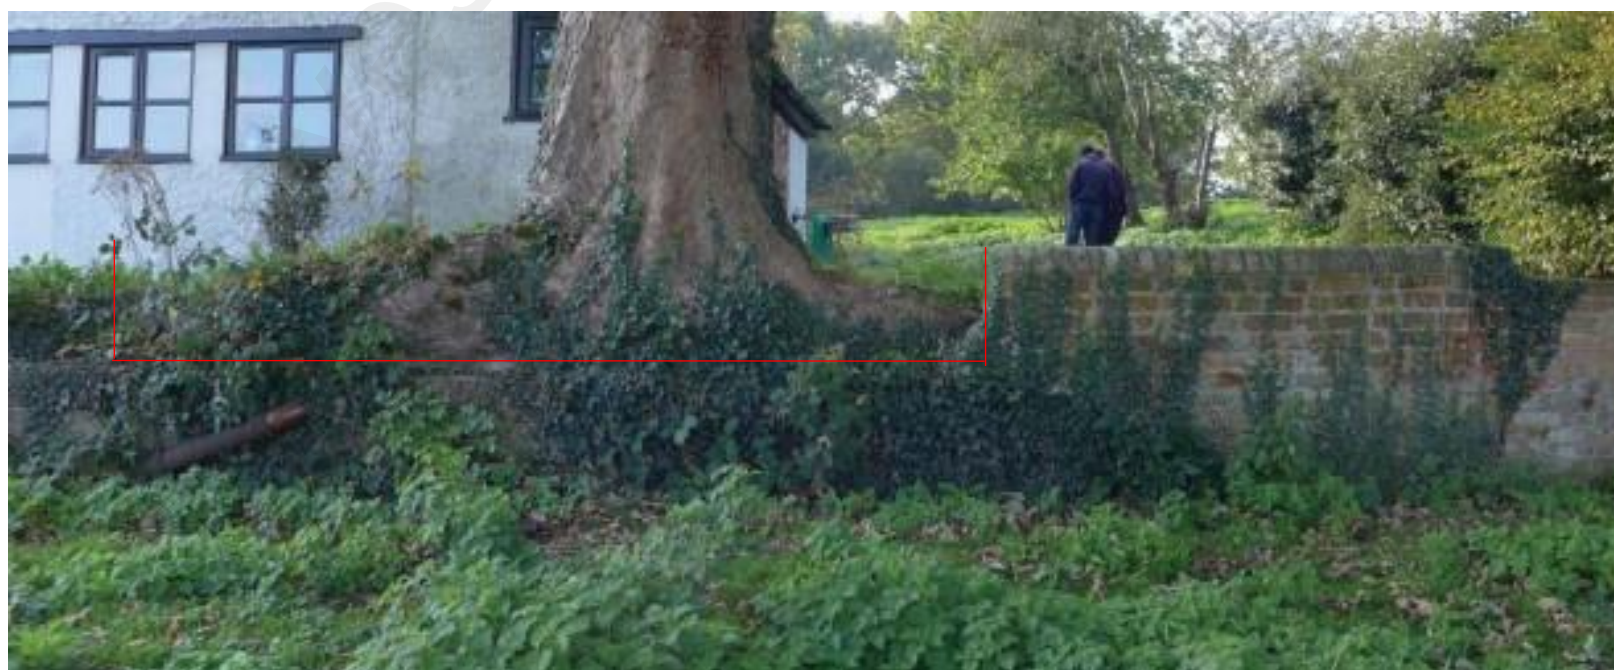
*Fig.3; Stem base of T1 against retaining wall of terrace. Red line details sections of root or bole which have grown through or over the wall.*

There are engineering alternatives to trench excavation that would limit damage to roots during excavations, such as air spading. However, it would not be possible to build the buttresses and repair the wall without major damage to the tree base and structural root network. Fig. 3 shows the expanse of wall affected by the trunk bole and roots that have grown through, giving a scale of the pruning and root/stem skimming that would be required. In my opinion, root severance and trunk skimming will either lead to structural instability of the tree immediately following root pruning or, if the tree does not fall immediately, decay will enter the large wounds and will allow decay to spread rapidly causing failure within a relatively short period after pruning. In the circumstances, I would advise that the tree is removed and replaced to allow these essential repairs as the risks to the tree are too great to allow it to remain.
