| PROJECT: Existing Photos Ground Floor - PART 1 | | |
| DESCRIPTION: Conversion to HMO<br>38 Windmill Street<br>Gravesend Kent DA12 1BA<br>for: Mr M Celli | | |
| 1124.WD.04 | | |

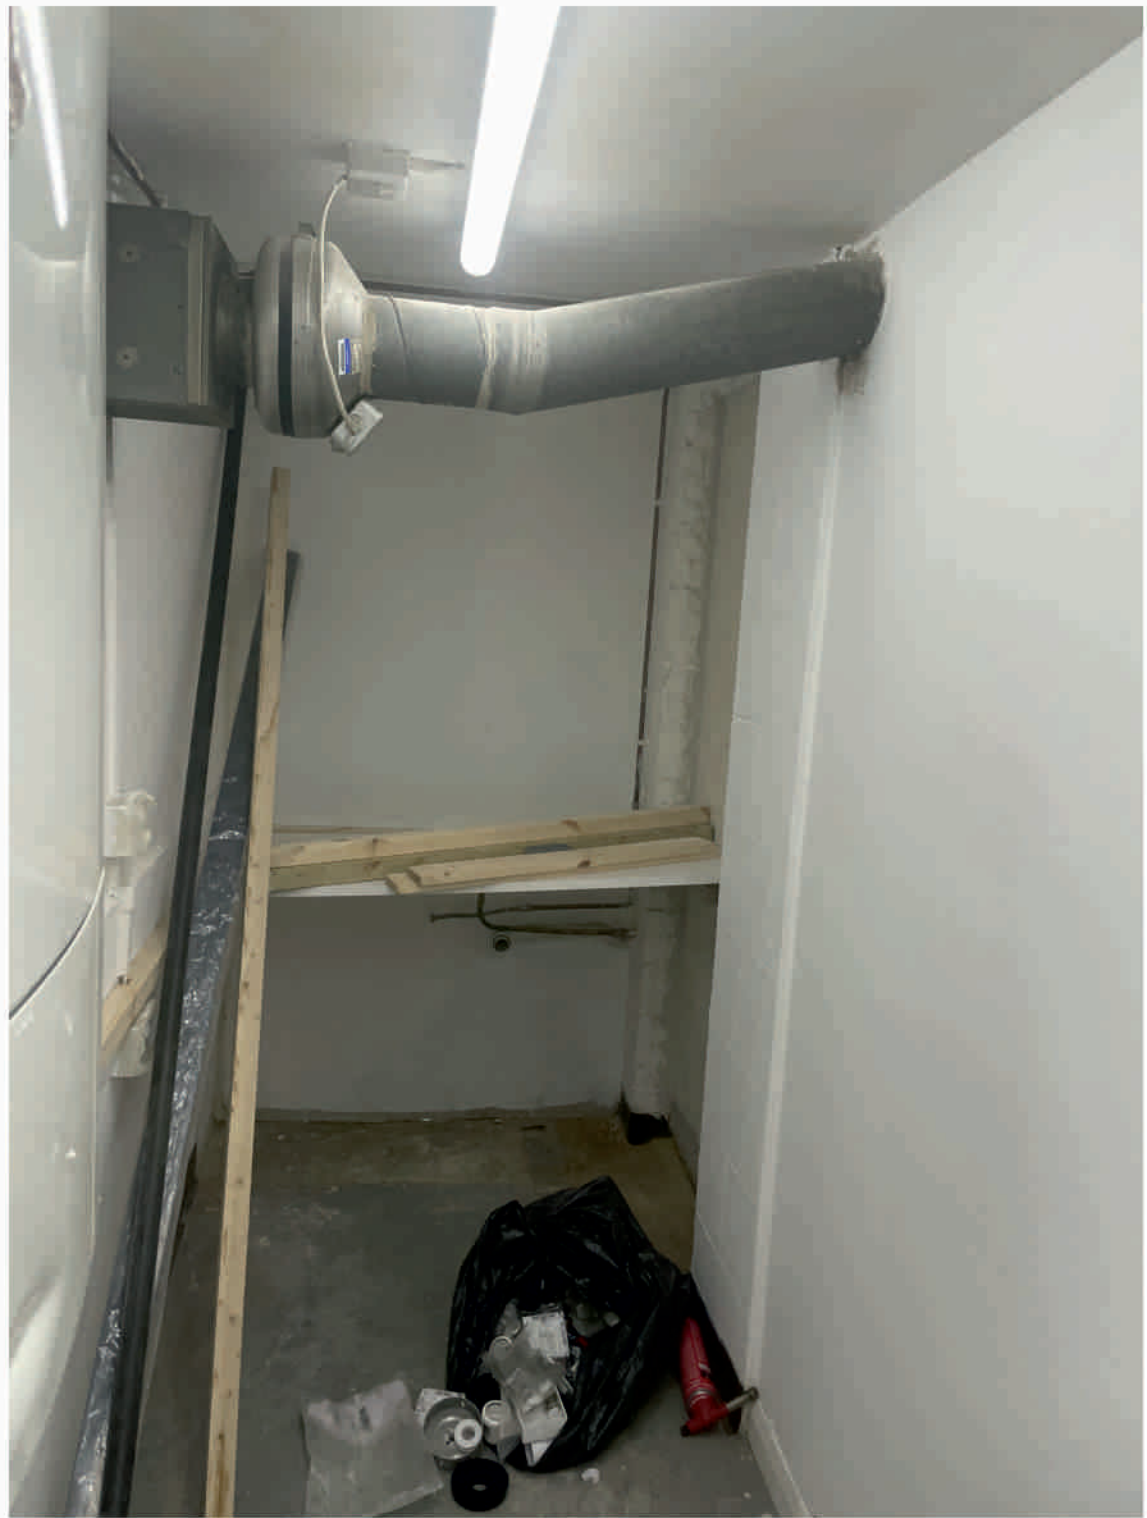
ROOM 7 - Store no original features

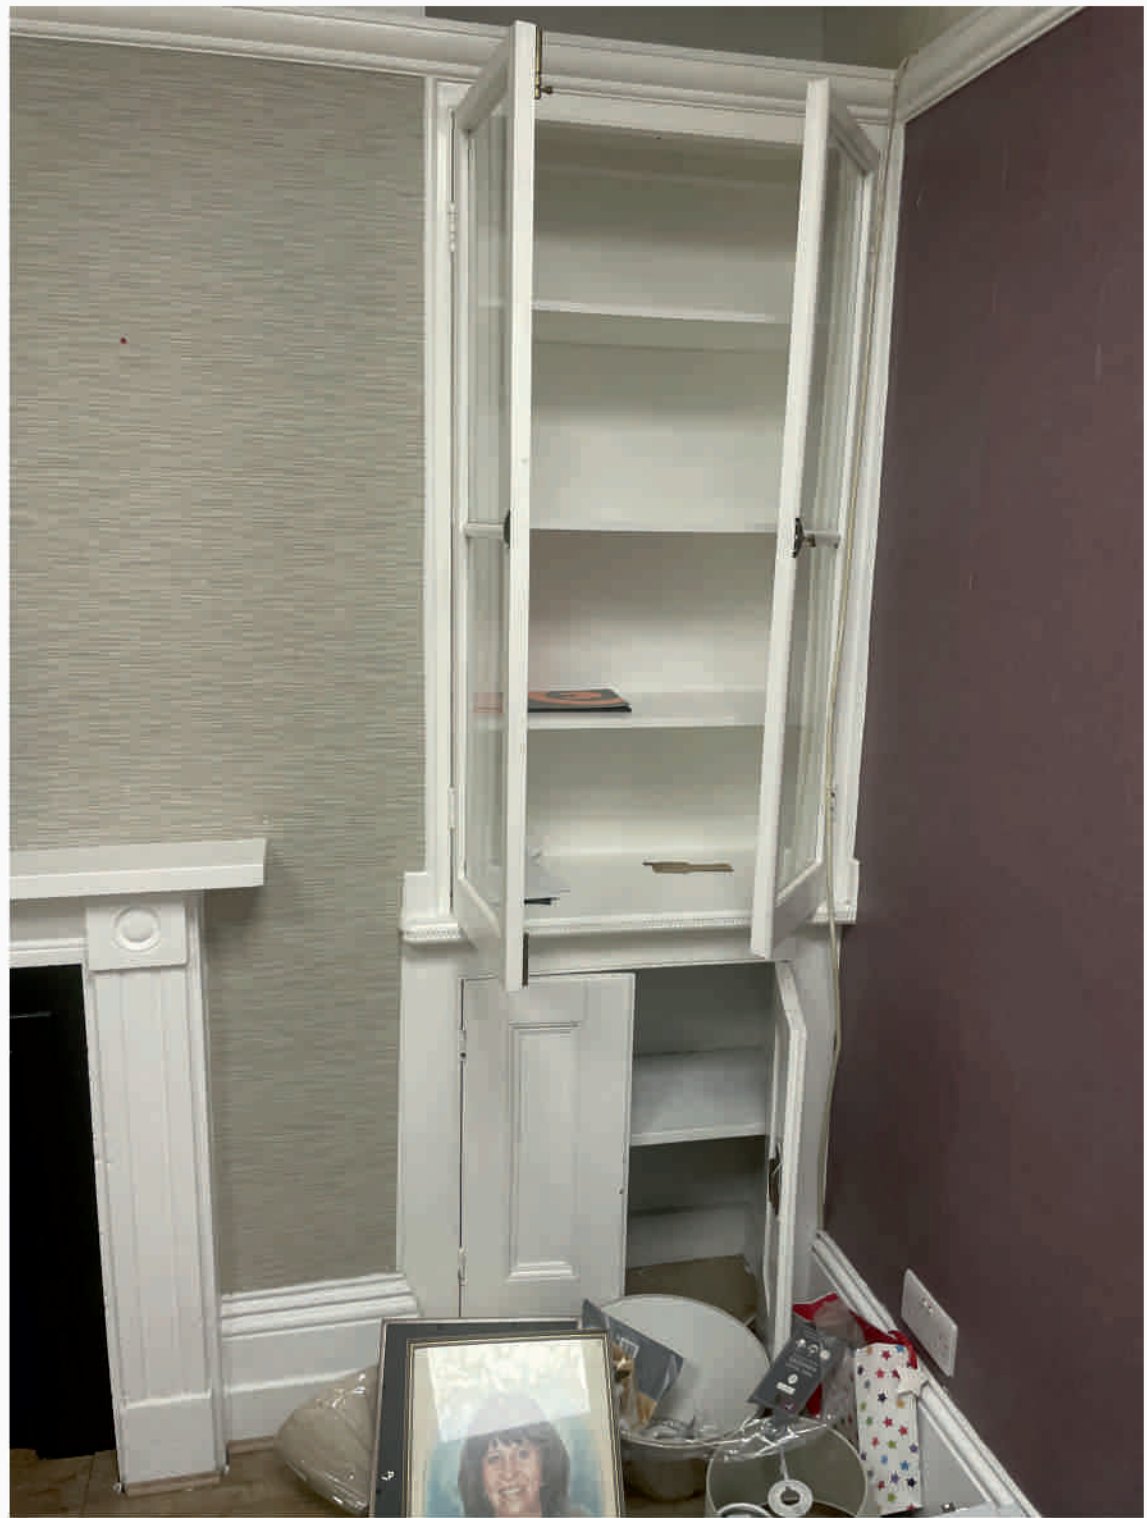
ROOM 6 - Right hand original built in cupboard and display cabinet with original picture rail and skirting

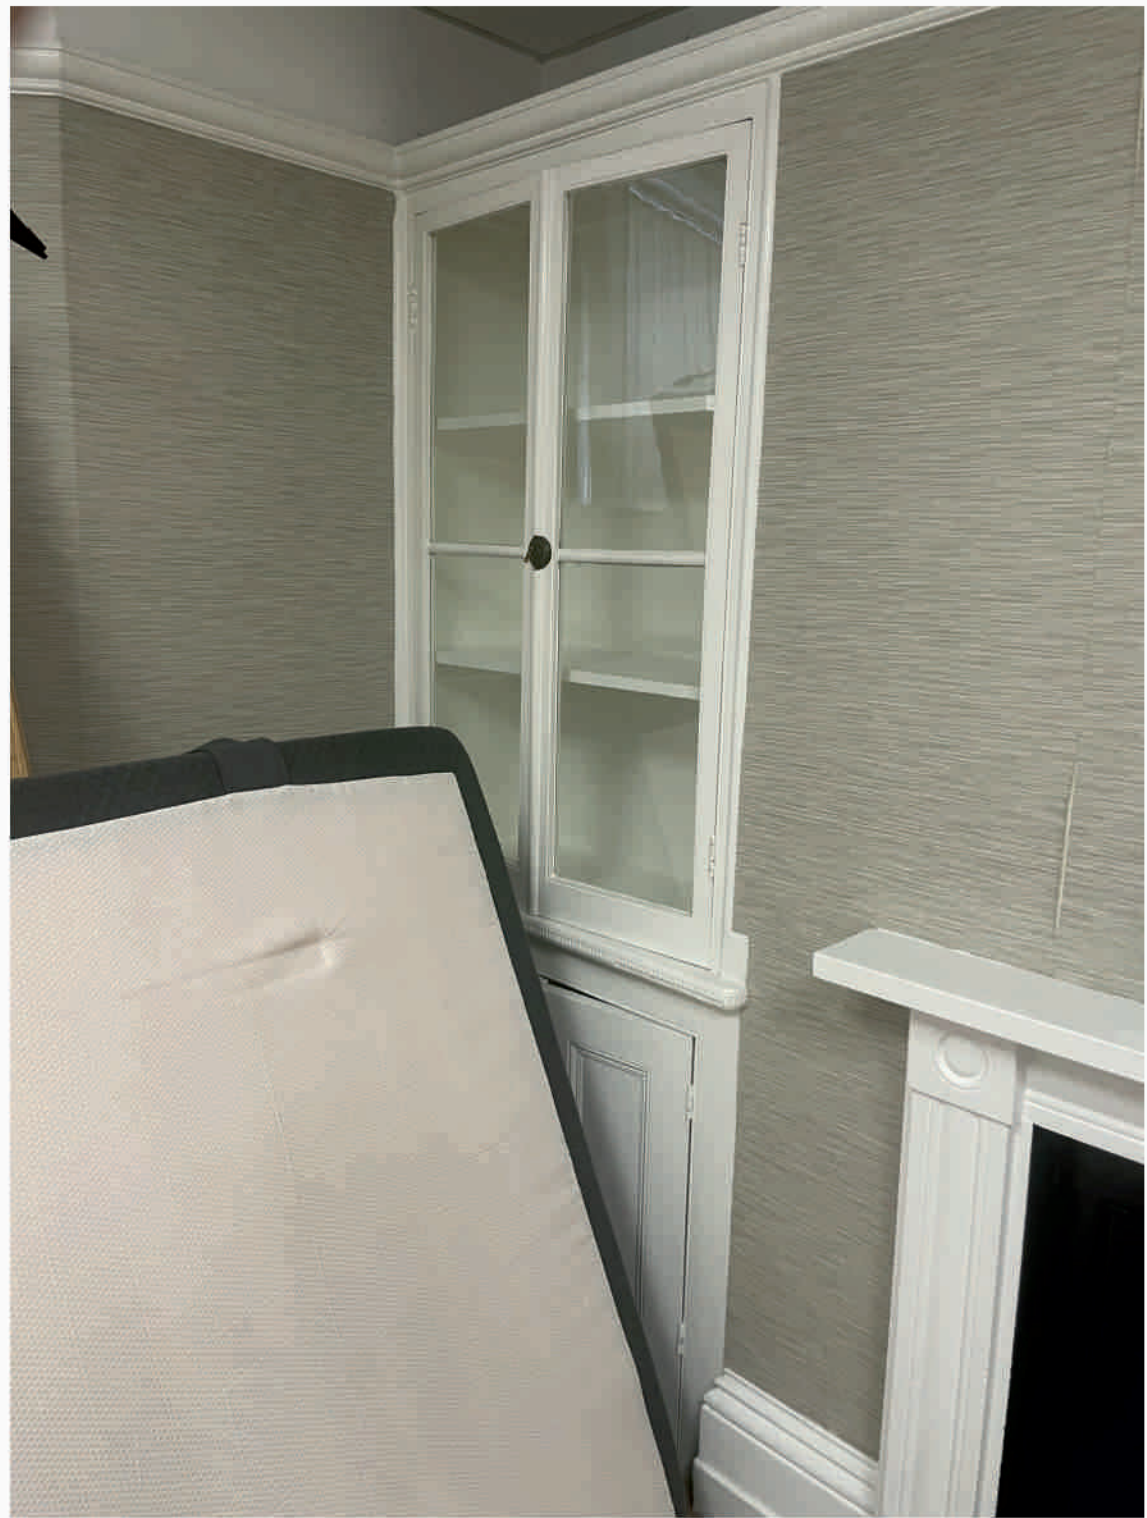
ROOM 6 - Left hand original built in cupboard and display cabinet with original picture rail and skirting

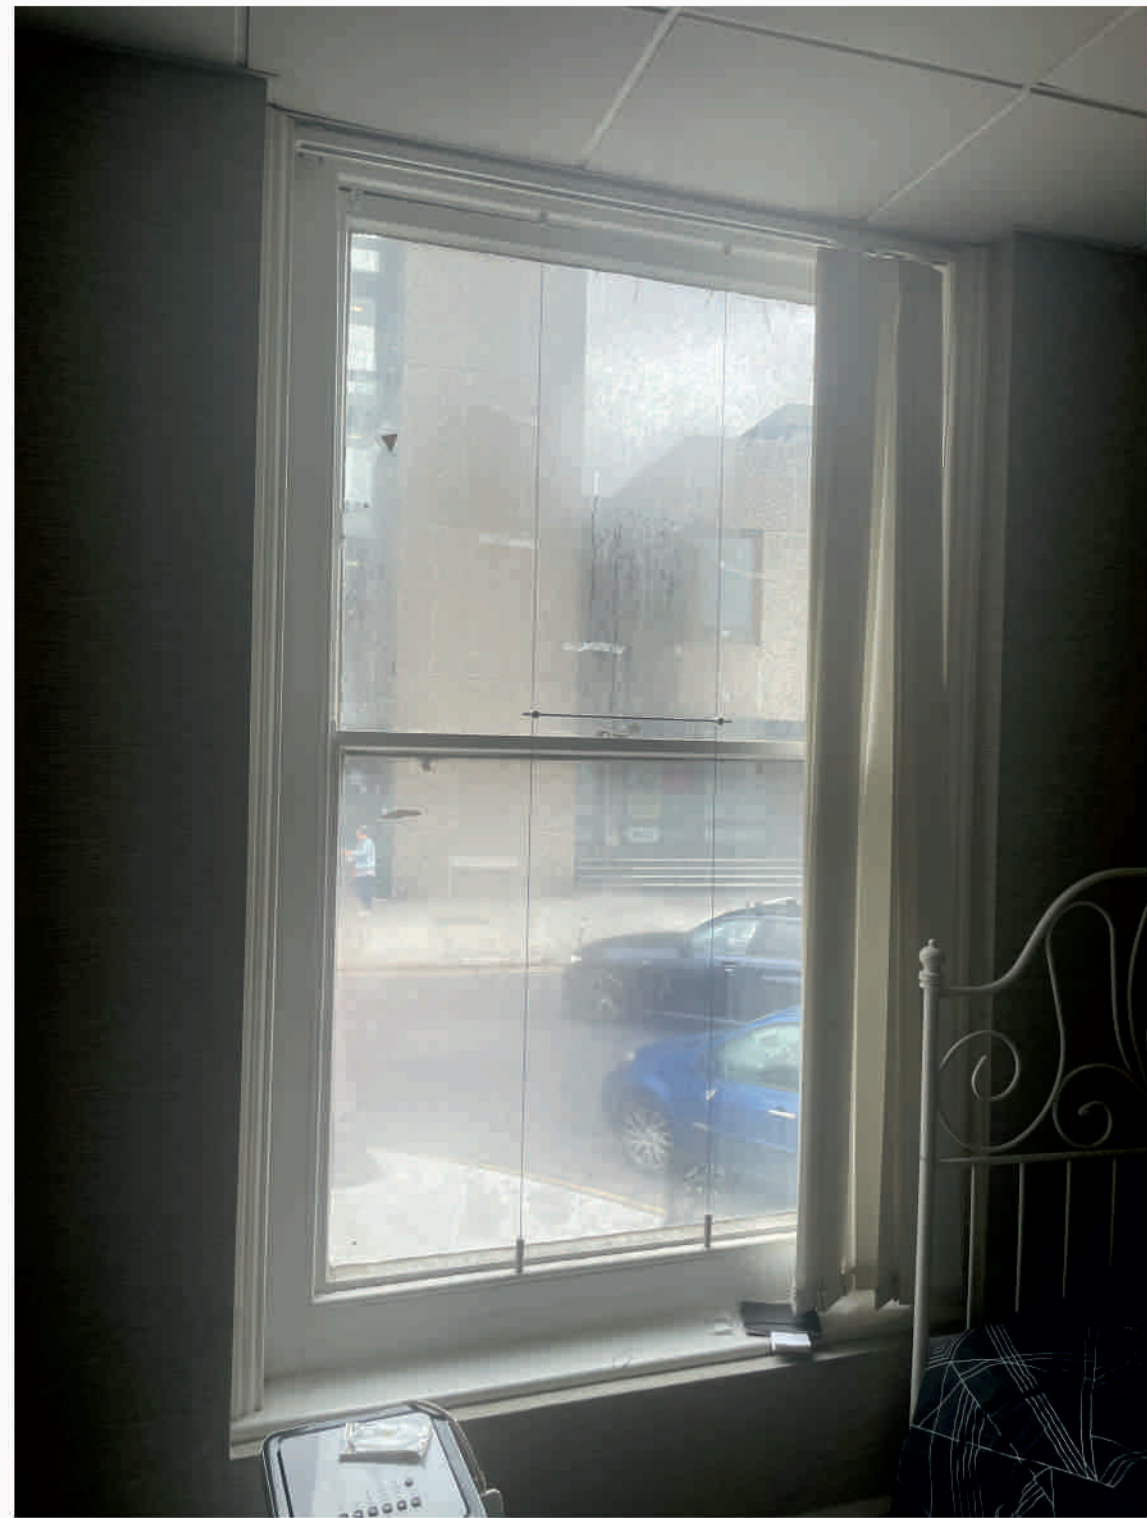
ROOM 2 - Original sash window in good order to be made good. Note there are no window bars and no sign that original bars have been removed, also front wall built out with internal stud work (find out why?).

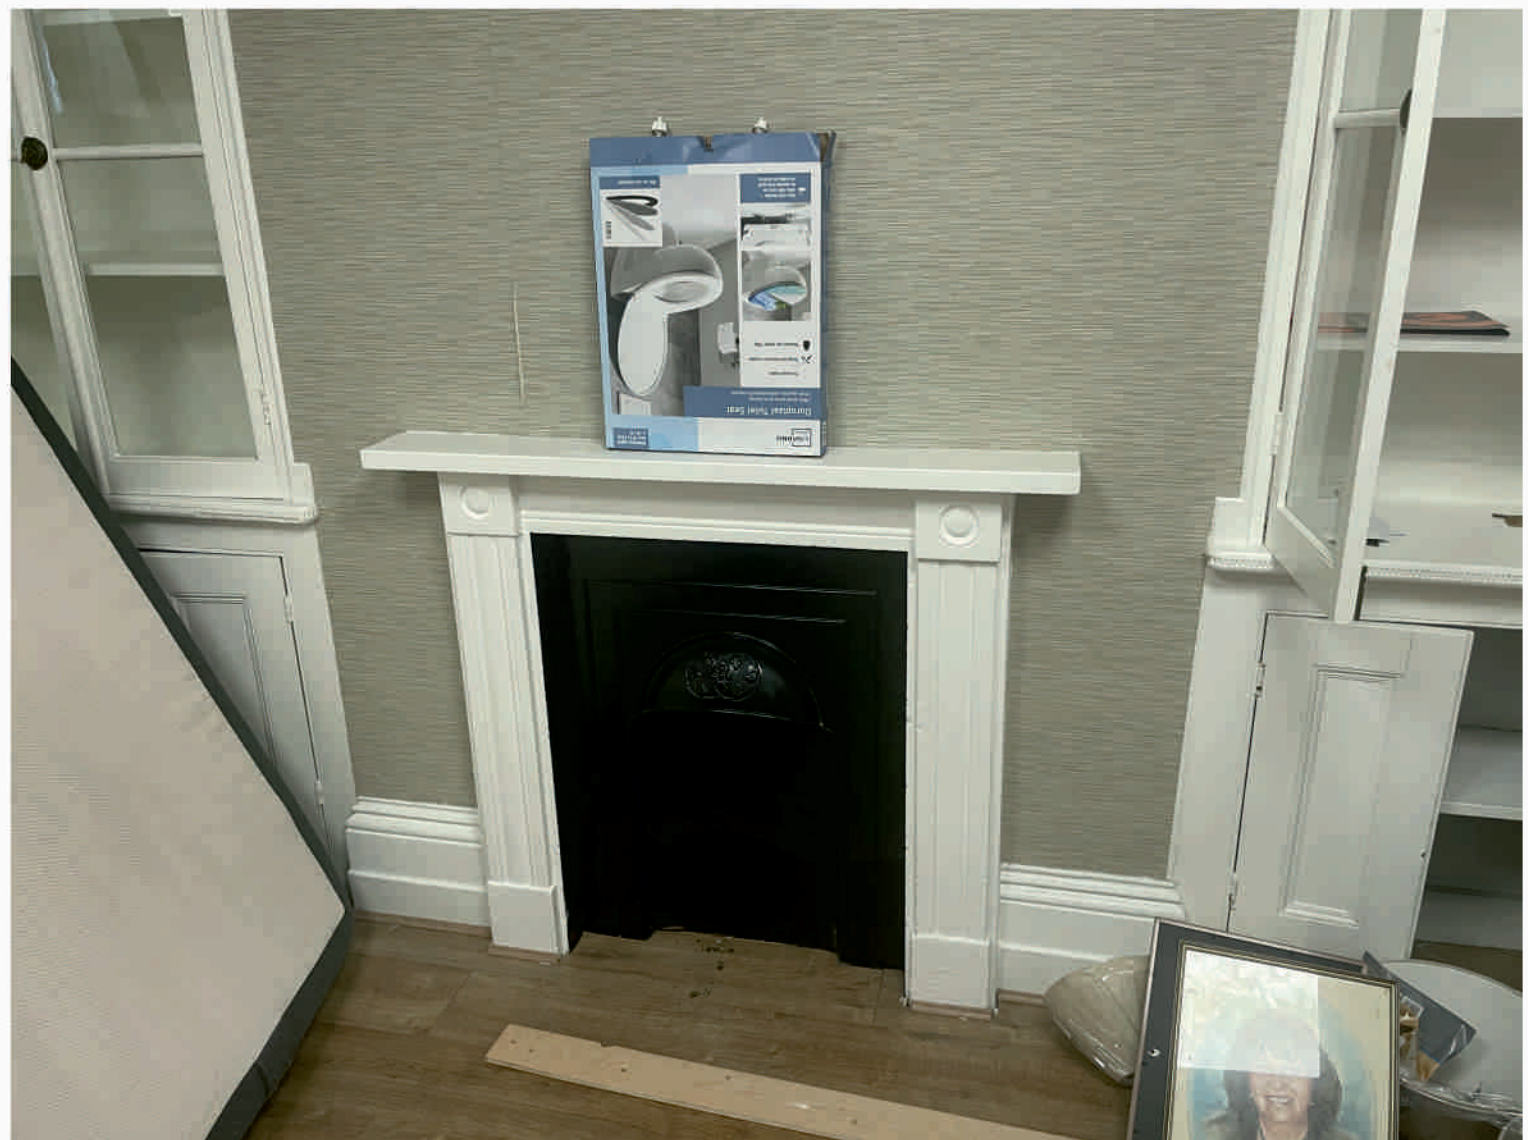
ROOM 6 - Central original fire place and surround to remain intact with original skirting

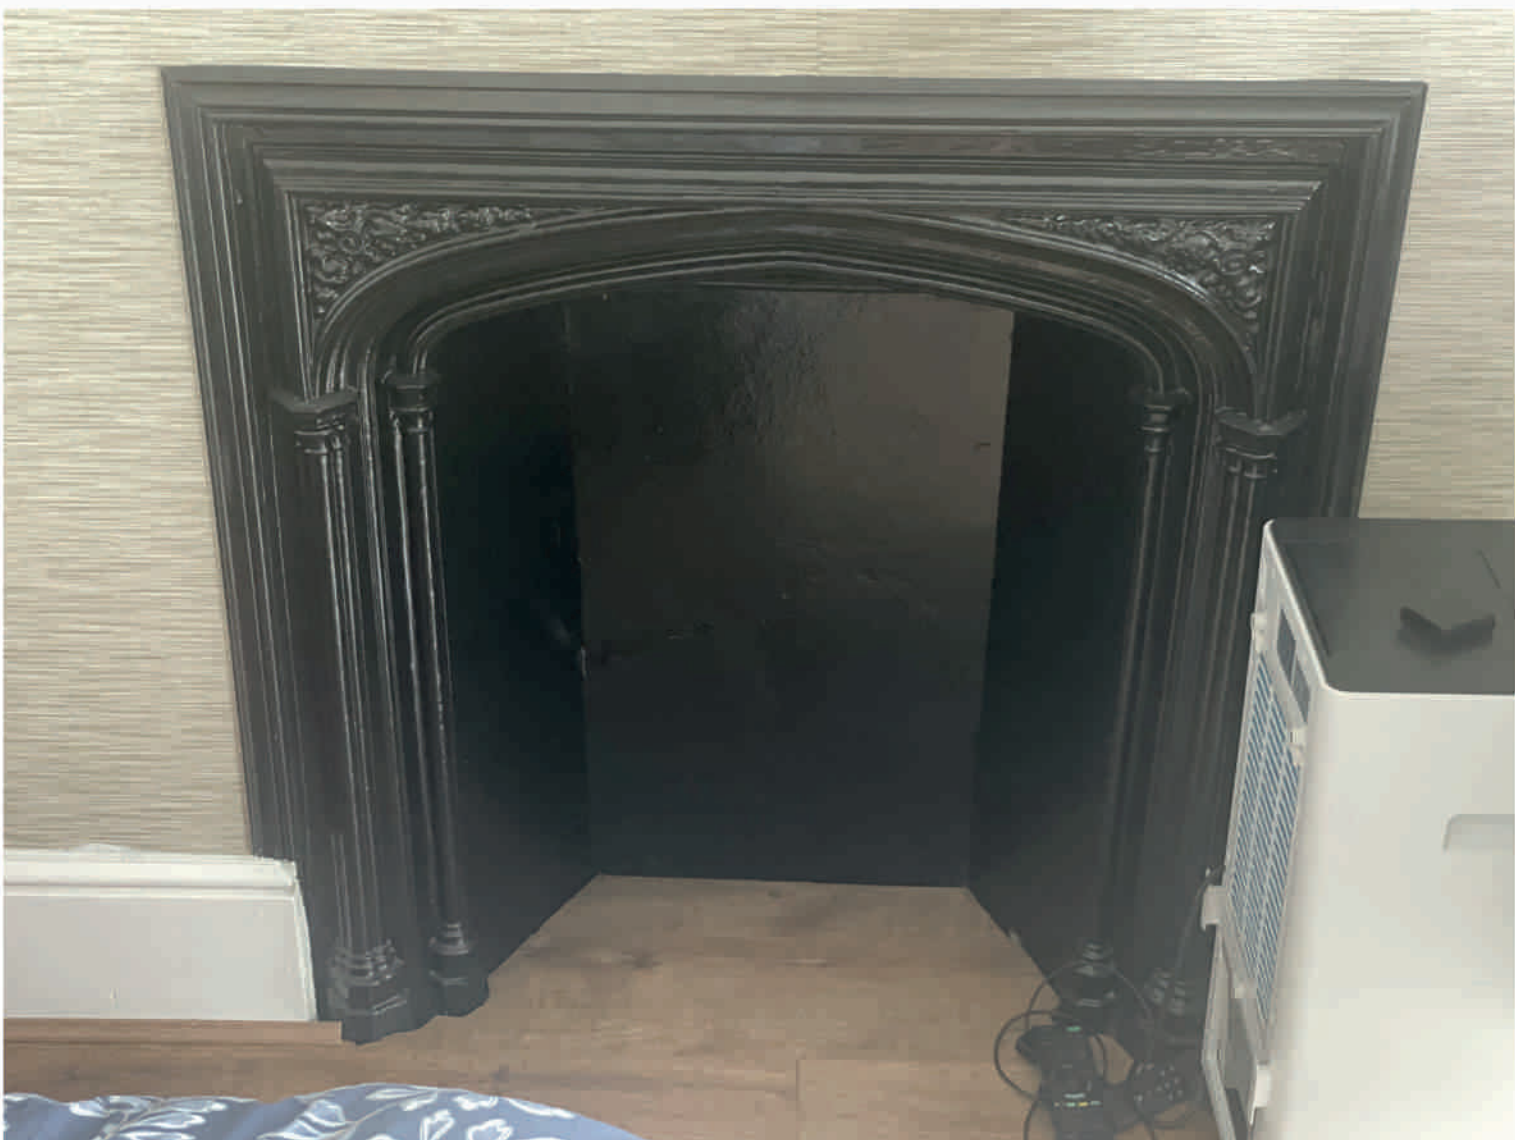
ROOM 1 - Central original fire place and surround to remain intact with replace skirting.
