**Gledsdale Associates**  
Consulting Structural Engineers

**Structural Appraisal  
Report  
on  
T J's  
15 Milton Road  
Gravesend  
DA12 2RF**

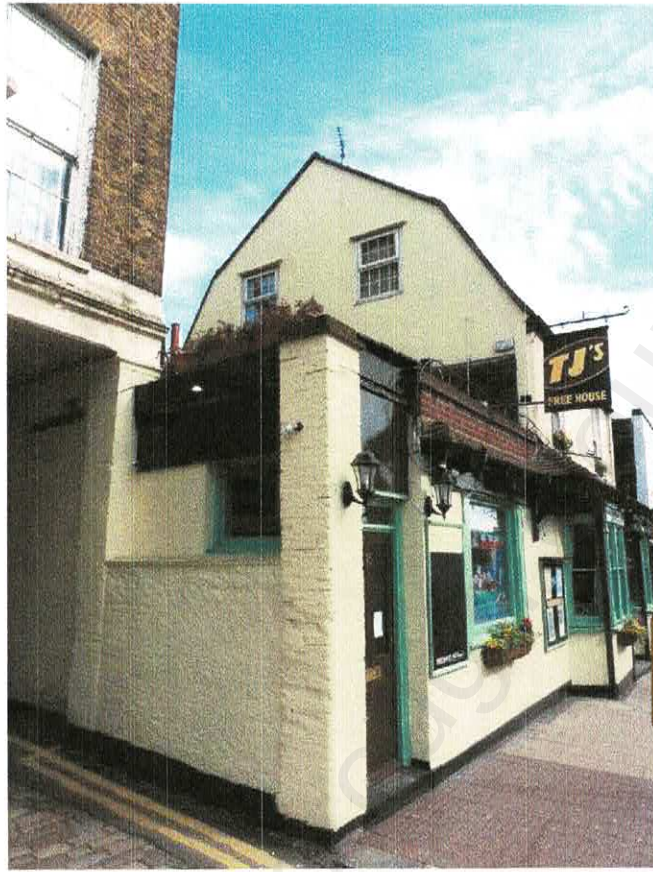
On the North elevation above the flat roof the construction is timber frame rendered over and with some tile hanging at the lower level. There was no sign of cracking or movement visible. At the lower level on the Northwest corner the brick pier is leaning out of vertical. Though there is no evidence of current cracking. There are some joints with mortar loss near the top of the pier.

The out of alignment of the brick pier on the Northwest corner is probably a result of where there is no adjacent brickwork to tie it in.

Front Elevation with out of vertical brick pier on Northwest corner

1. Check the connection between the top of the brick pier in the Northwest corner and the roof construction. Provide additional ties as necessary to ensure the top of the pier is fully tied into the structure.
2. Remove areas of cladding to the South elevation to check the condition of the timber framing. Replace the timber plate and bottom section of studs as necessary. Check the condition of the timbers at eaves level and replace or strengthen if necessary. Check cladding and flashings to ensure any water ingress is prevented.

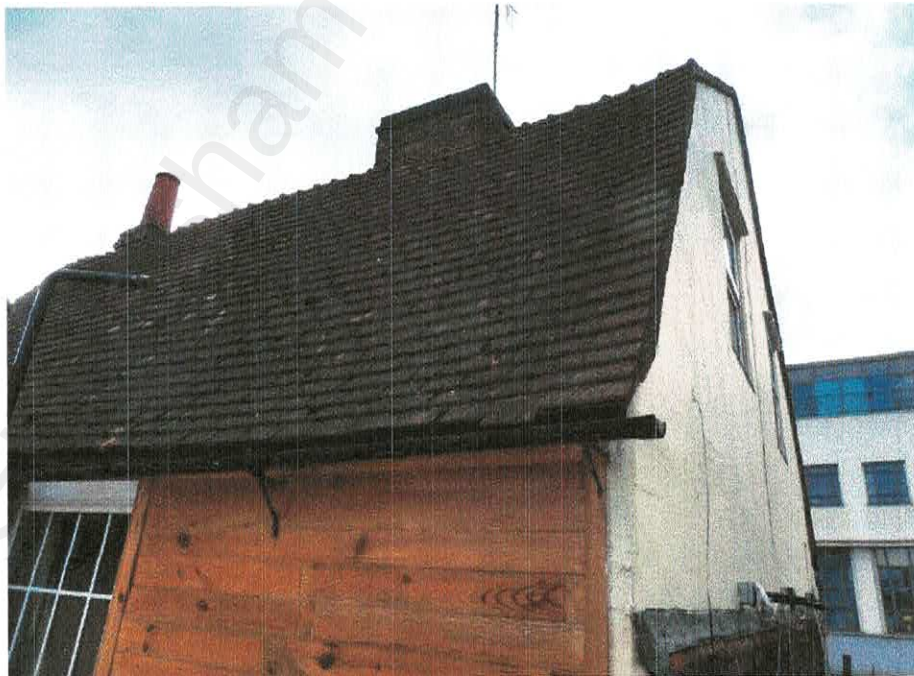
Both the main roof and the lower roof to the rear addition show signs of long term deflection and distortion of the roof shape. The tile coverings are in reasonable condition with only one or two slipped tiles to the higher roof. The brickwork to both the chimneys is in reasonable condition

The distortions and deflections of the structure to the roof and timber framed areas are typical of buildings of this age and type of construction. These are long term deflections which have gradually occurred over the 300 year life of the building. Although some of the deflections, particularly of the first floor and eaves lines, are quite excessive, there are no signs of current movement.

Main roof  
(Showing sag to slope and distortion at eaves)

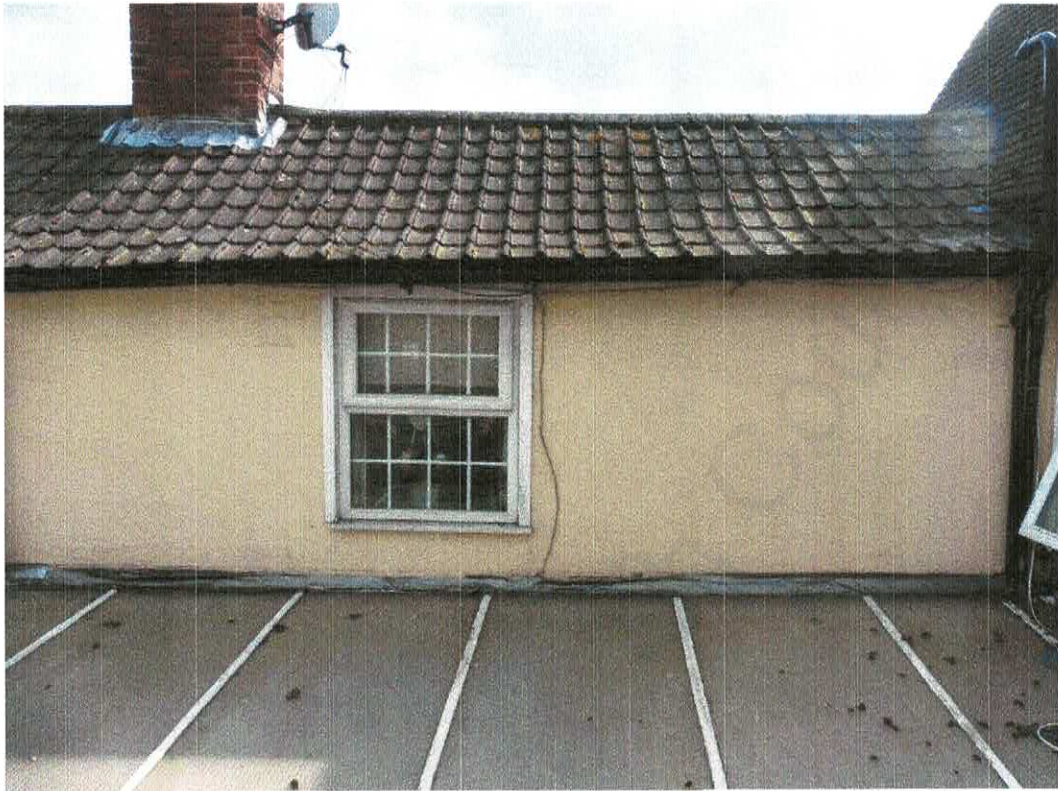
Roof to rear addition  
(Showing sag to roof and distortion of eaves)

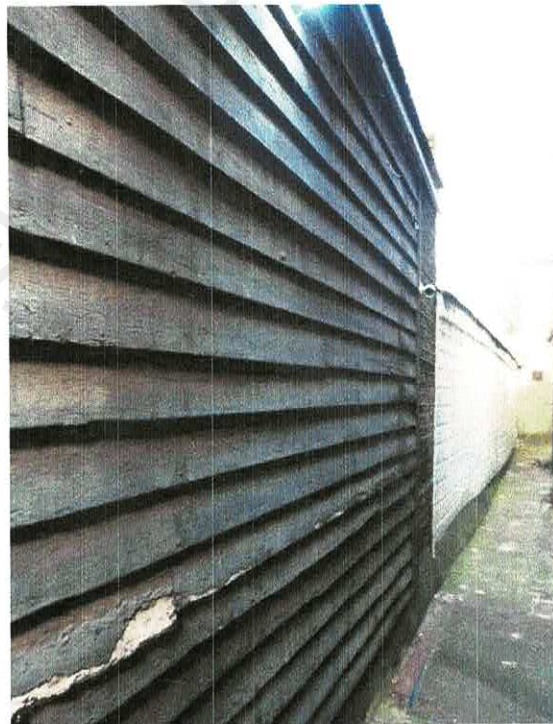
South Elevation

This elevation is timber framing with timber cladding. The rear section of the elevation appears to bow out slightly along the line of the elevation.

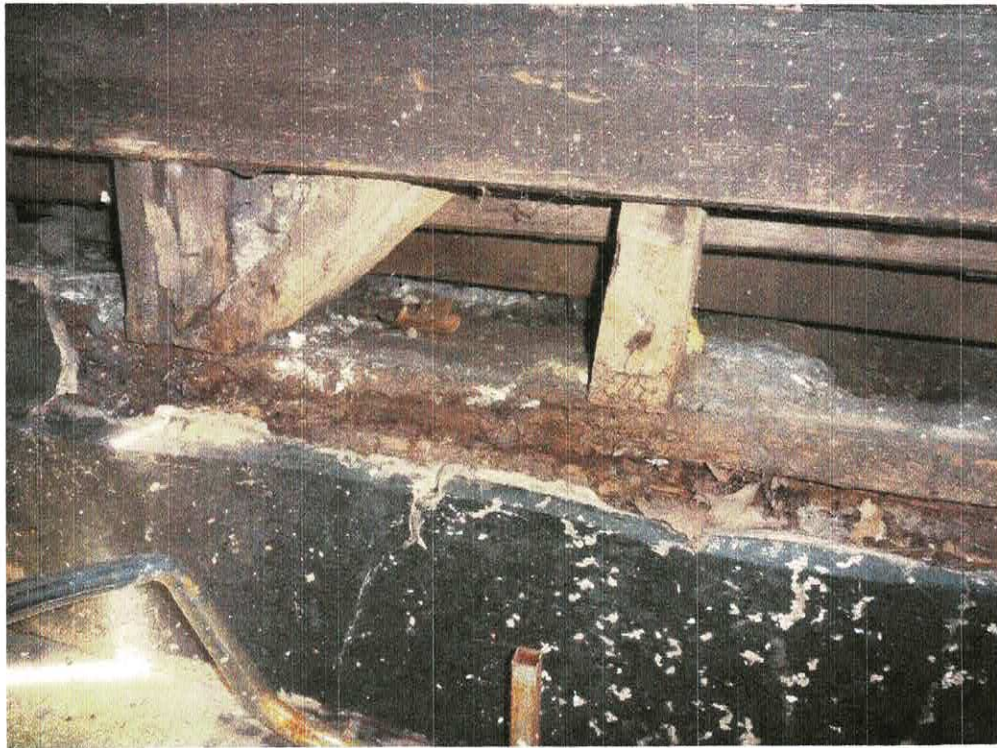
At the front corner some of the cladding has come away at low level and this has revealed rot to the timber plate and bottom of the vertical studs forming the structural framing.

The South elevation, where there is a single storey timber frame extension, is suffering from rising damp to the bottom of the frame. There is possibly some water ingress exacerbating the problem, as shown by the internal staining at eaves level to the rear section. This is now causing rot to the bottom plate member and to the bottom of the vertical studs.

Deterioration of plate and studs to timber frame on South Elevation

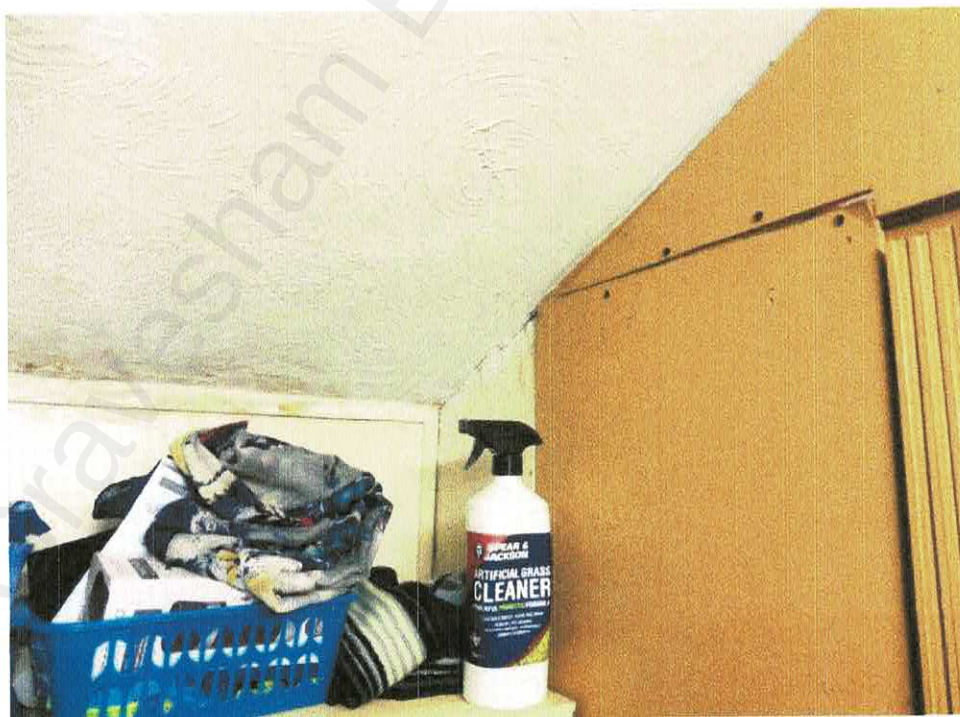
Damp ingress at eaves on South Wall

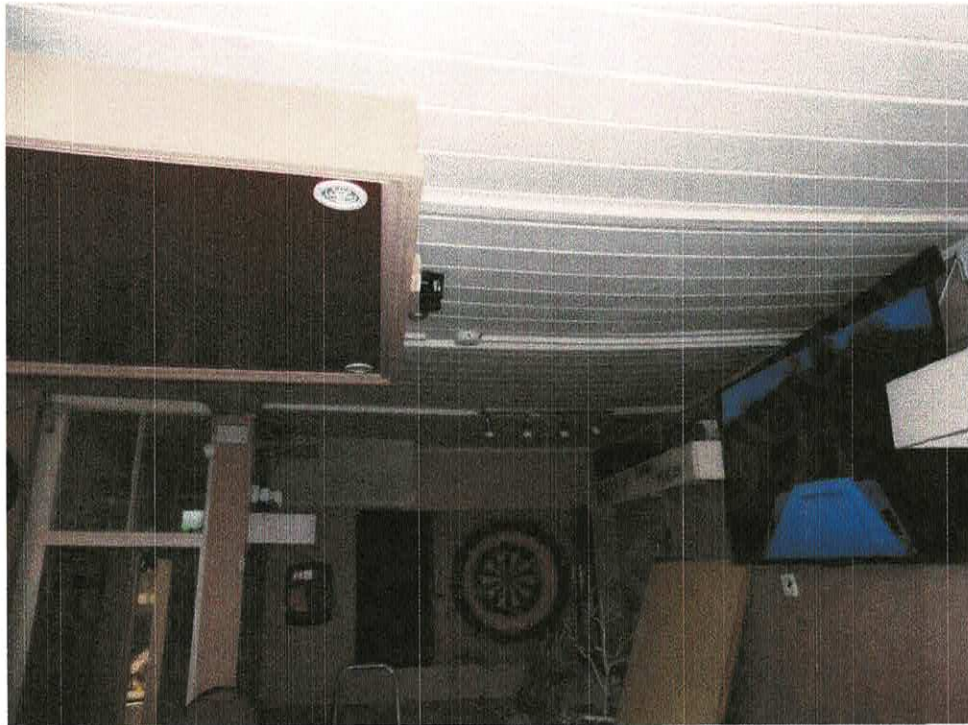
Deflection to some of the timber ceiling beams, particularly the beam over the right hand section of the bar area inside the entrance door. In this area there is also a definite sag in the ceiling line.

Deflections on ceiling at South end of bar
