**CUSTOM HOUSE, THE TERRACE, GRAVESEND, DA12 2BW  
REPAIR WORKS TO EXISTING ORIGINAL FEATURES – REV A**

This statement formally sets out the methodology details of all repair works to the existing original features within Custom House. This method statement includes the repair work information relating to existing original skirting, architraves, cornicing, fireplace and staircases.

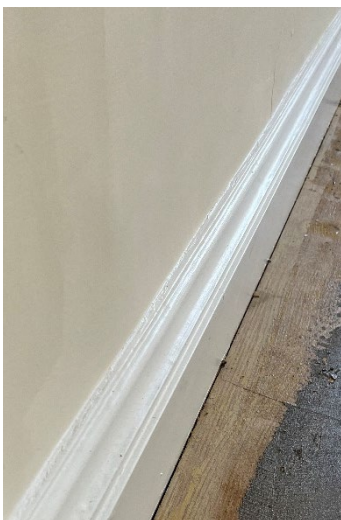
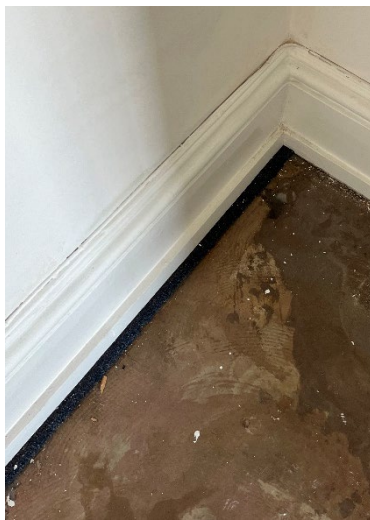
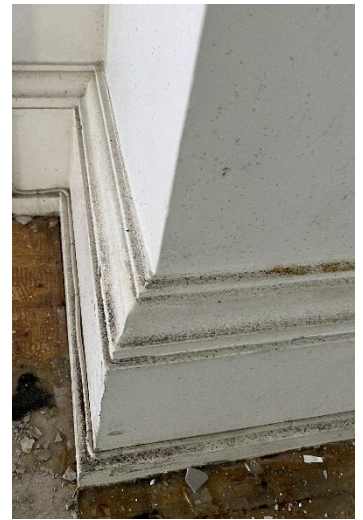
*Images of existing original skirting profile, to be retained and repaired.*

The skirtings that have been highlighted on the drawings as original skirting are considered either original or period features following consultation with the heritage consultant. All skirting highlighted will be carefully retained, rubbed down removing paint surface, repaired where required and redecorated.

A template of existing original skirting will be taken to produce a replica profile which matches the original and can be used where the other two types of skirting assessment have been determined.

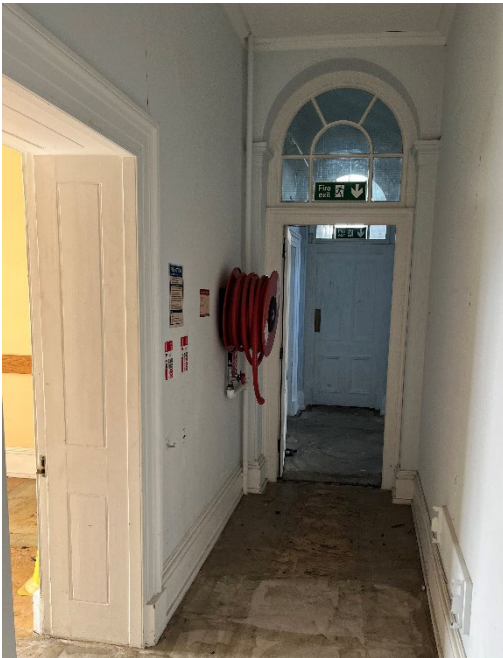
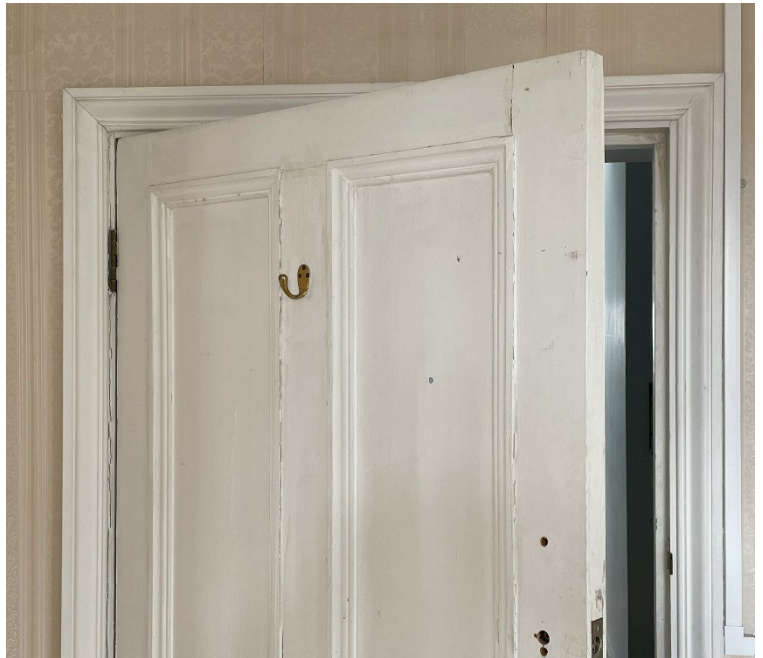
*Examples of varying original architraves to be retained across the main house.*

Initial repair works will start by cleaning of the architraves. While cleaning, the woodwork will be inspected for any further signs of damage such as cracks and chipped areas. Following the cleaning and inspection process, the architraves will be sanded down, smoothing any rough surfaces and working this into any area of chipped paintwork, priming the woodwork for new paint to be applied.

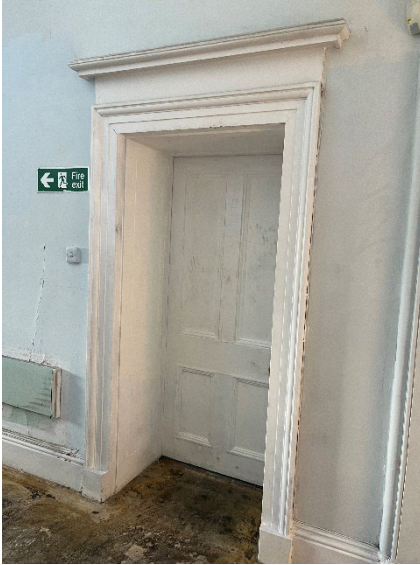
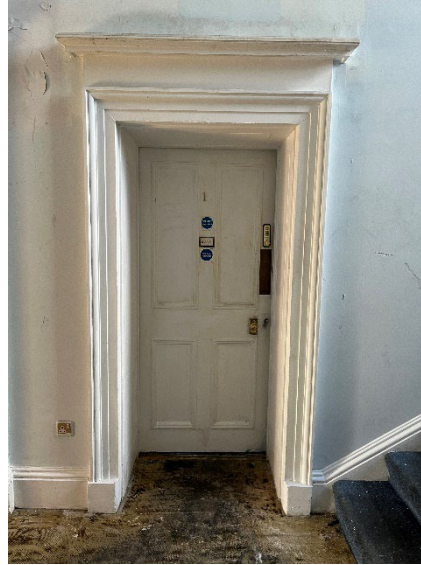
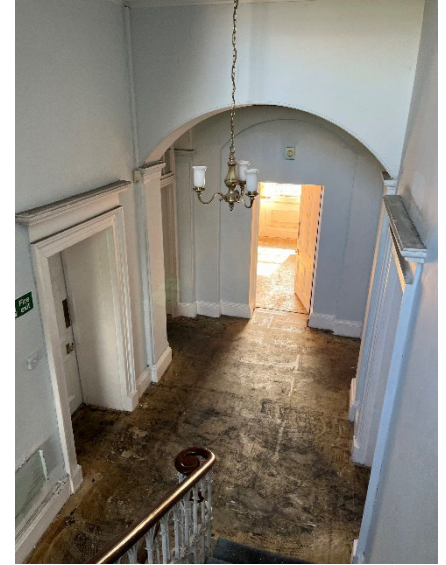
*Original doors and architraves on landing of main staircase to remain but become fixed shut with wall behind.*

Several original doors to the main central stair landings across all floors are being fixed shut, with original door, architraves and recesses to be retained on the stair landing side. The intention is that the landing remains as per it's historical intent, whilst being able to split the spaces into individual spaces.

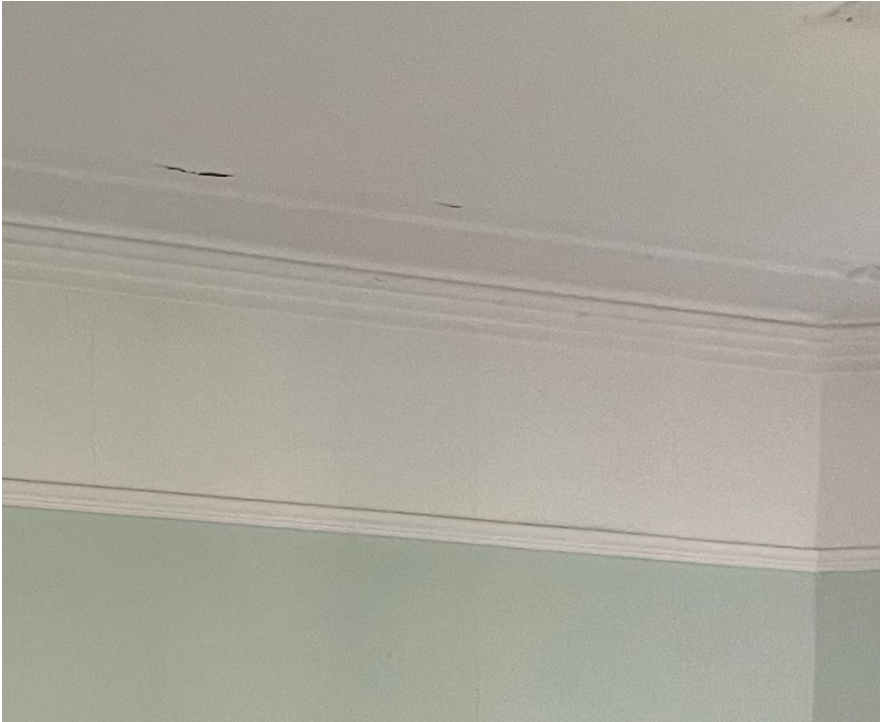
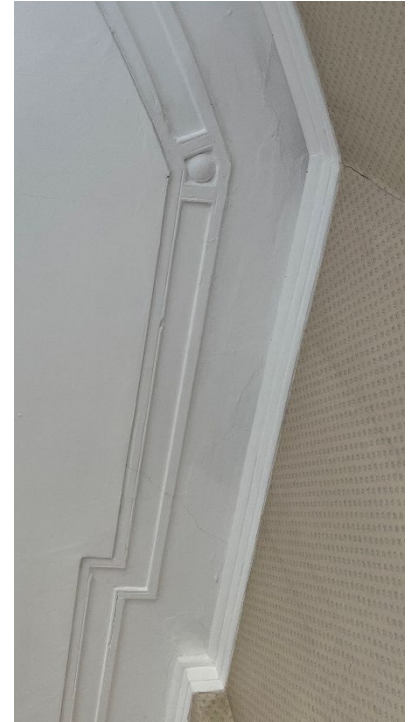
*Images of varying cornice details across the main house.*

The original cornicing identified in habitable rooms will be carefully preserved in-situ with a new suspended ceiling to be installed below which will not interfere with the original.

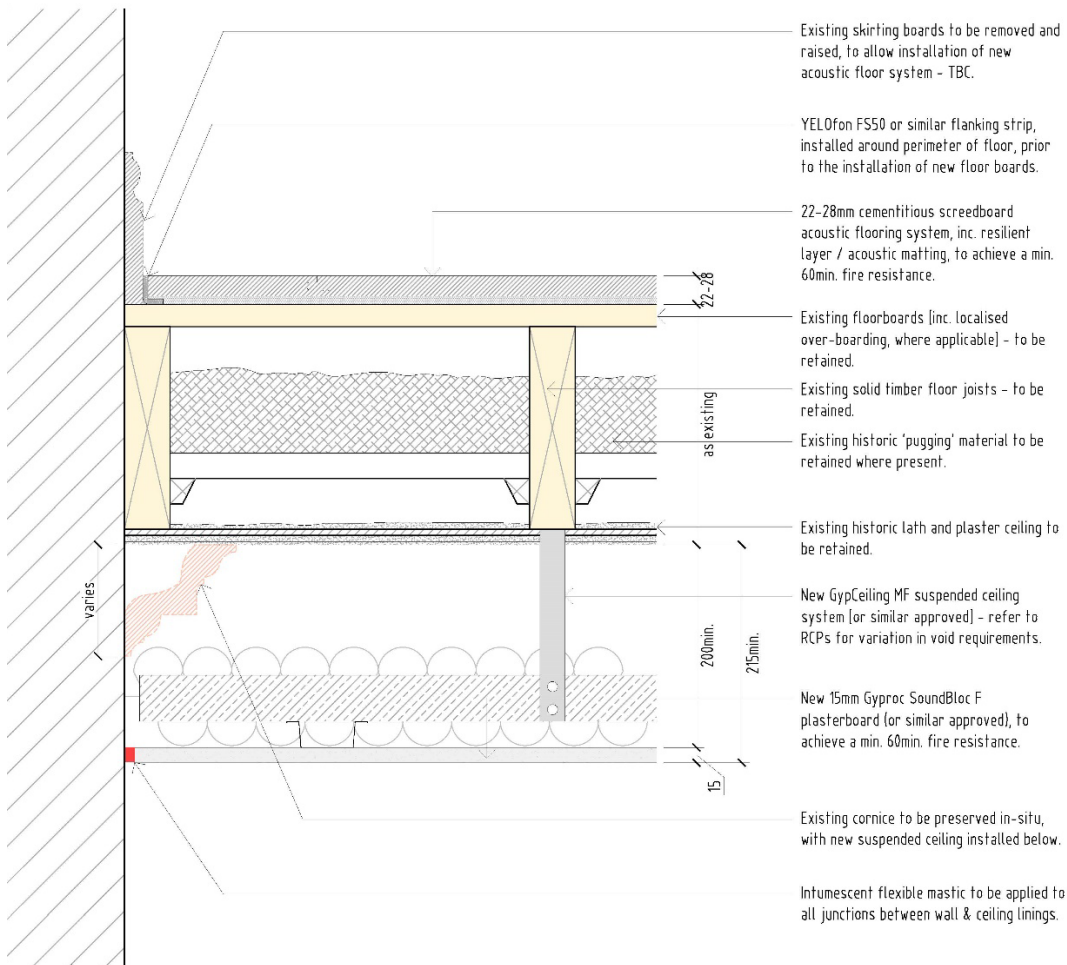
*Proposed suspended ceiling and cornice preserving detail.*

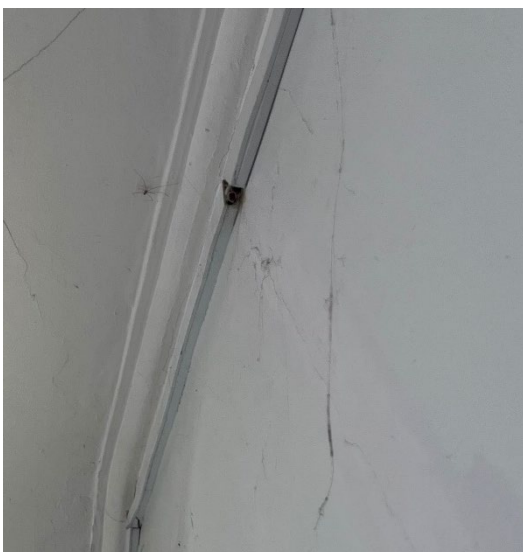
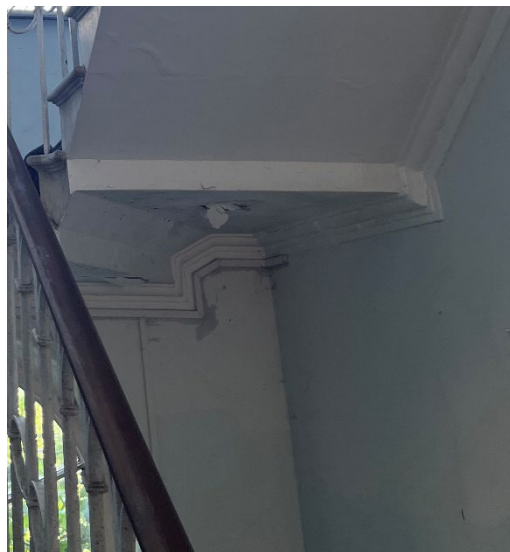
*Staircase cornice details found on the main staircases throughout the main house.*

Existing cornice to the stair areas highlighted on the reflected ceiling plans and images below will be carefully retained, rubbed down removing current paint surface and flaking, repaired where required and redecorated.

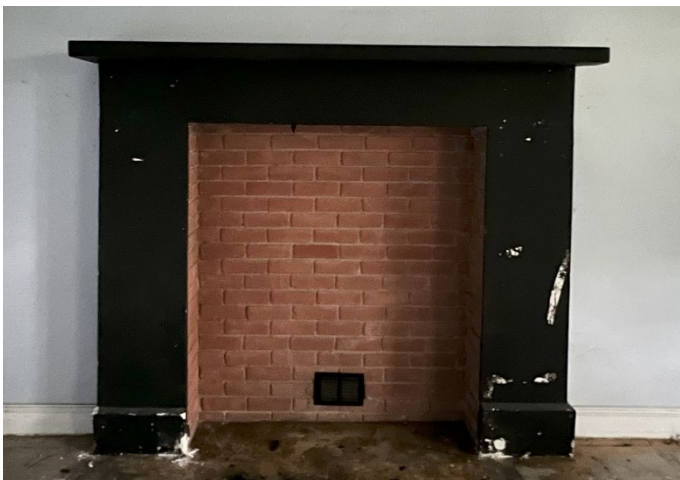
This fireplace is an early 19<sup>th</sup> century plain surround which has been altered over the years and a modern brick infill has been used to line the inside of the chimney.

*Front elevation of fireplace surround.*

Repairs to fire surround should only be carried out by specialists. The fireplace surround will be rubbed down, removing the flaking and damaged paint. Any visible repairs will be undertaken as necessary. If sections need to be removed it will be done so carefully, inspected, repaired and refitted.

Once repaired, the fireplace surround will be re-decorated as required. The internal fireplace zone will be lined out and kitchen units will be fixed in front of it, boxing in around where the surround connects with the kitchen. The top half of the fireplace surround will remain visible.

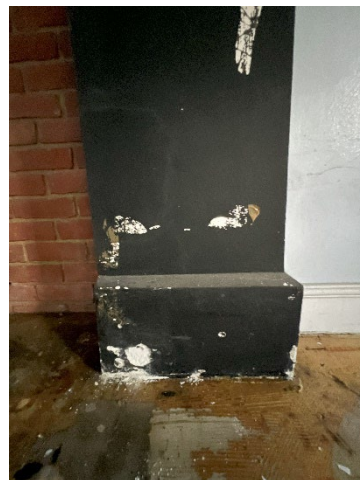
*Close up of wear and tear to surround.*

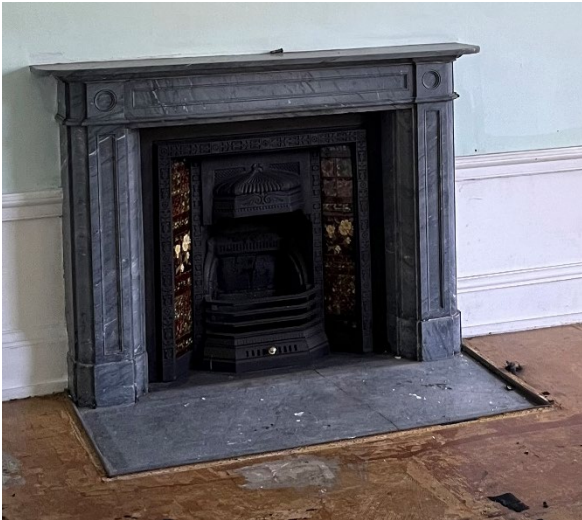
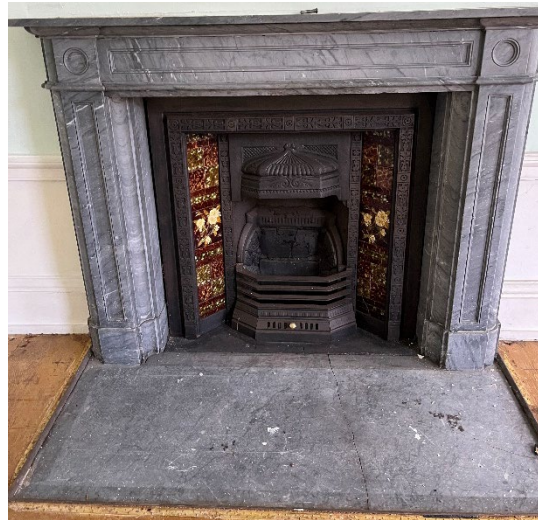
The fireplace to this unit is an early 19<sup>th</sup> century grey marble surround, late 19<sup>th</sup> century insert grate with ceramic tiles and a stone hearth. The intention for this fireplace as an important feature of the room that it will be conserved and remain a key feature to the space.

The fireplace appears well maintained and in good condition. The marble surround and insert grate will be carefully cleaned, inspecting any remedial work requirements. Any components for repair shall be carefully removed, if possible, inspected and repaired as necessary. The cast iron insert and grate will be polished /blackened where required. Any stone hearth repair work to be undertaken in-situ wherever possible.

*Images of fireplace to Unit 5.*

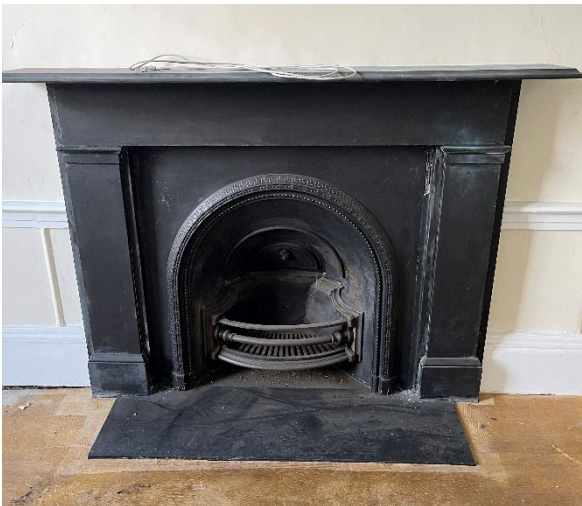
The fireplace is generally in a good condition however there is some discolouration to the surround and insert. There is also some minor visible damage where the insert abuts the surround in the top corner.

*Front elevation to fireplace to Unit 6.*

The slate surround, insert grate and stone hearth will be carefully cleaned with material specific appropriate cleaning products, inspecting any remedial work requirements during the process. Following the cleaning process, the discolouration to the slate surround will be repaired to restore colour uniformity. The cast iron insert and grate will be polished /blackened where required. Any components for repair shall be carefully removed, if possible, repaired as necessary and refitted carefully. Any stone hearth repair work to be undertaken in-situ wherever possible.

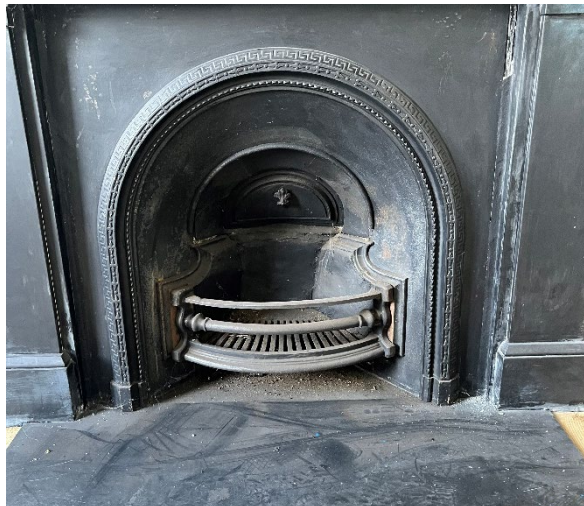
*Minor damage where insert abuts the surround.*

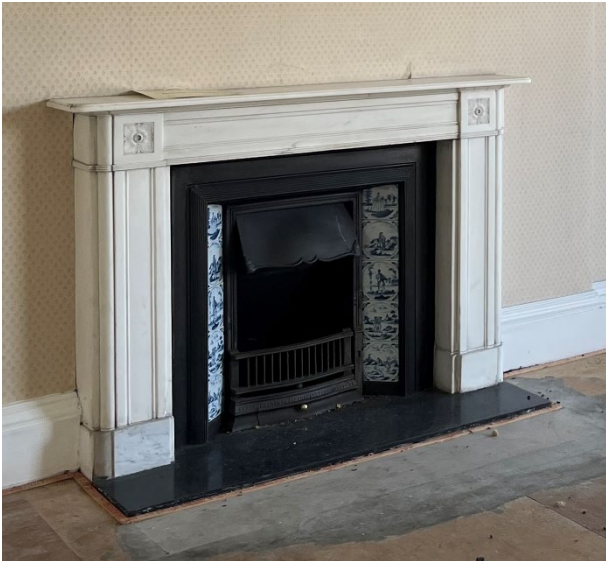
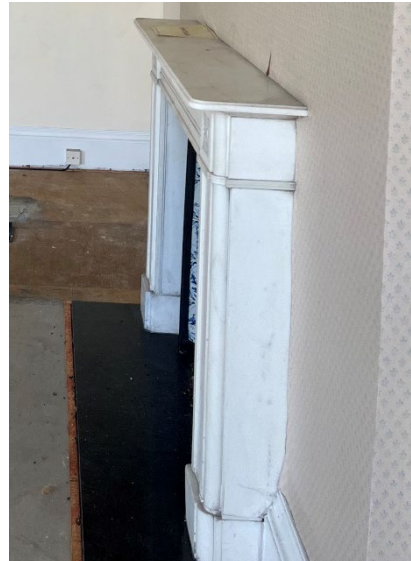
The fireplace appears in good condition, generally in need of cleaning to remove dirt, decay and debris build up. The marble surround, insert grate and stone hearth will be carefully cleaned with material specific appropriate cleaning

*Front view of fireplace.*

*Side view of fireplace.*

products, inspecting any remedial work requirements during the process. If any remedial work is discovered this will be repaired carefully, minimising any conflict with the other good condition areas.

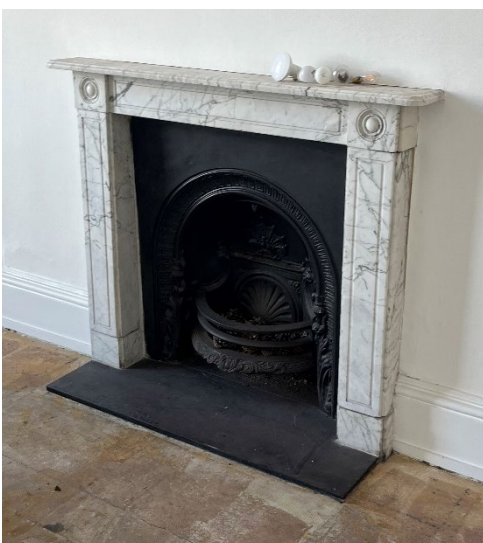
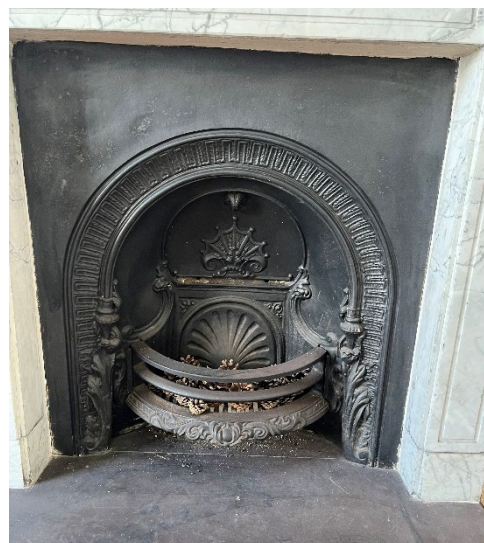
The fireplace appears in a generally good condition, however, there appears to be some minor chipping to the marble surround, discolouration to the black insert and poor seal connection between the insert and the marble. The marble surround and insert grate will be carefully cleaned and inspected prior to any remedial works taking place. Any components for repair shall be carefully removed, if possible, and repaired as necessary. The seal between insert and marble to be carefully removed and reapplied. The cast iron insert and grate will be polished /blackened where required to provide uniform colour. Any stone hearth repair work to be undertaken in-situ wherever possible.

*Front view of fireplace.*

*Close up of insert and grate.*

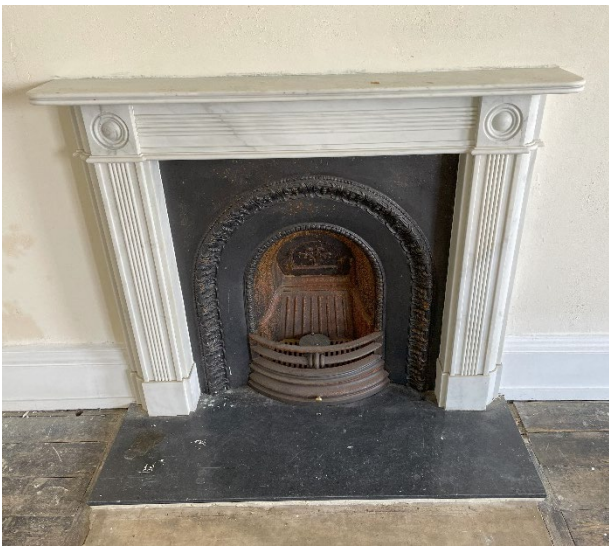
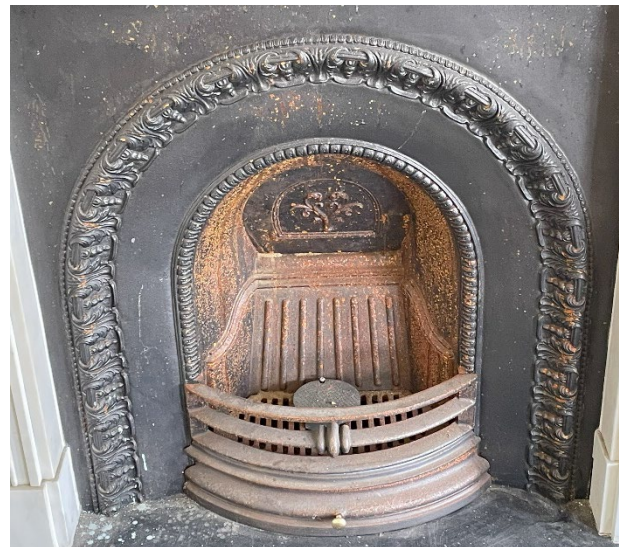
The fireplace appears well maintained and in good condition only requiring some cleaning and restoration to the insert. The marble surround and insert will be carefully cleaned, inspecting any remedial work requirements. The cast iron insert and grate are showing signs of rust and will therefore require some rust restoration treatment prior to being polished /blackened. The whole insert and grate will undertake this process to create a uniform finish. Any stone hearth repair work to be undertaken in-situ wherever possible.

*Front view of fireplace.*

*Close up of insert and grate.*

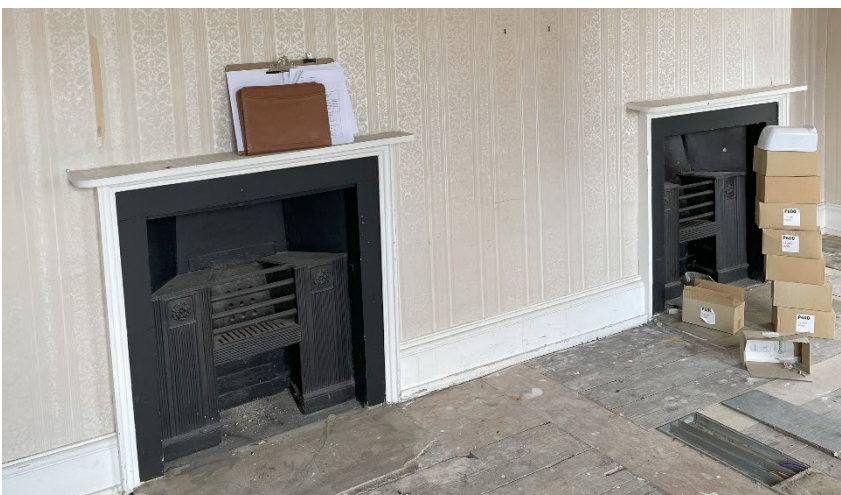
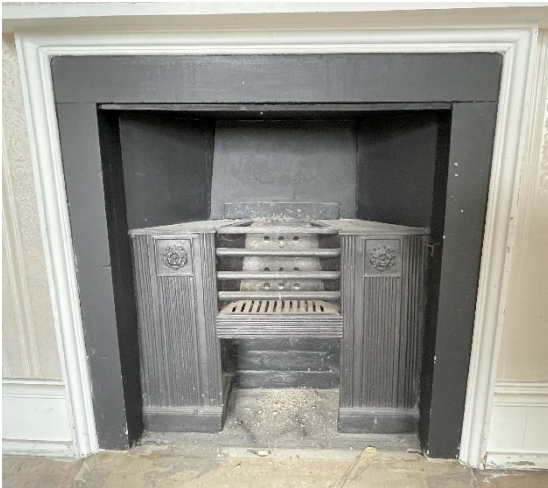
The fireplace grates appear in a good condition and require careful cleaning. The grates will be polished/ blacked where required to provide uniform colour across them. The surrounds comprise of black painted stone and timber architrave. There are some visible paint flaking and chipping which will require repair work. Surrounds area to be cleaned, rubbed down with flaking paint removed. Surround areas to be redecorated as required.

*Image of two adjacent fireplaces.*

*Close up of early 19<sup>th</sup> century grate.*

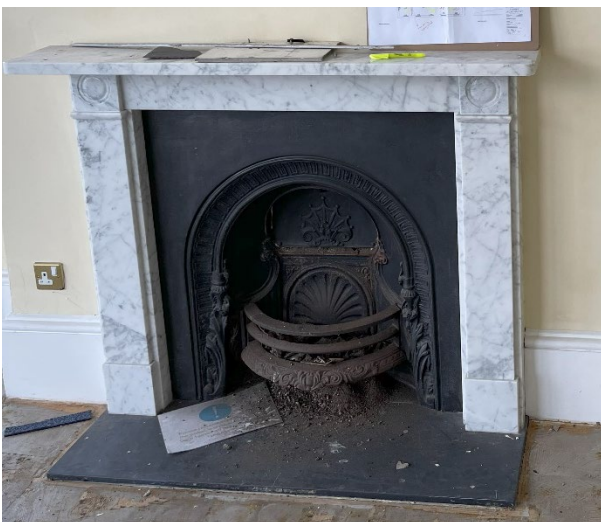
The fireplace appears well maintained and in good condition only requiring some cleaning and restoration to the insert. The marble surround and insert will be carefully cleaned, inspecting any remedial work requirements. The cast iron insert and grate are showing signs of rust and will therefore require some rust restoration treatment prior to being polished /blacked. The whole insert and grate will undertake this process to create a uniform finish. Any stone hearth repair work to be undertaken in-situ wherever possible

*Front view of fireplace.*

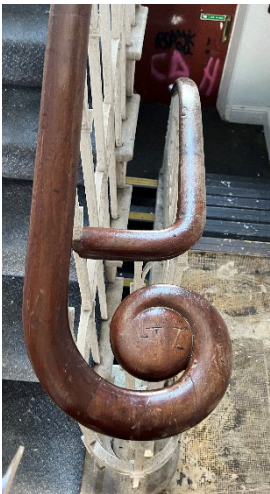
*Staircase 1.*

*Staircase 1 – Main Staircase Central to building.* Varnished wood, with curved wood and ornate detailing. Banister to be cleaned, carefully rubbed down and varnish to be reapplied to match existing appearance in colour.

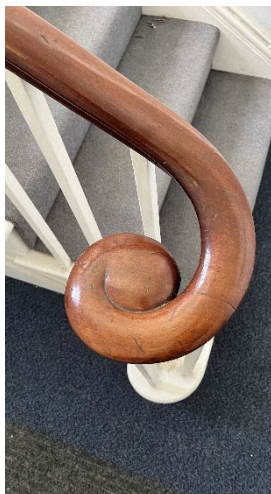
*Staircase 2.*

*Staircase 2 – Commissioners Staircase West of building.* Varnished wood, with curved wood and ornate detailing. Banister to be cleaned, carefully rubbed down and varnish to be reapplied to match existing appearance in colour.

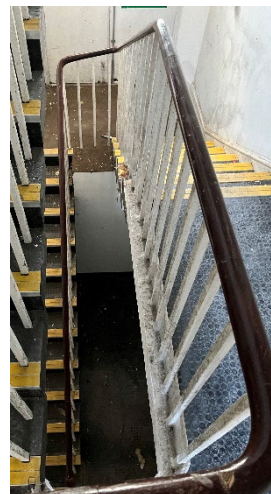
*Staircase 3.*

*Staircase 3 – Surveyors Staircase East of building.* Dark varnished wood, with simple curved wood and minimal detailing. Banister to be cleaned, carefully rubbed down, repair work required in places prior to a dark varnish being reapplied to match existing appearance in colour.

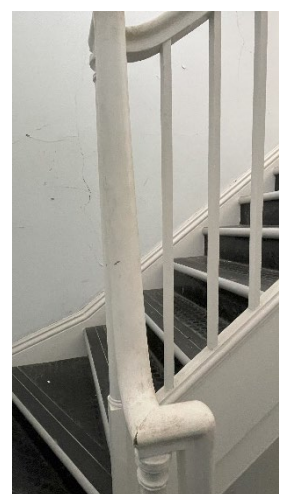
*Staircase 4.*

*Staircase 4 – Staircase to observatory.* White painted curved timber banister. Banister to be cleaned, carefully rubbed down and paint finish reapplied to match existing white colour.

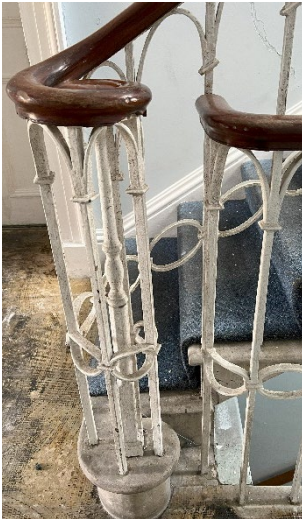
Staircase 1.

*Staircase 1 – Main Staircase Central to building.* White painted metal baluster with ornate detailing fixed into stone risers. Balusters to be cleaned, carefully rubbed down and paint finish reapplied to match existing white colour.

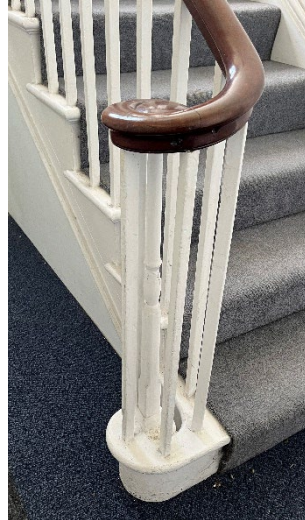
Staircase 2.

*Staircase 2 – Commissioners Staircase West of building.* White painted square timber balusters. Balusters to be cleaned, carefully rubbed down and paint finish reapplied to match existing white colour.

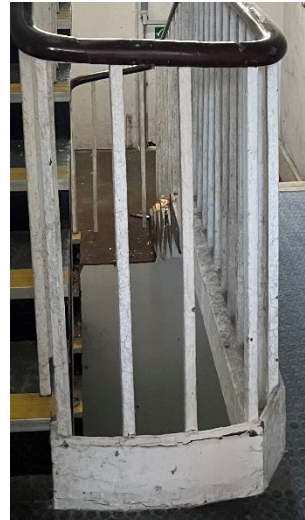
Staircase 3.

*Staircase 3 – Surveyors Staircase East of building.* White painted square timber balusters. Balusters to be cleaned, rubbed down to remove all flaking paint and reapply paint finish to match existing white colour.

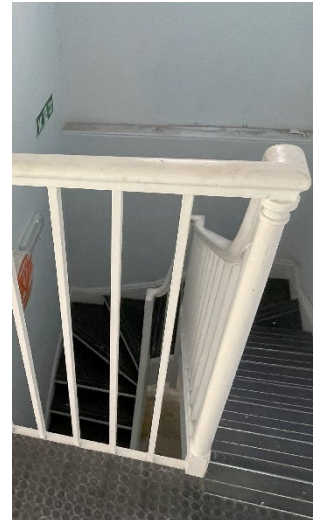
Staircase 4.

*Staircase 4 – Staircase to observatory.* White painted square timber balusters. Balusters to be cleaned, carefully rubbed down and paint finish reapplied to match existing white colour.

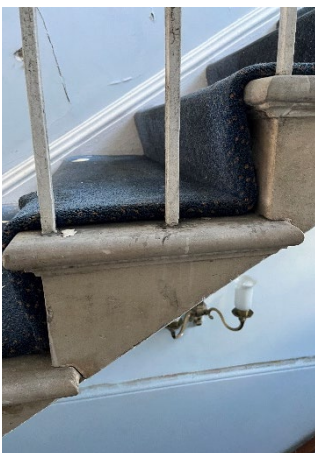
Staircase 1.

**Staircase 1 – Main Staircase Central to building.** Cantilevered stone stair treads and risers. Existing carpet floor finish and underlay to be removed. Extent of proposed carpet floor finish applied to stair is found on the floor finishes drawings. Visible areas of treads and risers to be carefully cleaned removing build-up of dirt.

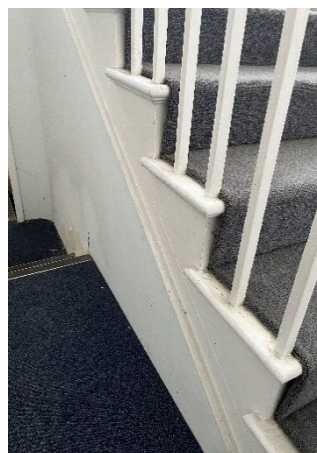
Staircase 2.

**Staircase 2 – Commissioners Staircase West of building.** White painted timber stair treads and risers. Existing carpet floor finish and underlay to be removed. Extent of proposed carpet floor finish applied to stair is found on the floor finishes drawings. Visible areas of treads and risers to be carefully cleaned, rubbed down, and paint finish reapplied to match existing white colour.

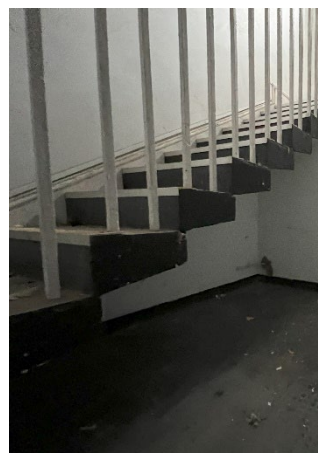
Staircase 3.

**Staircase 3 – Surveyors Staircase East of building.** Stone treads and risers. Vinyl existing floor finish to be removed. Extent of proposed carpet floor finish applied to stair is found on the floor finishes drawings. Visible areas of treads and risers to be carefully cleaned and rubbed down, removing build-up of dirt and black paint. Paint finish to be applied to visible areas.

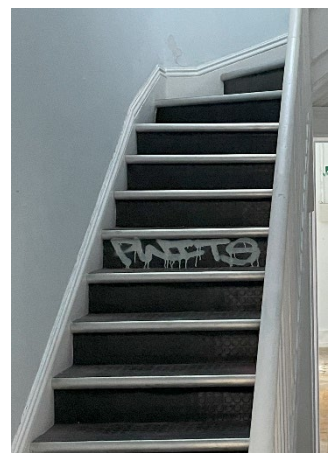
Staircase 4.

**Staircase 4 – Staircase to observatory.** Timber stair treads and risers. Vinyl existing floor finish to be removed. Extent of proposed carpet floor finish applied to stair is found on the floor finishes drawings. Visible areas of treads and risers to be carefully cleaned, rubbed down, and paint finish applied to match existing white colour of rest of staircase.
