## Arboricultural Report

### Tree Condition Assessment

**46 Timber Bank  
Vigo  
Kent  
DA13 0SE**

Ref: SA/01/22

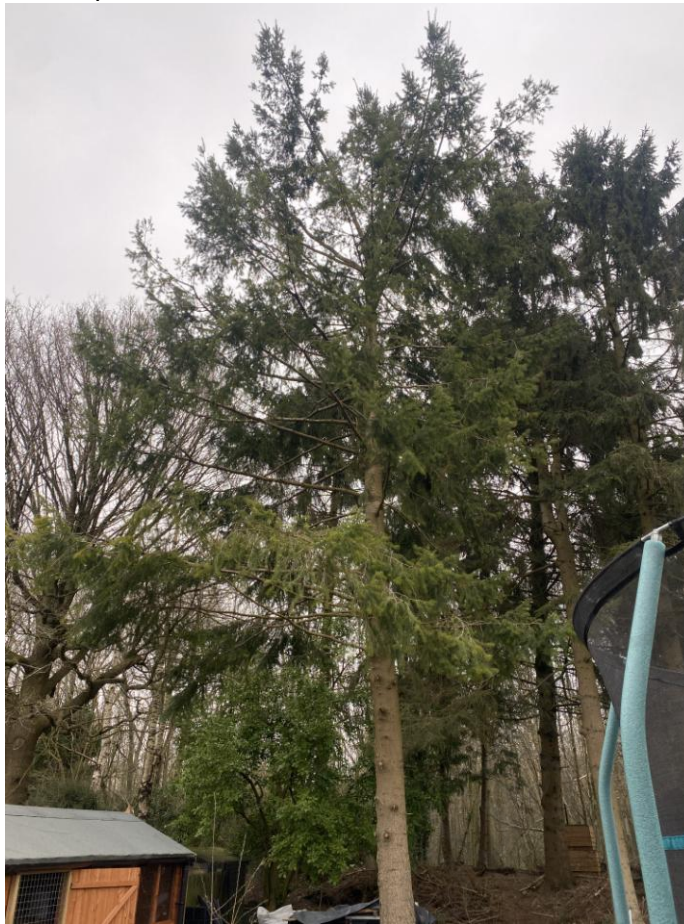
- 4.1.3 This particular tree has had the original top removed at 12m (either due to storm damage or pruning), with side branches now beginning to form multiple vertical leaders from the topping point.

- 4.1.4 This serves to establish a poor structural form that will present the risk of branch failures as these side branches develop to become multiple sub-stems from 12m.

| TPO ID No | SPECIES | HEIGHT (m) | STEM DIA. | AGE CLASS | NOTES / CONDITION | RECOMMENDED MGT. | WORK PRIORITY | INSPECTION FREQUENCY |
|---|---|---|---|---|---|---|---|---|
| T1 | Douglas Fir | 15 | 390 | Semi-mature | <ul style="list-style-type: none"> <li>- Top relatively recently lost at 12m, with whorl of branches beginning to take apical dominance.</li> <li>- Potential for significant growth development.</li> <li>- Bark damage to buttresses to S.</li> <li>- Will outgrow location.</li> </ul> | <ul style="list-style-type: none"> <li>• Fell</li> </ul> | L | 2 |

Photo 1: Tree T1 - Lost top at 12m.

| Tree No. | Species | Recommended Works | Reasons for Works |
|---|---|---|---|
| T1 | Douglas Fir | - Fell and grind stump. | <ul style="list-style-type: none"> <li>The tree is of poor form and will require ongoing management that will be detrimental to the structure and visual amenity of the tree.</li> <li>Will come to outgrow location.</li> </ul> |

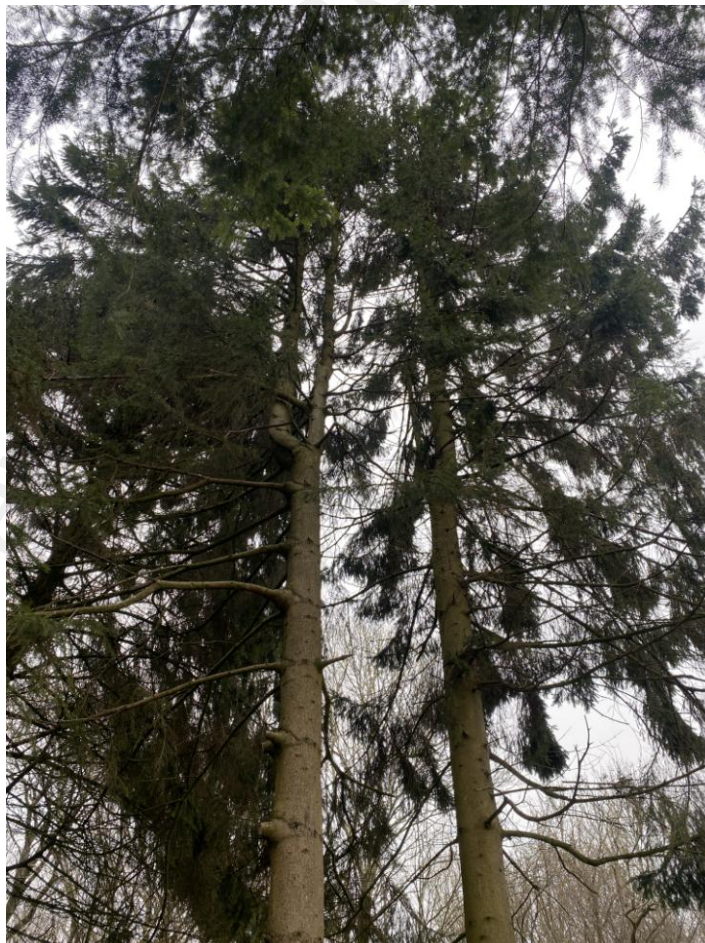
- 4.2.3 The main stems of both T2 and T3 have historically been lost at 8m (either due to storm damage or pruning), from which point two sub-stems have since developed to a current height of approx. 19-20m.

- 4.2.5 As for T1, the loss of the main stems at 8m, combined with the potential for the trees to significantly increase in height, presents structural concerns that result in the need for management intervention to be carried out in order to restrict the growth of the trees.

| TPO ID No | SPECIES | HEIGHT (m) | STEM DIA. | AGE CLASS | NOTES / CONDITION | RECOMMENDED MGT. | WORK PRIORITY | INSPECTION FREQUENCY |
|---|---|---|---|---|---|---|---|---|
| T2 | Norway Spruce | 19 | 370 | Semi-mature | <ul style="list-style-type: none"> <li>- Top historically lost at 8m, 2 x sub-stems developing to 19m.</li> <li>- Companion tree with T3.</li> <li>- Poor form.</li> <li>- Will outgrow location.</li> </ul> | <ul style="list-style-type: none"> <li>• Fell</li> </ul> | L | 2 |
| T3 | Norway Spruce | 20 | 350 | Semi-mature | <ul style="list-style-type: none"> <li>- Top historically lost at 8m, 2 x sub-stems developing, one being of more dominance and reaching 20m.</li> <li>- Companion tree with T2.</li> <li>- Poor form.</li> <li>- Will outgrow location.</li> </ul> | <ul style="list-style-type: none"> <li>• Fell</li> </ul> | L | 2 |

Photo 2: T2 & T3 - Bifurcated at 8m.

| Tree No. | Species | Recommended Works | Reasons for Works |
|---|---|---|---|
| T2-T3 | Norway Spruce x 2 | - Fell and grind stumps. | <ul style="list-style-type: none"> <li>These trees are of poor form and will require ongoing management that will be detrimental to their structure and visual amenity.</li> <li>Will come to outgrow location.</li> </ul> |

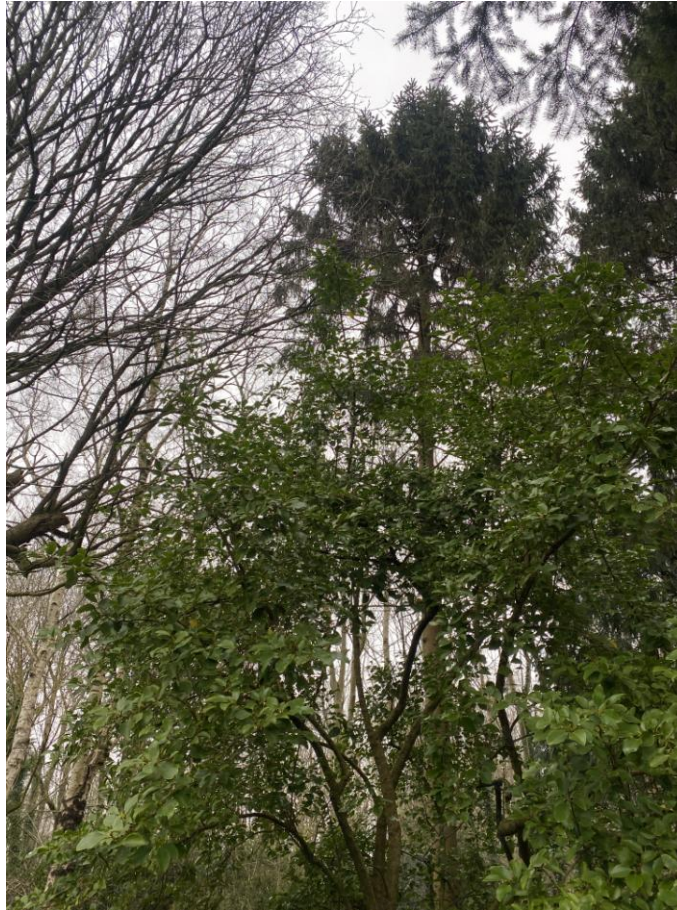
- 4.3.4 The proximity of this tree to the adjacent oak has resulted in the development of the oak canopy being suppressed. This is likely to become more pronounced as T4 continues to develop through to maturity. The further growth of T4 will also increasingly detract from the visual prominence of the higher value oak.

| TPO ID No | SPECIES | HEIGHT (m) | STEM DIA. | AGE CLASS | NOTES / CONDITION | RECOMMENDED MGT. | WORK PRIORITY | INSPECTION FREQUENCY |
|---|---|---|---|---|---|---|---|---|
| T4 | Norway Spruce | 18 | 370 | Semi-mature | <ul style="list-style-type: none"> <li>- Impacting on development of adjacent high value oak tree.</li> <li>- Significant growth potential.</li> <li>- Will outgrow location.</li> </ul> | <ul style="list-style-type: none"> <li>• Fell</li> </ul> | L | 2 |

Photo 3: T4 - Impacting on development of adjacent oak, will come to dominate.

| Tree No. | Species | Recommended Works | Reasons for Works |
|---|---|---|---|
| T4-T5 | Norway Spruce x 2 | - Fell and grind stumps. | <ul style="list-style-type: none"> <li>Will come to significantly outgrow the setting and dominate the small garden setting.</li> </ul> |

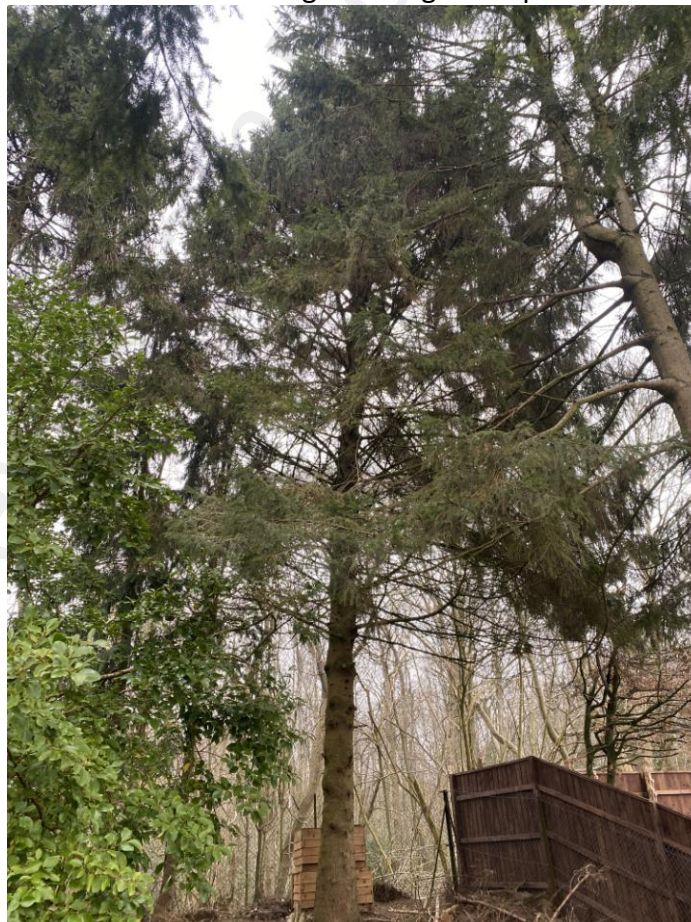
- 4.4.3 T5 is the most dominant tree of the five trees in the garden, being of good form and vigorous physiological condition. This suggests that there would be no reason to expect the tree to not attain full height potential at maturity.

| TPO ID No | SPECIES | HEIGHT (m) | STEM DIA. | AGE CLASS | NOTES / CONDITION | RECOMMENDED MGT. | WORK PRIORITY | INSPECTION FREQUENCY |
|---|---|---|---|---|---|---|---|---|
| T5 | Norway Spruce | 18 | 530 | Semi-mature | <ul style="list-style-type: none"> <li>- Dominant and vigorous individual with significant growth potential.</li> <li>- Will outgrow location.</li> </ul> | <ul style="list-style-type: none"> <li>• Fell</li> </ul> | L | 2 |

Photo 4: T5 - Large dominant tree with significant growth potential.
